**2802 Whitis Ave.**

***Austin, TX***

Report #: 54498-0

**RESERVE STUDY**

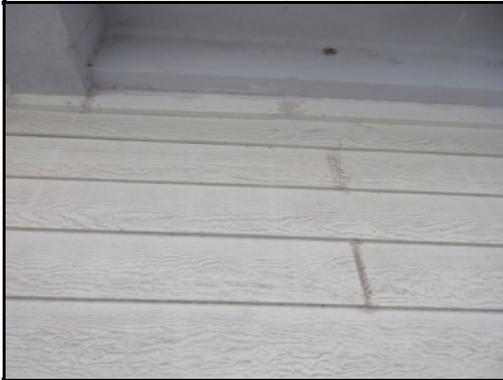
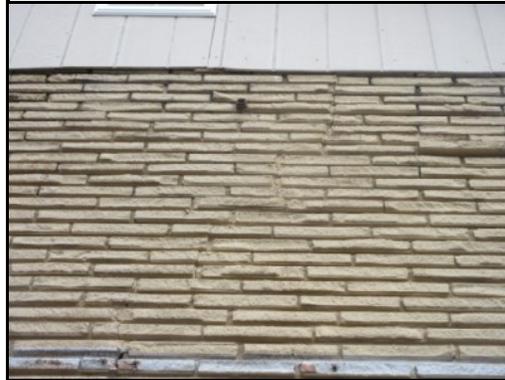
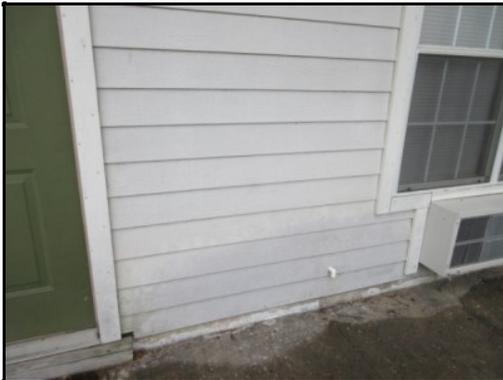
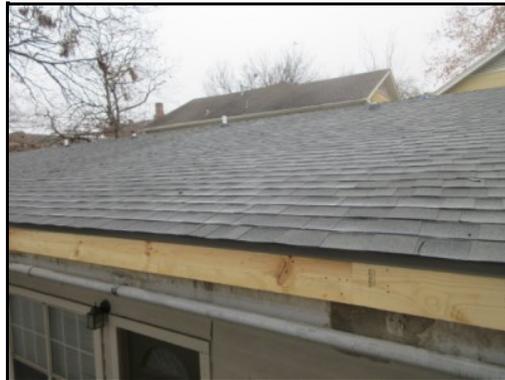
During our site visit on 1/28/2025, we started with a brief meeting with the Russell Artman, and then started the site inspection beginning with the building exteriors. We thank them for their assistance and input during this process. During our inspection, we visually inspected and were able to see all common areas. Please refer to the Component Details section at the end of this document for additional photos, observations and other information regarding each component.

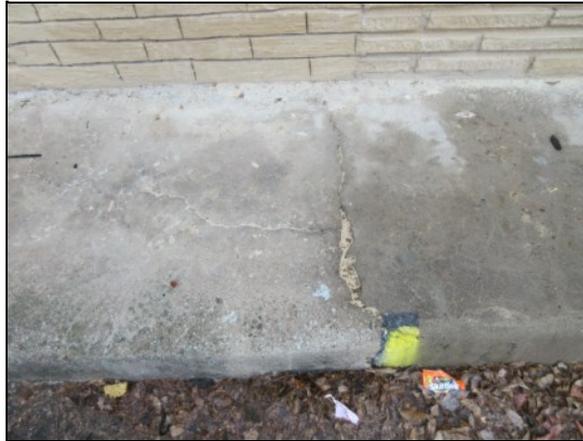
**Comp #: 206 Concrete: Surfaces - Repair**

Comments: Funding for the repair of 10% of the total surface area or ~ 274 GSF.

Fair condition: Concrete surfaces determined to be in fair condition typically may exhibit small changes in slope and narrow “hair-line” wide cracks. Overall, no unusual or extreme signs of age noted. Evidence of past grinding/repairs may have also been evident at the time of inspection. Some areas show more advanced deterioration.

Driveways are reported to be the maintenance, repair, and replacement responsibility of the client. All areas should be inspected periodically to identify potential trip hazards or other safety issues. Concrete maintenance typically consists of pressure washing, crack repairs, and replacement of small sections as-needed. Exposure to sunlight, weather, and frequent vehicle traffic can lead to larger, more frequent repairs, especially for older properties. Although life expectancy for comprehensive replacement has been deemed to be too indeterminate for reserve designation, conditions observed merit inclusion of an allowance for ongoing repairs and partial replacements. Timeline and cost ranges shown here should be re-evaluated during future reserve study updates, and adjustments made based on the most current information available at that time.

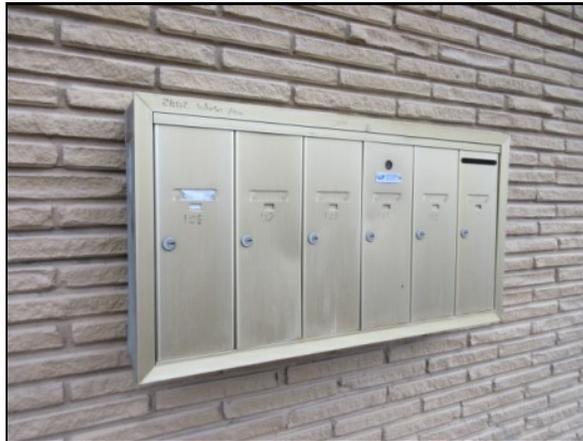
**Comp #: 403 Mailboxes - Replace**

Comments: Fair condition: Mailboxes determined to be in fair condition typically exhibit some amount of surface wear and/or rusting, but remain in serviceable and generally decent aesthetic condition.

The client is reported to be responsible for maintenance, repair, and replacement of mailboxes throughout the property/development. Individual home owners may be responsible for routine upkeep. Mailboxes should be inspected periodically for damage, vandalism, etc. and repaired as-needed. We recommend replacement at the approximate interval shown below. Unless otherwise noted, cost estimates are based on replacement with comparable sizes and styles. However, a wide variety of replacement options are available and this component should be adjusted if the client expects to replace with a different size and/or style.

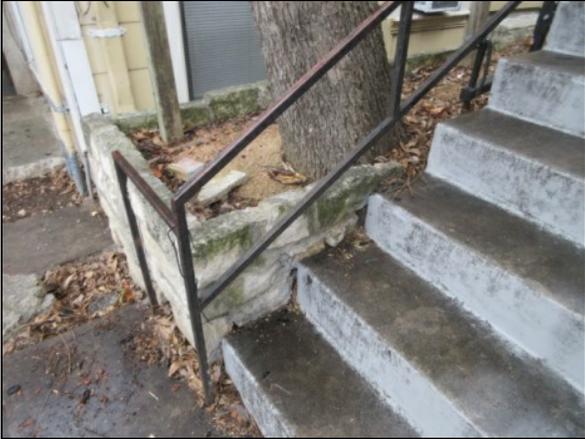
**Comp #: 114 Railings: Metal - Repair/Replace**

Comments: Cost estimates related to this component are not expected to meet the minimum threshold for reserve funding. As such, costs related to this component are expected to be included in the client's operating budget. Therefore, there is no recommendation for reserve funding at this time. However, any repair and maintenance or other related expenditures should be tracked, and this component should be re-evaluated during future reserve study updates based on the most recent information and data available. If deemed appropriate for reserve funding, components can be included in the funding plan at that time.

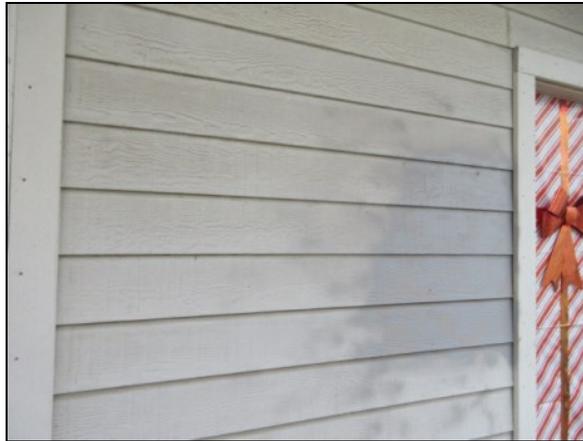
Comments: Poor condition: Painted exterior surfaces determined to be in poor condition typically exhibit clearly noticeable aesthetic concerns such as staining, fading, inconsistent color and texture, etc. Physically, paint/coatings in poor condition may be peeling and cracking in many locations, may no longer be adhering properly to the painted surface, or otherwise are otherwise no longer providing effective protection to the structure.

There are two important reasons for painting and waterproofing a building: to protect the structure from damage caused by exposure to the elements, and to restore or maintain good aesthetic standards for curb appeal. As routine maintenance, we recommend that regular inspections, spot repairs and touch-up painting be included in the operating budget. Typical paint cycles can vary greatly depending upon many factors including; type of material painted, surface preparations, quality of material, application methods, weather conditions during application, moisture beneath paint, and exposure to weather conditions. Proper sealant/caulking at window and door perimeters and other "gaps" in the building structure are critical to preventing water intrusion and resulting damage. The general rule of thumb is that sealant/caulking should be in place wherever two dissimilar building surfaces meet, such as window frame to concrete structure junctions. For best results, the client may want to consult with a paint company representative, building envelope specialist and/or structural engineer to specify the types of materials to be used and define complete scope of work before bidding. In our experience, cost estimates for painting and waterproofing can vary widely, even when based on the same prescribed scope of work. Estimates shown here should be updated and revised as needed based on actual bids obtained or project cost history during future reserve study updates.

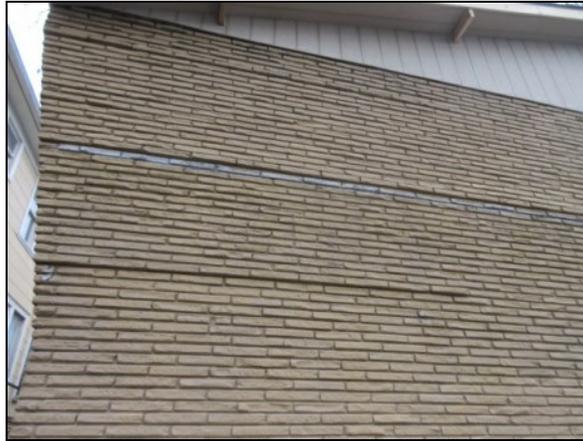
**Comp #: 1126 Siding: Brick - Repair/Repoint**

Comments: Funding for the repair of 20% of the total surface area or ~ 126 GSF.

Fair Condition: There appeared to be some cracking and deteriorated mortar on the brick siding. Overall, the siding is in fair condition.

Brick or other masonry siding is typically a low maintenance surface that requires minimal, infrequent repair. However, in some cases (usually after several decades or more), the original mortar between bricks may require repointing to restore appearance and adequately protect against water intrusion. Repointing involves taking out a portion of the existing mortar and installing new mortar and continuing on until all affected sections have been replaced. Timeline and cost estimates shown here are recommended for budgeting purposes. We strongly recommend further inspection by a qualified engineer and/or masonry specialist to diagnose existing conditions and recommend a formal scope of work. If new information is obtained by the client, the reserve study should be adjusted as-needed going forward.

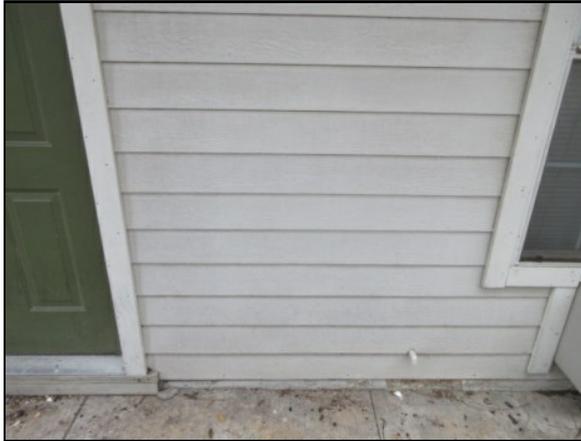
**Comp #: 1128 Siding: Fiber Cement - Replace**

Comments: Good condition: Fiber cement siding/trim sections determined to be in good condition typically exhibit vibrant, consistent color and little or no signs of damage, deterioration, etc.

Association Reserves does not specifically endorse any products, manufacturers or vendors, but James Hardie Building Products, Inc. is the leading manufacturer of fiber cement siding, and their website ([www.jameshardie.com](http://www.jameshardie.com)) is an informative resource for proper care and maintenance of fiber cement siding. Their "Best Practices" guidelines offer specific guidelines for materials to be used; we strongly recommend complying with recommendations specific to your geographical area. We recommend that the association consult with qualified exterior painting/waterproofing consultants and/or contractors to ensure that proper materials are used in painting and sealing the building siding.

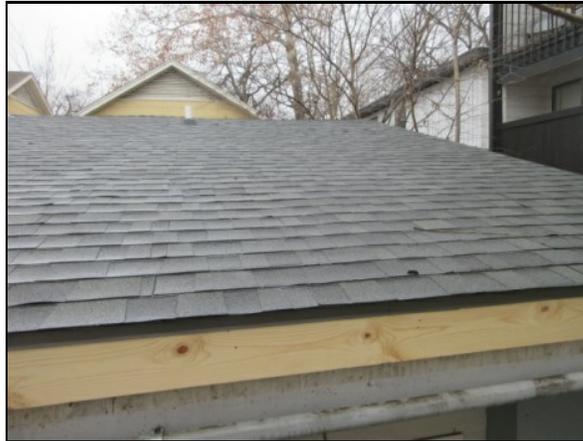
**Comp #: 1303 Roofing: Asphalt Shingle - Replace**

Comments: Good condition: Asphalt shingle roofs determined to be in good condition typically exhibit few or no signs of curling/cupping of shingles, and granule cover appears to be thick and consistent. Little to no organic growth or staining patterns evident, and no unusual or significant leaks reported. Shingles and flashing appear to provide good coverage to all areas, especially at intersection points and around any penetrations.

As routine maintenance, many manufacturers recommend inspections at least twice annually and after large storm events. Promptly replace any damaged/missing sections or conduct any other repair needed to ensure waterproof integrity of roof. Keep roof surface, gutters and downspouts clear and free of moss or debris. Moss growth can decrease the life of the roofing shingles and should be removed promptly. We recommend having roof inspected in greater detail (including conditions of sub-surface materials) by an independent roofing consultant prior to replacement. There is a wealth of information available through organizations such as the Roof Consultant Institute <http://www.rci-online.org/> and the National Roofing Contractors Assn. (NRCA) <http://www.nrca.net/>. If the roof has a warranty, be sure to review terms and conduct proper inspections/repairs as needed to keep warranty in force. Dimensional shingles typically have longer useful lives and are generally considered to be more valuable from an aesthetic standpoint. We recommend budgeting to replace with dimensional shingles upon failure. Also known as architectural shingles, these types of roofs are typically more durable and wind-resistant than 3-tab shingles. Remaining useful life is based on consideration of installation/replacement date, evident visual conditions, and/or repair history provided by the Client. Unless otherwise noted, costs shown here assume that only a minimal amount of substrate/decking repairs or replacement will be required. For very old roofs or those with significant leak problems, additional repair costs may be incurred.

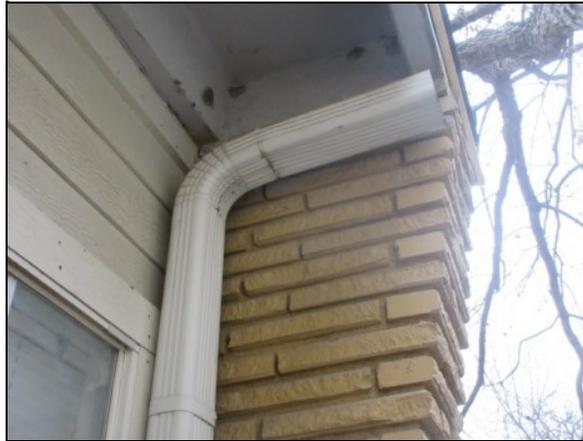
**Comp #: 1310 Gutters/Downspouts - Replace**

Good condition: Gutters and downspouts determined to be in good condition typically exhibit little to no significant surface wear or deterioration of material. No obvious sagging or tilting sections. Attachments to building appear to be strong and stable.

Gutters and downspouts are assumed to be functioning properly unless otherwise noted. As routine maintenance, inspect regularly, keep gutters and downspouts free of debris. If buildings are located near trees, keep trees trimmed back to avoid accumulation of leaves on the roof surface which will accumulate in the gutters and increase maintenance requirements while reducing life expectancy. Repair or replace individual sections as needed as an Operating expense. We generally recommend that the gutters and downspouts be replaced when the roof is being resurfaced/replaced. National Roofing Contractor Association (NRCA) roofing standard includes installing eave flashings at the gutters. We suggest to plan for total replacement of gutter and downspouts at the same intervals as roof replacement for cost efficiency. Unless otherwise noted, costs shown here assume replacement with similar type as are currently in place.
