MARION

February 1, 2023

SITE READINESS REPORT

**Report of Site Reconnaissance Study
and Preliminary Geotechnical Engineering
Investigation
Proposed Industrial Site Development
Marion, Arkansas
Patriot Project No. 5-06-1500**

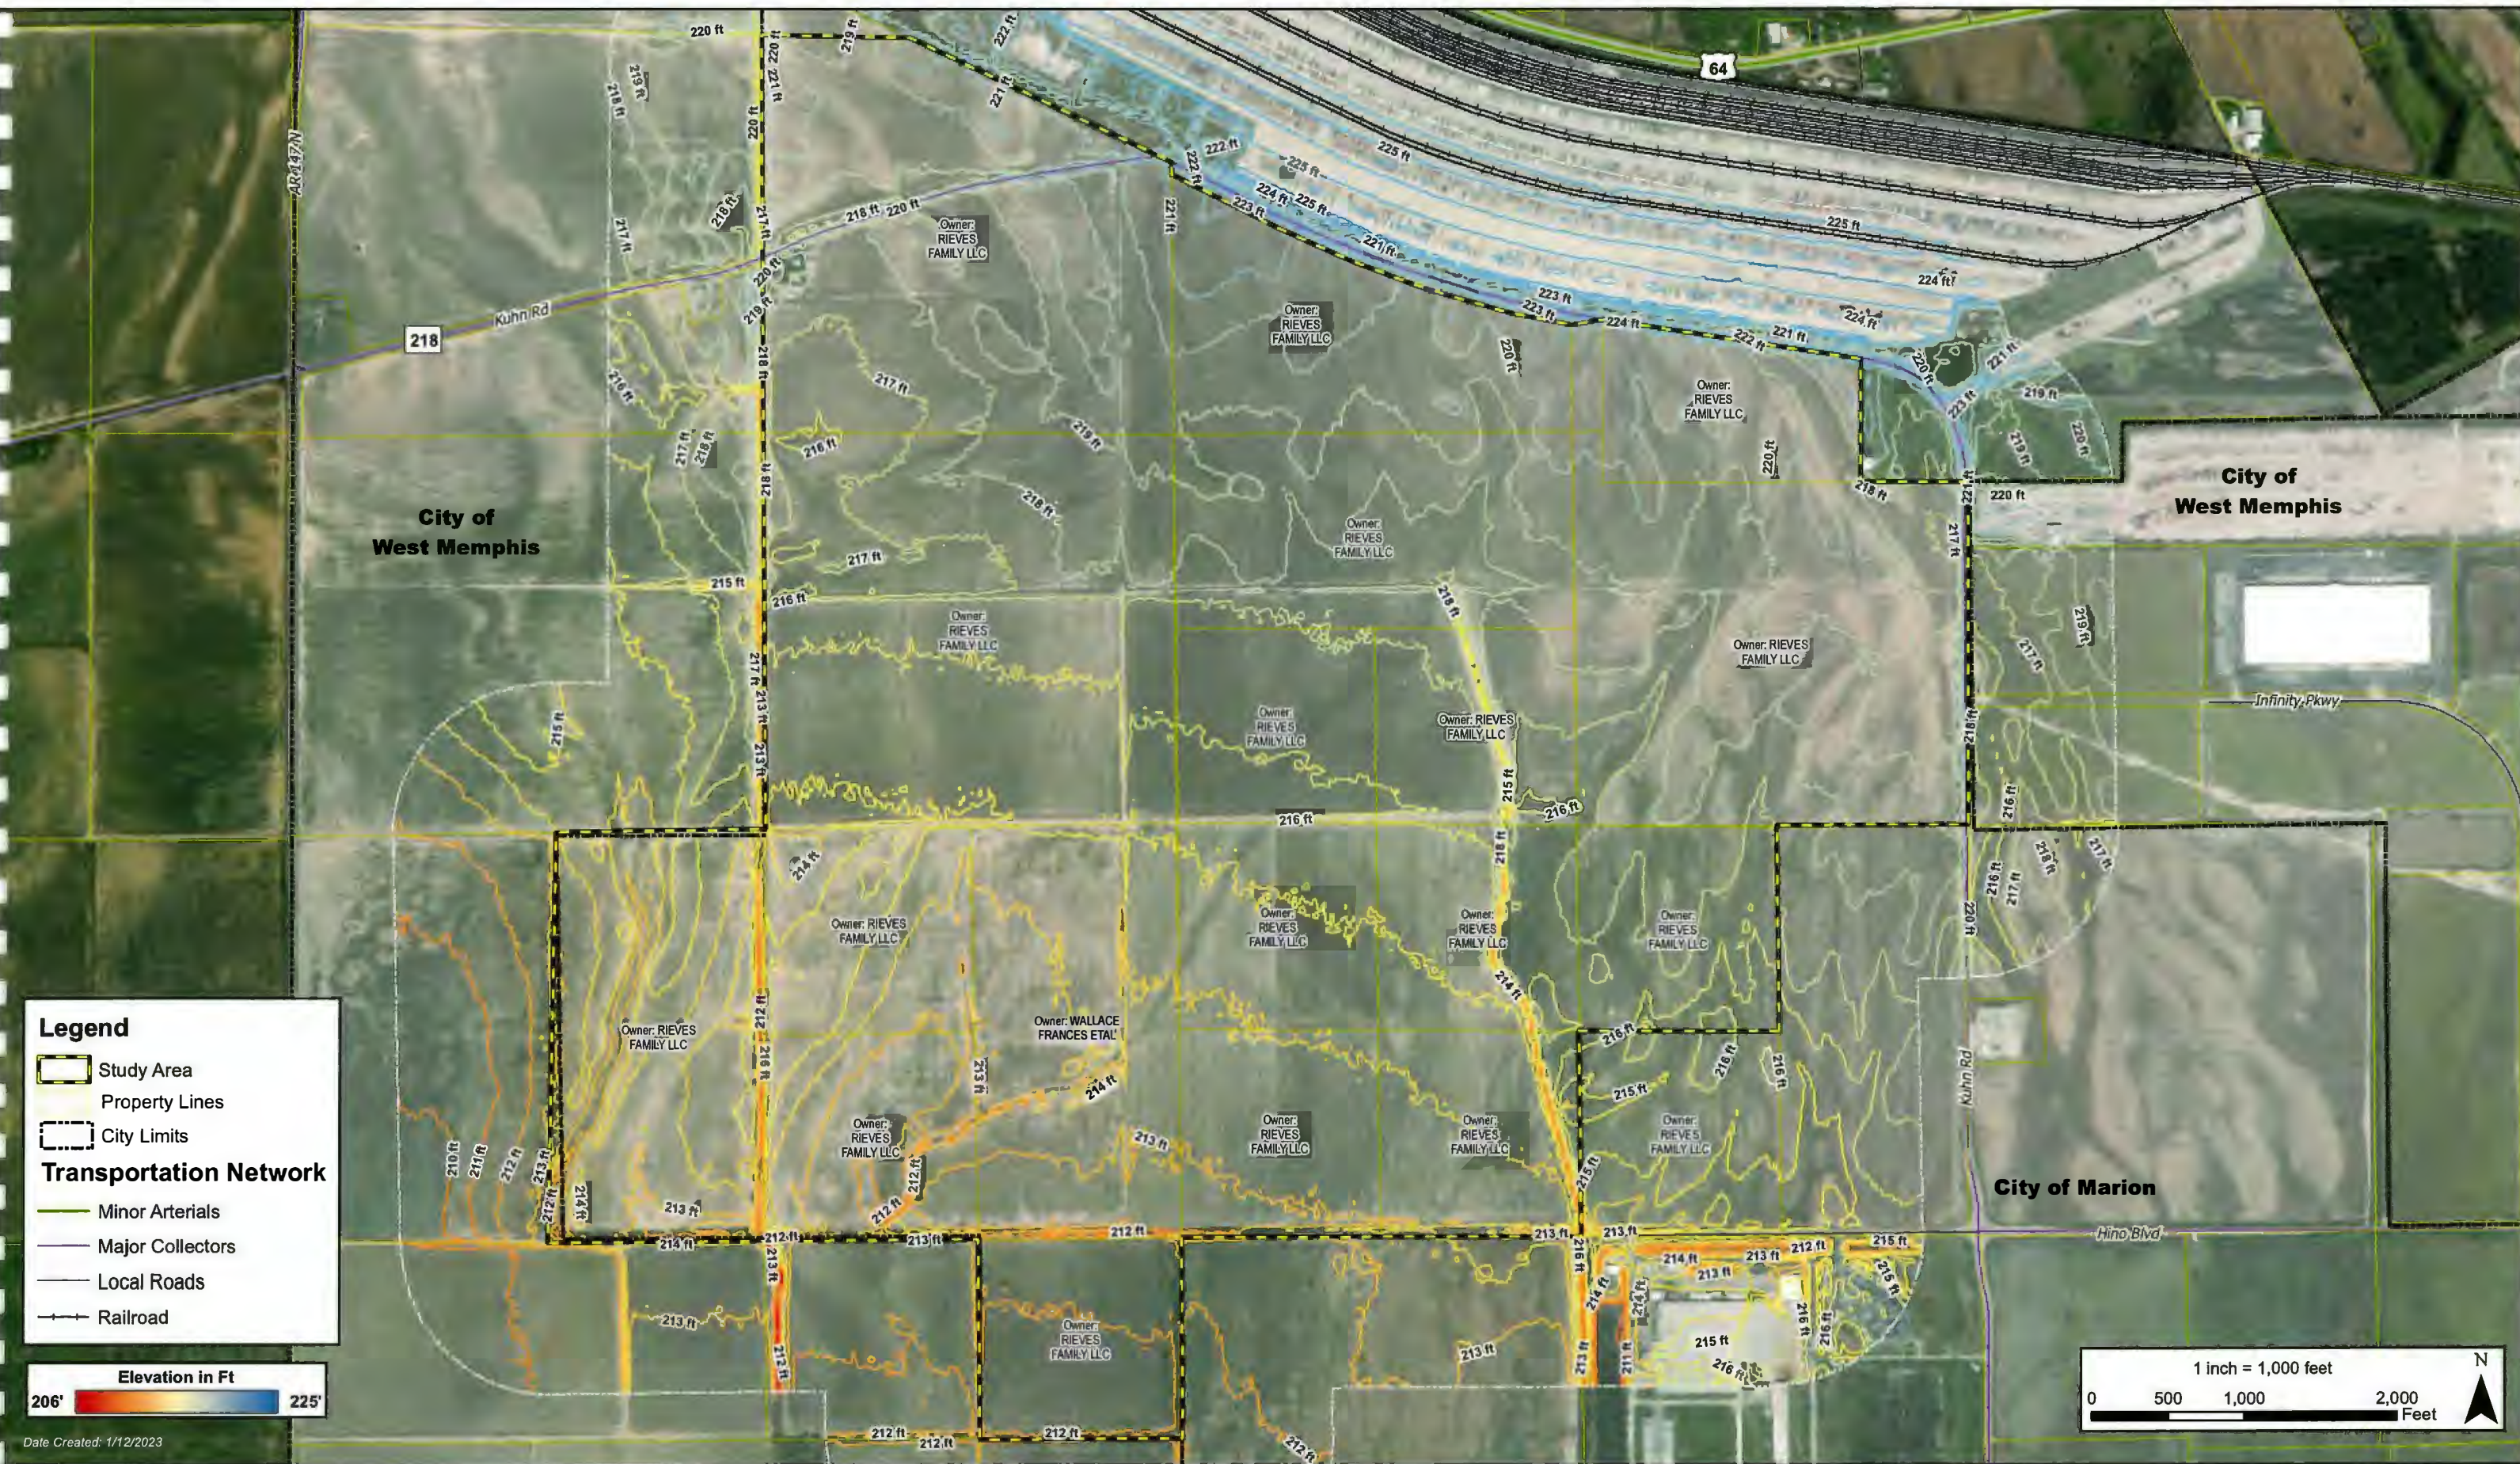
1-FT CONTOUR MAP

- Per the USGS Contour database, site topography and drainage patterns are as follows:
 - The site is essentially flat with average slopes less than 1% from north to south, dropping about 7 feet in elevation over approximately ~7,500 feet horizontally.
 - There appears to be roadside ditches along the gravel roads that segment the Site into parcels/fields.
 - There are multiple treelined hedgerows that run north to south on the property that may function as a swale that drains the south of the site.

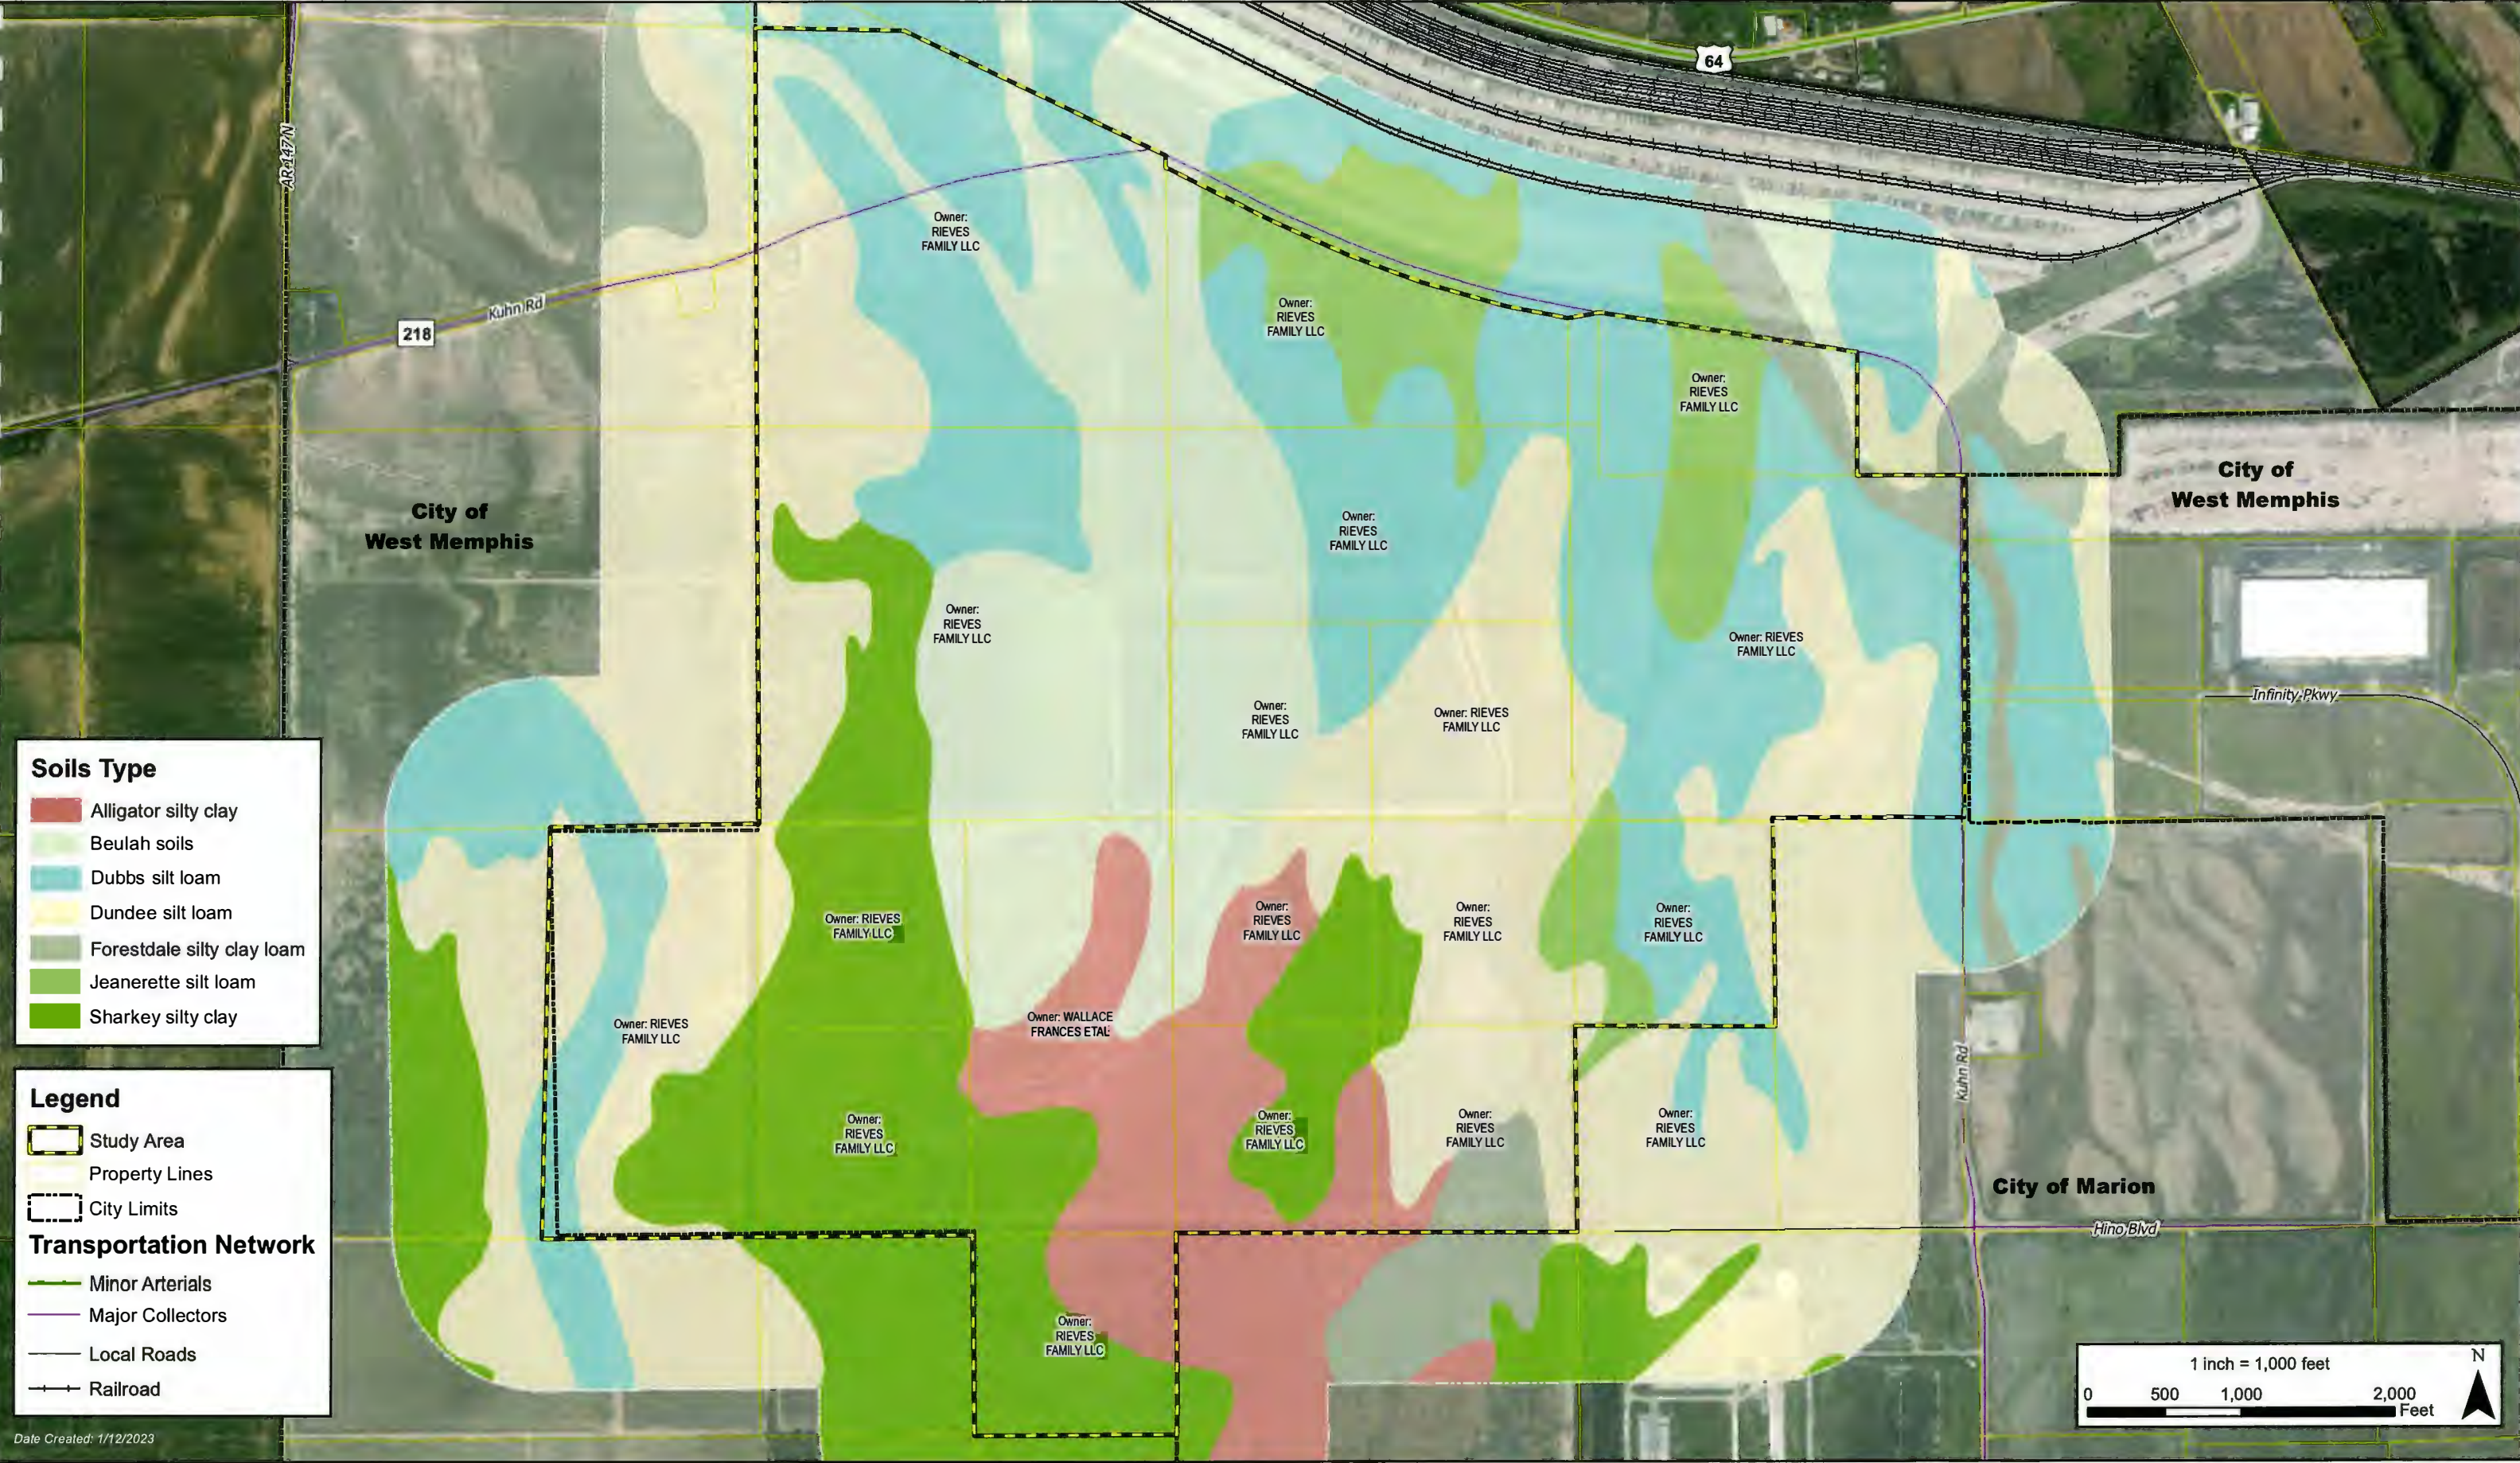
Soils Type

- Alligator silty clay
- Beulah soils
- Dubbs silt loam
- Dundee silt loam
- Forestdale silty clay loam
- Jeanerette silt loam
- Sharkey silty clay

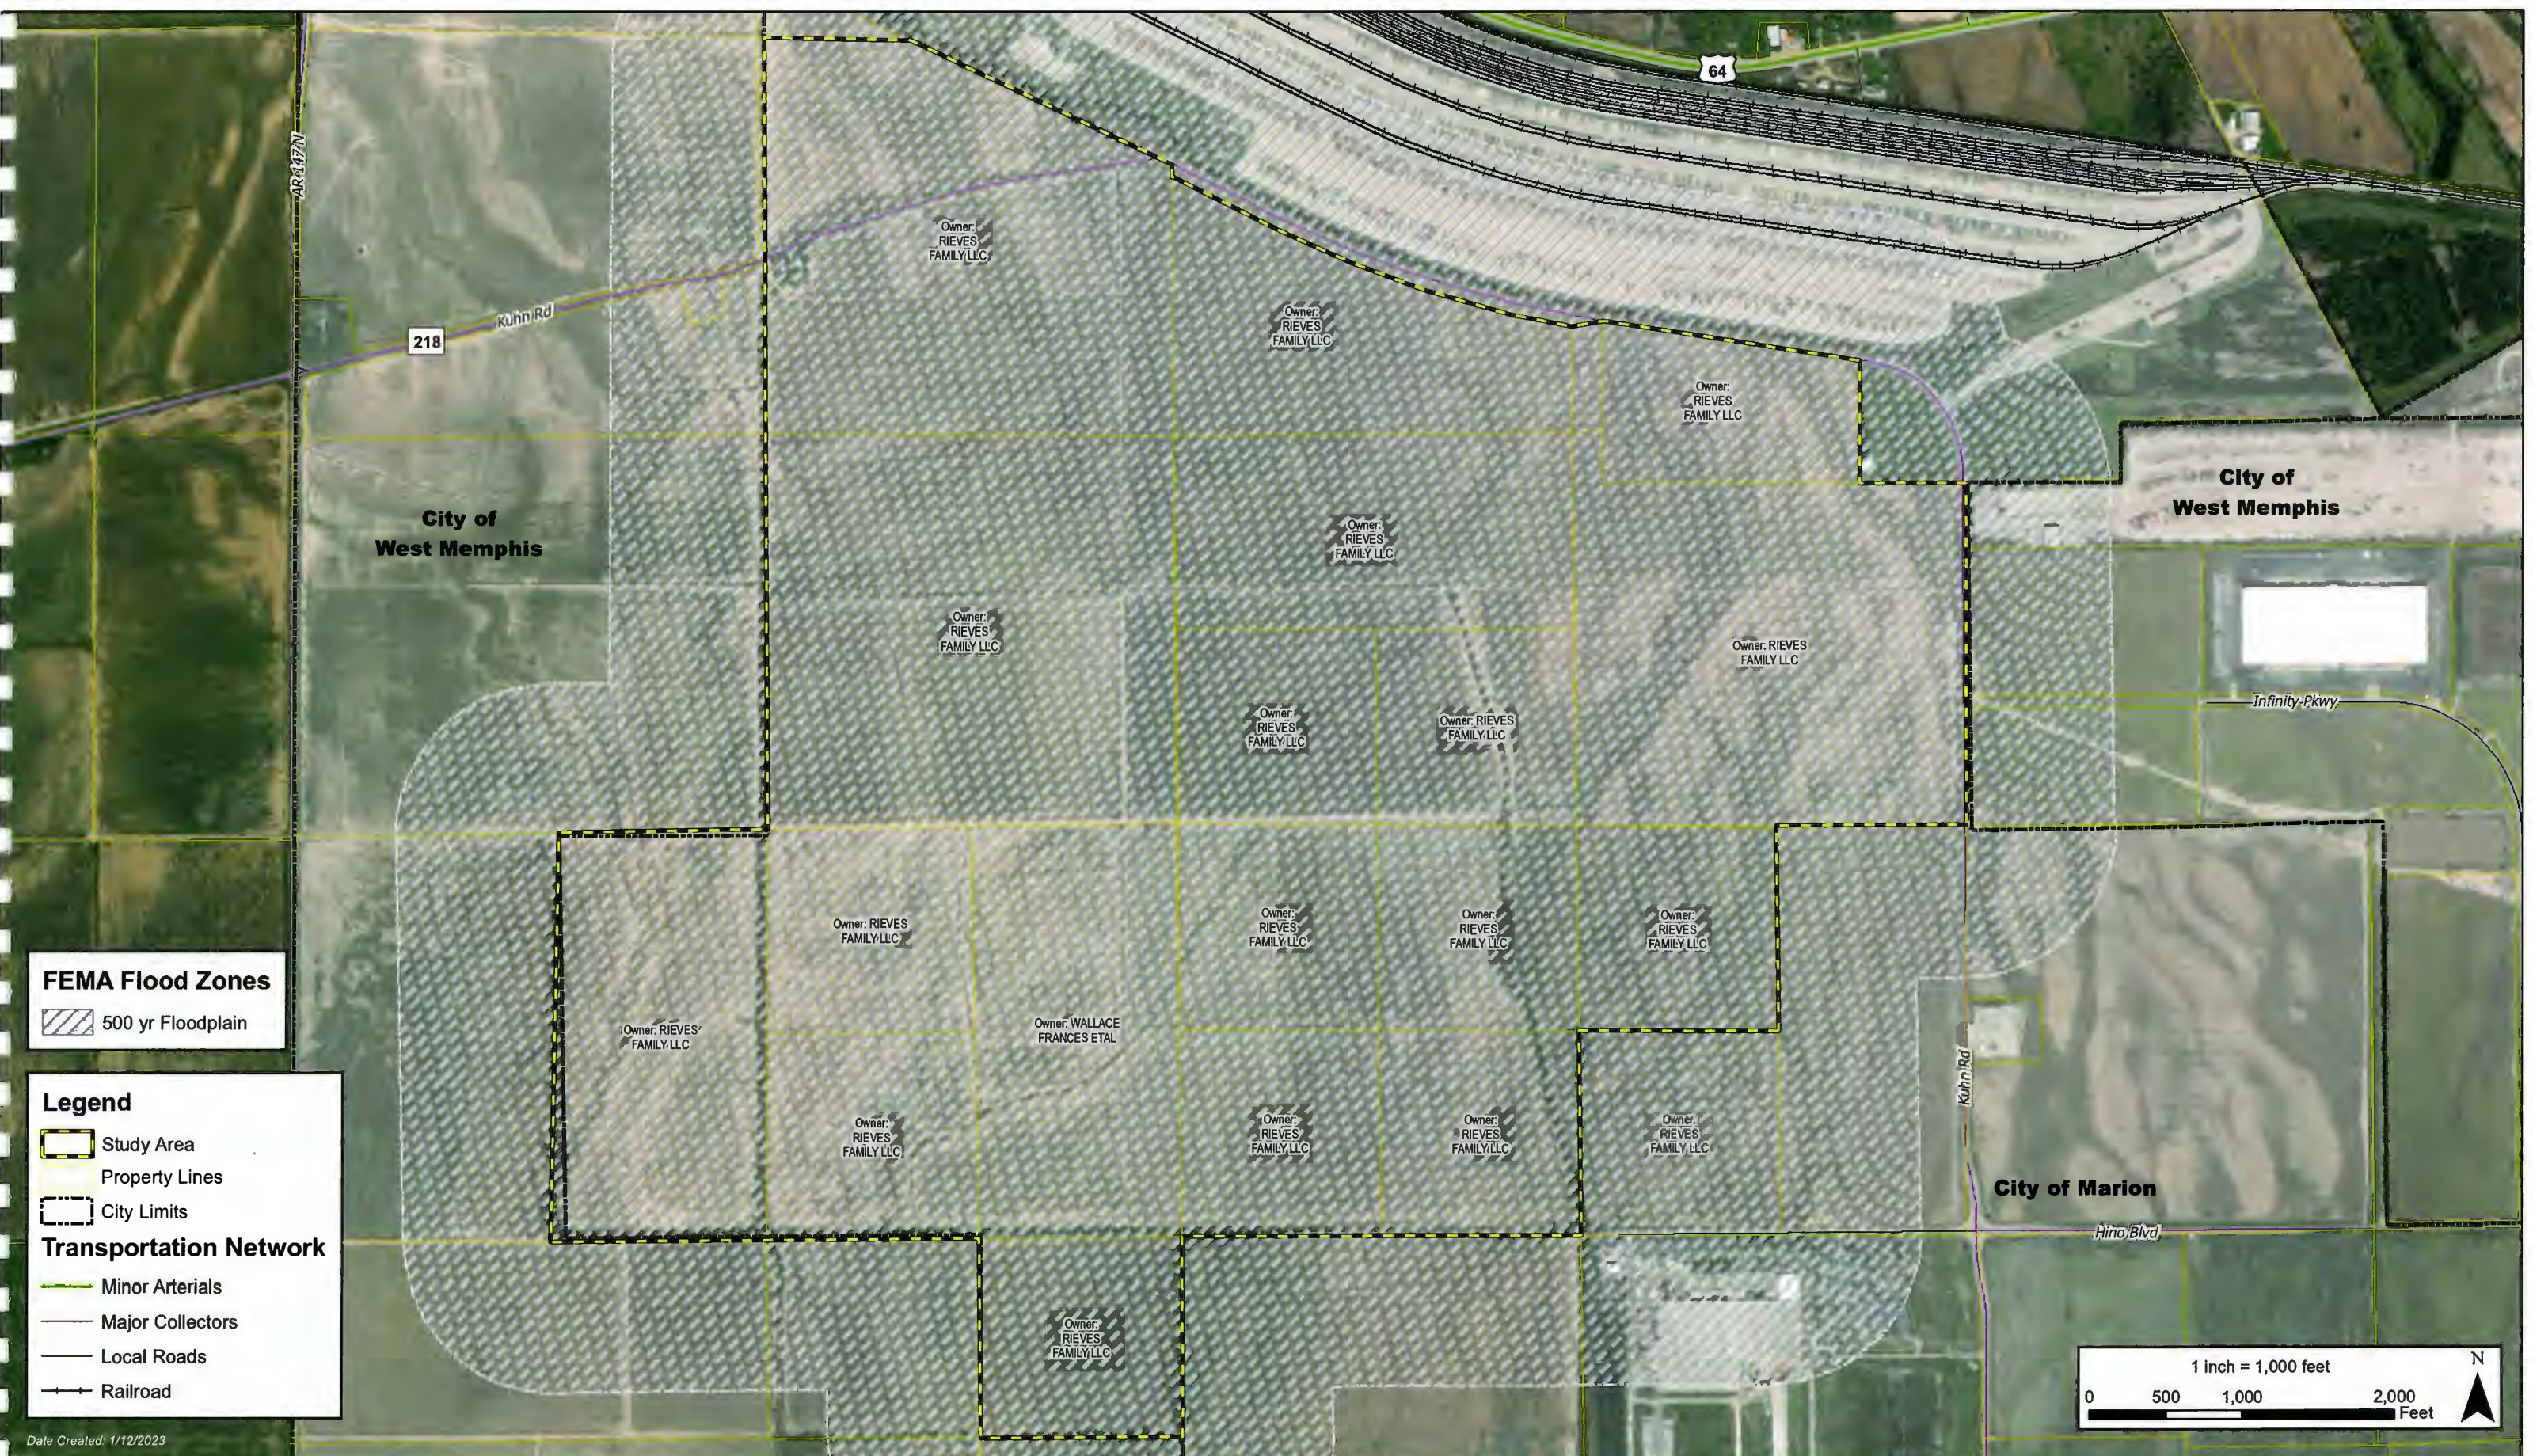
FEMA Flood Zones

500 yr Floodplain

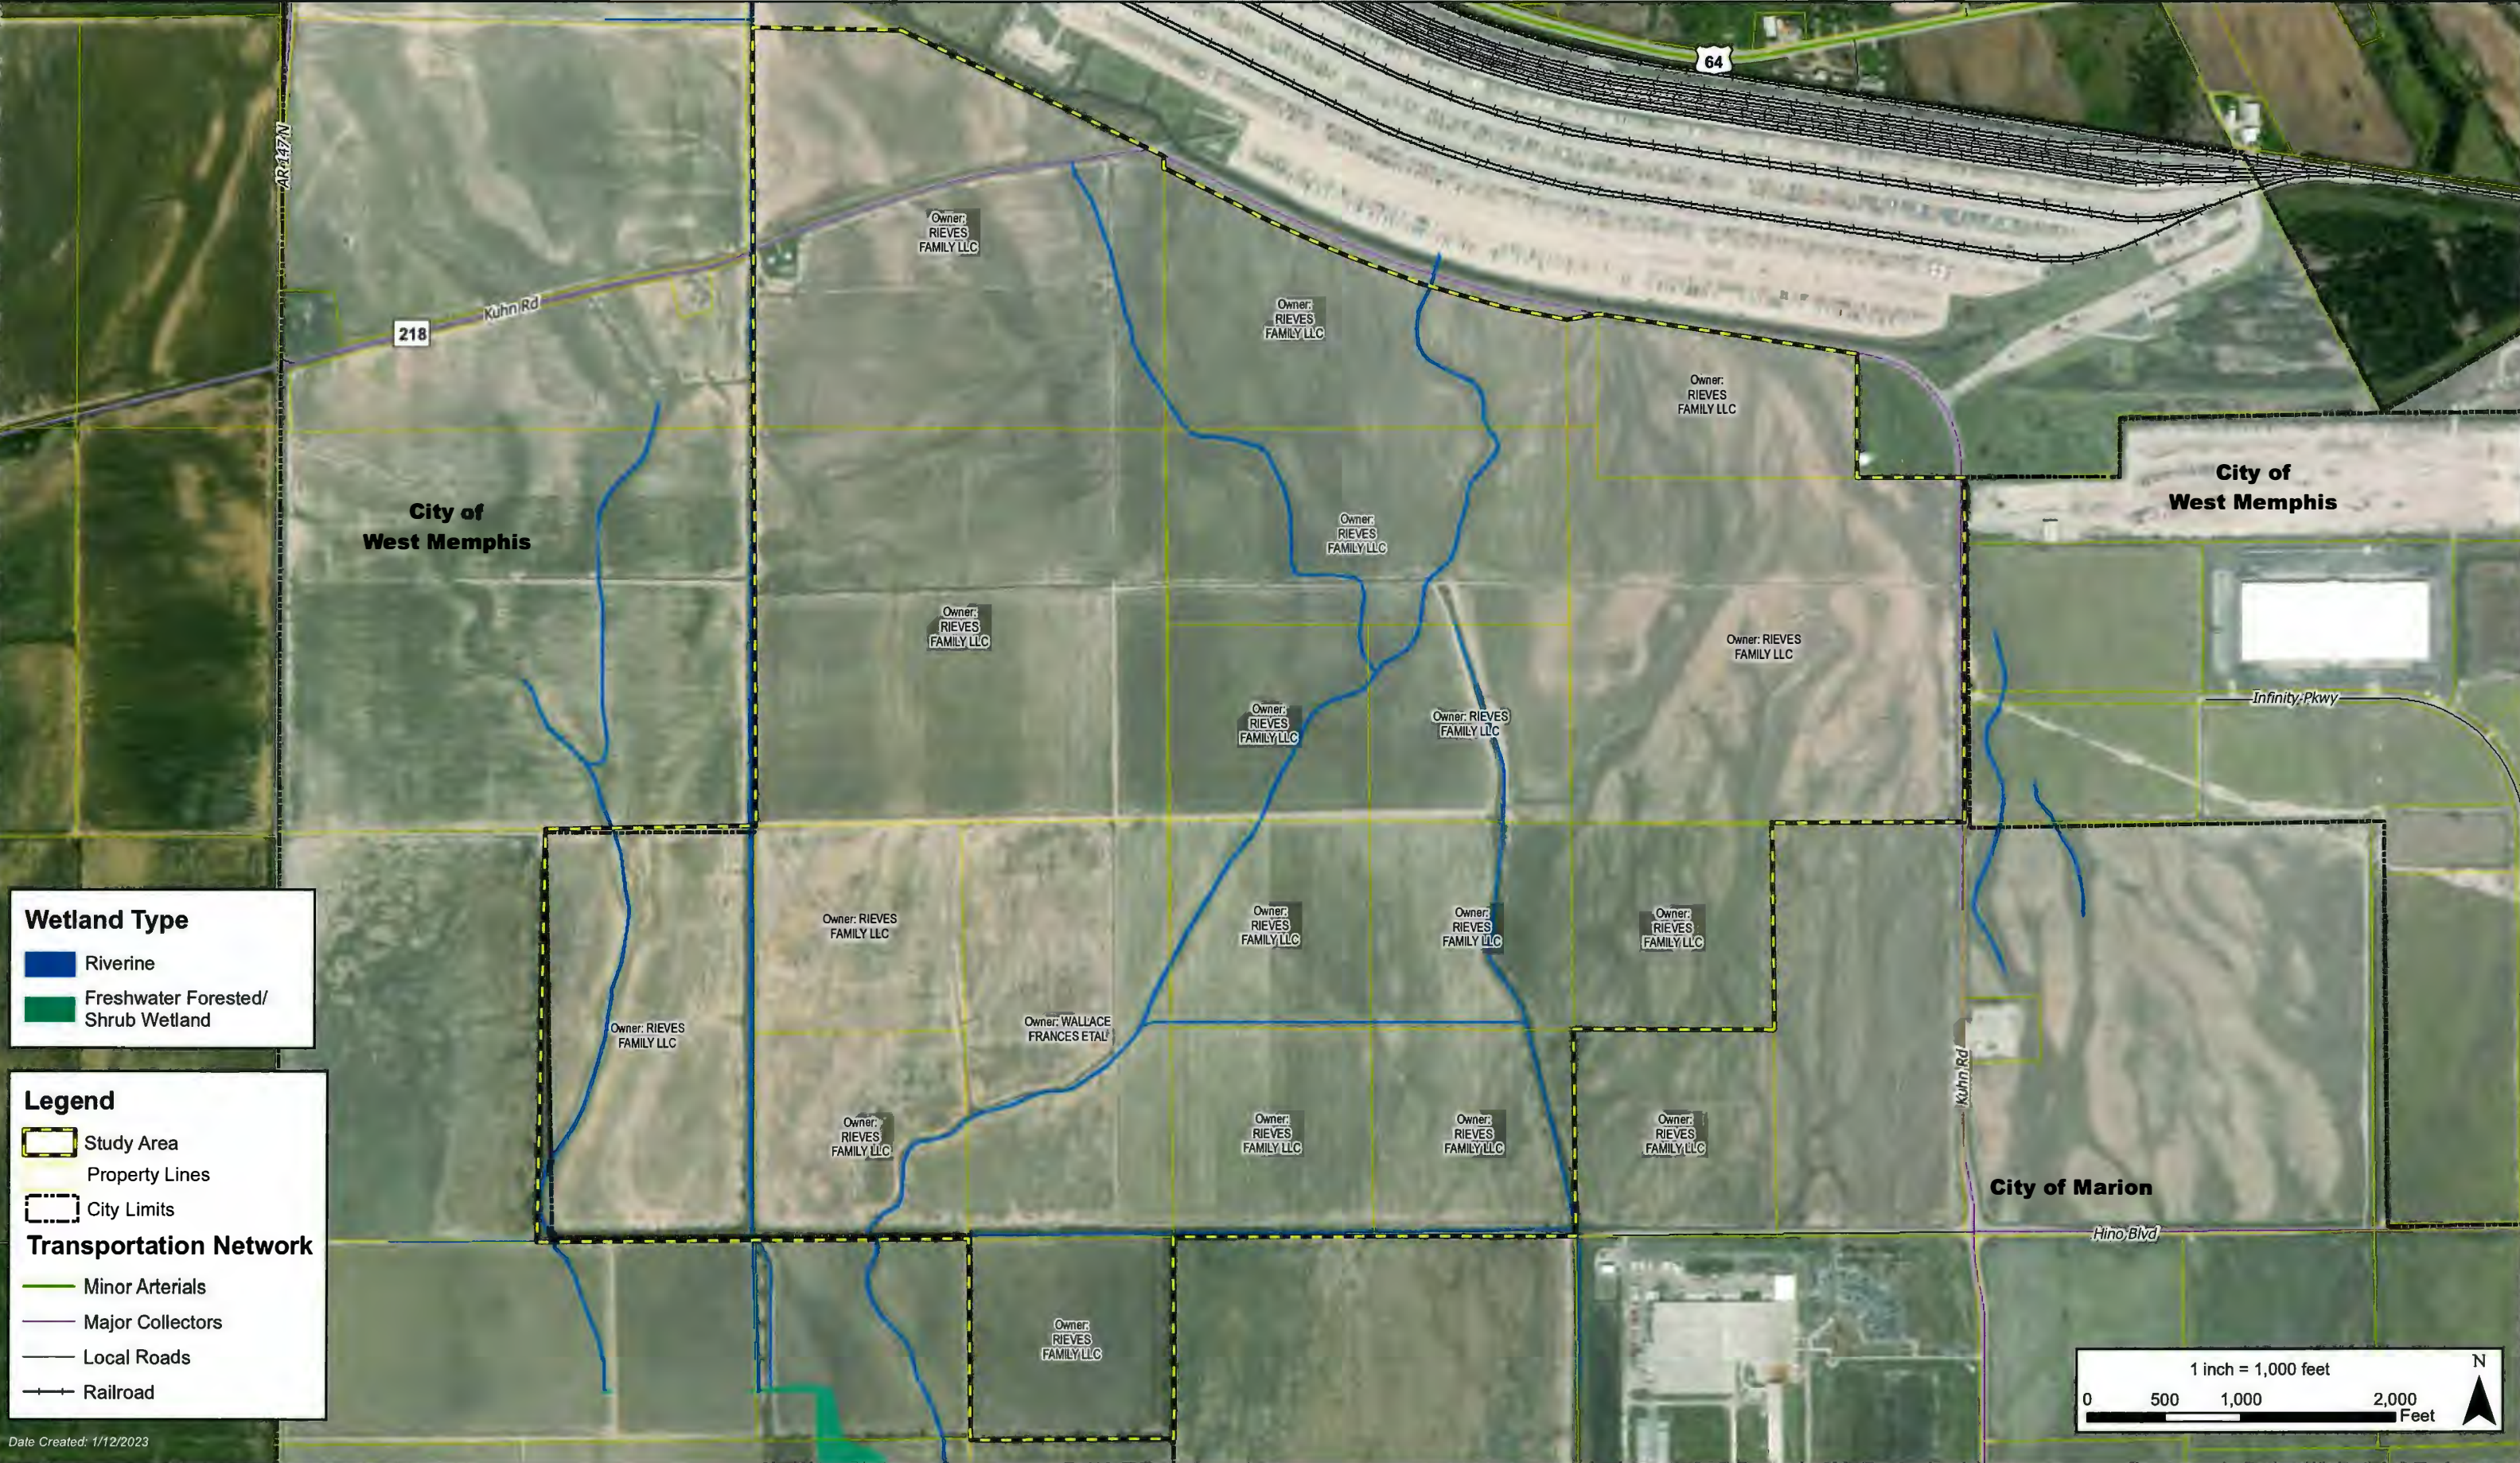
Wetland Type

- █ Riverine
- █ Freshwater Forested/ Shrub Wetland

A full wetland delineation is recommended prior to any development on the Site as well as getting a current Approved Jurisdictional Determination (AJD) from the Army Corps of

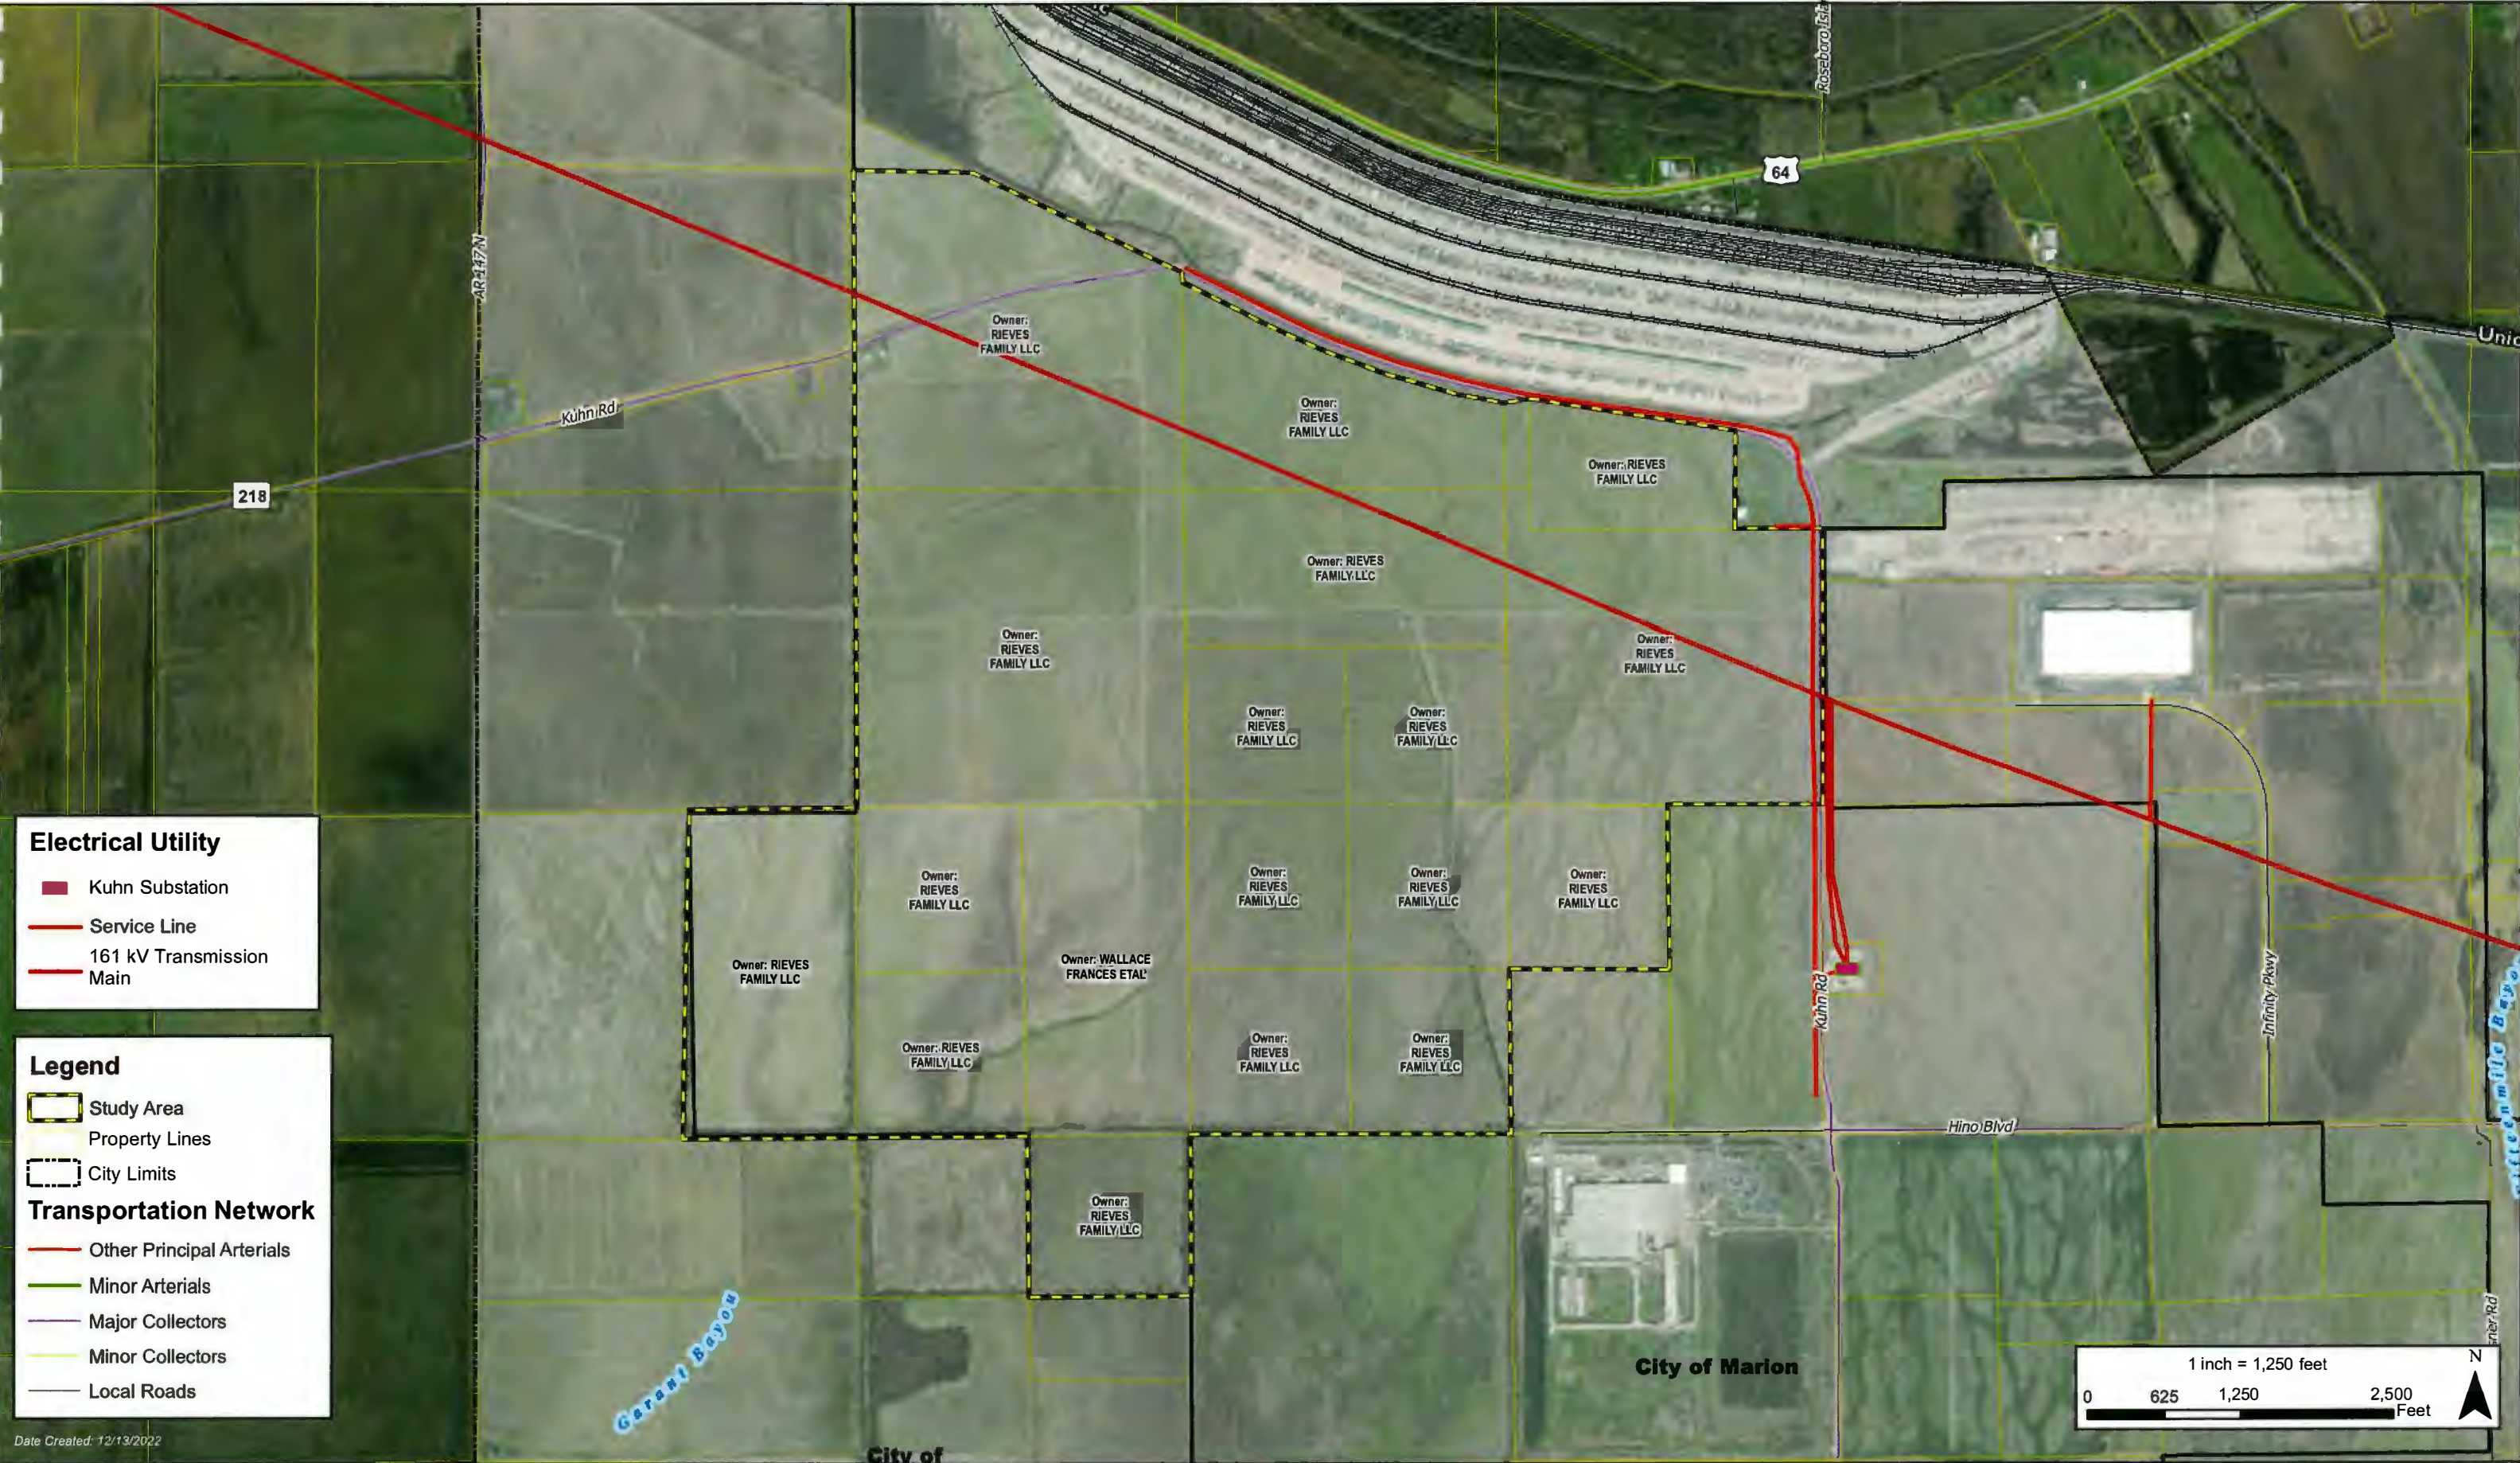
Electrical Utility

- Kuhn Substation
- Service Line
- 161 kV Transmission Main

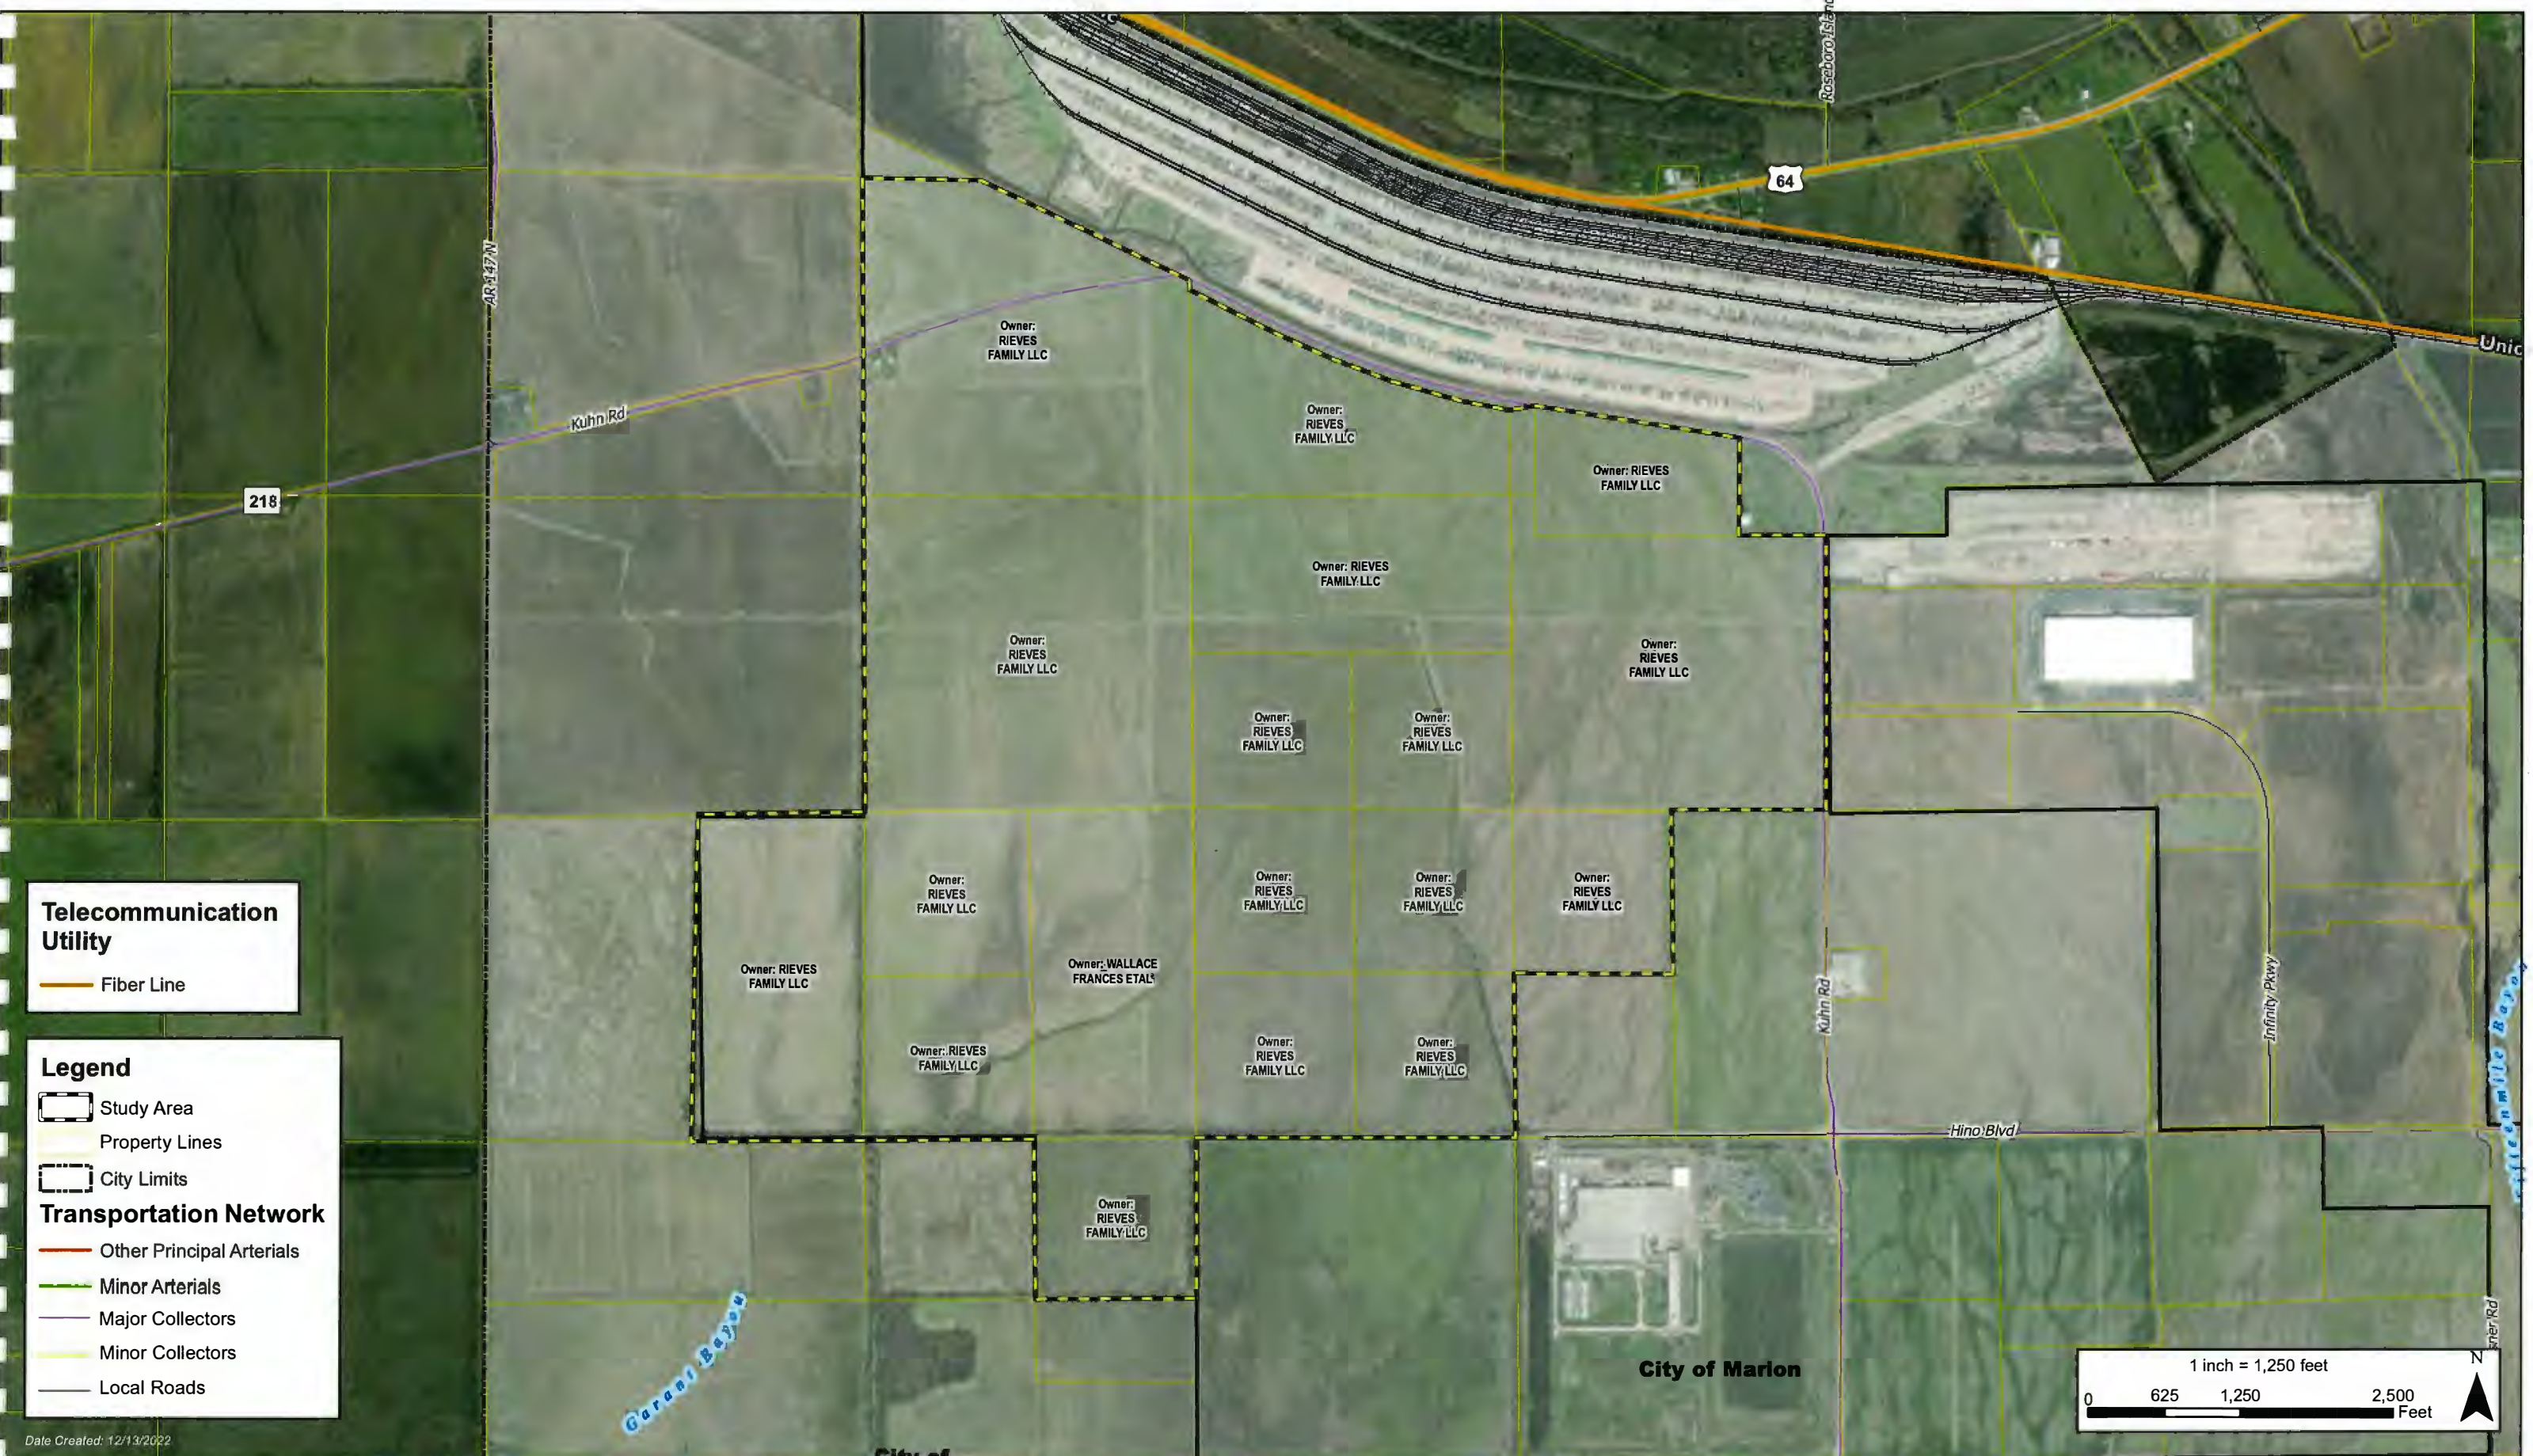
Telecommunication Utility

— Fiber Line
