MARION

February 1, 2023

SITE READINESS REPORT

**Report of Site Reconnaissance Study
and Preliminary Geotechnical Engineering
Investigation
Proposed Industrial Site Development
Marion, Arkansas
Patriot Project No. 5-06-1500**

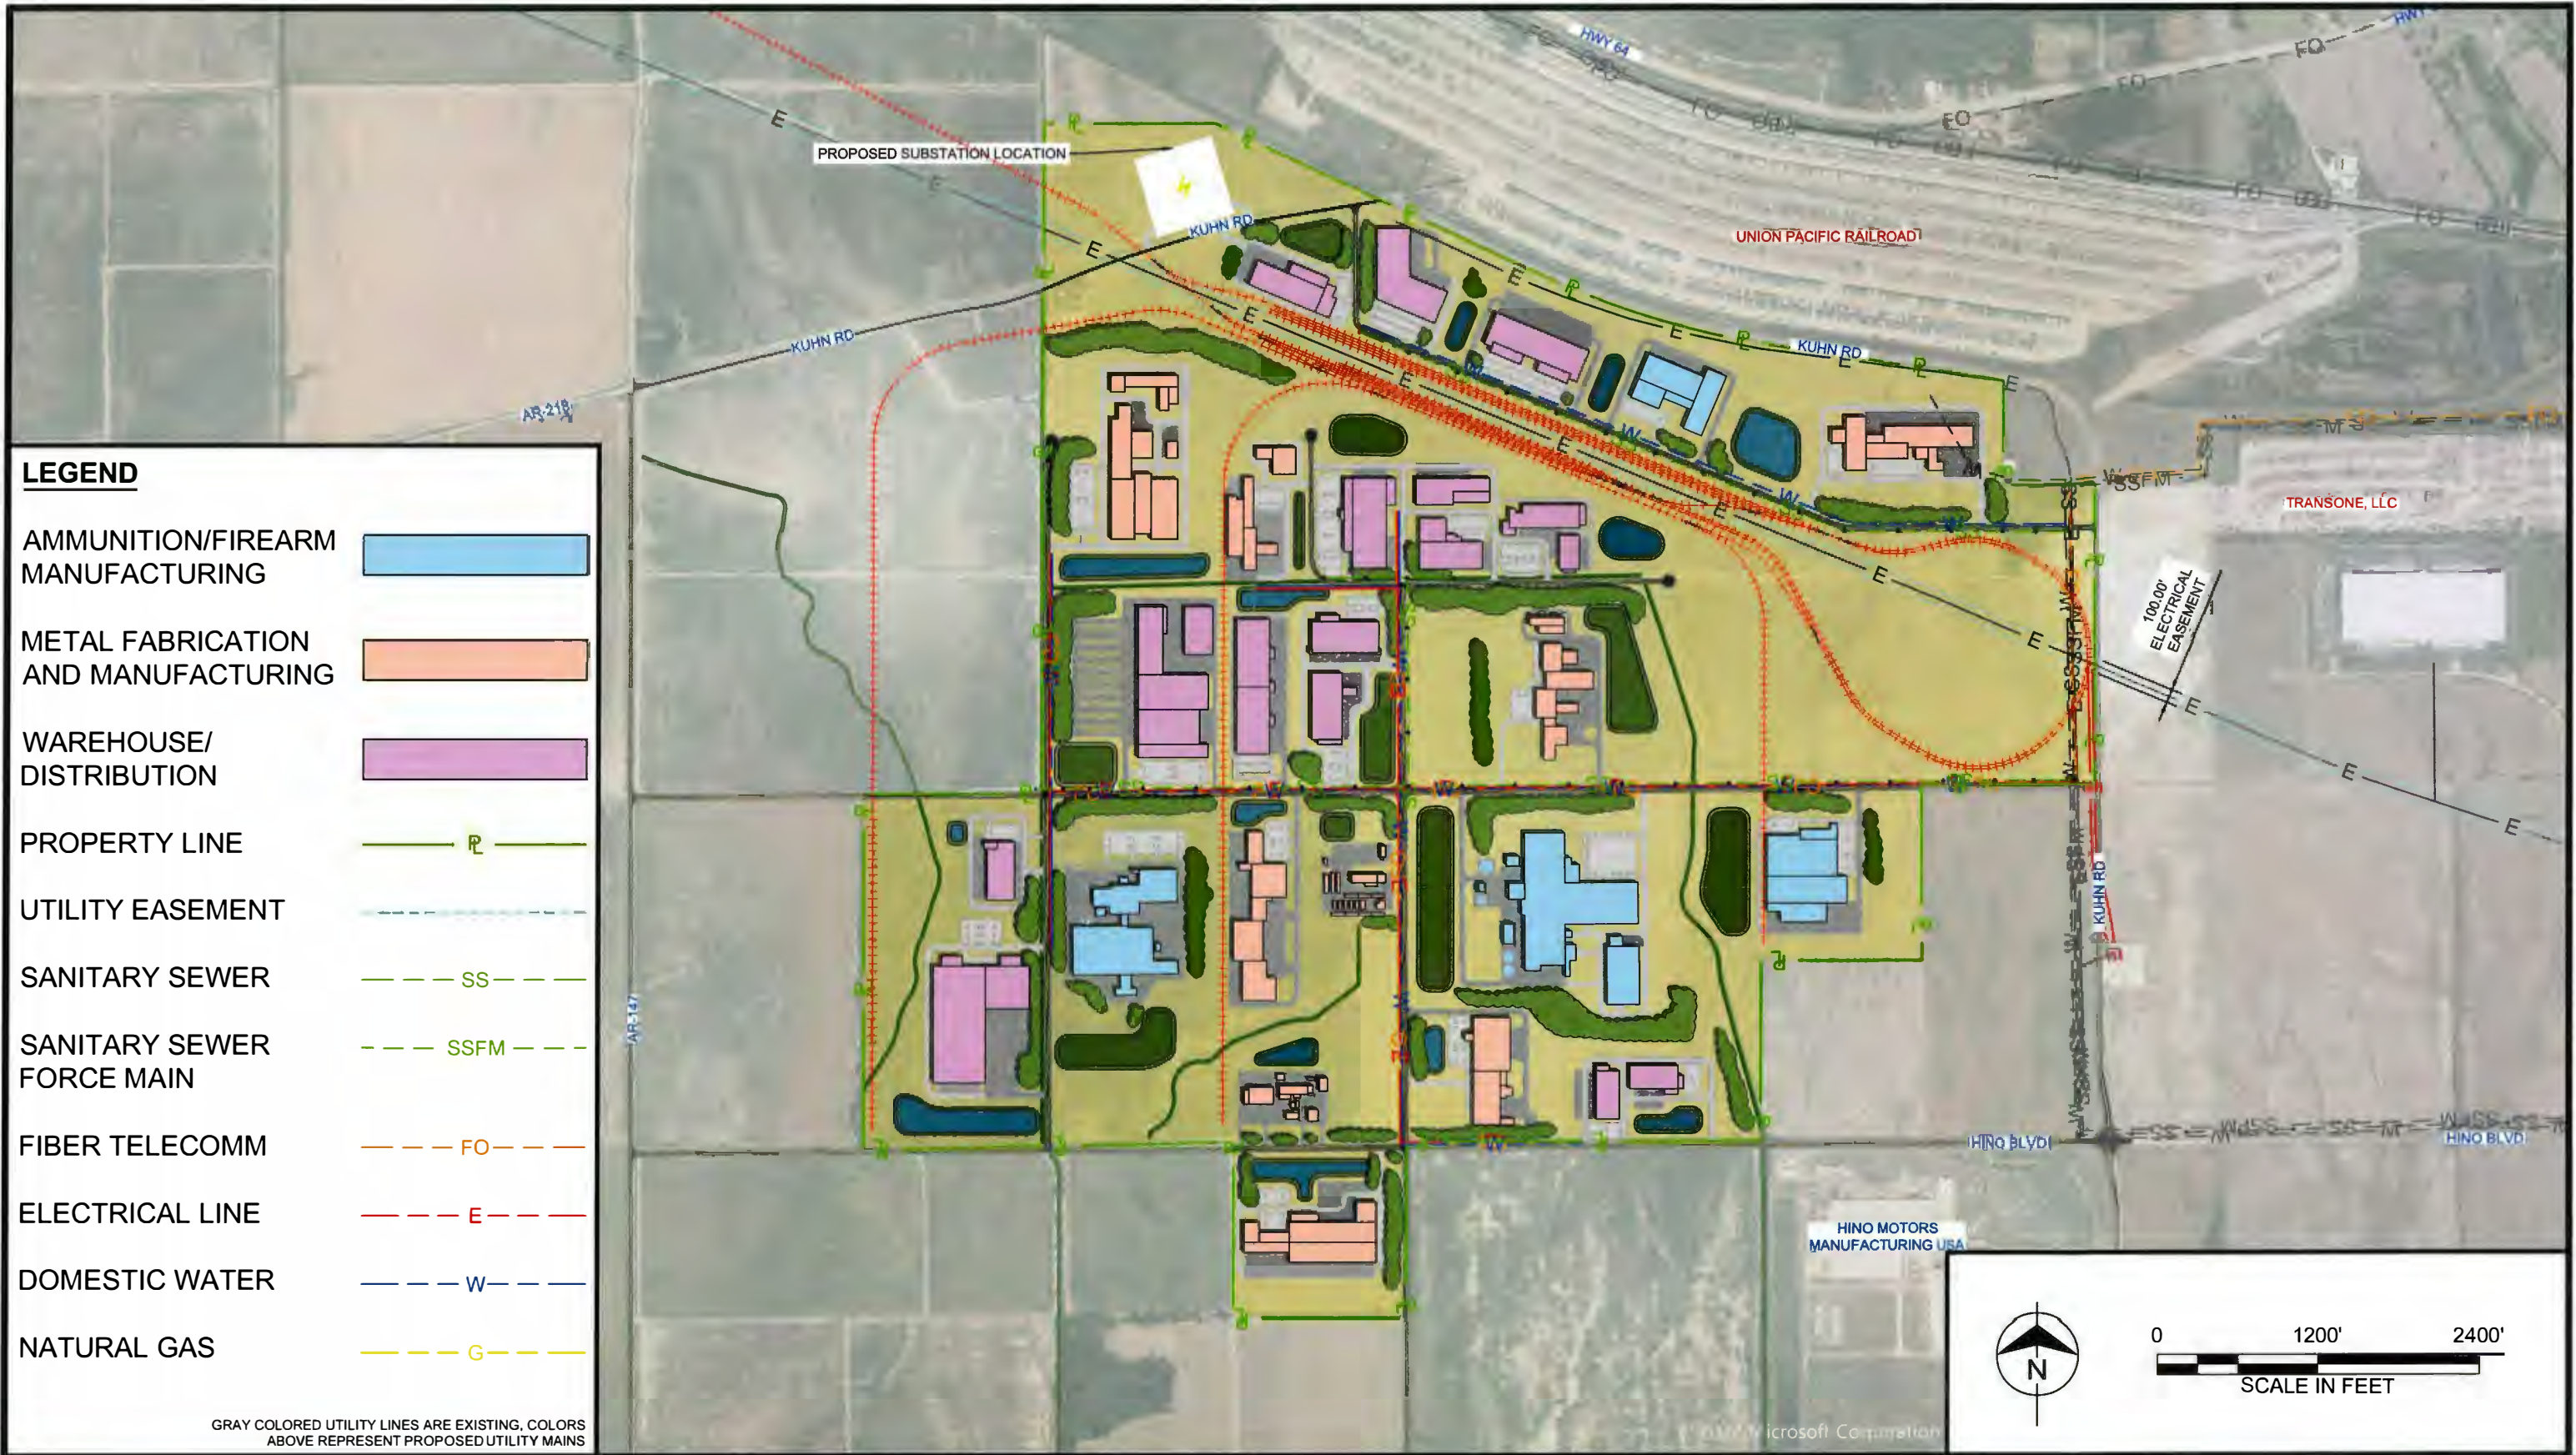
MASTERPLAN WITH RAIL:
PARCEL LABELS

PARCEL NO.	PARCEL AREA (ACRES)	BLDG AREA (SQ. FT)
1	68	414,000
2	20	153,000
3	23	207,000
4	28	202,000
5	30	210,000
6	54	239,000
7	31	123,000
8	82	606,000
9	44	482,500
10	47	506,000
11	88	199,000
12	50	286,000
13	23	167,000
14	78	561,000
15	73	402,000
16	23	256,000
17	26	62,000
18	26	70,000
19	82	660,000
20	28	211,000
21	27	138,000
22	51	352,000
23	35	291,000
24	25	0
