QUIGLEY INSPECTION SERVICES

RESIDENTIAL REPORT

2081 Victor Ave
Redding, CA 96002

ddf dfvd
02/02/2026

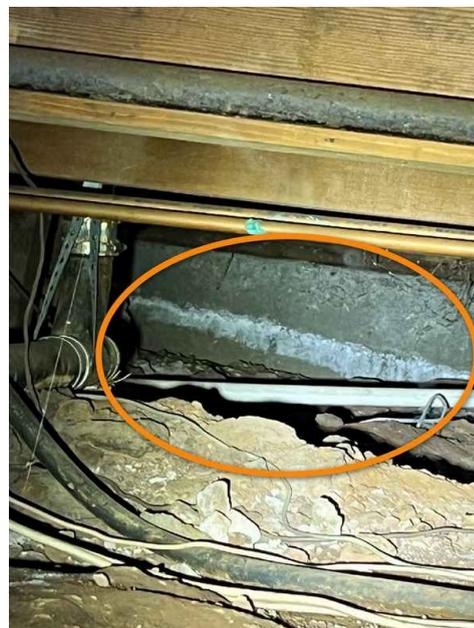
2.1.1 Foundation, Basement & Crawlspaces

EFFLORESCENCE

Efflorescence noted on the foundation walls under the dental office. This a white, powdery deposit that is consistent with moisture intrusion and will need to be monitored.

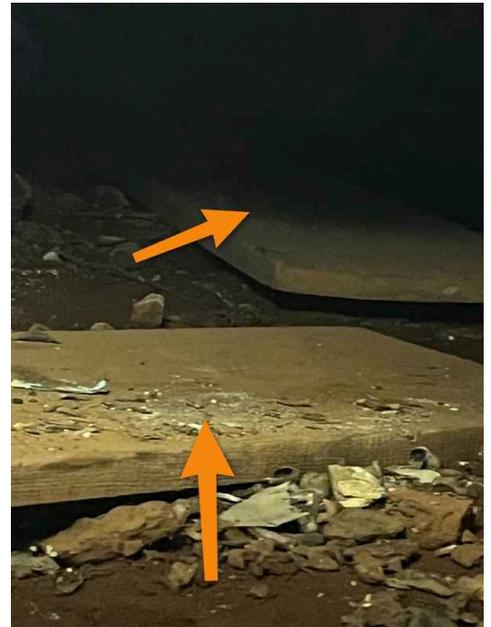
2.1.2 Foundation, Basement & Crawlspaces

CELLULOSE DEBRIS IN CRAWLSPACE

There is wood debris on the crawlspace floor under the dental office that will need to be removed to help prevent termite intrusion.

Contact a qualified professional.

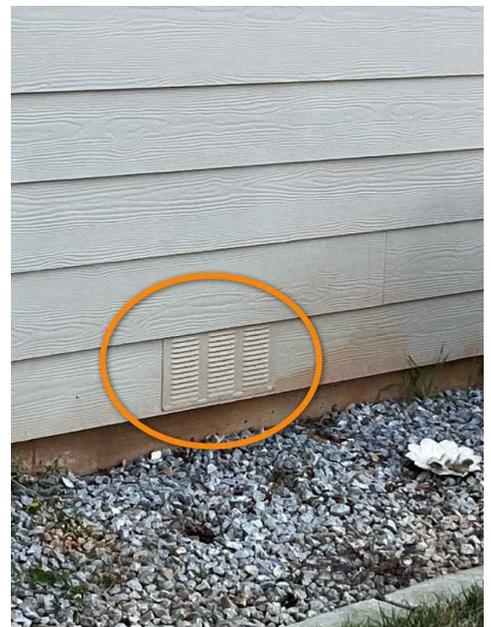
2.1.4 Foundation, Basement & Crawlspaces

LOUVERED VENT SCREENS

The louvered vent screens that are installed on the manufactured residence are known to restrict air flow and should be replaced with regular screens for better crawlspace air flow.

Contact a qualified professional.

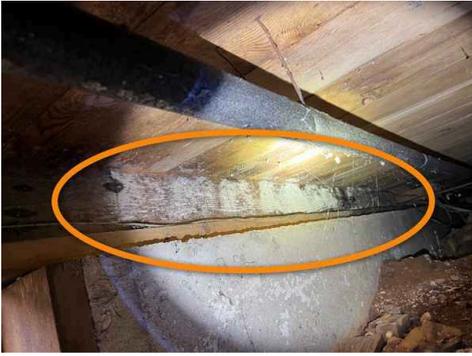
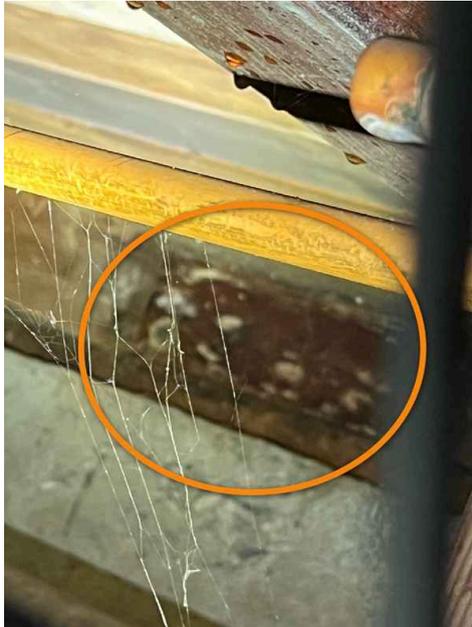
2.2.1 Floor Structure

MILDEW/FUNGUS

Observed signs of fungus/mildew in one or more areas in the flooring structure under the dental office. See termite inspection for details.

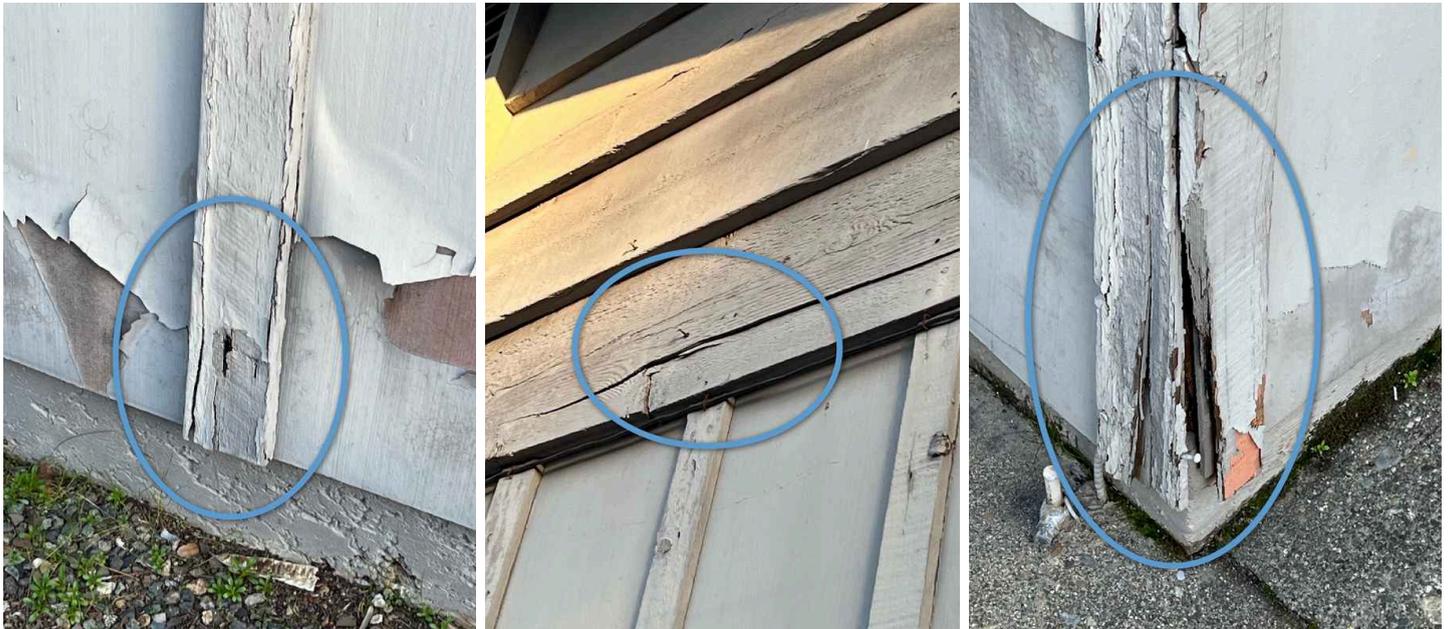
3.1.1 Siding, Flashing & Trim

SIDING DAMAGE

There is damage to the siding at multiple locations around the dental office that should be repaired to maintain water tightness.

Contact a qualified professional.

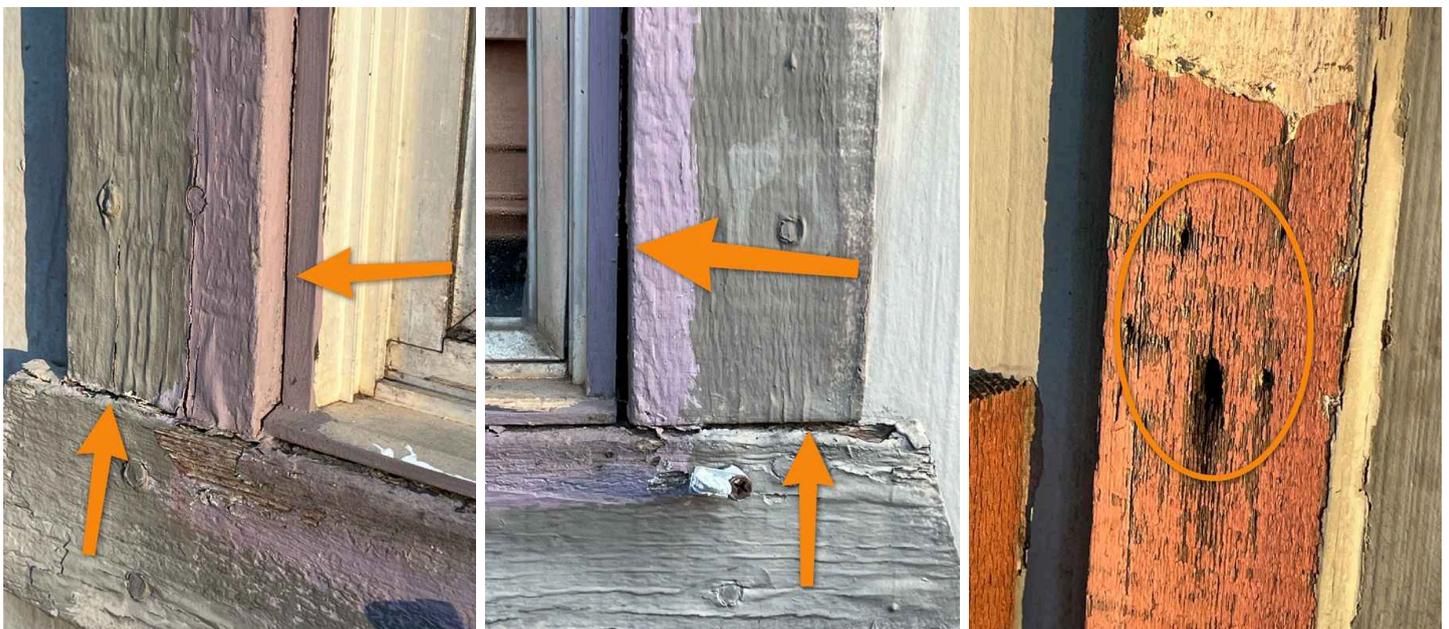
3.1.3 Siding, Flashing & Trim

CAULK MISSING/DETERIORATED

Caulking was found to be absent, deteriorated, or not meeting the expected standards at multiple locations. This includes areas such as around windows, doors, siding butt joints, siding-trim junctions and wall penetrations. It is recommended that a qualified individual takes the necessary steps to replace or install caulk as required. In situations where gaps exceed a width of 1/4 inch, it is advisable to use a suitable material other than caulk to address the gaps.

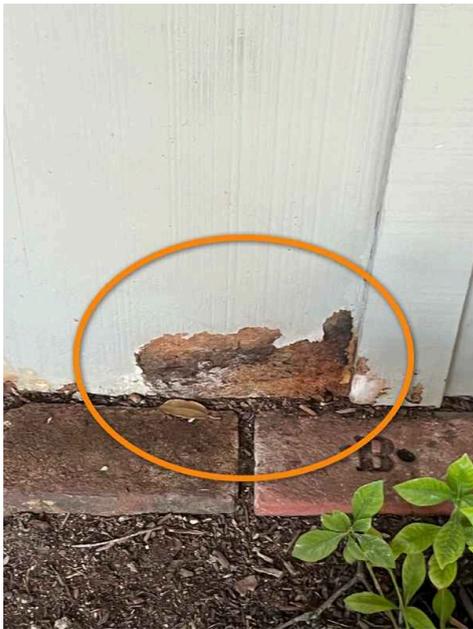
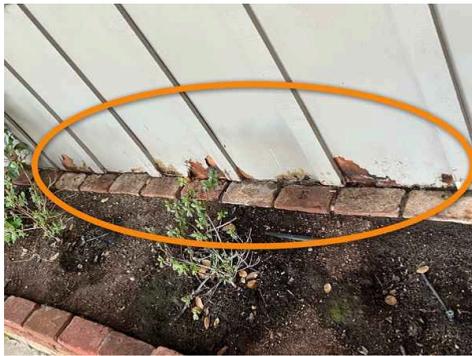
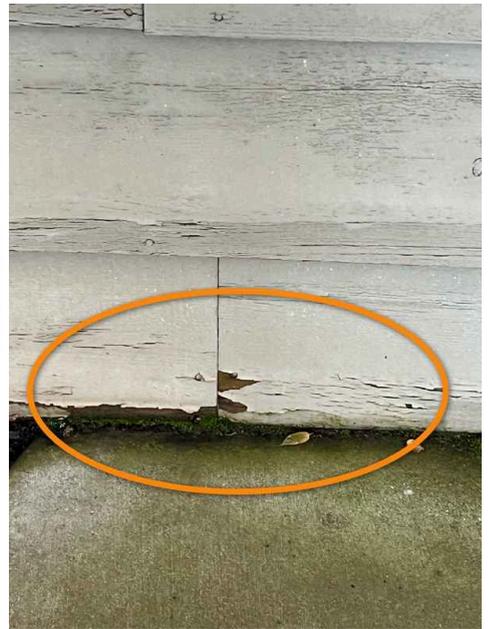
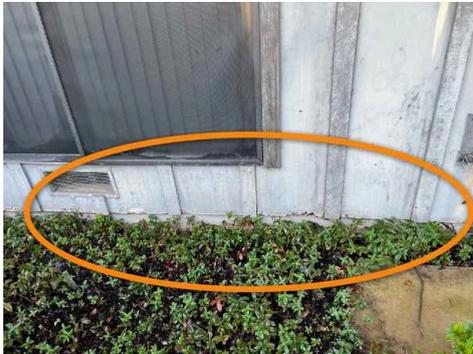
3.1.4 Siding, Flashing & Trim

SIDING WOOD ROT/DETERIORATION

There is wood rot/deterioration of the siding at multiple location around the dental office. See termite report for details.

Contact a qualified professional.

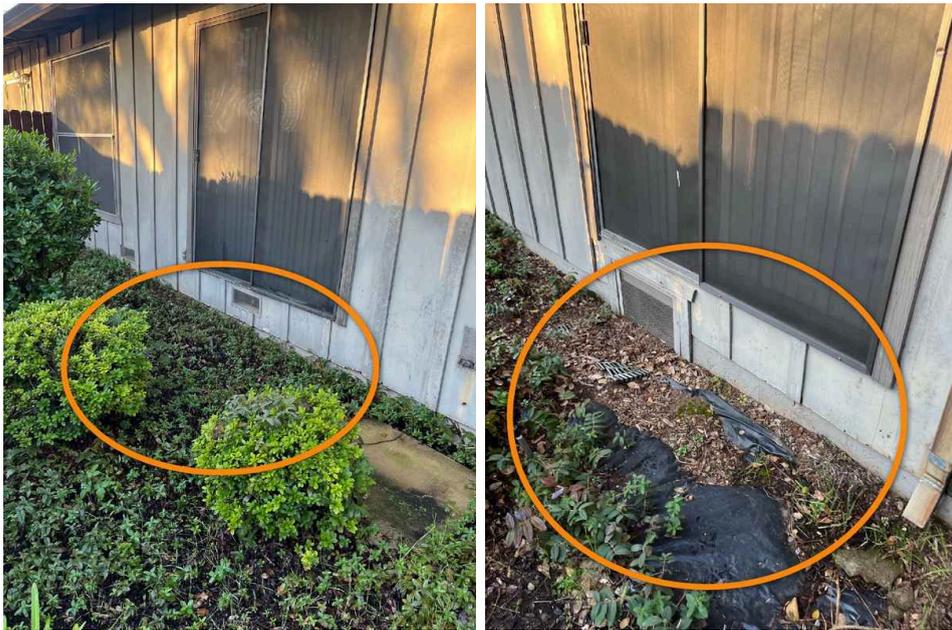
3.3.1 Decks, Balconies, Porches & Steps

MISSING STEPS

Two of the sliding glass doors are missing the exterior steps and installing then is recommended.

Contact a qualified professional.

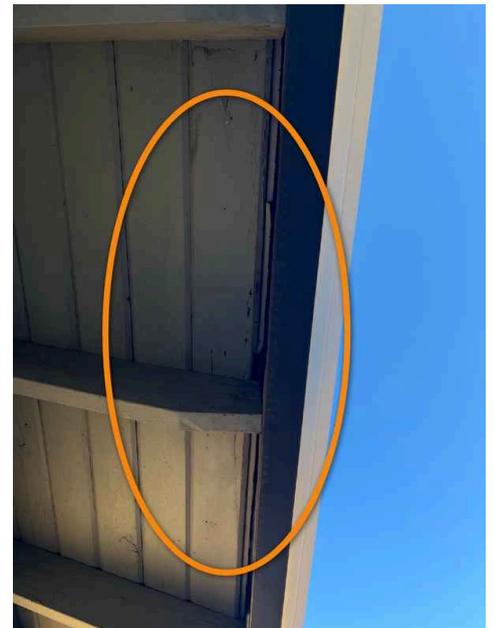
3.4.1 Eaves, Soffits & Fascia

EAVE ROT/DETERIORATION

There is eave rot/deterioration at the east side of the dental office. See termite report for details.

Contact a qualified professional.

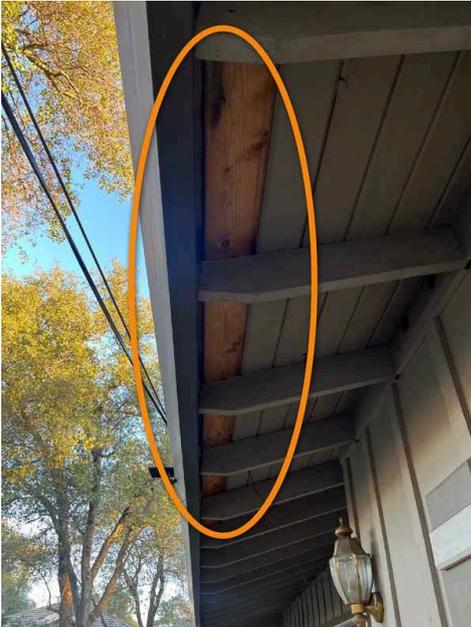
3.4.2 Eaves, Soffits & Fascia

PAINT LOSS OR BARE WOOD

There is eave bare wood at the multiple locations around the dental office that needs to be painted for protection from the elements.

Contact a qualified professional.

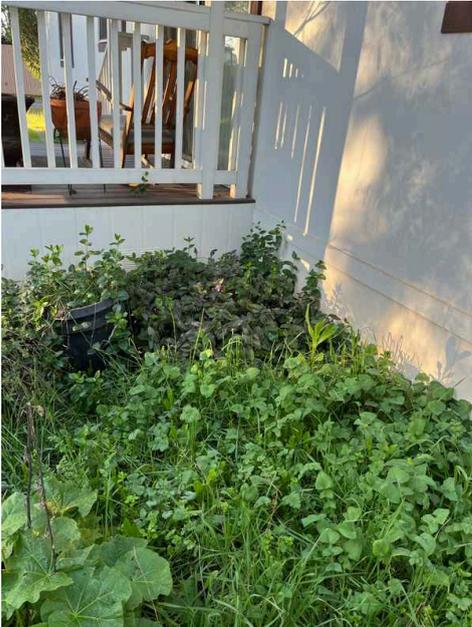
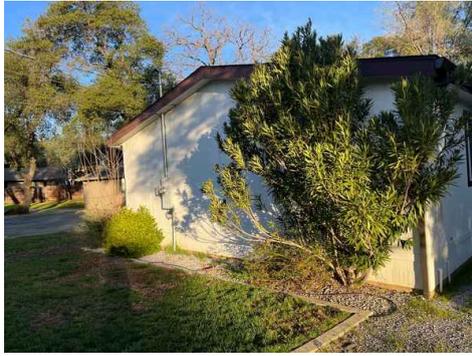
3.5.2 Vegetation, Grading, Drainage & Retaining Walls

FOLIAGE ON SIDING

There is foliage, including shrubs, and/or vines, in direct contact with or within one foot of the manufacture residence exterior. This foliage has the potential to trap moisture against the exterior following rainfall, leading to increased moisture levels in and around the building. It is recommended to trim or eliminate this foliage as needed to maintain a one-foot clearance between it and the residence exterior.

Contact a qualified professional.

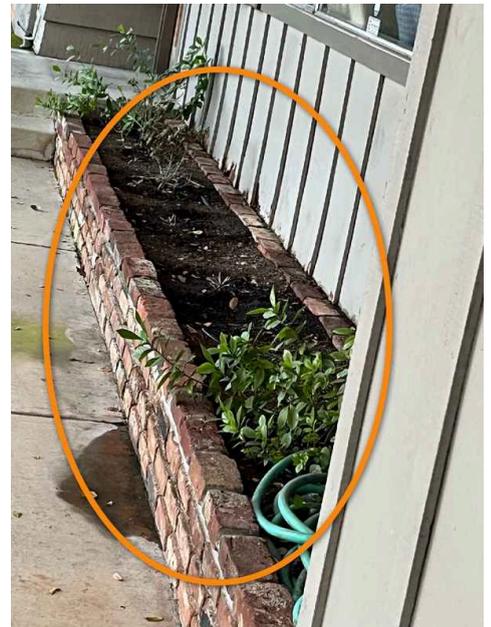
3.5.3 Vegetation, Grading, Drainage & Retaining Walls

PLANTER BOX

There is a planter box at the west side of the dental office that is a common source of moisture and/or termite intrusion and should be removed as a preventative measure.

Contact a qualified professional.

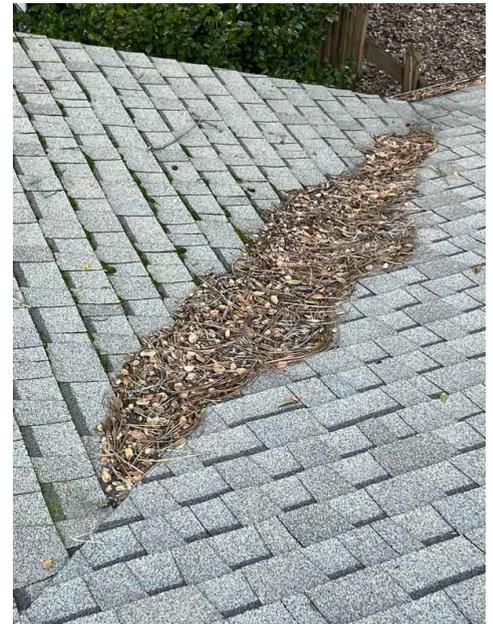
4.1.1 Coverings

LEAVES AND DEBRIS ON ROOF

There is leaves and debris on the dental office roof that needs to be cleaned off to maintain proper water flow.

Contact a qualified professional.

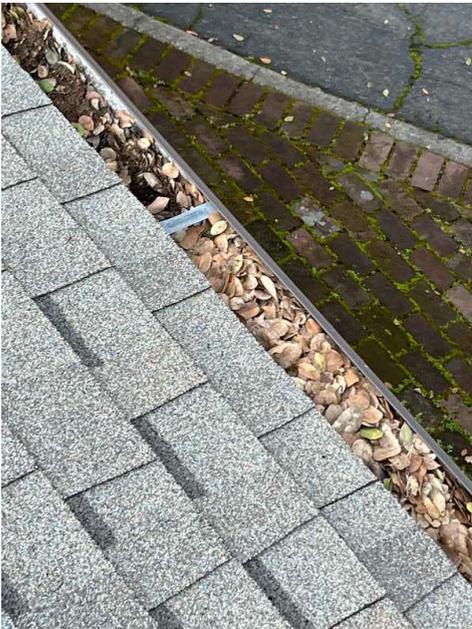
4.2.1 Roof Drainage Systems

DEBRIS

Debris has accumulated in the gutters of both buildings. Recommend cleaning to facilitate water flow.

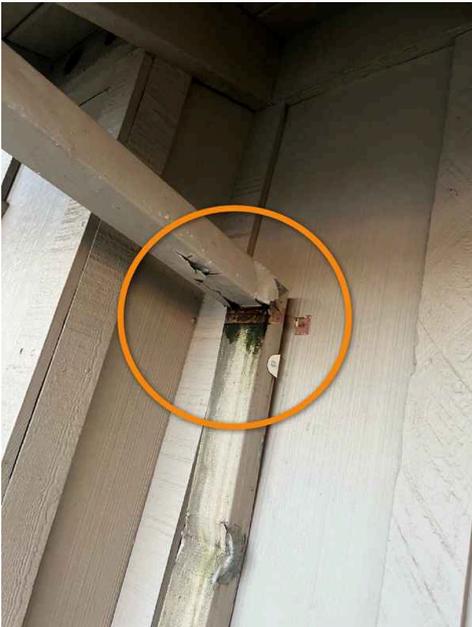
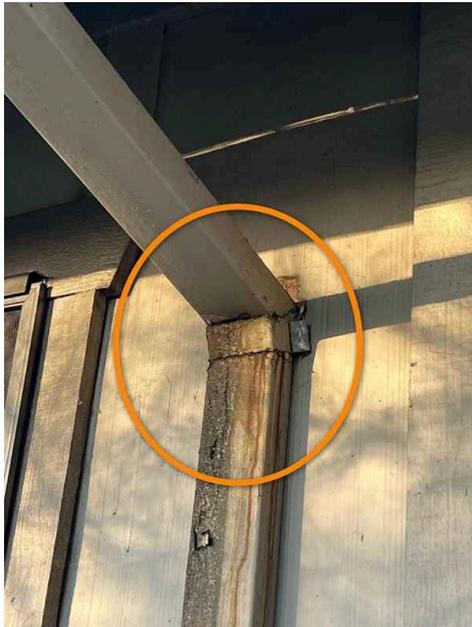
4.2.2 Roof Drainage Systems
DOWNSPOUT LEAKAGE

The downspouts along the dental office appear to be leaking at the seams and it is recommended to seal these areas to maintain proper water flow.

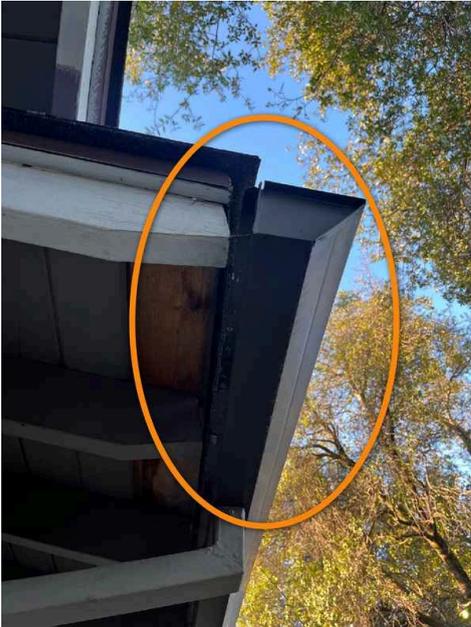
4.2.3 Roof Drainage Systems
GUTTER DETACHED

The gutter is detached a little at the west side of the dental office and needs repair for proper water drainage.

Contact a qualified professional.

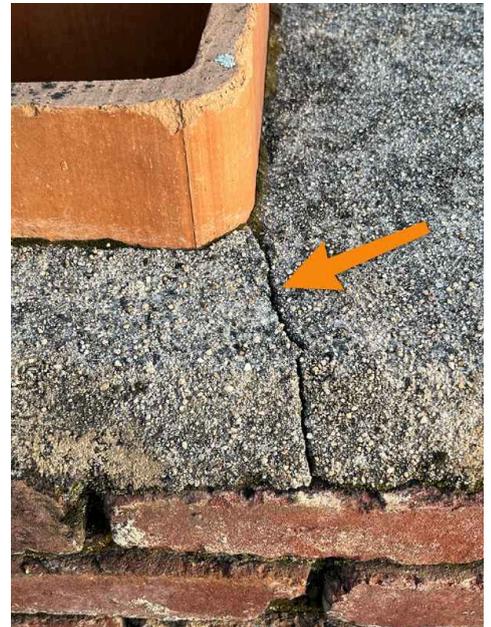
4.4.2 Skylights, Chimneys & Roof Penetrations

CHIMNEY CROWN CRACKED

The chimney crown has several cracks in it which is intended to shed water away from the fireplace and it is recommended to have this repaired.

Contact a qualified professional.

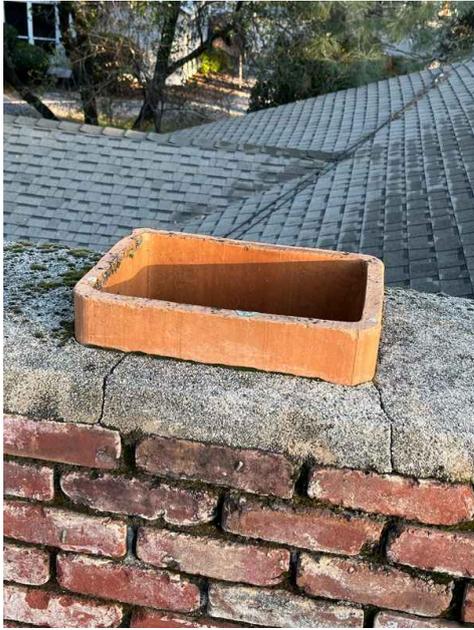
4.4.3 Skylights, Chimneys & Roof Penetrations

CHIMNEY SPARK ARRESTER MISSING

The chimney spark arrester is missing and should be installed to contain any sparks.

Contact a qualified professional.

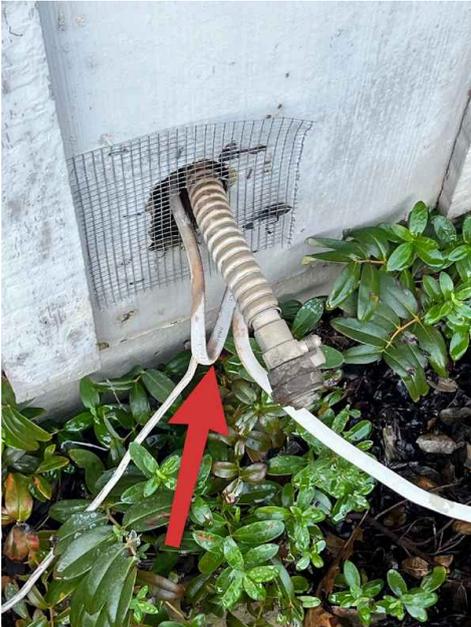
5.3.1 Branch Circuit Conductors, Overcurrent Devices and Compatibility of Their Amperage & Voltage

EXPOSED EXTERIOR WIRES

There are exposed wires at the east side of the dental office that should be enclosed in a protective conduit for safety.

Contact a qualified professional.

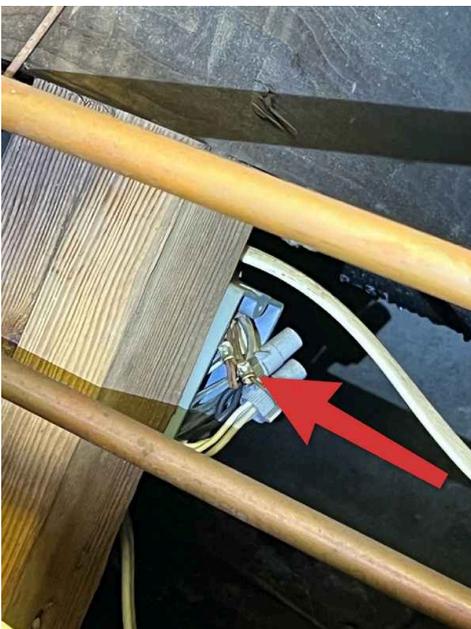
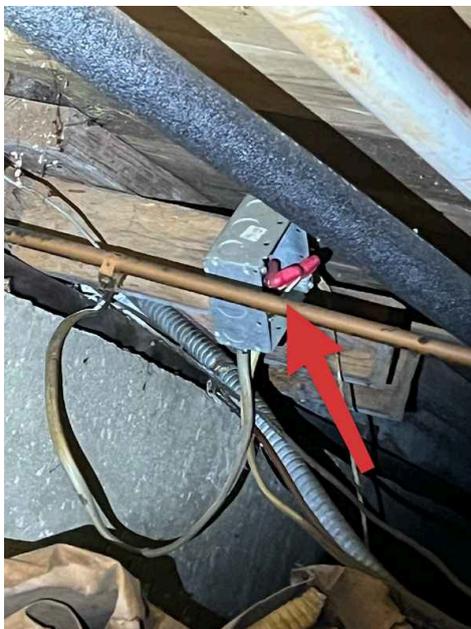
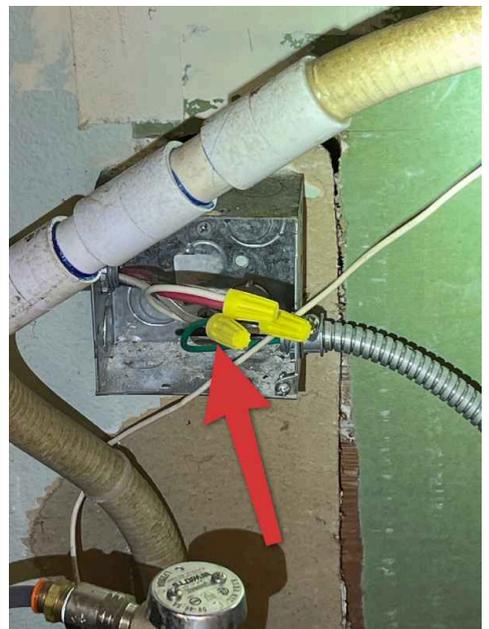
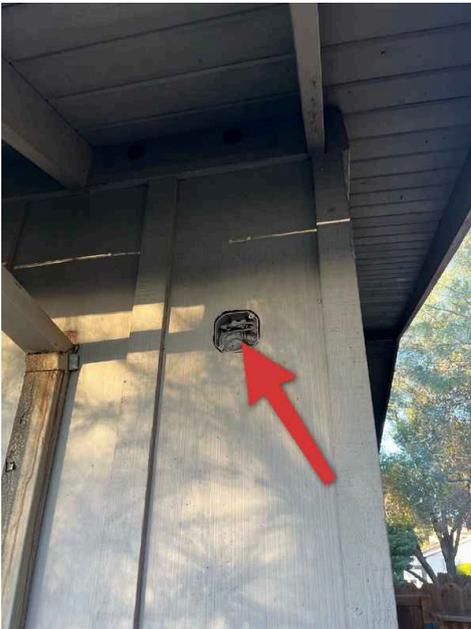
5.3.2 Branch Circuit Conductors, Overcurrent Devices and Compatibility of Their Amperage & Voltage

OPEN JUNCTION BOX

There are multiple open junction boxes in the dental office crawlspace, one at the east exterior of the dental office, and one under the dental office laundry room sink that needs a cover plate for safety.

Contact a qualified professional.

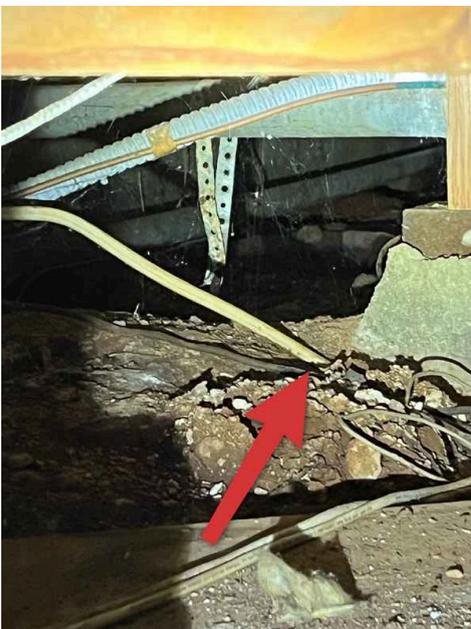
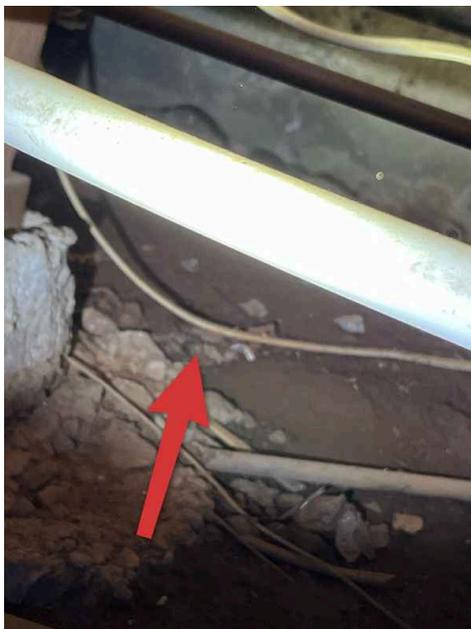
5.3.3 Branch Circuit Conductors, Overcurrent Devices and Compatibility of Their Amperage & Voltage

WIRING ON THE CRAWLSPACE FLOOR

There is wiring on the crawlspace floor under the dental office that should be tacked up off the ground for safety.

Contact a qualified professional.

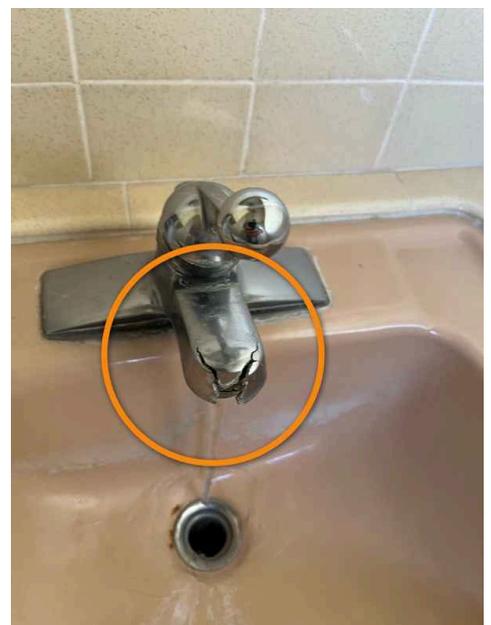
6.1.1 Fixtures / Faucets

FAUCET DAMAGED

The faucet in the full bathroom of the dental office is damaged and needs replacement.

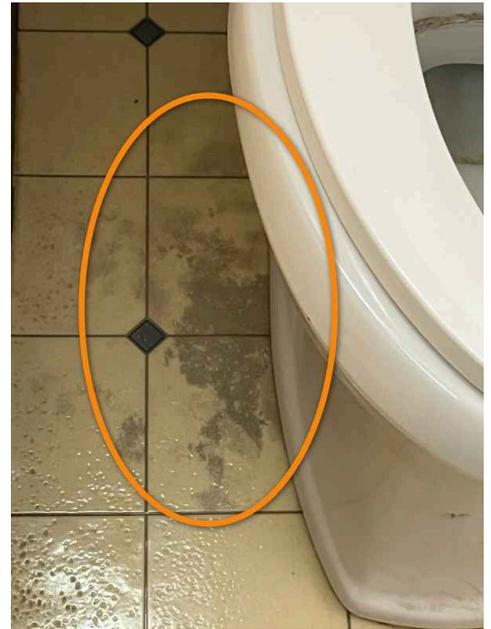
6.1.2 Fixtures / Faucets

TOILET LEAKING

The full bathroom toilet wax seal is possible leaking evidenced by the stain around the base of the toilet. Recommended removing the toilet and replacing the was seal.

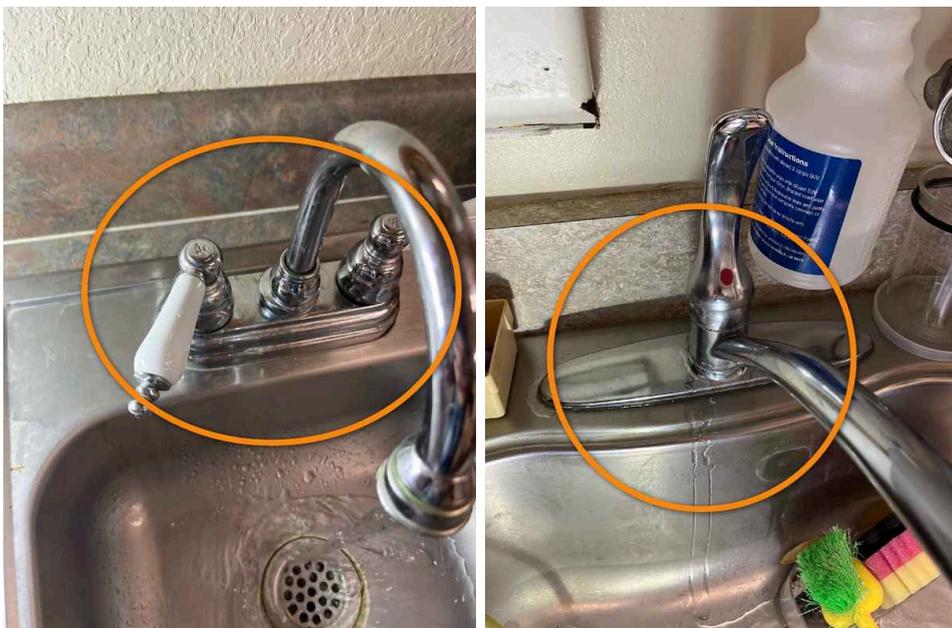
6.1.3 Fixtures / Faucets

FAUCET CORRODED AND LEAKING

The north/center room and front exam room faucet in the dental office is corroded and leaking under the sink and needs replacement.

Contact a qualified professional.

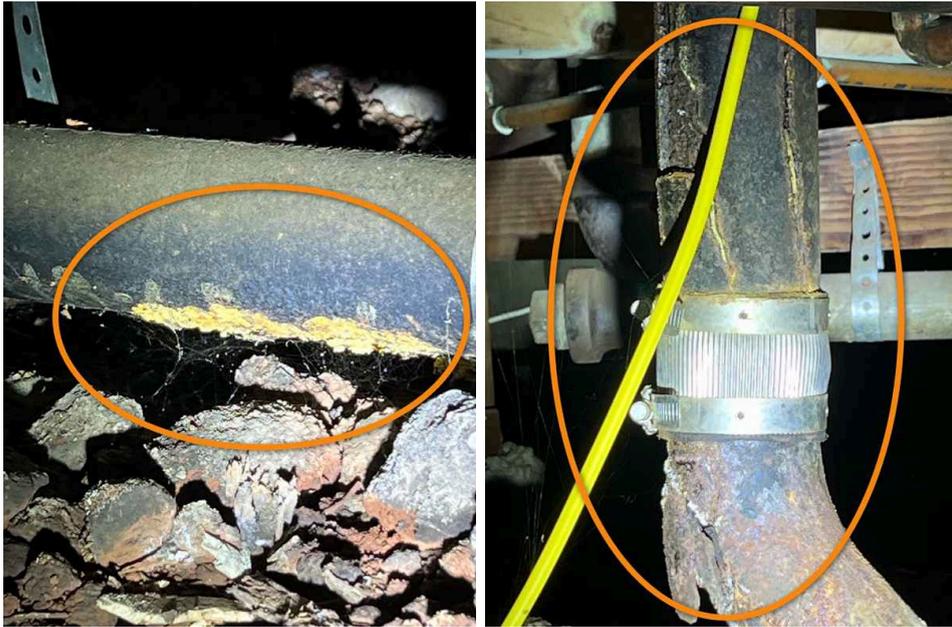
6.2.1 Drain, Waste, & Vent Systems

RUSTING DRAIN LINES

There were sections of the drain lines under the dental office that are rusting out and damaged in areas. Recommended replacement of the lines at these areas.

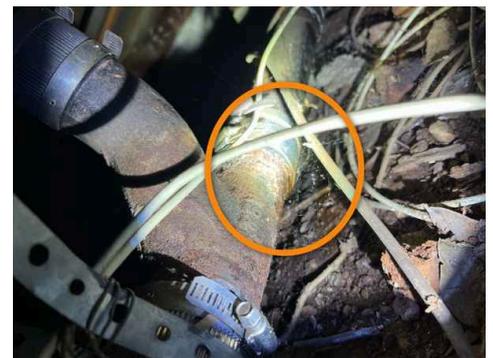
6.2.2 Drain, Waste, & Vent Systems

CRAWLSPACE DRAIN LINE LEAKING

The drain line is leaking in the crawlspace under the north/center room and needs repair.

Contact a qualified professional.

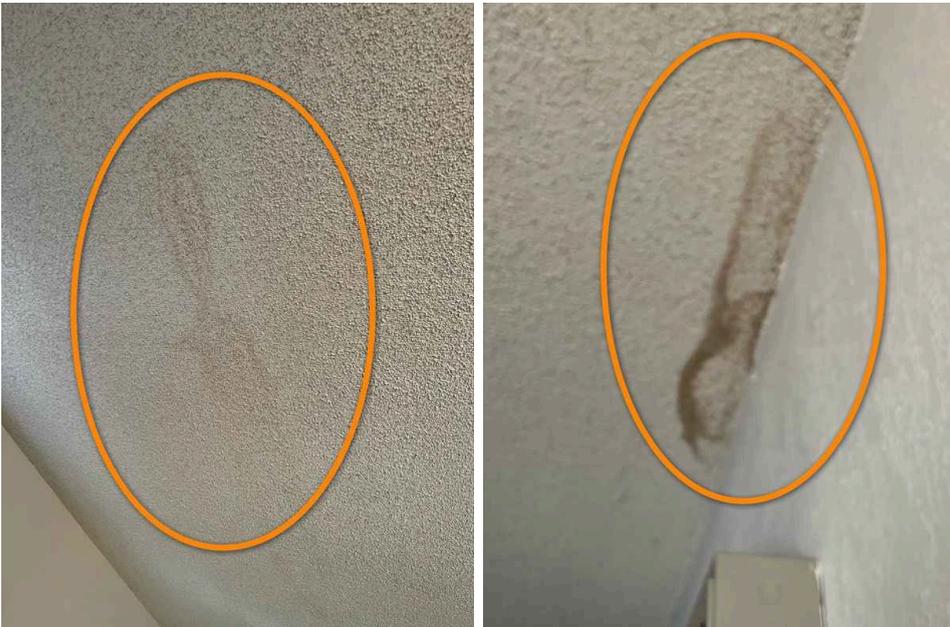
CEILING STAINS

There are water stains or other evidence of moisture intrusion in the dental office break room ceiling covering that you will need to have evaluated further by an appropriate qualified specialist. This is important because our inspection does not warranty or guarantee the roof against leakage.

Contact a qualified professional.

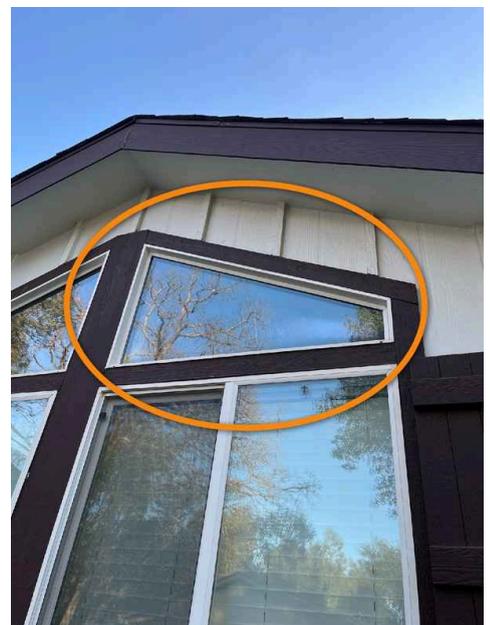
FAILED SEAL

There is a failed window seal at the west side of the manufactured residence that needs repair. Recommend qualified window contractor evaluate & replace.

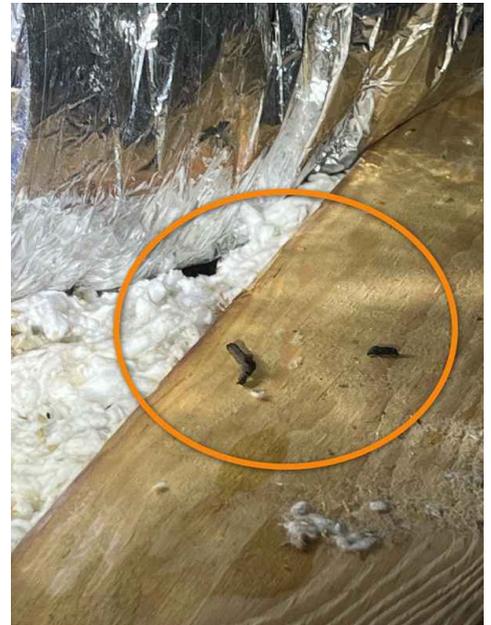
There is evidence of rodents in the dental office. It is recommended to have pest control company service the residence. At any rate traps should be set and checked every few months.

Contact a qualified professional.
