### PHASE II ENVIRONMENTAL SITE ASSESSMENT

# **LUTHER ROAD PROPERTY 0 LUTHER ROAD AUBURN, CA 95603**

Project Number 2021-11-037

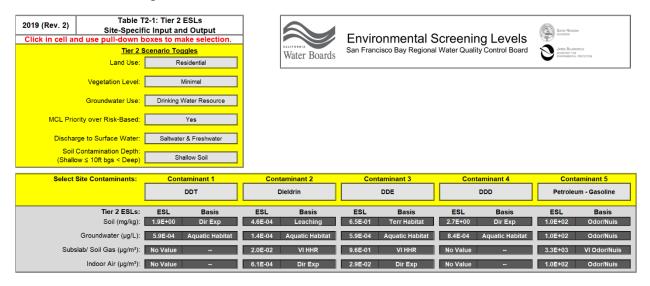
The results of the Tier 2 evaluation indicate that the Tier 2 ESL levels for DDT at the site is set at the 1.9 mg/kg (1.9E+00mg/kg) concentration level. See The Regional Board Tier 2 Evaluation Spreadsheet results below. Specifically under Contaminant 1 under Soil the ESL is 1.9E+00 and the basis is Direct Exposure.

A closer look at the data indicates that the low limit is due to the Direct Exposure levels set by California. A description of direct exposure is defined by the California Regional Water Quality Control Board in 2007 (Screening For Environmental Concerns at Sites with Contaminated Soil and Groundwater, Regional Water Quality Control Board, Interim November 2007) as the following:

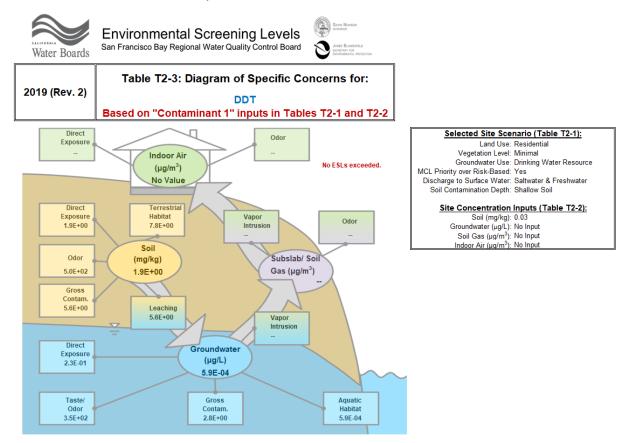
The Phase II Environmental Site Assessment results indicate that DDD, DDE and DDT and Dieldrin are present at the subject property. Based on the Tier 1 screening levels, DDT and Dieldrin are elevated above the State of California allowable screening level criteria on the property. After further evaluation, the limiting factor in this Tier 1 evaluation is the terrestrial ecology limits. Therefore, A Tier 2 Evaluation was conducted. Based on the criteria utilized for the subject property, the results indicate that no ESLs were exceeded in the any of the four sub soil categories. An illustration of the calculation is provided below (Note the illustration is for DDT and no ESLs were exceeded in the evaluation).

Based on the results of this Tier 2 Evaluation, the chemicals of concern (OCPs) are not elevated above the Tier 2 Site Specific levels identified in this evaluation. Therefore, the Phase II Environmental Site Assessment results indicate that no further action is required under this evaluation.

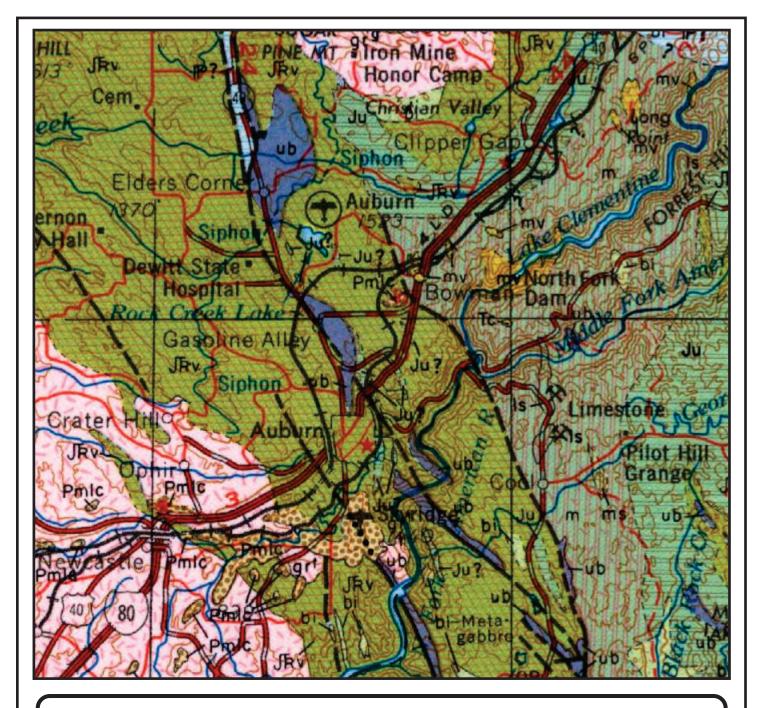
2021-11-037 December 9, 2021 PLATE: A3 PHASE II ENVIRONMENTAL SITE ASSESSMENT LUTHER ROAD PROPERTY 0 Luther Road Auburn, CA 95603 ASSESSMENT, PC
Environmental • Hydro • Geology

## Site specific labeled Rock type as JTrv. Jtrv: Jura-Trias Metavolcanic rocks.

These rocks are Jurassic to Triassic age Metamorphosed volcanic rocks.

### **GEOLOGICAL MAP**

According to the Geological Map of California, the Property is located within the Jtrv: Jura-Trias

Metavolcanic Rocks. These rocks are Jurassic to Triassic age Metamorphosed volcanic rocks."<sup>3</sup>

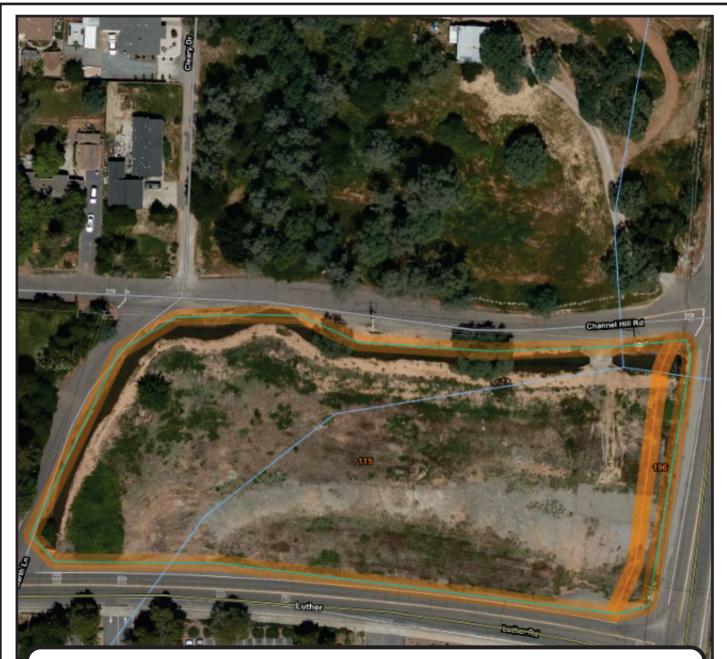
2021-11-037 December 9, 2021 PLATE: A4 PHASE II ENVIRONMENTAL SITE ASSESSMENT LUTHER ROAD PROPERTY 0 Luther Road Auburn, CA 95603 ASSESSMENT, PC
Environmental • Hydro • Geology

### Placer County, California Western Part (Ca620)

Map unit Map unit name
115 Auburn-Argonaut complex,
2 to 15 percent slopes

196 Xerorthents, cut and fill areas

### **SOIL MAP**

The soils of the Property are reported by the USDA as Placer County, California Western Part (CA620) as Auburn-Argonaut complex, 0 to 15 percent slopes and Xerorthents, cut and fill areas and represented with the map unity 115 and 196 respectively<sup>2</sup>. Soils encountered at the site are represented in the Plates located in the Appendix.

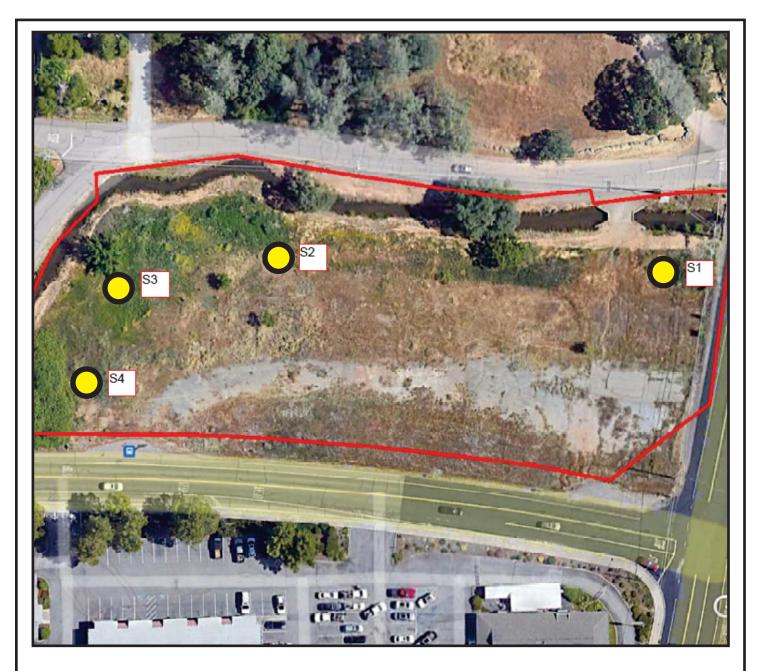
2021-11-037 December 9, 2021 PLATE: A5 PHASE II ENVIRONMENTAL SITE ASSESSMENT LUTHER ROAD PROPERTY 0 Luther Road Auburn, CA 95603

Samples take 4" to 6" in depth, Sandy silty clay, slightly moist, loose.

### **GENERAL BOREHOLE LOCATION**

Please refer to Plate A5 for the sample location map.

The sampling event occurred on December 7, 2021. Four (4) shallow boreholes were advanced onsite. The boreholes were advanced with a hand trowel to depths up to 6 inches below the ground surface. In each borehole, soil samples were collected by the environmental professional. Samples were collected from the desired strata and placed into containers, capped, and labeled. All samples were observed for contamination. The selected samples were immediately placed on ice and
