Wetland Delineation Report

Tax Parcel #B-261-1
Private Claim 13E,T23N-R21E
Village of Bellevue
Brown County

**Broadway Realty
P.O. Box 6115
De Pere, WI 54115**

**George & Holdt
LLC**
6350 Nero Lane
Sobieski, WI 54171

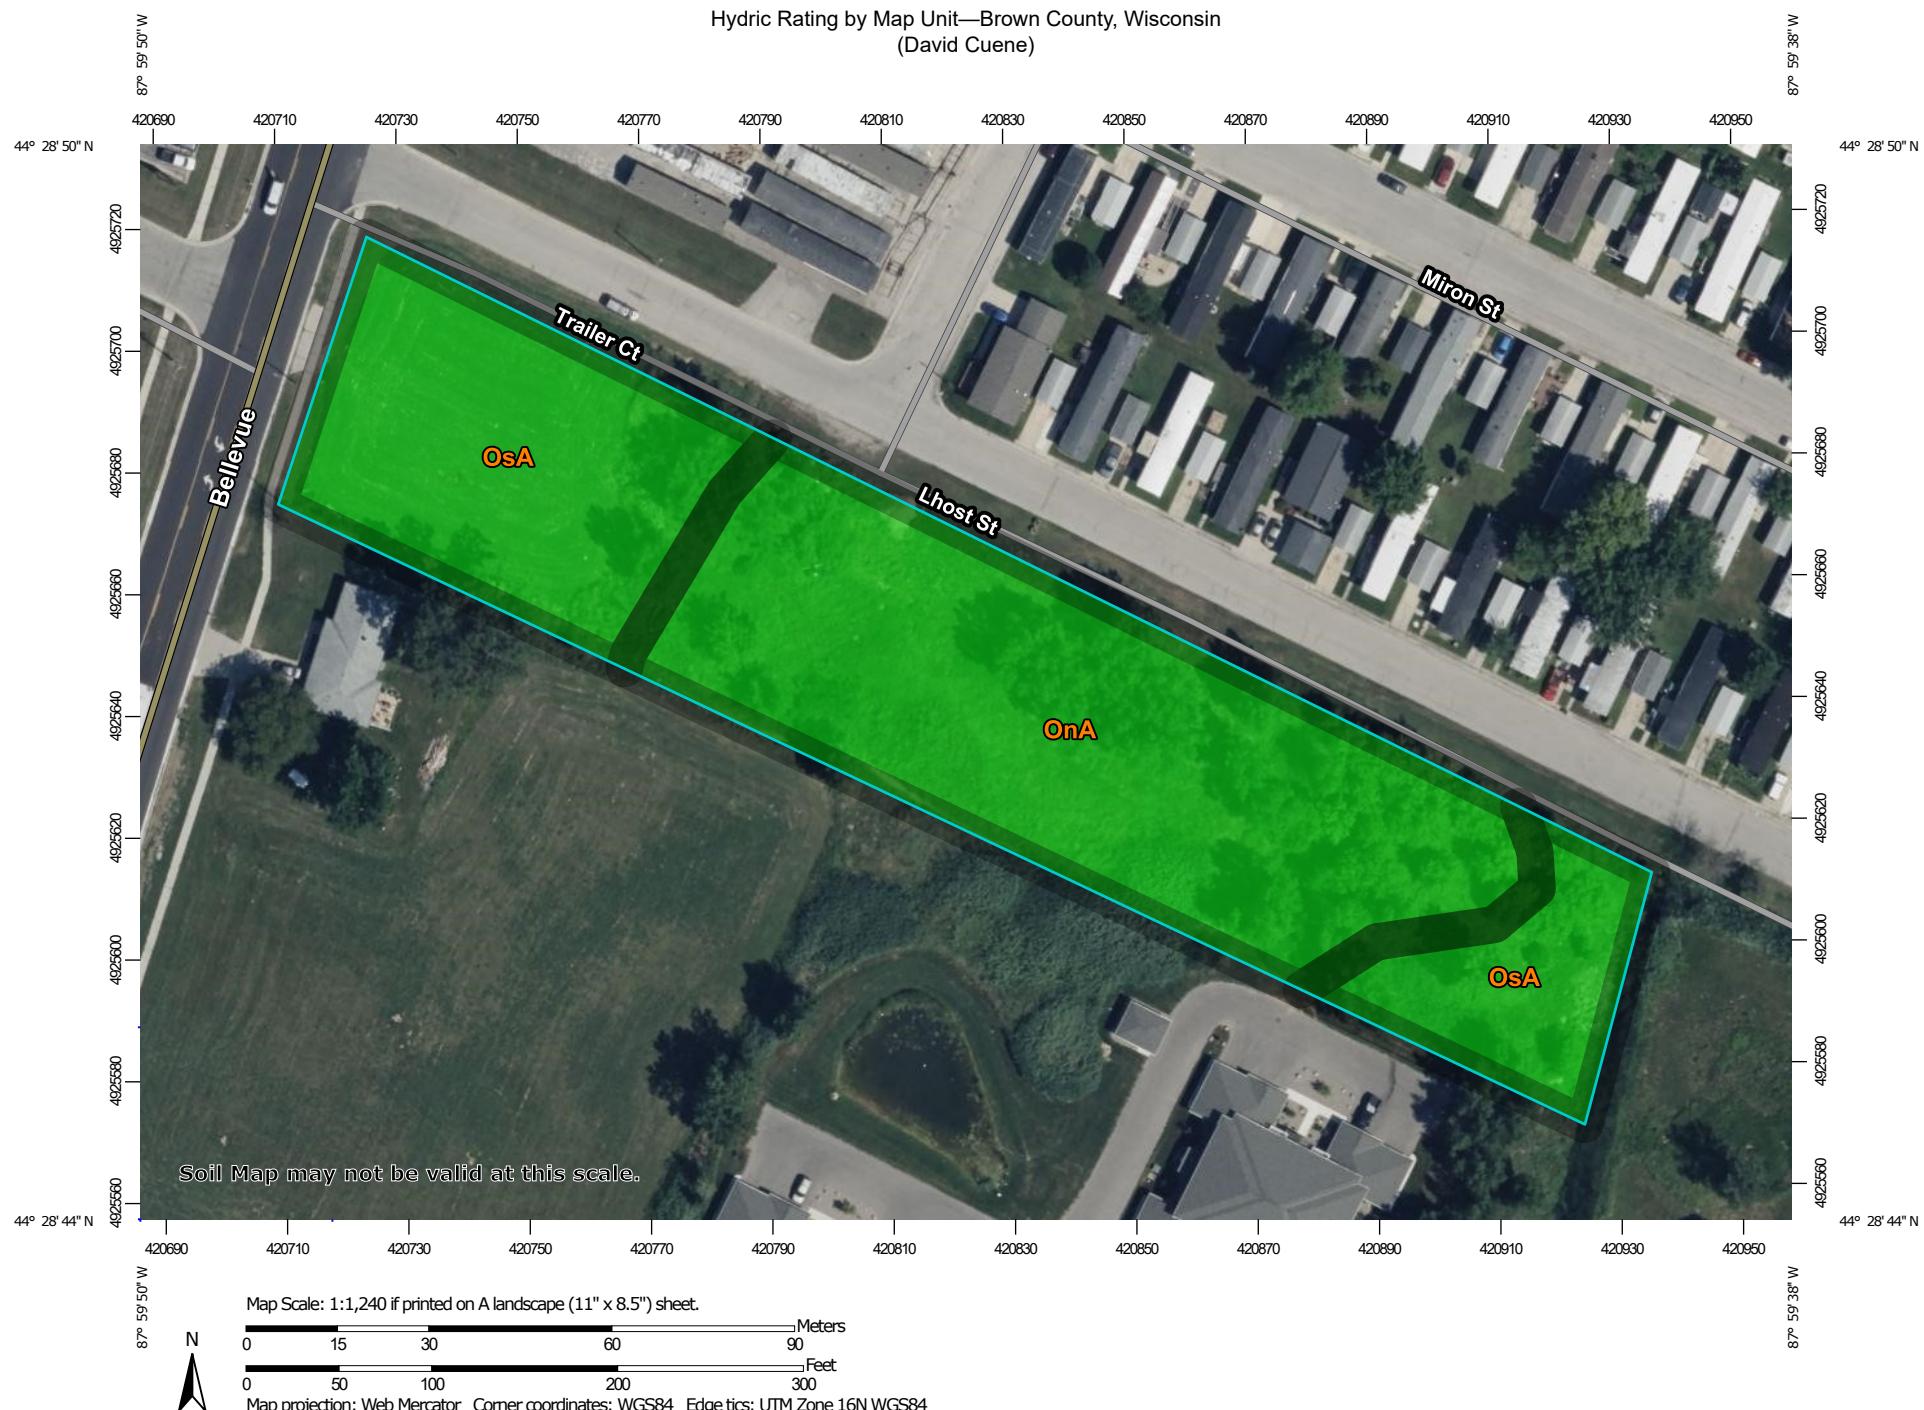
Hydric Rating by Map Unit—Brown County, Wisconsin (David Cuene)

The Oshkosh silt loam soil series is described as a **well-drained soil** that has a **hydric soil rating of 0** based upon a review of the Web Soil Survey (WSS). This soil series is considered **non-hydric** based upon the hydric soil rating.

The Oshkosh silty clay loam soil series is described as a **well-drained soil** that has a **hydric soil rating of 0** based upon a review of the Web Soil Survey (WSS). This soil series is considered **non-hydric** based upon the hydric soil rating.

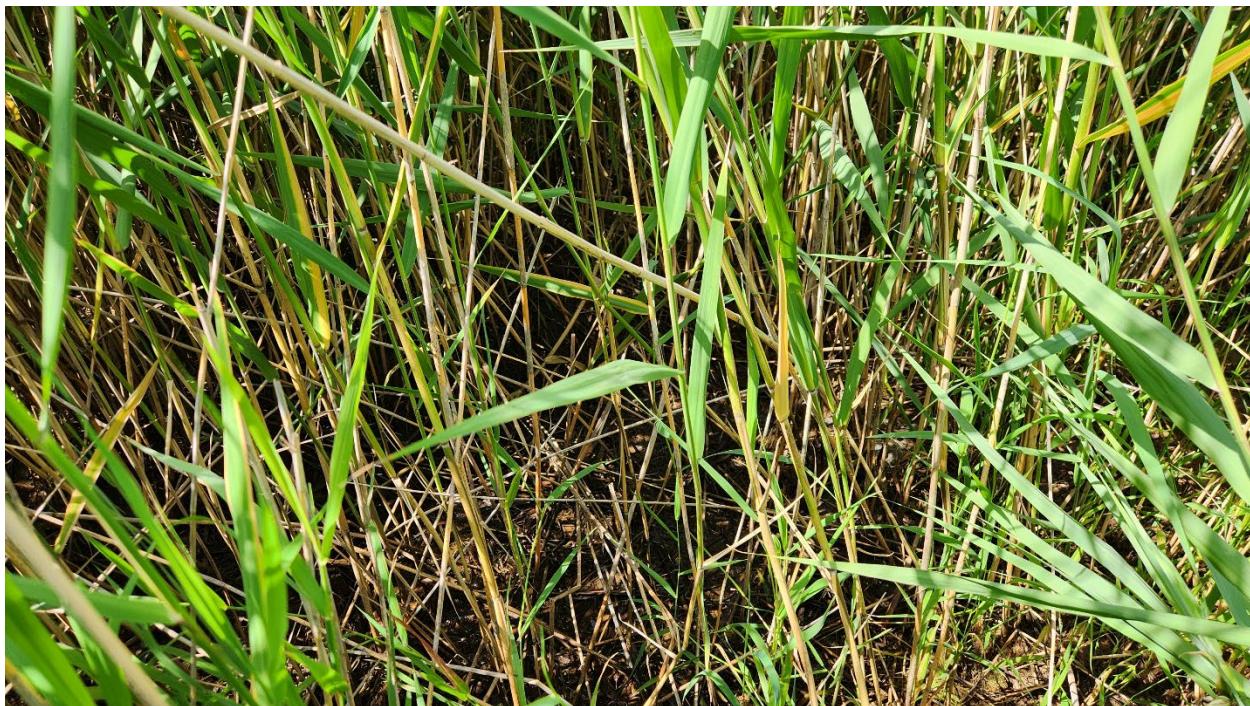
Wetland #1 is a degraded wet meadow that formed in a human-made ditch. The wetland is dominated by *Typha angustifolia* and has an area of 2251 sq ft within the project area.

Wetland #1

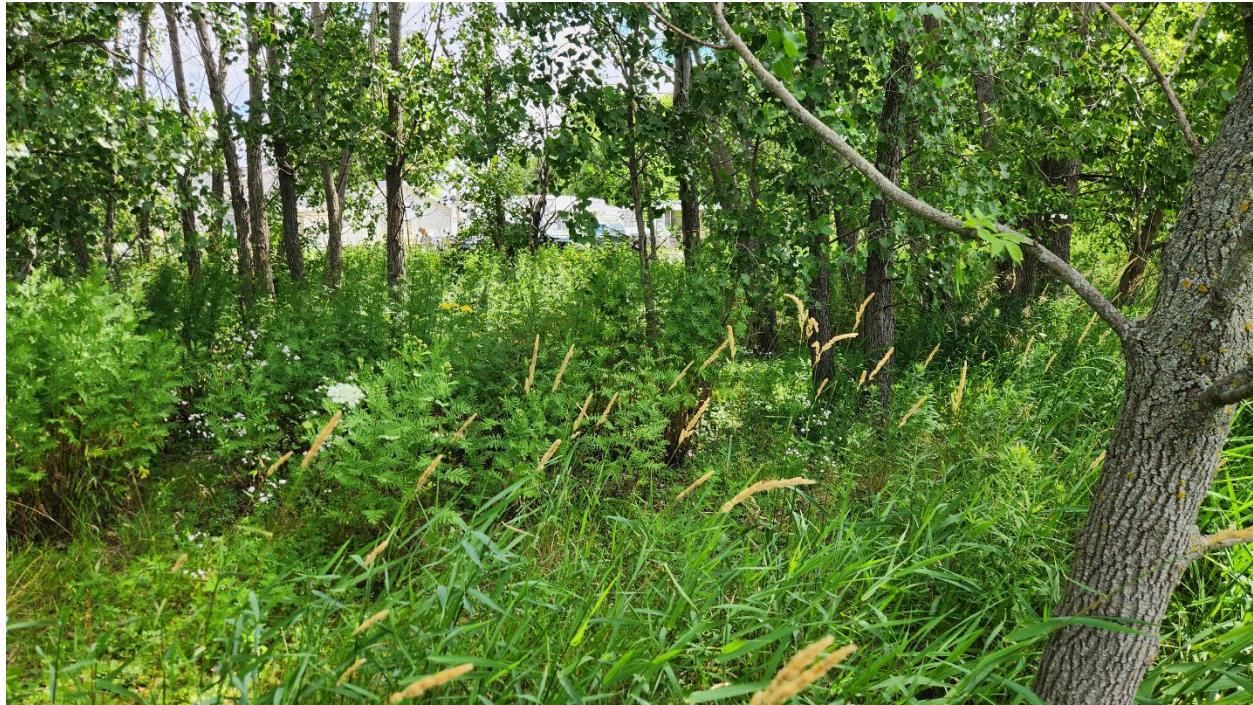
Wetland #2 is a degraded wet meadow that formed in a human-made ditch. The wetland is dominated by *Phragmites australis* and *Phalaris arundinacea*. The wetland has an area of 2251 sq ft within the project area.

Wetland #2
