REAL ESTATE INSPECTION REPORT

LARocca
INSPECTIONS

2912 Adams St La Crescenta CA 91214.

DATE OF INSPECTION: Thursday, October 31, 2024

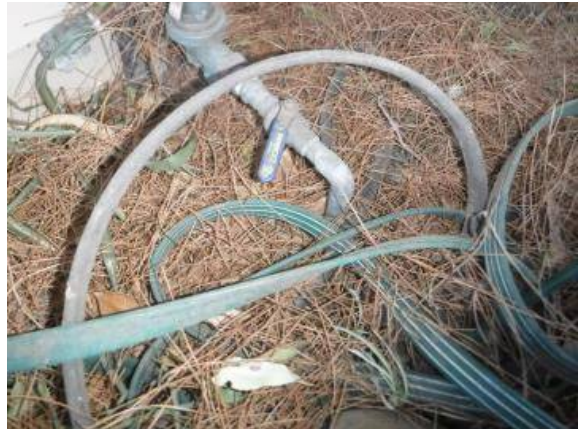
SHUT OFF VALVE CONDITION

During a general visual inspection valves are not operated or tested for correct operation, due to the potential of failure. Their operating condition is not determined. If more information is desired it is recommended to consult with a qualified plumber.

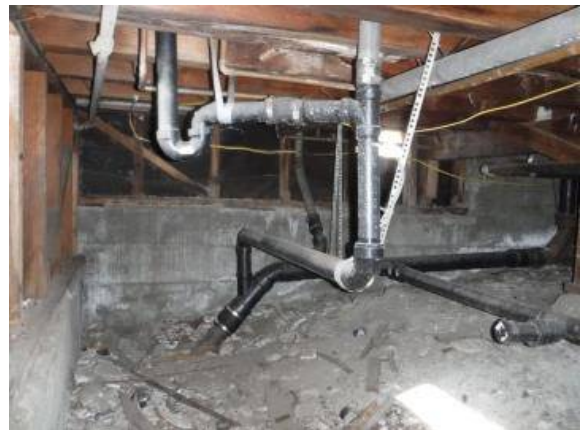
WASTE LINE CONDITION

NEEDS ATTENTION. There are rusted areas on the exterior of the waste lines. This external rusting is a sign of internal rust and sometimes past leakage (that has been "sealed" by the rusting pipe).

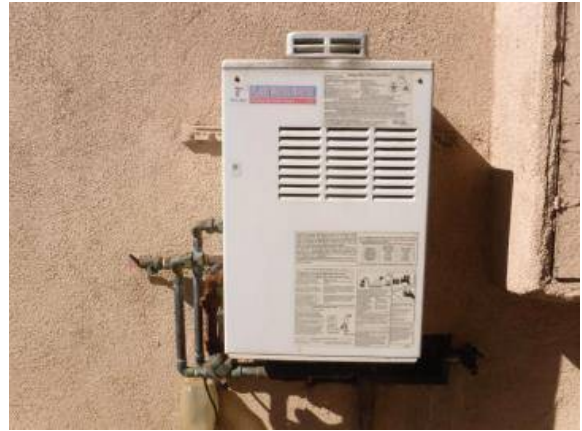
WATER HEATER

The water heater is located on the exterior of the building on the left side.

SERVICEABLE. Within my ability to observe, the condition of the water heater was found to be acceptable. Additionally, my observations of the location are from a generalist view. There may be specific requirements for this unit that should be determined by a qualified specialist. Each manufacturer has their own requirements and there are also varying requirements for different cities and municipalities. Consult with your local building codes or a licensed plumber for more information. Additionally, "set-back" requirements are not determined.

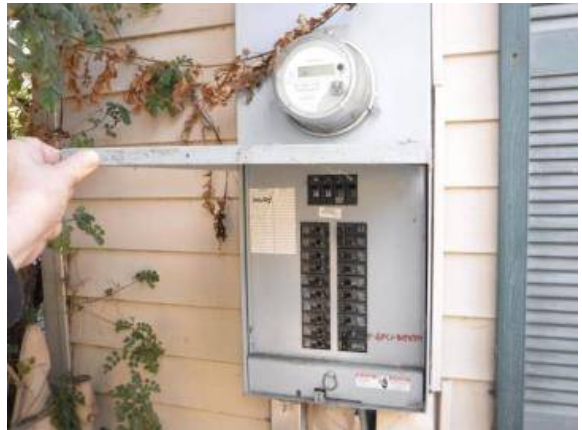
MAIN PANEL LOCATION

The main electrical panel is located on the right exterior side of the building, near the front.

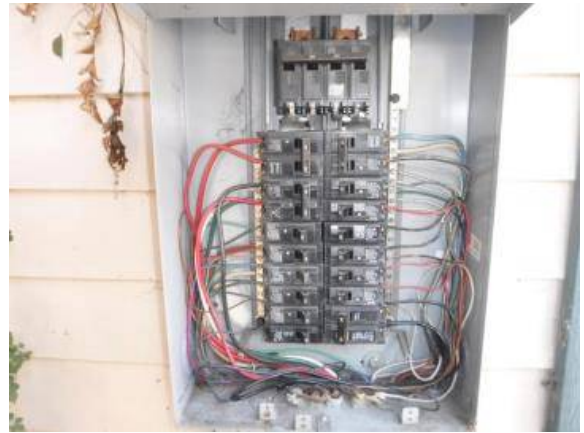
MAIN PANEL CONDITION

PRESENT. I found no issues with the main electrical panel.

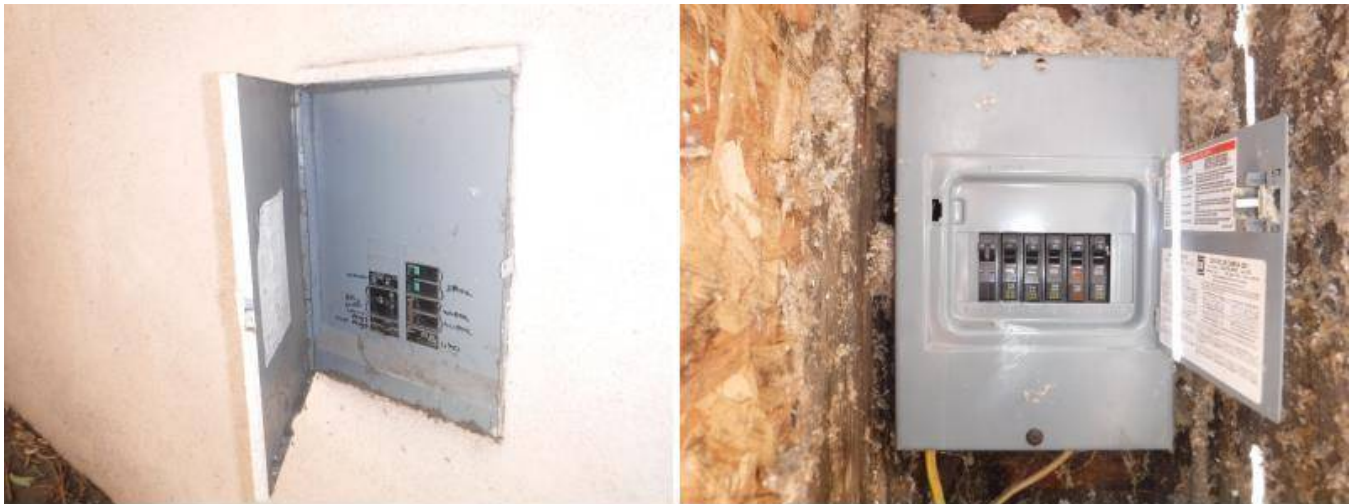
LOCATION

There is an electrical subpanel on the left exterior of the main building and at the right exterior of the ADU.

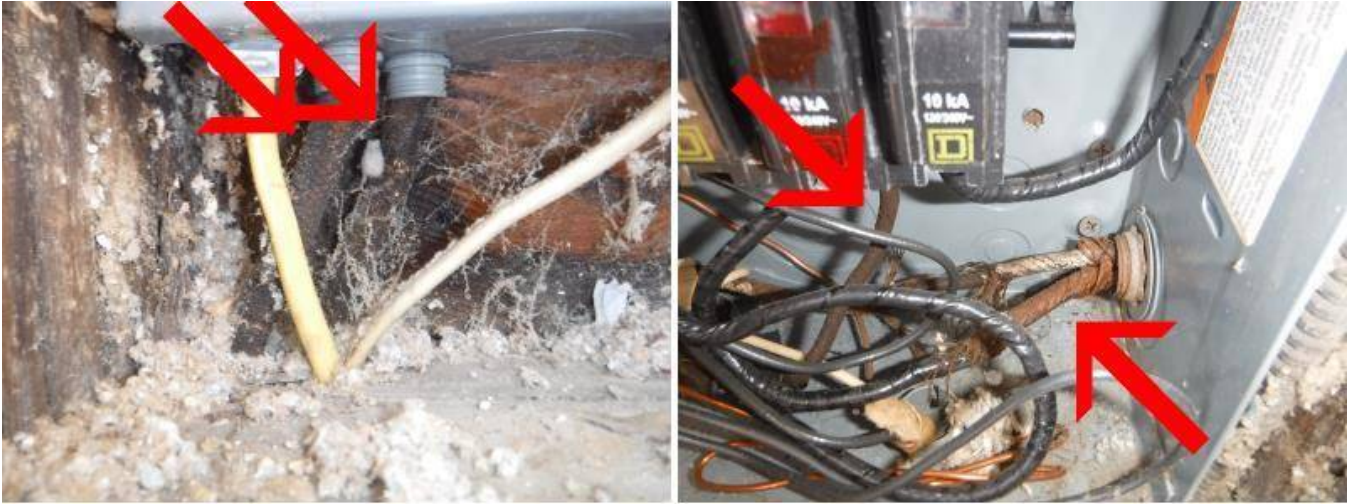
INTERIOR WIRING CONDITION

SAFETY ALERT. The wiring is a combination of the original cloth insulated copper wiring and the plastic insulated copper wiring. The cloth covered wiring is old and may continue to function unless it is disturbed or overloaded.

The cloth covering will continue to wear out and poses a significant increased risk of failure. This wire is considered to be past its expected working life. It is recommended that this wiring be fully evaluated by a qualified electrician to determine if it is time for replacement at this time or in the near future.

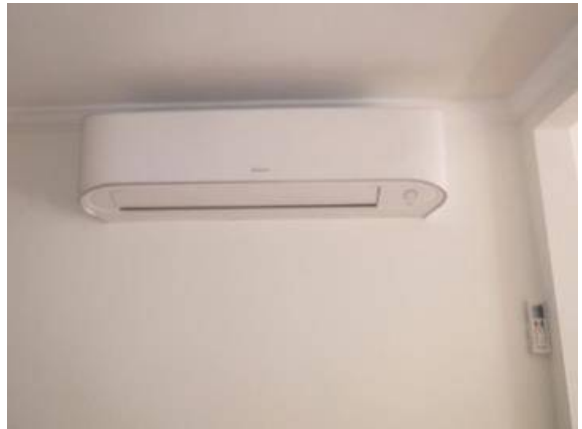
FAN-COIL LOCATION: On the wall.

Within my ability to observe, the location of the unit was found to be acceptable.

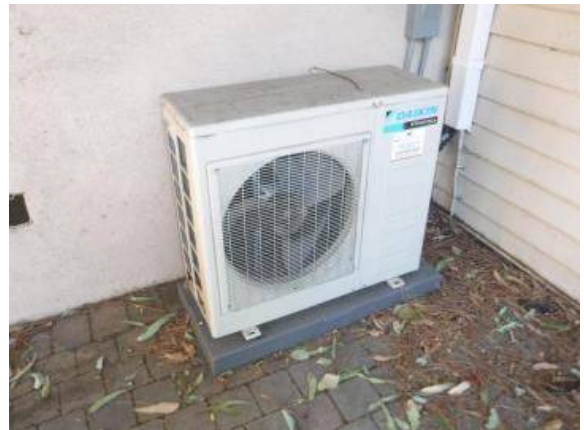
LOCATION: The air conditioning condenser is located in the front yard.

The air conditioning is a heat pump system. This is where the heating and cooling are both electric. The refrigerant goes in one direction for heating and reverses when cooling is needed. There are two components to the system, with one component being the Forced Air Unit and Evaporator coil inside, and the other component being the Condenser outside, typically on the roof or side yard or on the roof.

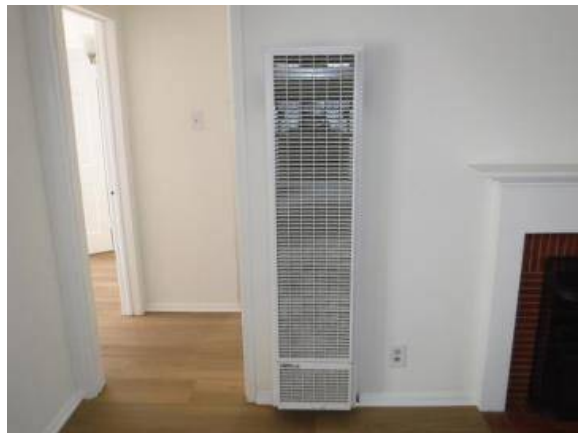
FURNACE LOCATION: In the wall. This is a 2 sided unit between the Dining Room and Hallway.

Within my ability to observe, the location of the unit was found to be acceptable.

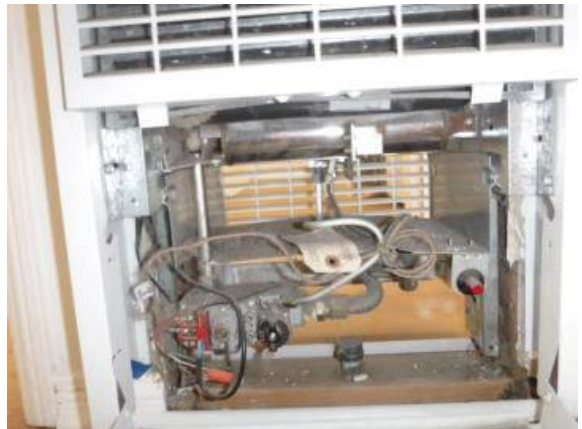
GAS CONNECTION

NEEDS ATTENTION. The pilot is not lit in the furnace though the gas was turned on in the building. It could not be fully inspected while in operation. The furnace should be evaluated by a qualified HVAC contractor to determine its condition.

NOTE. There is no 'Drip Leg' or 'sediment trap' noted on the gas line immediately in front of the unit. This component is recommended and may be a manufacturer and/or city requirement for safe operation. Consult with a qualified plumber for more information.

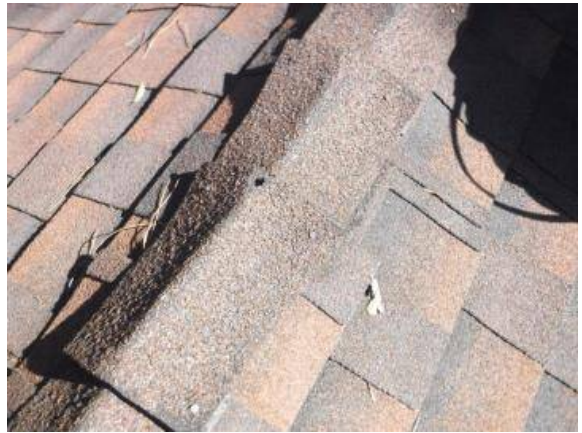
NEEDS ATTENTION. On the composition roof: The roof is older and showing signs of age and wear / deterioration (such as at the edges and a little at the ridge caps). Although the roof may not be at the end of its life at this time, it is older and does have a limited life expectancy. Consult with a qualified roofer for more information.

On the roof, there are nails heads that are exposed on the roof surface, not only will this allow them to rust but it is a potential leak hazard.

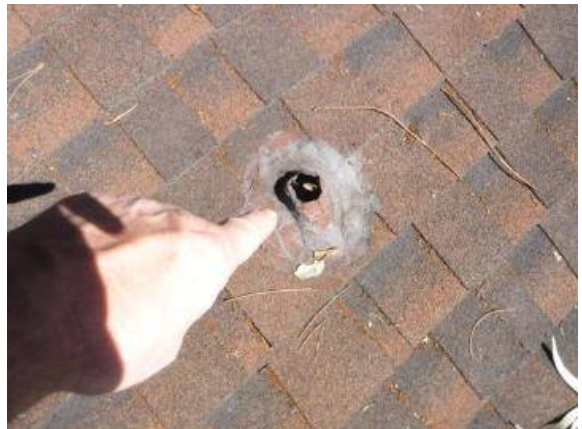
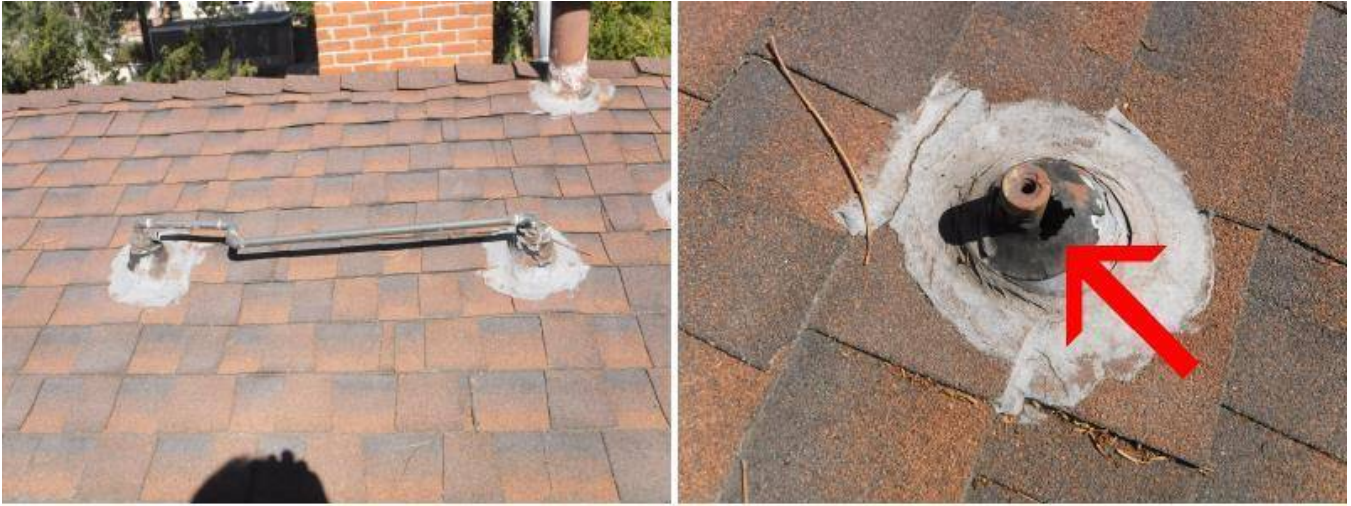
NOT ACCEPTABLE. Some of the flashings do not have vent piping through them any longer and are open to the attic or into the bldg and need to be closed off, Such as at the back left side

NEEDS ATTENTION. Mastic has been used to seal roof penetrations in areas. This material cracks over time and loses its ability to maintain a seal. It requires regular maintenance/repairs to ensure a leak free condition.

NEEDS ATTENTION. There are penetrations in the roof that are damaged and may allow moisture to enter the bldg.

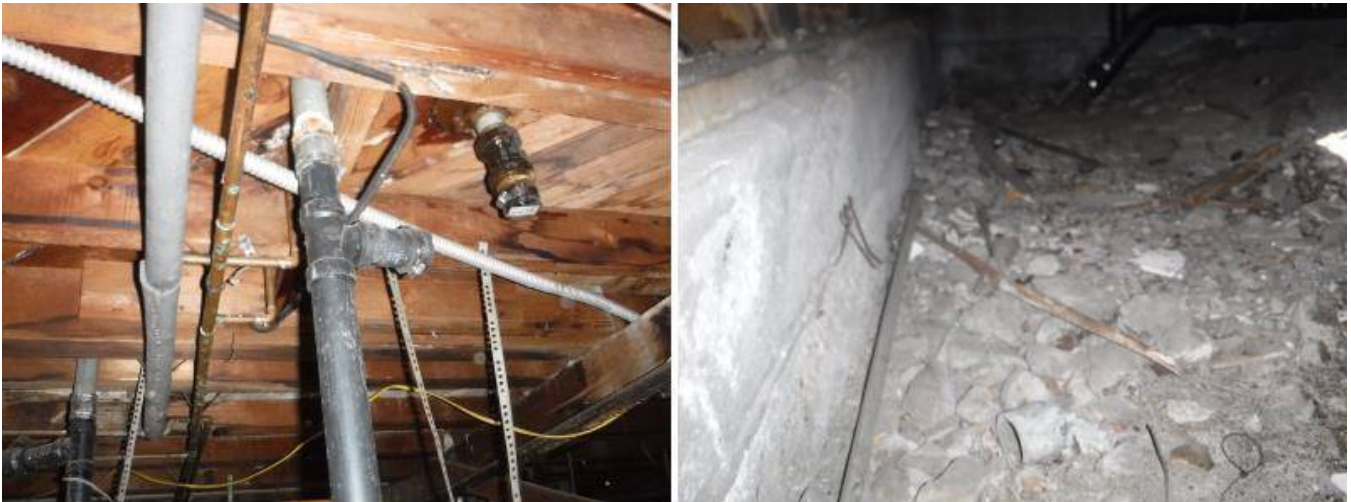
CRAWL SPACE

NEEDS ATTENTION. The crawl space has debris in it, it is advisable to have this removed and the area cleaned up. Wood especially should be removed to help prevent future infestations.

There are areas of damp soil under the house, such as under the bathroom.

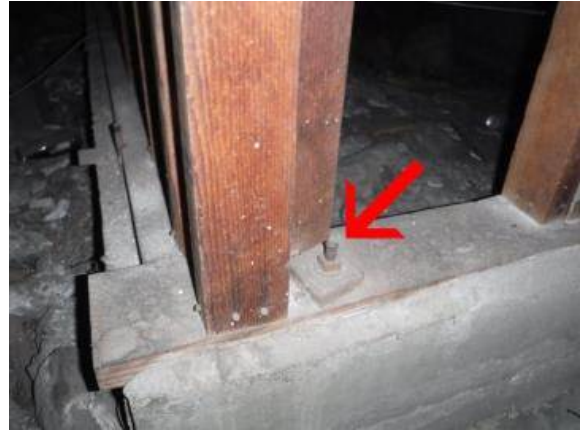
PRESENT. The structure has original anchor bolts. These bolts are farther apart and smaller than current established bolting standards would dictate.

For more information, further evaluation would be needed by a foundation specialist to determine what additional upgrades could be undertaken to help increase this foundations' ability to withstand seismic activity.

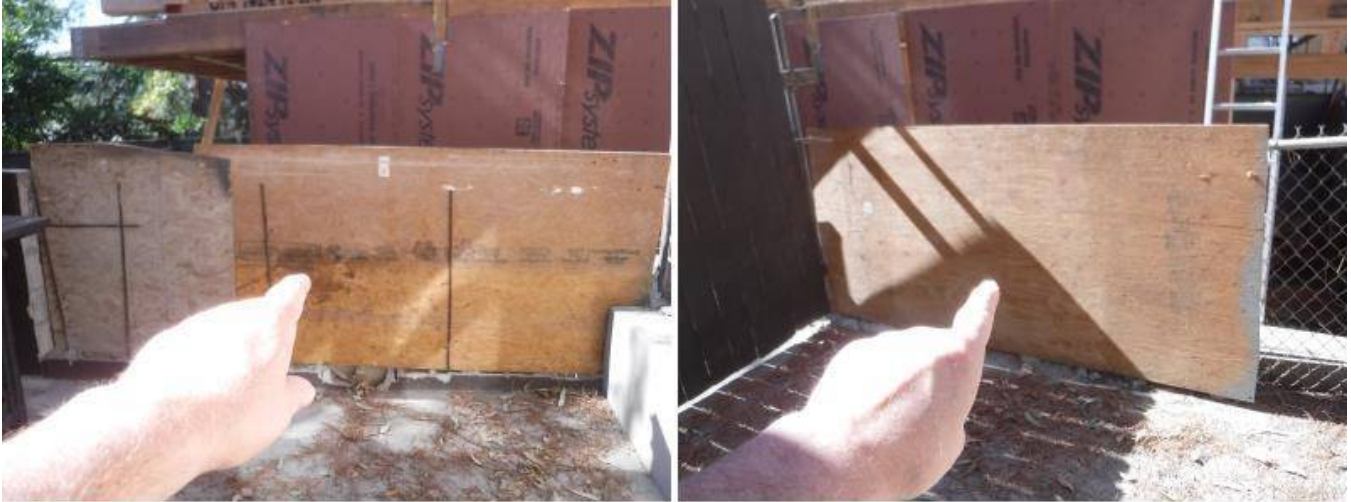
NEEDS ATTENTION. The fencing is missing in the areas and a temporary set up is in place, such as at the right side of the lot.

The walls or fencing could not be fully seen and inspected due to vegetation growing on them.

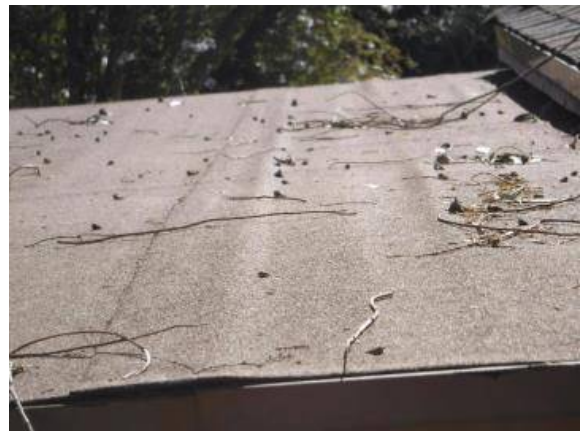
NEEDS ATTENTION. On the low sloped roof there are bubbled areas of roofing material. This is an indication that some moisture has gotten under the material.

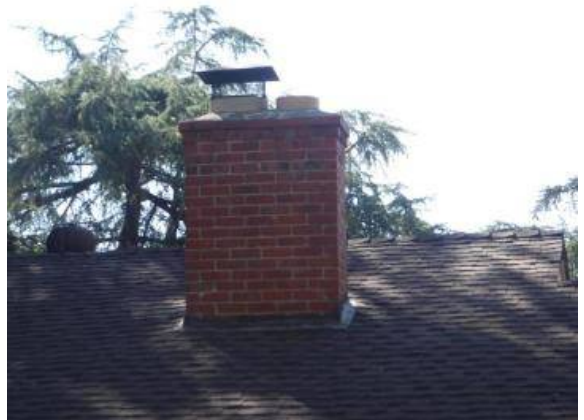
LIVING ROOM/DEN.

The chimney is made of masonry.

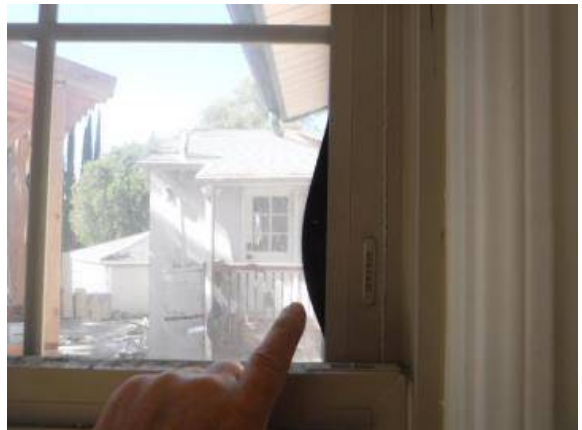
Some of the window hardware is older and may need some adjustment/repairs to work properly.

The window seals are pushed out into the glass in areas.

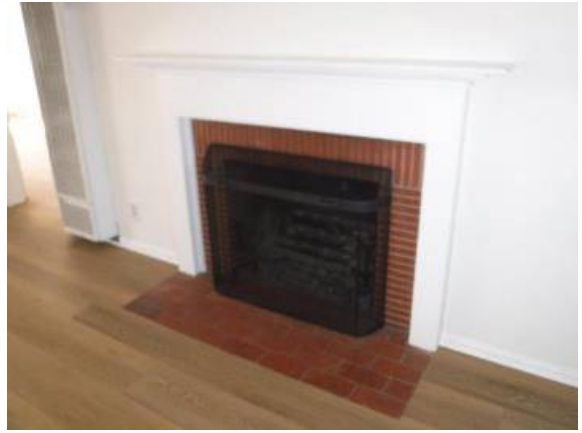
LIVING ROOM: All fireplaces should be cleaned and inspected on a regular basis to make sure that they are safe and structurally sound.

This is a masonry wood burning fireplace. A gas log lighter installed. It is beyond this inspection to determine the condition of this log lighter or to determine the condition of the gas line system, including whether or not there are gas line leaks.

It is beyond the scope of this inspection to determine the existence of defects or damage to the fireplace, chimney or its flue. This can only be determined by a specialty chimney inspection which should be performed at this time.

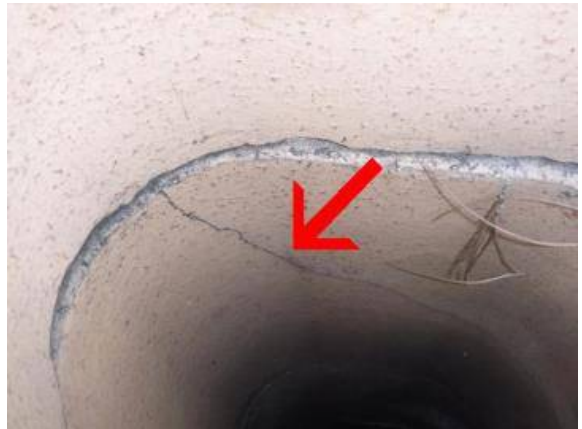
NEEDS ATTENTION. The flue is dirty and needs to be fully evaluated by a professional chimney inspector. During their inspection they may find additional items that need repair.

The flue tiling has some cracking in it.

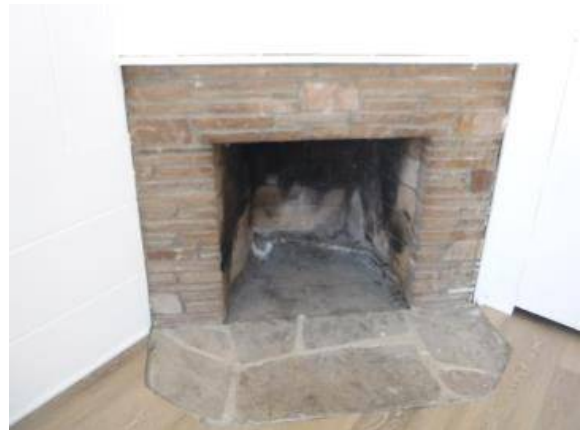
DEN: All fireplaces should be cleaned and inspected on a regular basis to make sure that they are safe and structurally sound.

This is a masonry wood burning fireplace. A gas log lighter installed. It is beyond this inspection to determine the condition of this log lighter or to determine the condition of the gas line system, including whether or not there are gas line leaks.

It is beyond the scope of this inspection to determine the existence of defects or damage to the fireplace, chimney or its flue. This can only be determined by a specialty chimney inspection which should be performed at this time.

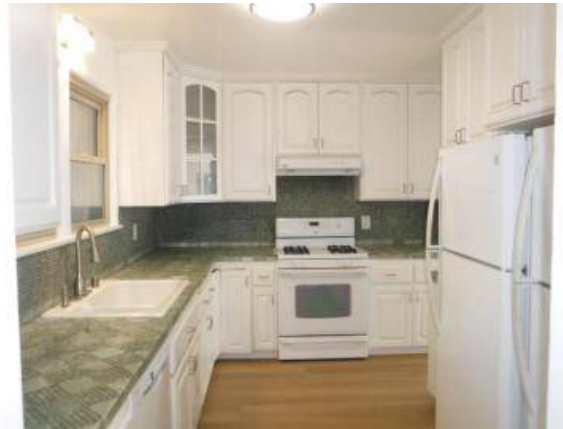
KITCHEN AREA

SERVICEABLE. The general condition of the walls and ceiling appears serviceable.

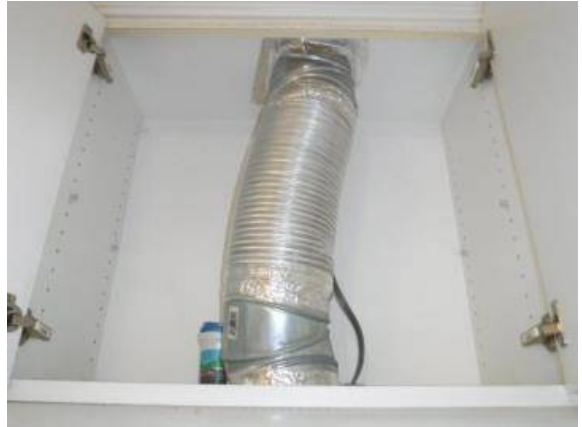
VENTILATION FAN

NOT ACCEPTABLE. The range hood exhaust duct is made of aluminum corrugated material, this is not recommended as it can trap grease. It should be smooth wall steel ducting.

NEEDS ATTENTION. The exhaust fan is noisy and may be wearing out.

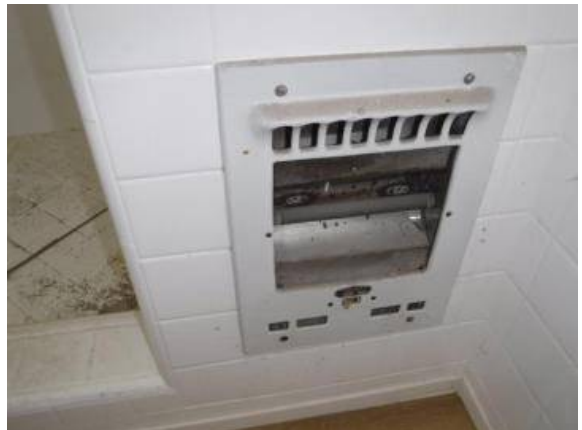
BATHROOM HEATER

SAFETY ALERT. There is a very old wall heater that is not working. These get very hot and are considered to be a potential burn hazard.
