COMMERCIAL PROPERTY CONDITION STATEMENT

2307 W Harris

San Angelo, TX 76901

PROPERTY INSPECTION REPORT

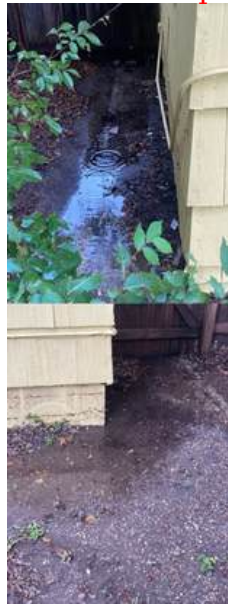
- ☐ Exterior: Soil grade and drainage patterns around areas of house do not appear to properly direct water away from foundation to aid in controlling runoff water and could cause differential movement of the foundation or water penetration during heavy rains.

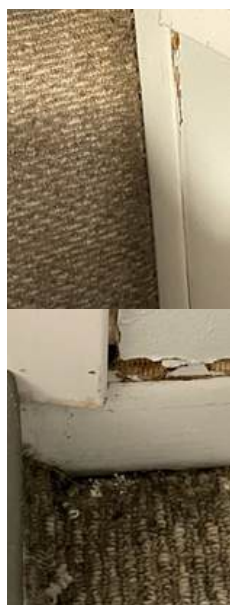
- ☐ Exterior: Grading allows water to enter through side door, carpet was wet and trim has water damage, recommend specialist for further evaluation

- ☐ **Exterior: Grading allows water to enter through side door, carpet was wet and trim has water damage, recommend specialist for further evaluation**

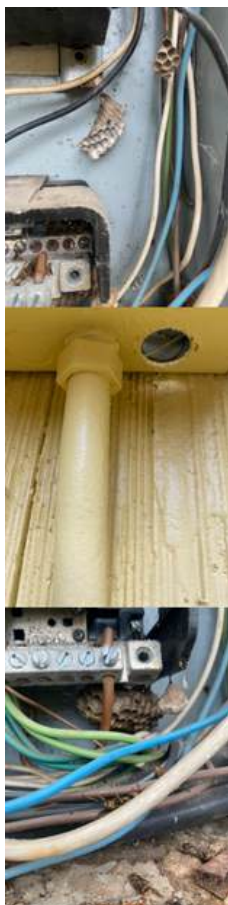
- ☐ Exterior: Not all breakers are identified
- ☐ Exterior: Panel exterior circular knock out(s) need to be sealed to prevent wasp / bee infestation.

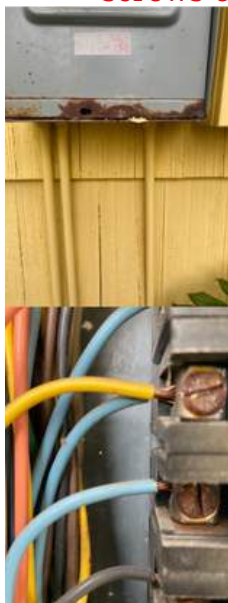
- Exterior: Rust observed on panel and on several set screws on breakers

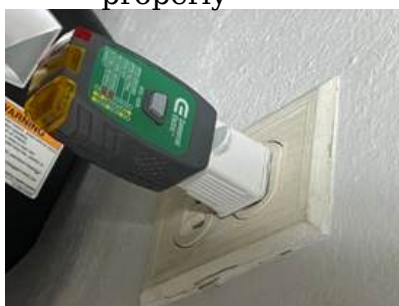
- ☐ Several outlets throughout building were not working properly
