## Comprehensive Site Summary

Former Rush Woodford Amoco Property  
800 Washington Road  
Washington, PA 15301

Report Date:  
April 17, 2014

## 4.0 REMEDIAL SOIL EXCAVATION

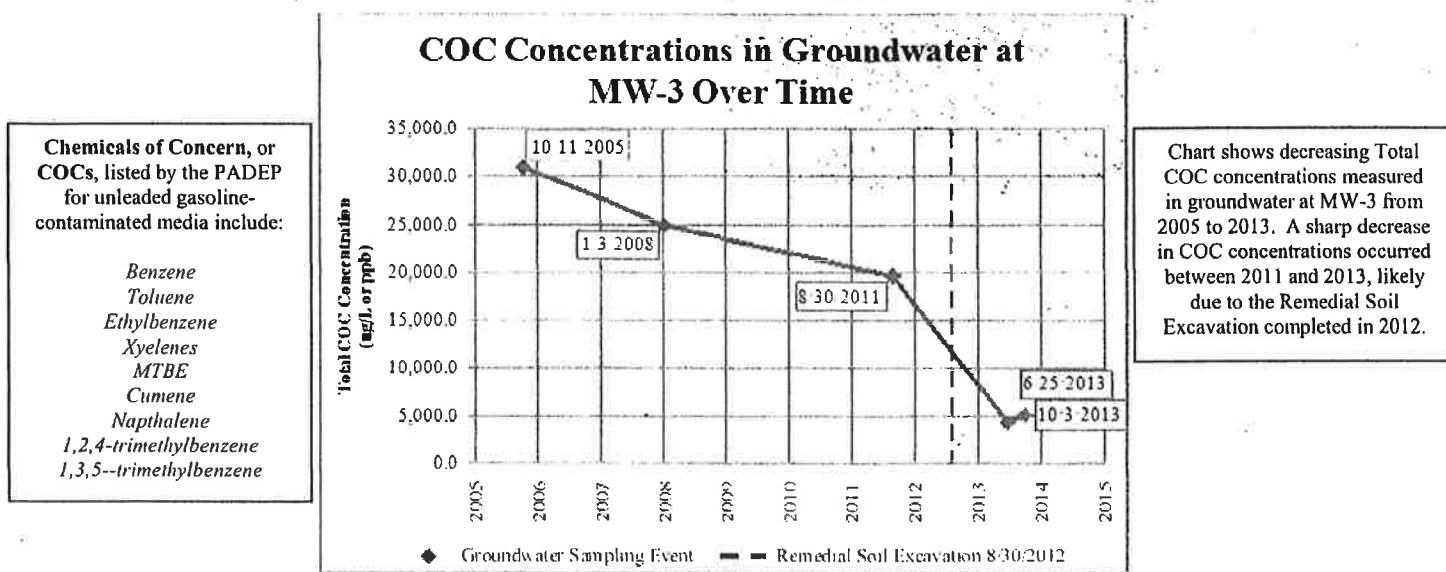
Groundwater analytical results indicate that elevated COC concentrations remained at the location of *MW-3* in 2013. However, as illustrated on the chart on the following page, a significant decrease (74%) in COC concentrations had occurred since the previous sampling event in 2011. Concentrations of *benzene*, *ethylbenzene*, *naphthalene*, *1,2,4-trimethylbenzene*,

and *1,3,5-trimethylbenzene* remain above the value for compliance with the SWHS at Non-Residential sites.

The excavation of PCS from the subsurface of the former dispenser island area in August 2012 appears to have been an effective approach at reducing contaminant concentrations at the Property. Post-excavation assessment data indicate that the excavation may have aided in reducing dissolved-phase groundwater contaminant concentrations by as much as 74%.

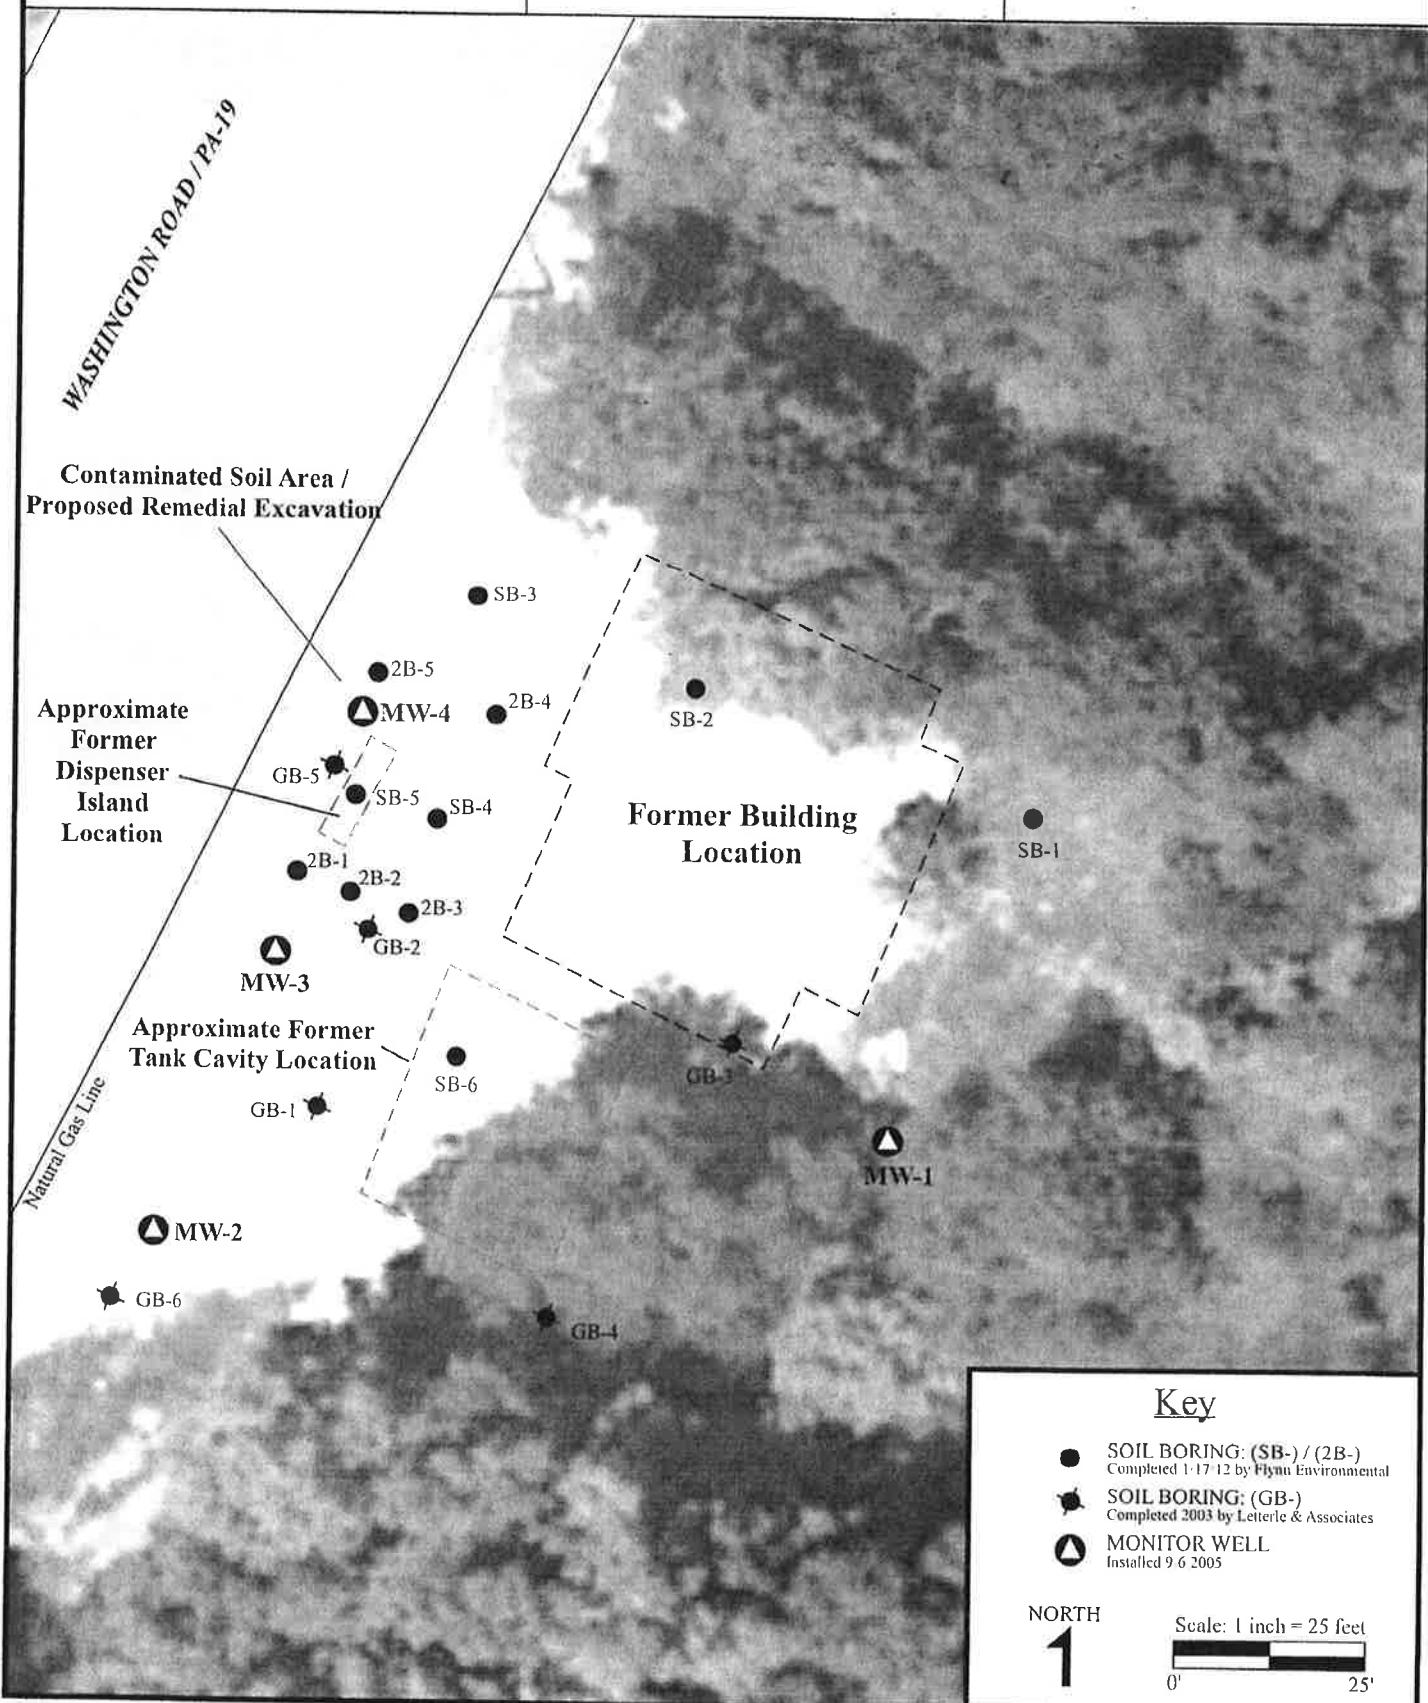
FIGURE 2

Figure 2 Pre-Excavation Site Plan on 2010 Aerial Photo

Figure 2 of this report illustrates the locations of samples collected between 2002 and January 2012; Table 1 includes comprehensive soil analytical data; and Table 2 includes comprehensive groundwater analytical data. Note: the validity of all data pre-dating 2012 is subject to the methodologies and reporting of the respective consultants.

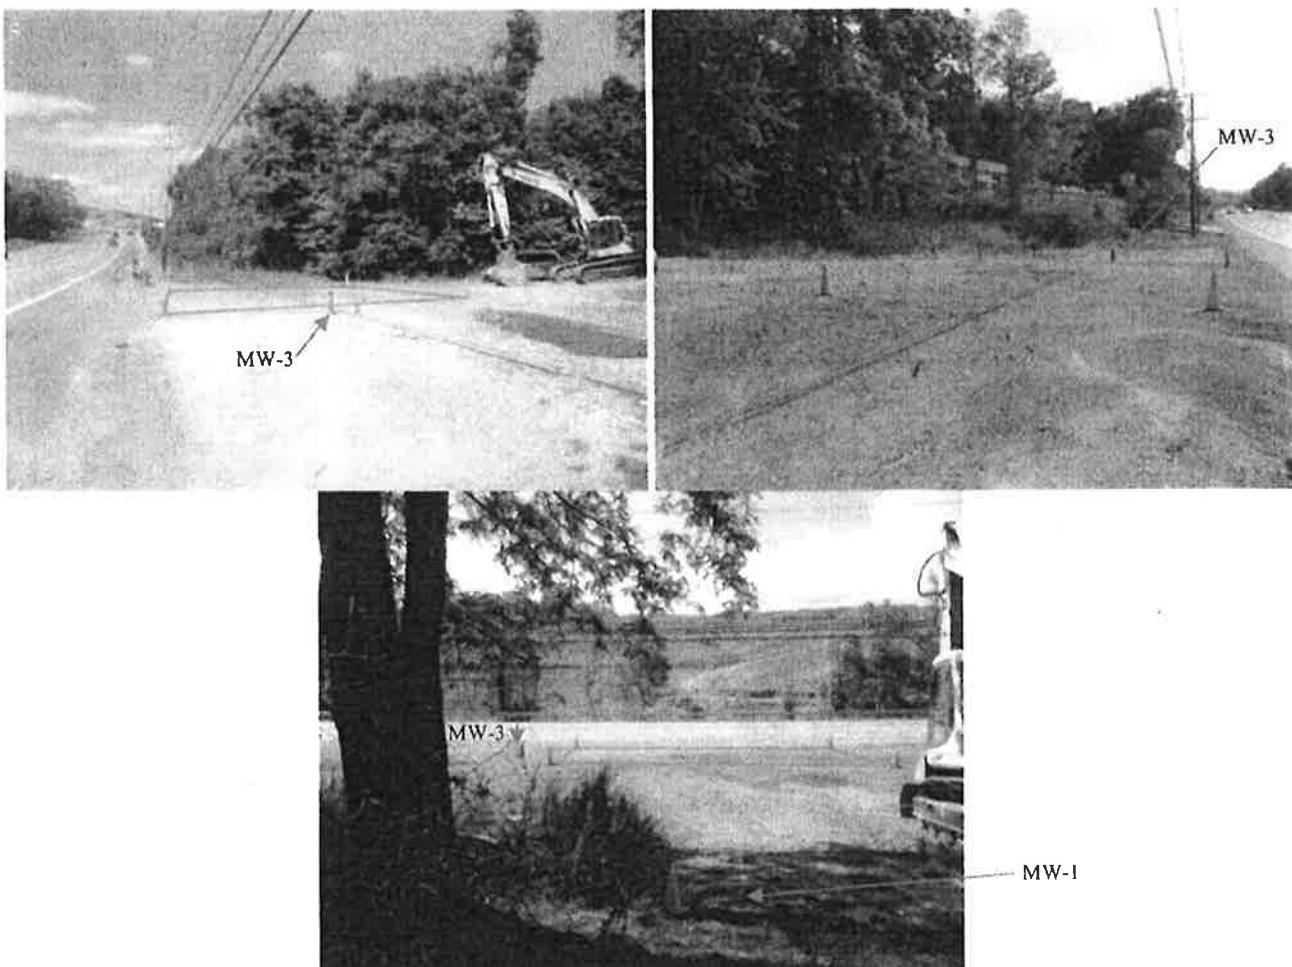
**Photos 1,2&3 (8/29/2012):** Overview of Property prior to commencement of excavation activities: cones mark the corners of the proposed excavation area, and orange lines were added to illustrate the area. The locations of existing groundwater monitoring wells MW-1 and MW-3 are also shown. Top left shows view looking north along Washington Road; top right shows view looking south; bottom shows view looking west.

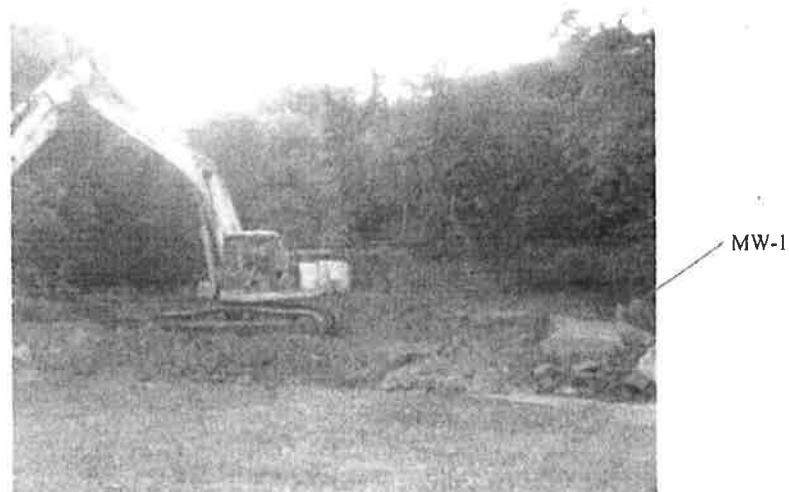
**Photo 4 (8/30/2012):** Preparation of the stockpiling / soil treatment area: an area measuring approximately 40 feet by 30 feet was graded level and surrounded with an earthen berm approximately 30 inches high.

An area measuring approximately 40 feet by 30 feet was graded level and surrounded with an earthen berm approximately 30 inches high. Heavy, black plastic (6mil) was spread across the entire bottom of the stockpiling / soil treatment area and over the berms to prevent any liquids from leaching through the stockpile into the subsurface. As contaminated soils were excavated and field-screened, they were added to the pile. The stockpiled soil was covered with 6mil plastic to allow for air movement below the plastic and to prevent rainwater or runoff from infiltrating the pile.

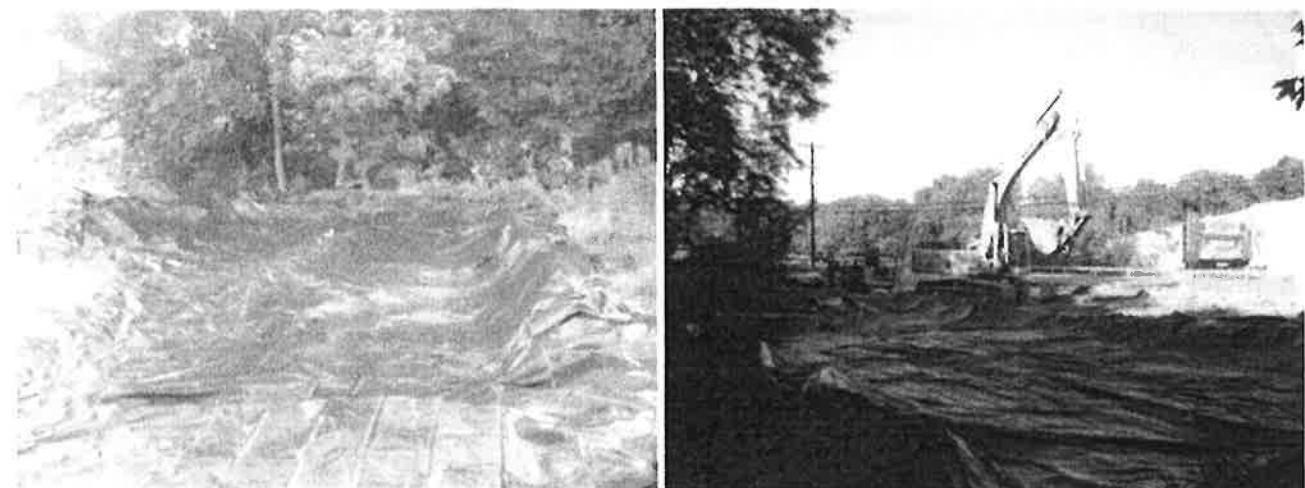
**Photos 5&6 (8/30/2012):** 6mil plastic was laid across the entire bottom of the stockpiling / soil treatment area and up the berms to contain any liquids from leaching through the stockpile into the subsurface.

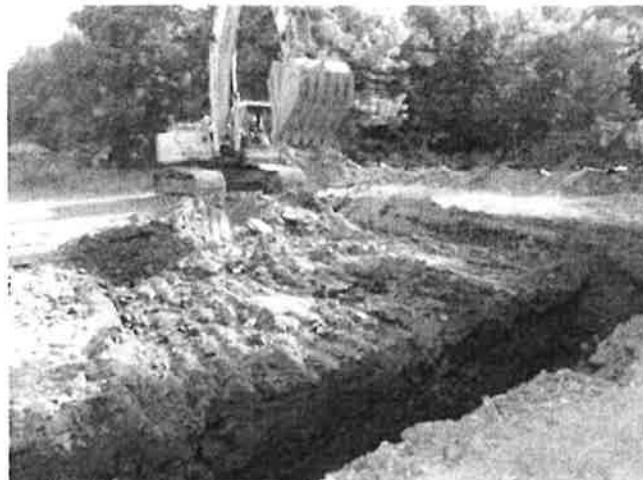
**Photo 7 (8/30/2012):** To commence excavation activities, the top 20-36 inches of gravel and clean material from the proposed area were removed. Some of this material was used to create a berm between the excavation and Washington Road; the remaining material was added to the "presumably clean soil pile".

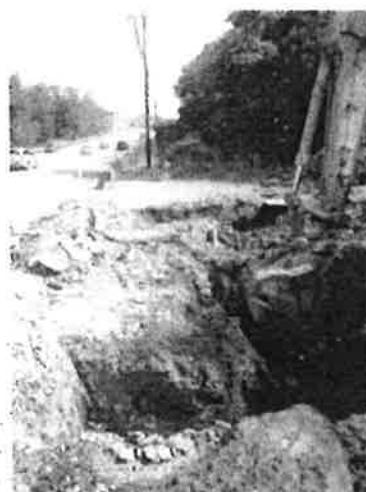
**Photo 8 (8/30/2012):** The western extent of the excavation was moved 4-6 feet to the east due to proximity to utilities near the edge of the highway.

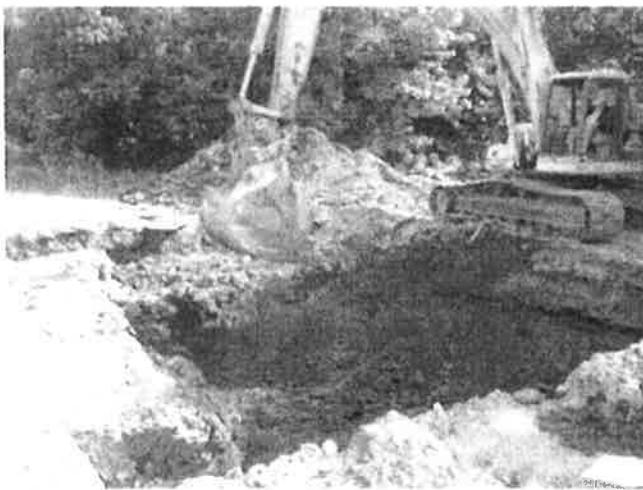
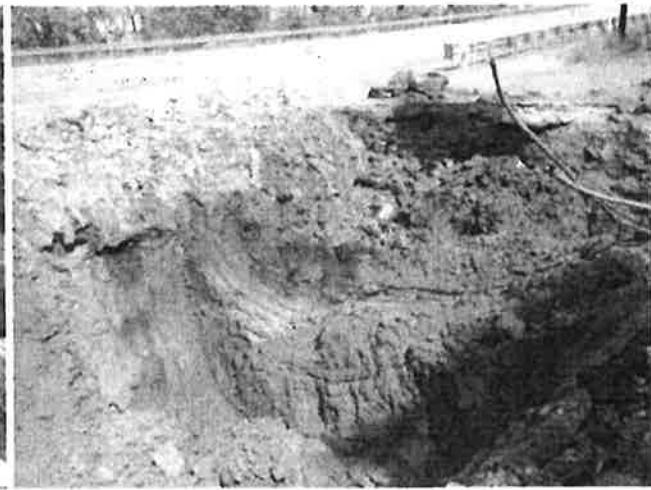
**Photos 9&10 (8/30/2012):** Soils 3 to 9 feet below grade across the excavation generally exhibited indications of significant petroleum impact such as staining and strong vapors; they were dug out and added to the contaminated soil pile for on-site treatment.

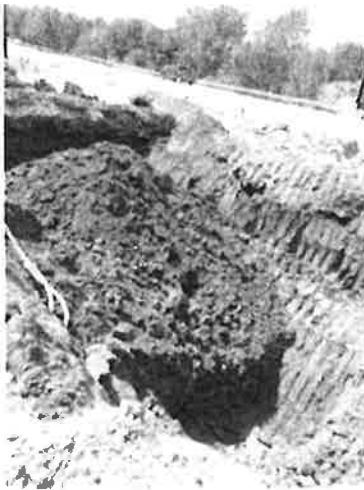
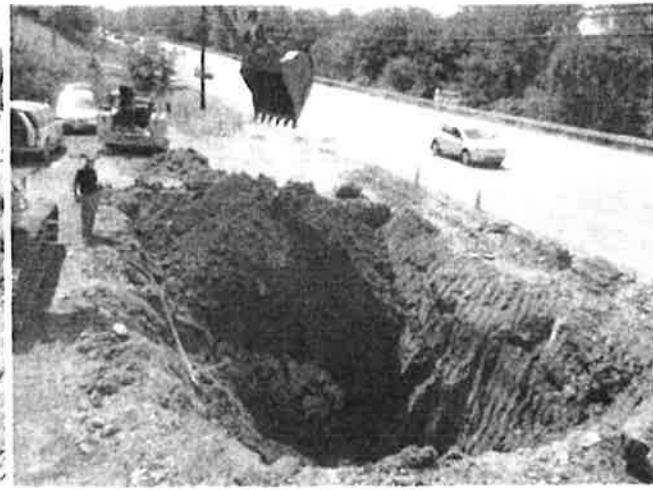
**Photo 11 (8/30/2012):** Soils 9 to 14 feet below grade generally did not exhibit obvious visual indications of contamination, though they did exhibit variable degrees of petroleum vapors. Therefore, soils from 10 to 14 feet below grade were dug within the excavation and completely turned over so as to release any volatile organic compounds and introduce oxygen to the subsurface to facilitate in situ remediation of soils remaining at the Site.

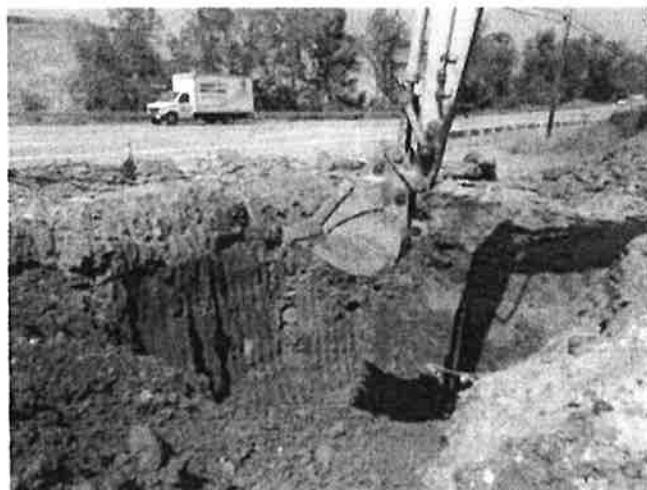
**Photo 12 (8/30/2012):** Soil samples were collected from the sidewalls of the excavation at 10-foot intervals with a bias toward the most obviously contaminated.

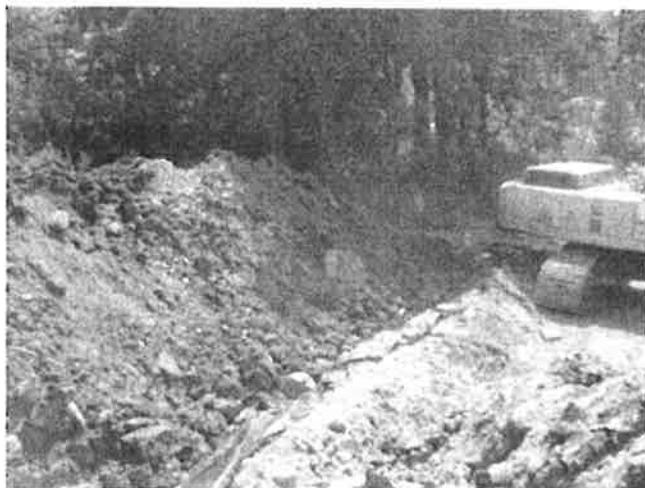
**Photo 12 (8/30/2012):** On-site soil treatment pile prior to being covered with 6mil plastic.

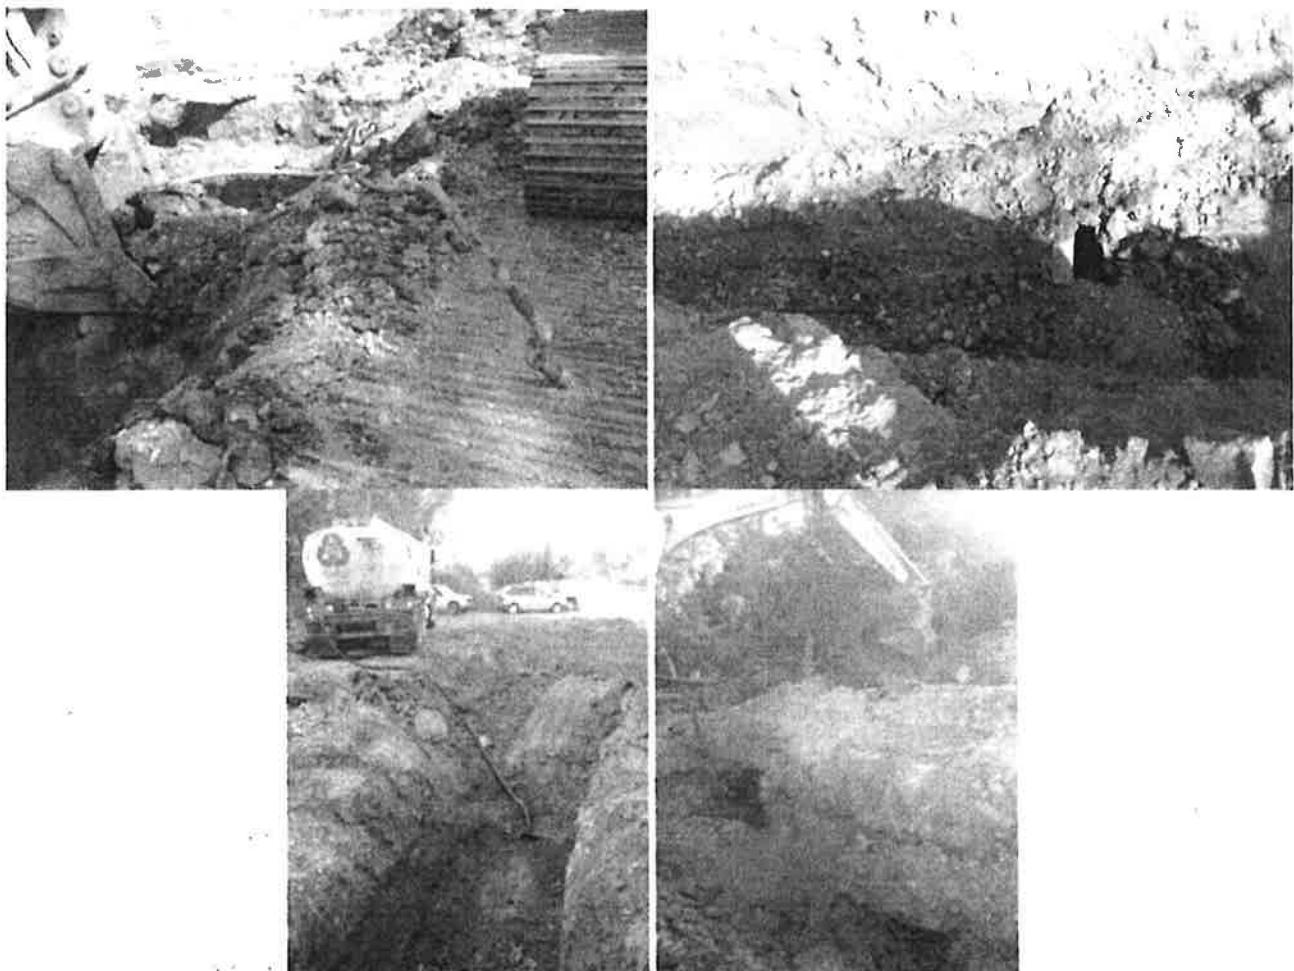
**Photos 13,14, 15&16 (8/31/2012):** An unregulated steel UST of approximately 550-gallon capacity was discovered north of the primary excavation area by following a steel product line from the former dispenser island. The tank contained water free of any signs of petroleum product, which was evacuated by Environmental Specialists, Inc. The tank was removed and exploratory digging was completed to a depth of 8 feet below grade in the area north of the primary excavation area. Soil screening samples were collected throughout the area. No additional tanks were encountered.

A second area, adjacent to the northern extent of the primary excavation, was also excavated after an "orphan" tank was identified and removed. Exploratory digging was completed in the vicinity of the orphan tank across an area measuring 18 feet by 25 feet and 8 feet deep. No other tanks were discovered. Soil conditions in this area generally did not exhibit signs of obvious contamination. Soil samples *B-1* through *B-6* were collected from this area. Less than 2 tons of stained soil was removed from this area and added to the soil treatment stockpile.

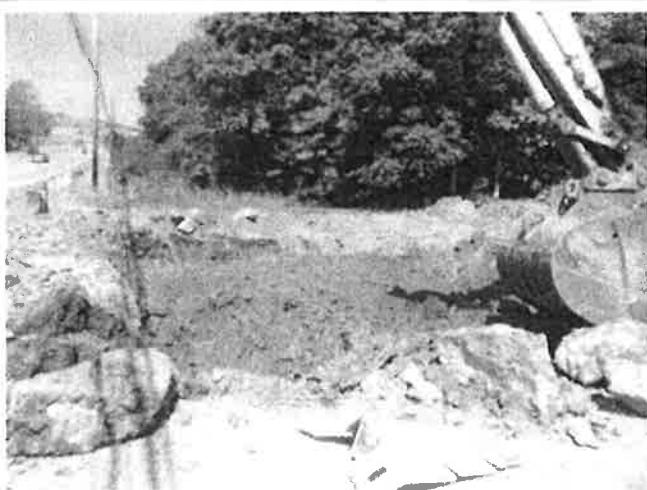
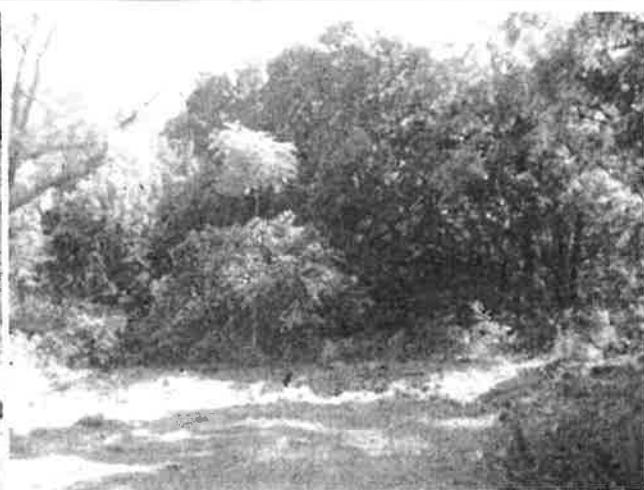
**Photos 17&18 (8/31/2012):** The excavation cavity was backfilled with clean soil material borrowed from elsewhere on the Property.

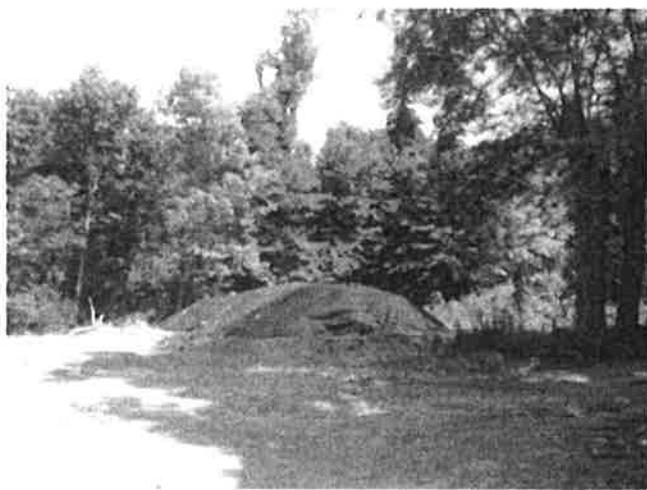
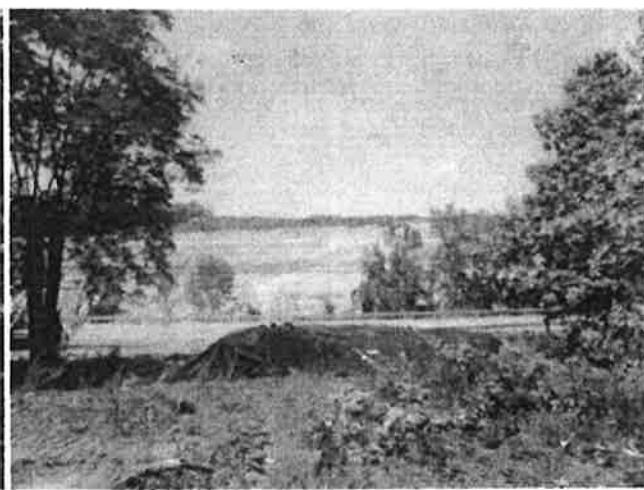
**Photos 19&20 (8/31/2012):** The stockpiled soil was covered with 6mil plastic to allow for air movement below the plastic and to prohibit rainwater or runoff to infiltrate the pile.

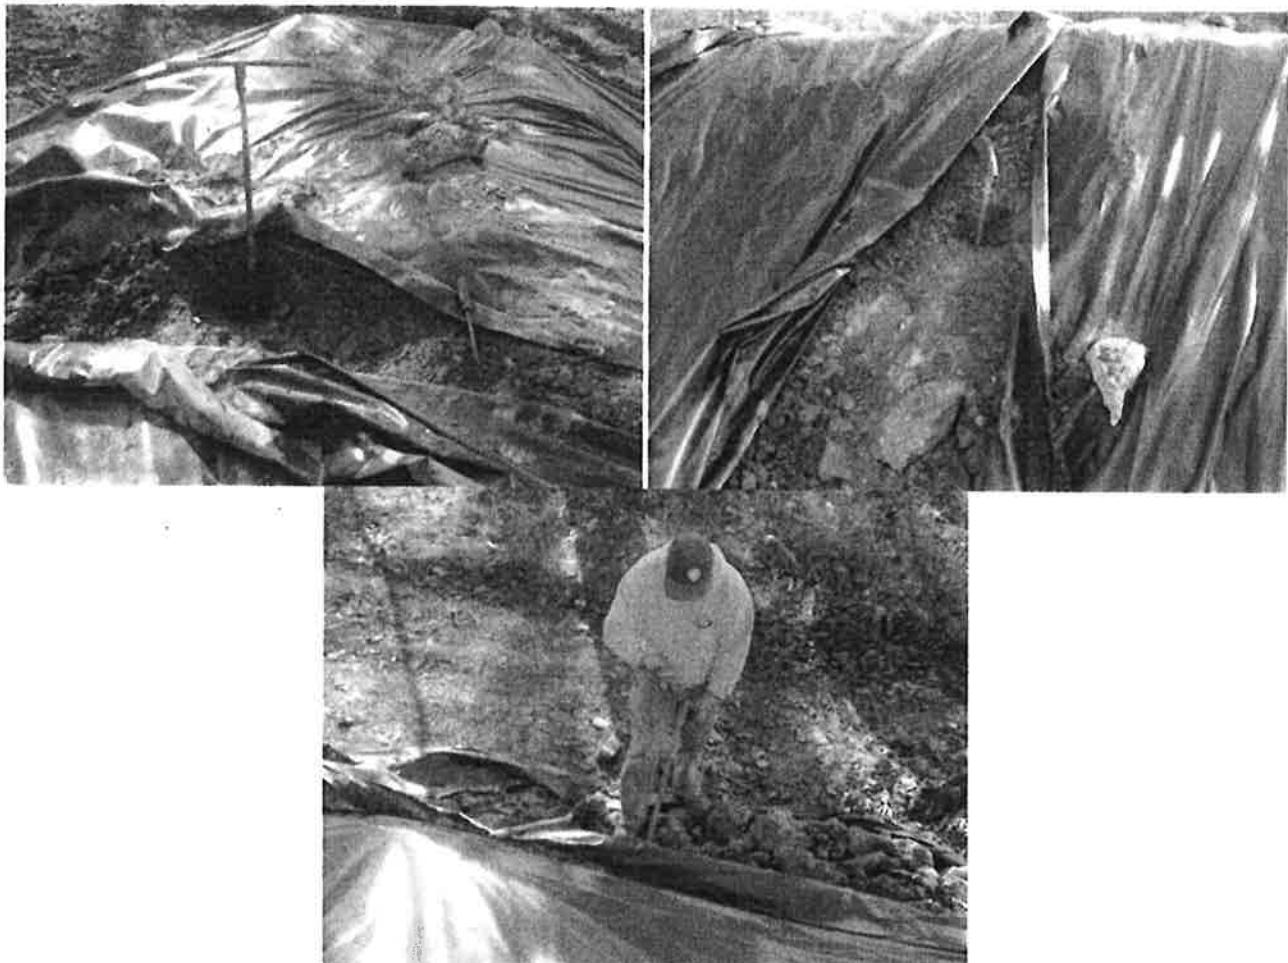
**Photos 21, 22, & 23 (11/29/2012):** 90 days following the excavation, 11 samples were collected from across the soil pile using hand augers to assess contaminant levels remaining in the treated soil.

After 90 days, on November 29, 2012, Flynn personnel returned to the Property and collected soil samples from throughout the pile. Visual examination revealed minimal signs of obvious petroleum impact on the exposed soil. Samples were collected by advancing hand-augers from 0 to 6 feet into the pile (or until met with refusal) and collecting soil from the augered interval which exhibited the highest PID reading. If no obviously impacted soil was observed, soil was sampled from the maximum depth achieved. A total of eleven (11) samples (SP-1 through SP-11) were collected from across the pile. Sample locations are illustrated on Figure 3; sample collection data are presented on Table 3.

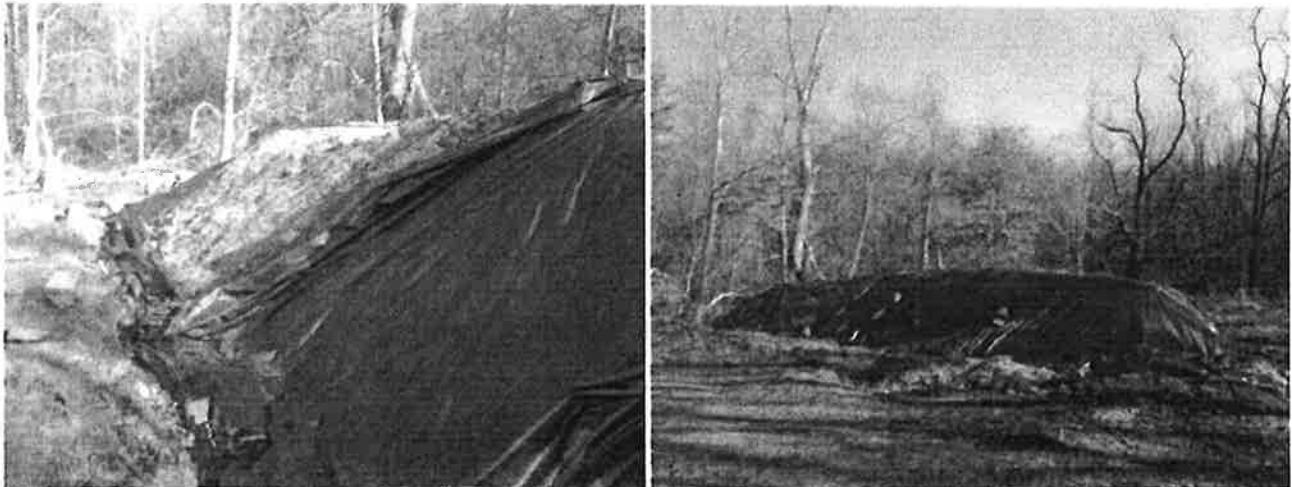
**Photos 24&25 (11/29/2012):** The pile was partially uncovered and visual assessment of soil conditions was noted. After soil samples had been collected, the pile was completely covered and secured.

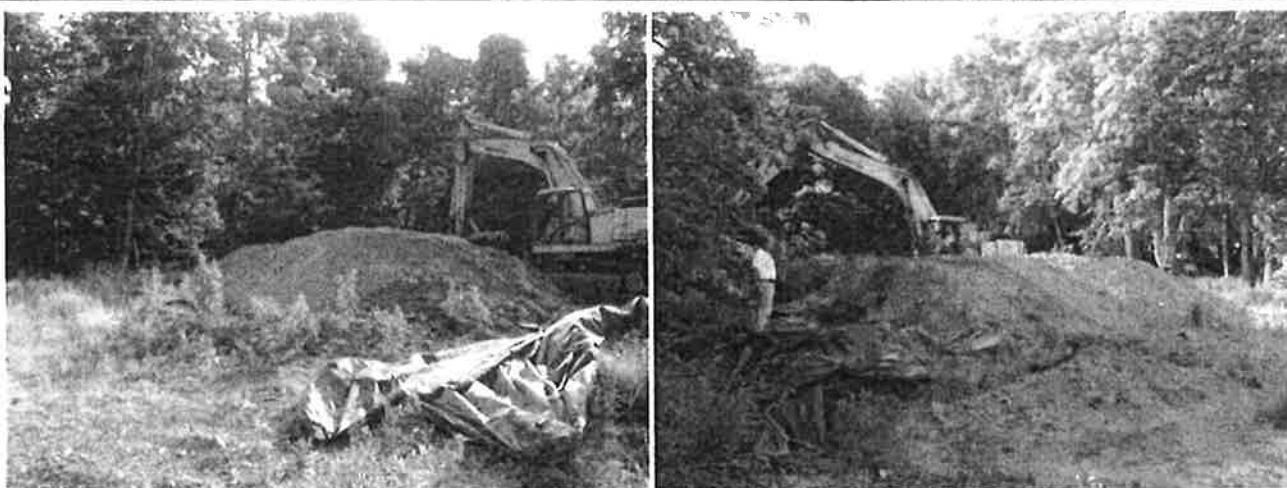
**Photos 26&27 (6/25/2013):** The soil pile appeared free of visual signs of contamination before it was completely turned and moved to Treatment Cell Location B.

After 300 days, on June 25, 2013, FEI and Gregg personnel returned to the Property and stirred the pile to promote degradation of the petroleum COCs. The soil pile was completely turned and moved (as illustrated on Figure 3) using a trackhoe. FEI inspected the soil pile and found only small pockets of soil which appeared to remain contaminated, from which samples SP2-1 through SP2-20 were collected. Four (4) of the twenty (20) samples (SP2-4, -8, -9, and -17) were submitted for analysis; each contained concentrations of *benzene*, *1,2,4-trimethylbenzene*, and *1,3,5-trimethylbenzene* above PADEP's Standard for Re-Use of Soil On-Site, therefore additional treatment time was recommended.

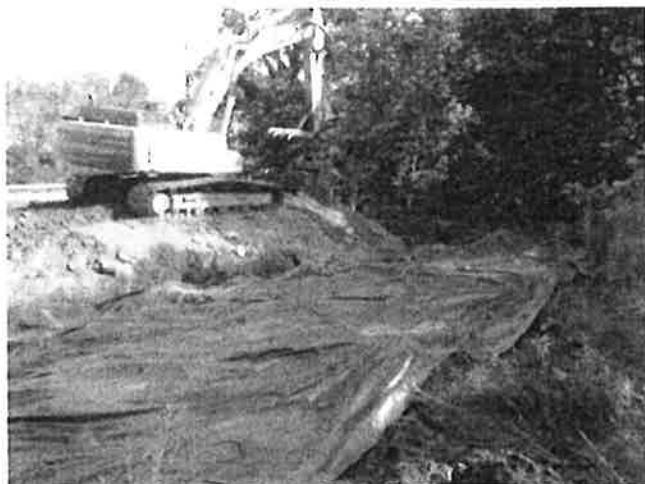
**Photo 28 (6/25/2013):** Showing the preparation of Treatment Cell Location B immediately east of Location A, prior to movement of the soil pile.

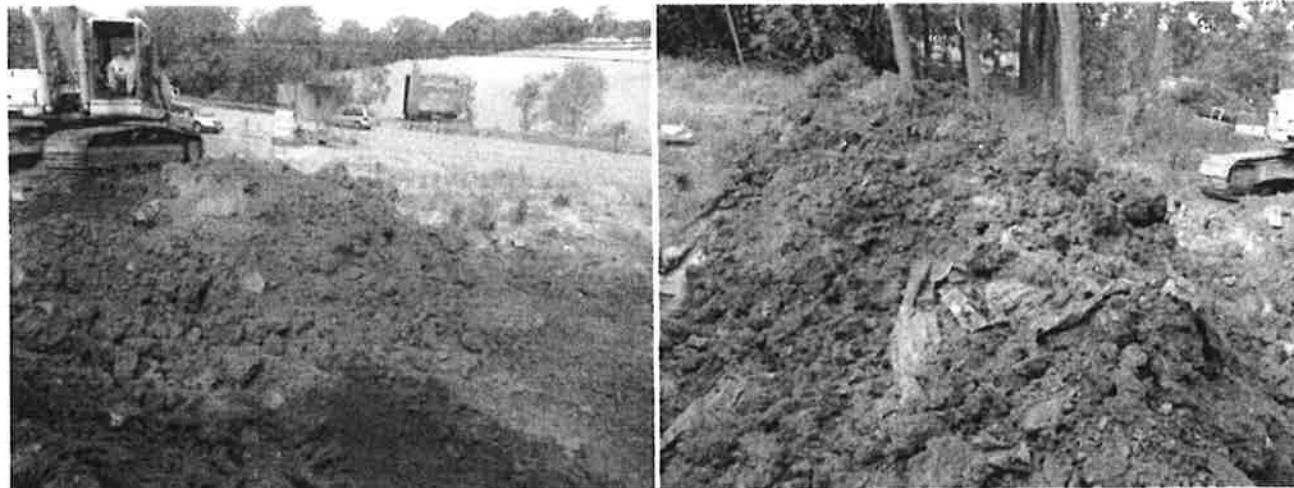
**Photos 29&30 (6/25/2013):** The vast majority of the soil appeared free of any signs of petroleum impact, and areas obviously petroleum-impacted appeared only as small pockets. As the pile was moved, only samples of soil exhibiting staining were collected. A total of 20 samples were collected (SP2-1 through SP2-20), and the four samples which produced the highest field-screenings were submitted for analysis.

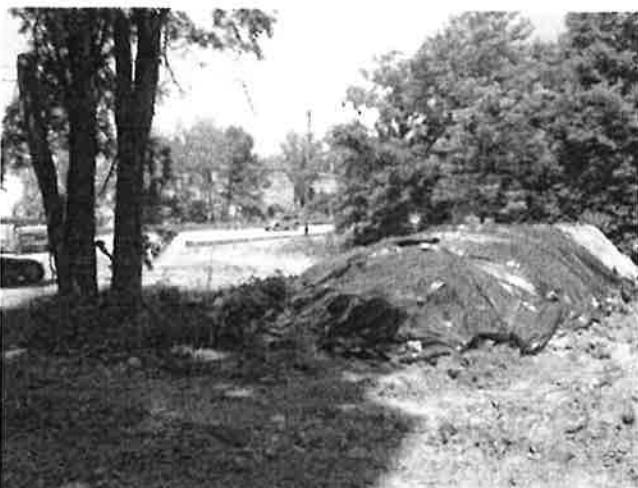
**Photo 31 (6/25/2013):** After the soil pile had been completely turned and moved, it was completely covered with 6mil plastic and secured.

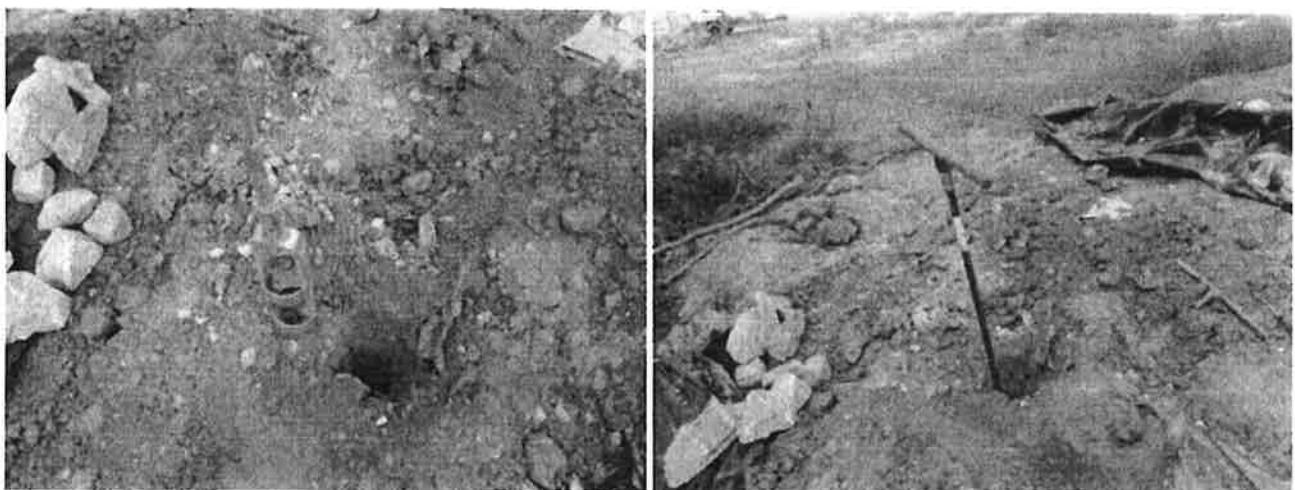
**Photos 32&33 (10/3/2013):** The soil pile was uncovered for visual inspection after 400 days of on-site treatment, and 11 samples were collected using a hand auger. The majority of the soil pile appeared to be free of obvious signs of petroleum contamination.

After 400 days, on October 3, 2013, FEI personnel returned to the Property and collected soil samples using the protocol established during the 90-day sampling event described above. Visual examination of the exposed soil revealed little or no signs of obvious petroleum impact. Eleven soil samples (*SP3-1* through *SP3-11*) were collected from across the soil pile as illustrated on Figure 3. The four samples which produced the highest field screening readings (*SP3-5*, *SP3-7*, *SP3-9*, and *SP3-11*) were submitted for laboratory analysis.

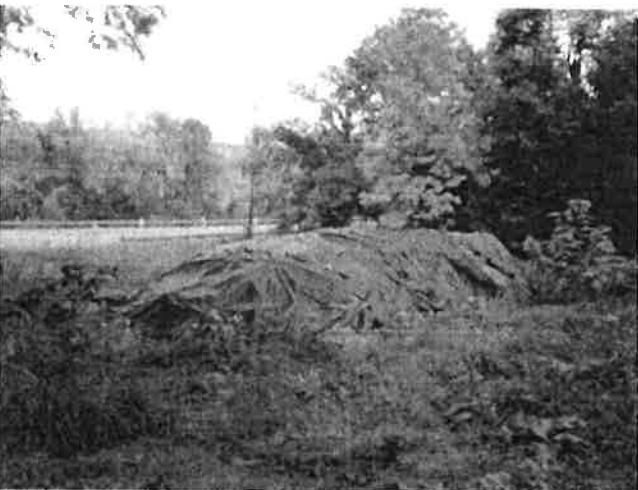
**Photo 34 (10/3/2013):** After the soil pile had been sampled, it was completely re-covered with 6mil plastic and secured.
