WEECO Project # 2015-5133

Phase I Environmental Site Assessment

**923 W. Carson Street
Torrance, CA 90502**

December 7, 2015

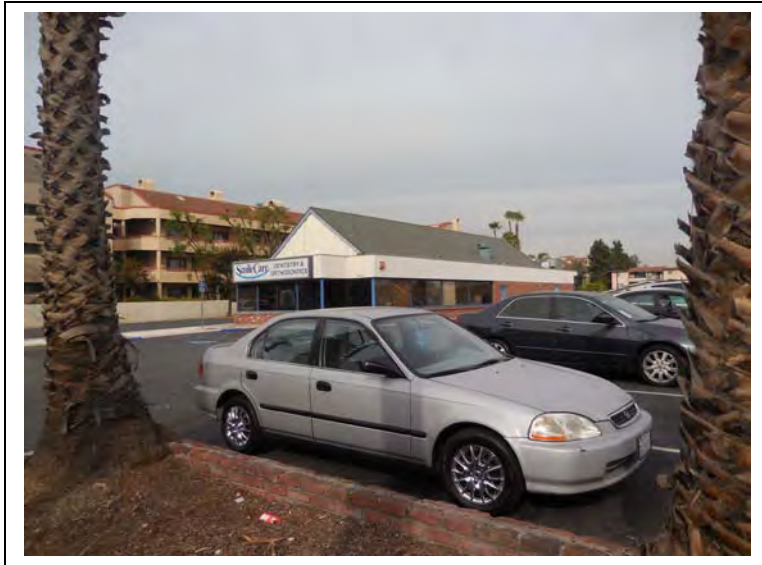
From the visual inspection, the subject site is composed of one (1) single-story commercial office building being used as a dental clinic. Asphalt-paved parking areas were observed throughout the subject site.

The subject building appeared to be constructed of brick walls; wood frame/shingled roof; and concrete slab floors. The building materials appeared to be in good condition at the time of visual inspection. See Attachment (G).

Picture (1). Subject Site Facing Northwest

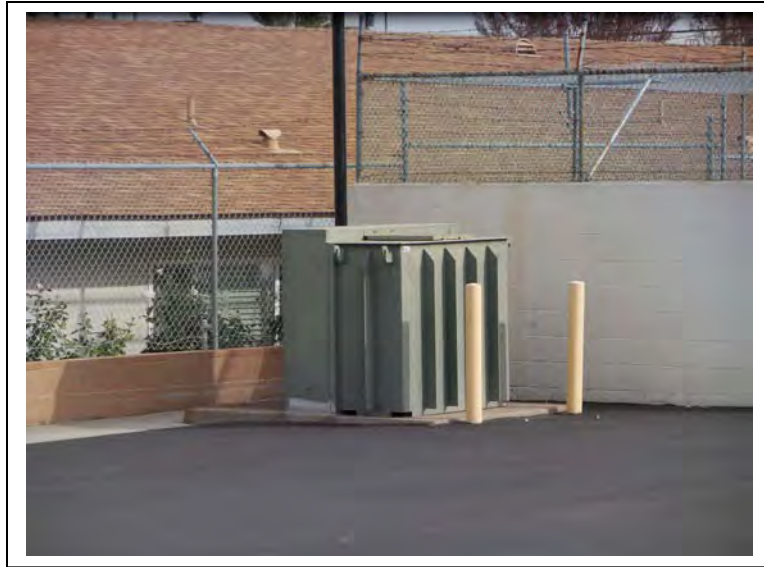
One (1) pad-mounted electrical transformer was observed at the northeast corner of subject site. No evidence of leaking was observed.

Picture (5). Pad-Mounted Electrical Transformer at the Subject Site

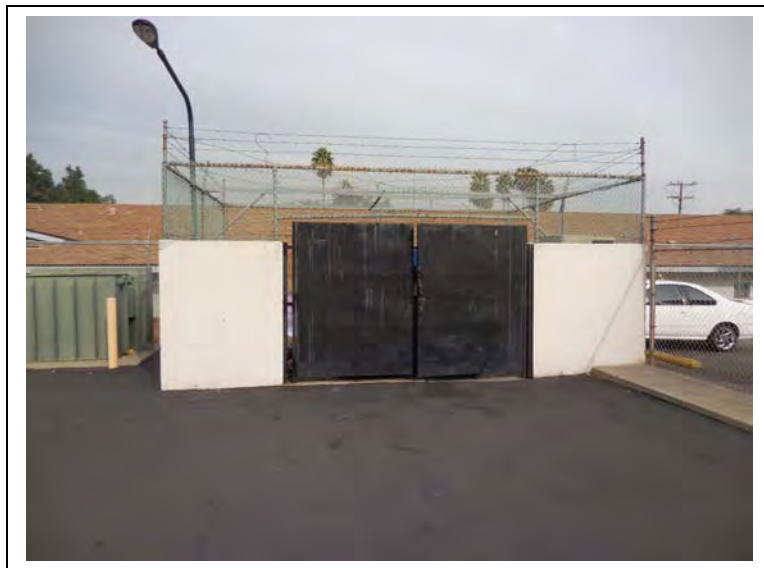
From the visual inspection, WEECO investigator observed no hazardous materials being used or stored at the subject site. No 55-gallon industrial drums were observed at the subject site. No 5-gallon buckets were observed at the subject site. One (1) trash-bin with trash enclosure was located to the northeast corner of the subject site, and did not appear to contain any hazardous materials or waste. See Attachment (G).

Picture (6). Trash Enclosure at the Subject Site

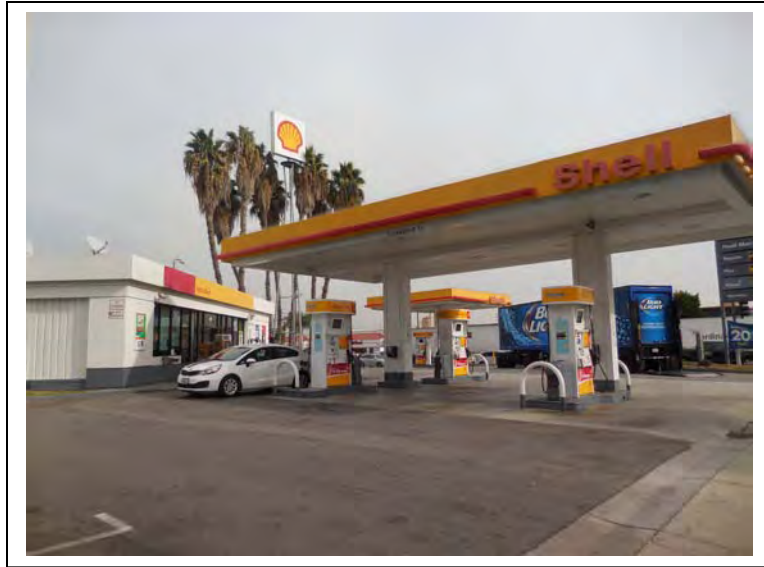
- 3b. Is any adjoining property used as a gasoline station, motor repair facility, commercial printing facility, dry cleaners, photo developing laboratory, junkyard or landfill, or as a waste treatment, storage, disposal, processing, or recycling facility (if applicable, identify which)? **YES (gas station)**

Picture (9). Adjoining Property to the East (Shell Station)
