**Subsurface Exploration and
Geotechnical Evaluation**

**New Life Church Building
2701 N. Austin Avenue
Georgetown, Texas**

**Alliance Engineering Group Project # AE24-0702
TBPE Firm No. 11290**

September 5, 2024

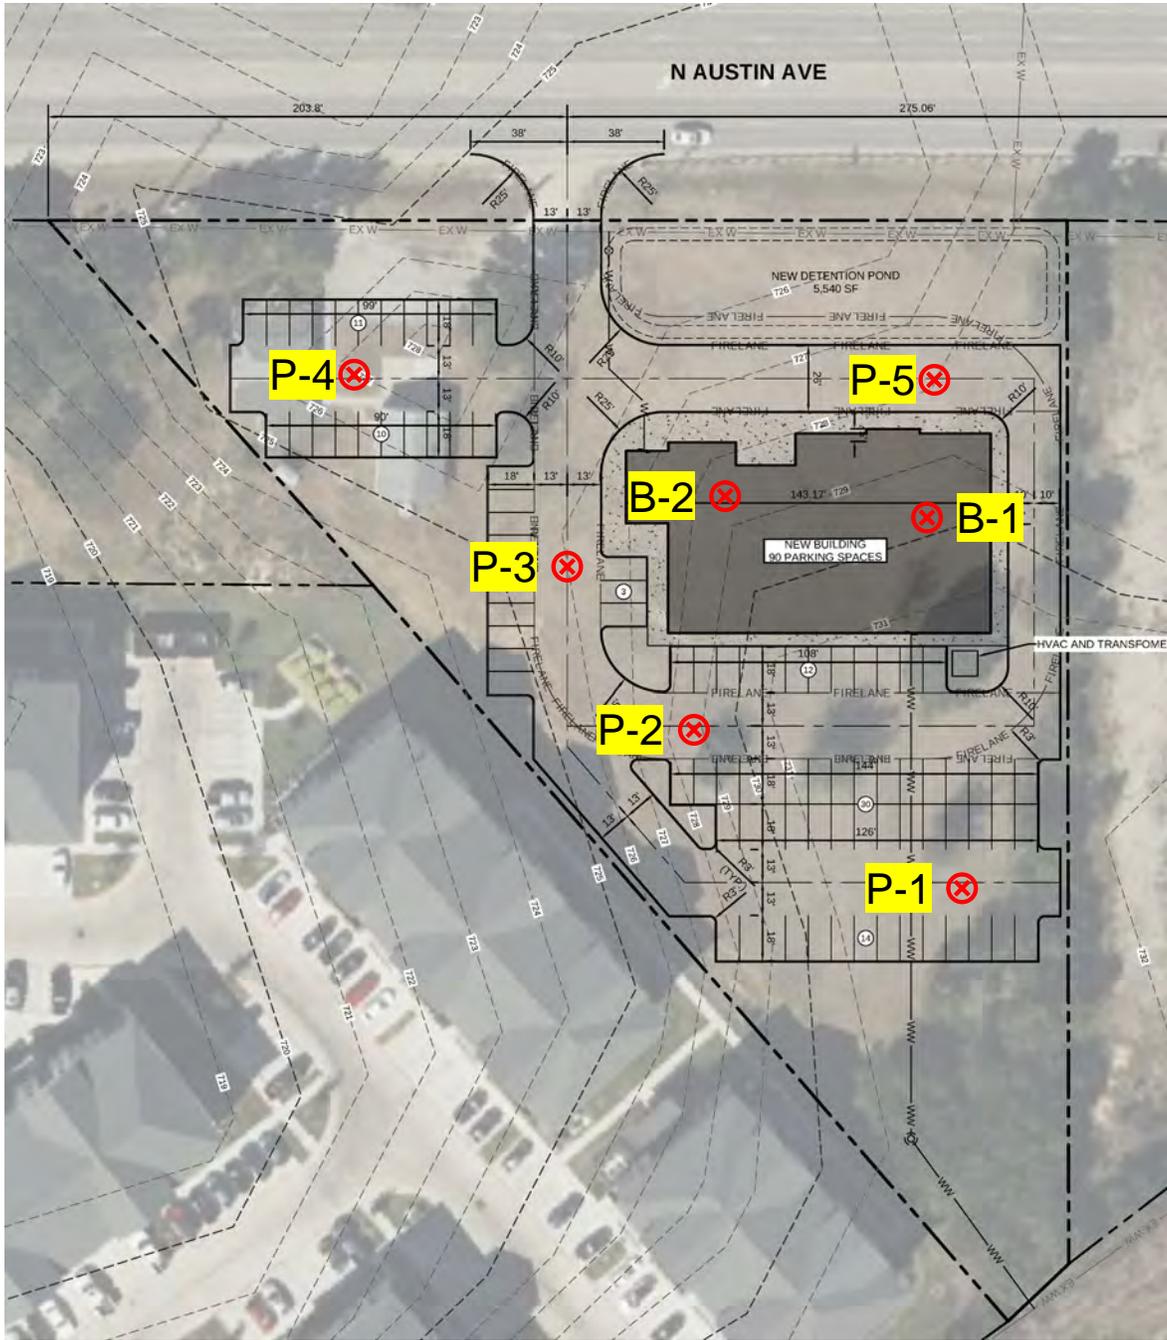
Approximate Locations of Borings

Two (2) exploratory borings were drilled to auger refusal in limestone to depths of approximately ten (10) feet below existing grade in the building area. Five (5) exploratory borings were drilled to depths of approximately six (6) feet below existing grade for the pavement/drive lanes areas. Approximate boring locations are provided as **Figure 2**.

2. The subsurface profile consists of hard, dry, fat clay over dry, hard, lean clay and/or gravelly lean clay over soft to moderately hard (rock basis), dry, yellowish brown severely weathered and weathered limestone. The fat clay layers were noted at the surface in Borings B-1, B-2, P-1, P-2 and P-5. Approximate boring locations are shown in **Figure 2**.

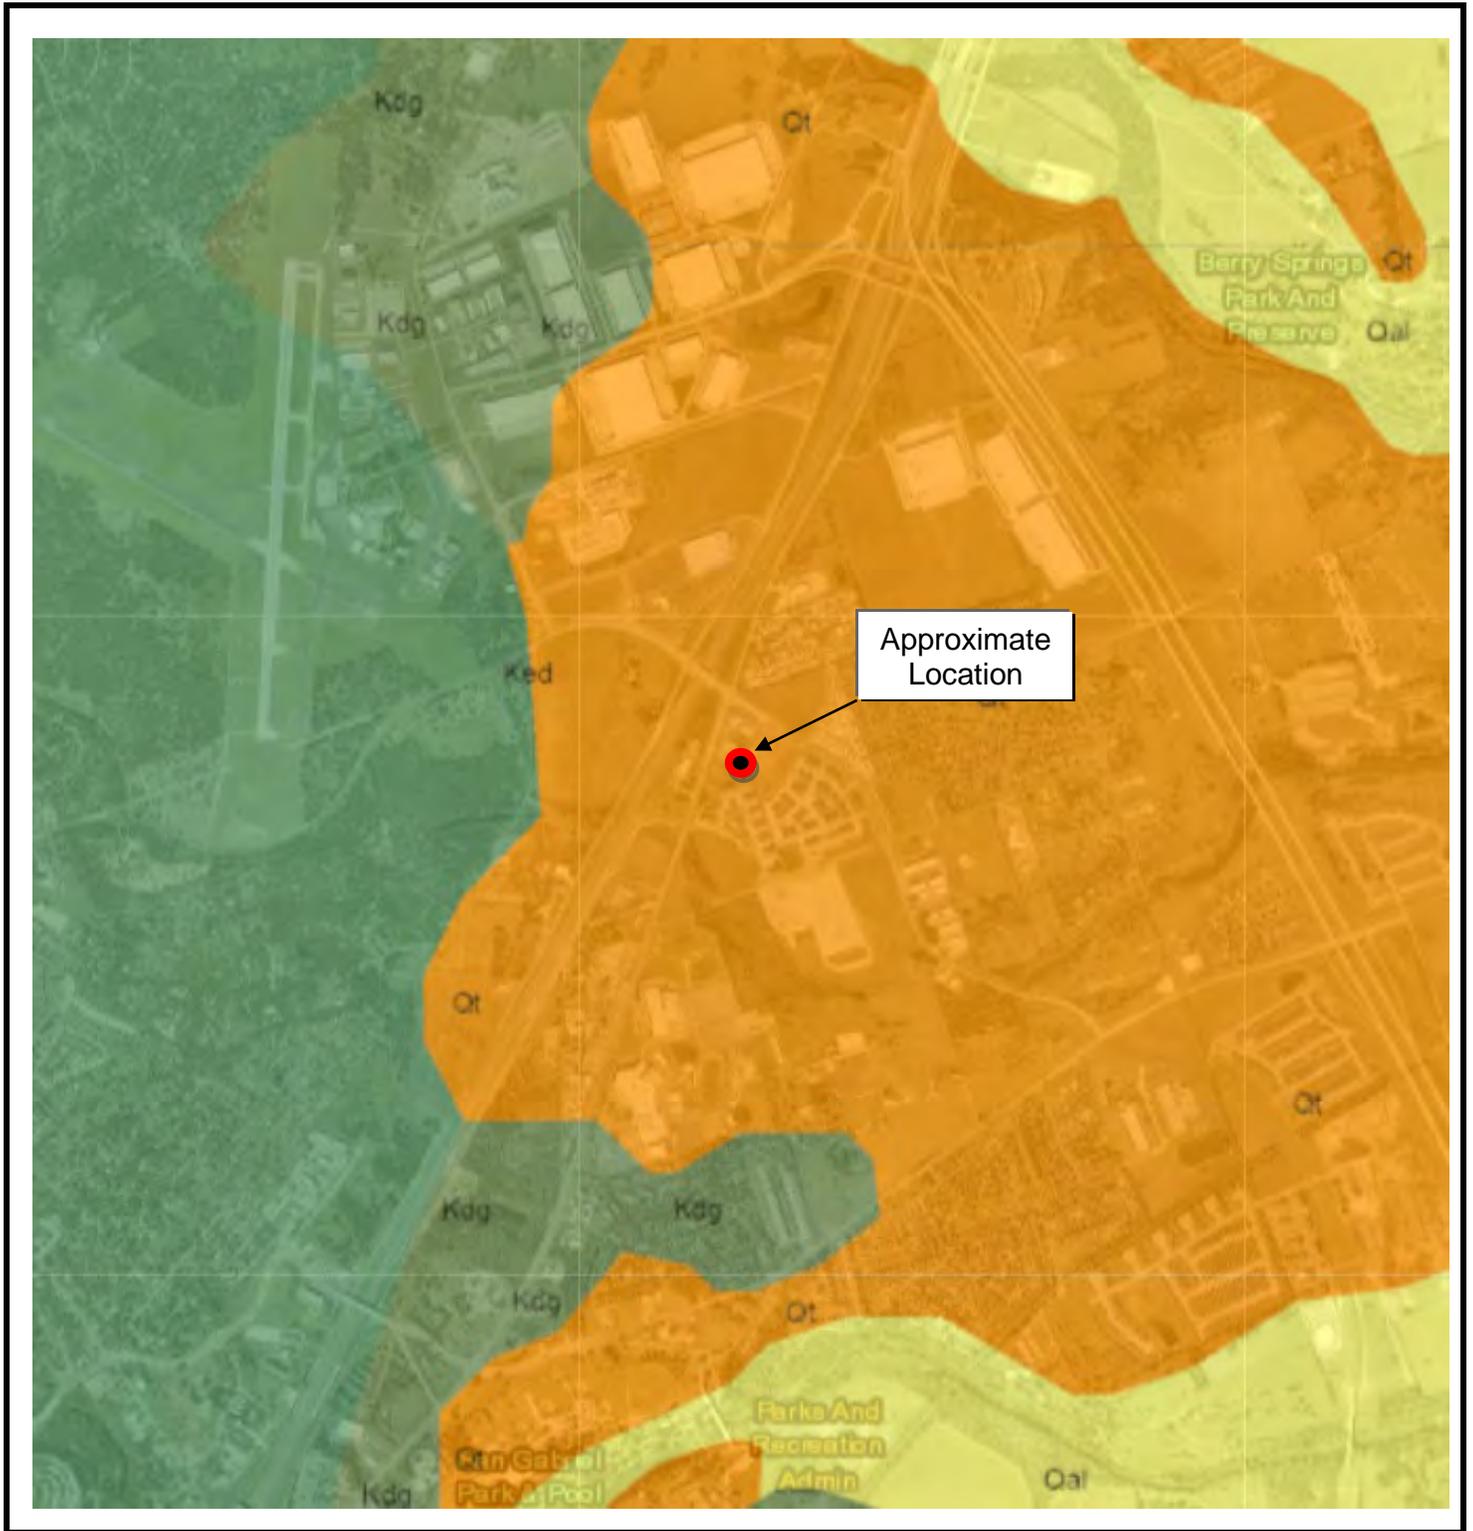
Geology Map

According to available geologic mapping information by the U.T. Bureau of Economic Geology, the site is located within the Terrace Deposits of the San Gabriel River over the Del Rio Clay and Georgetown, undivided, Formation. The Terrace deposits may consist of varying amounts of clay, sand, and gravel. Groundwater is also common within Terrace Deposits.

The Del Rio and Georgetown, undivided, geologic formation is generally comprised mainly of highly expansive clay over marl, shale and limestone. Gravel or gravelly seams/layers may also be present. A geology map is provided as Figure 3.

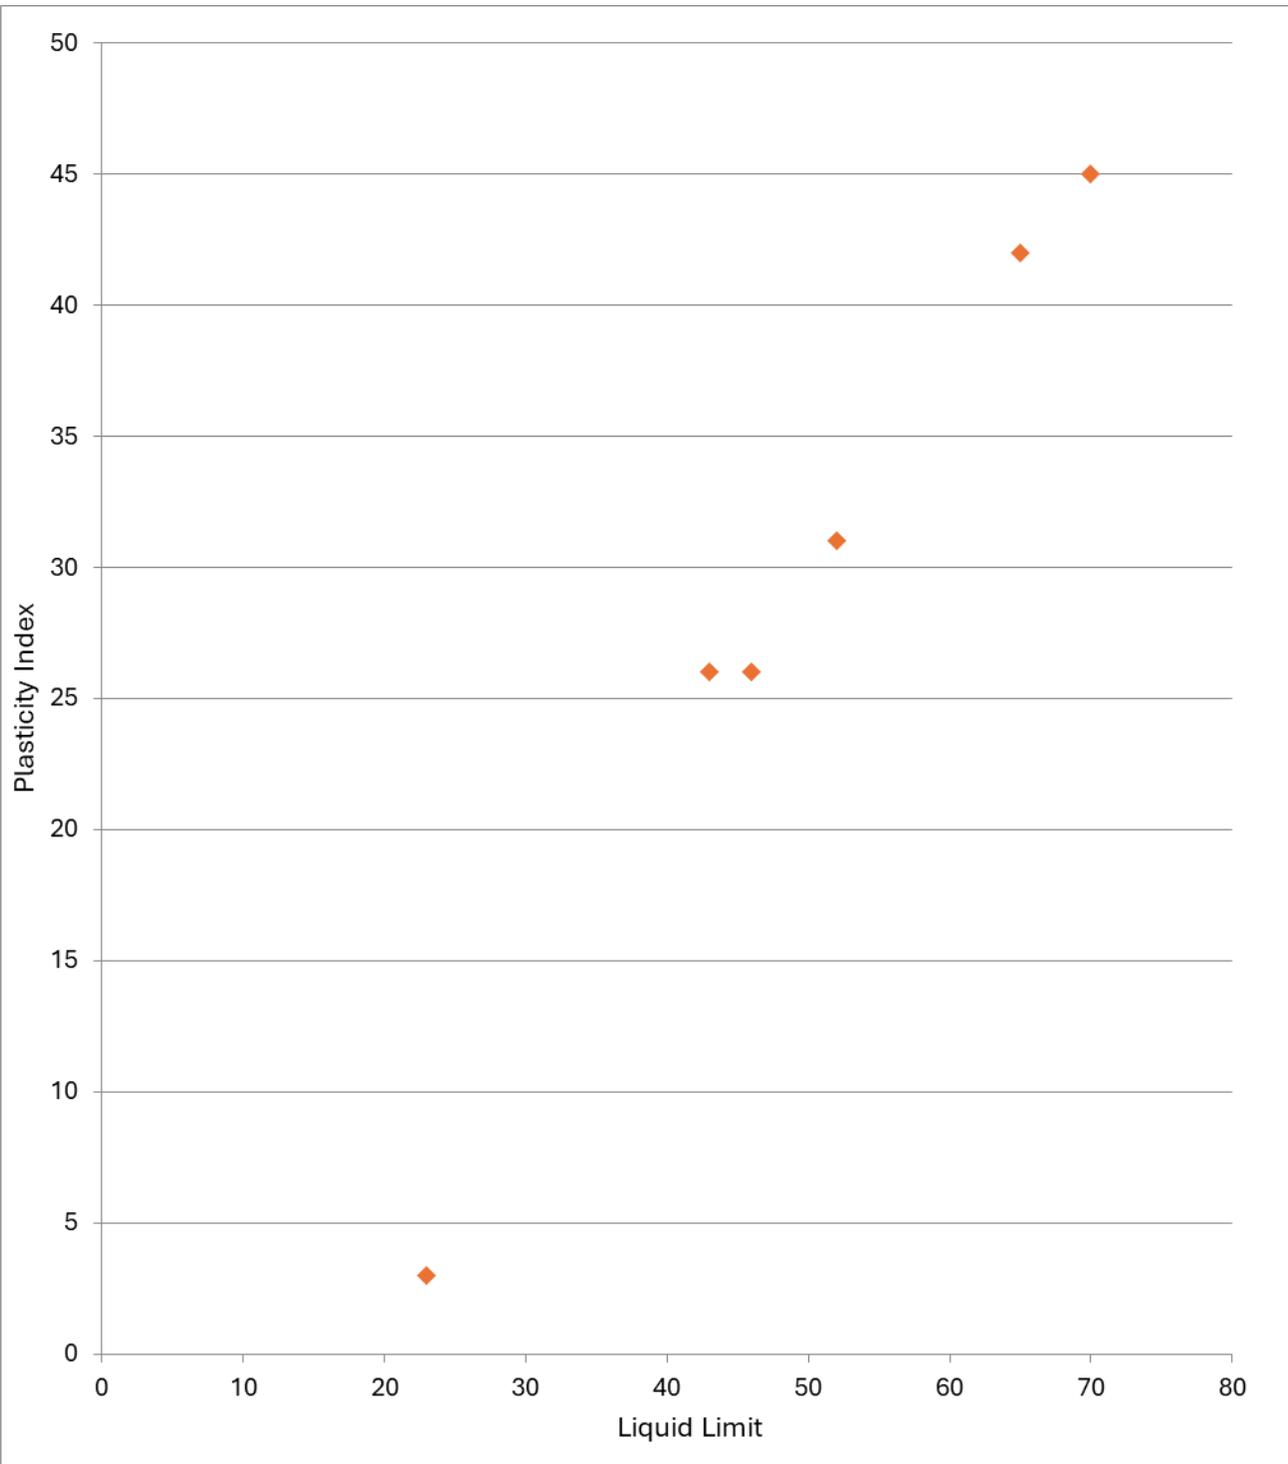
Atterberg Limit Chart

Prepared By: JAM		Project #: AE24-0702
Test Method: ASTM D-4318	Date: September, 2024	Figure #: 12

Results of the testing are provided on the boring logs and Figures 12 – 14. Soil samples not consumed during testing will be retained and stored for 2 months, after which time, they will be discarded unless we receive instructions on their disposition.
