**RE: Listed Species Review
Piermaj Lane Property
Hillsborough County, Florida**

Horner Environmental Professionals, Inc. (HEP) visited the referenced property on March 18, 2022. The purpose of the site visit was to provide guidance pertaining to environmental constraints and listed wildlife species and their possible existence on site. This correspondence offers a summary of our efforts.

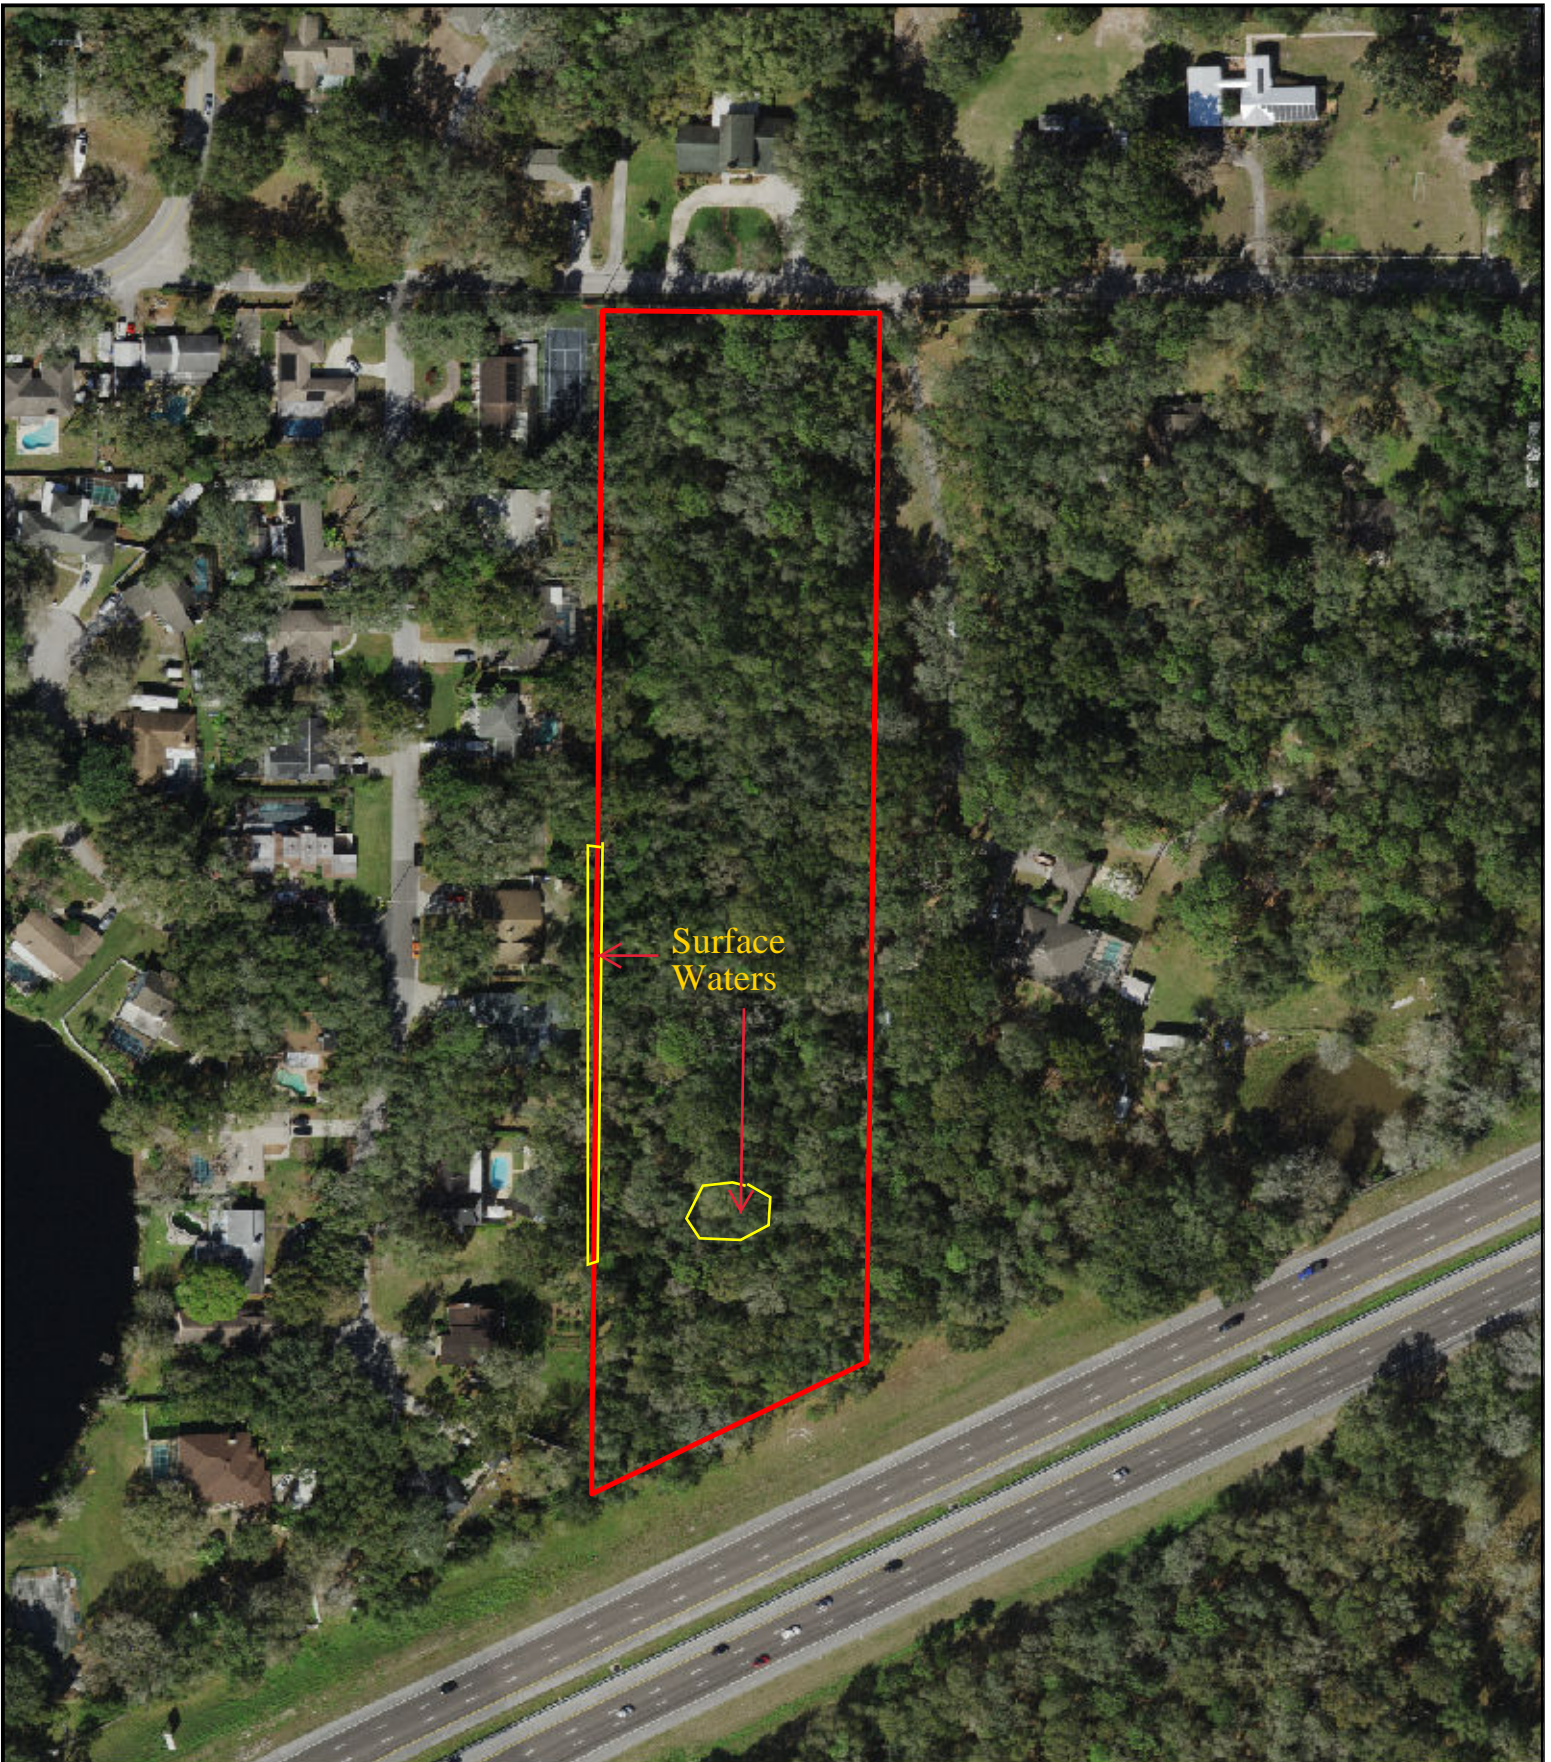
Desoto Holdings
 Figure 4: Approximate Surface Waters
 Sections 30, Township 19 South, Range 27 East
 Hillsborough County, Florida

A review of wetlands and surface waters was also conducted during the site review. A ditch exists along the southwestern property boundary and a small, depression appears to temporarily hold water, but it did not meet the definition of a wetland, according to 62.340 F.A.C on the date of the site review. No other wetlands or surface waters were identified on the property
