**APPRAISAL REPORT
WM. G. ROE & SONS, INC. PROPERTY
500 & 650 AVENUE R SW
WINTER HAVEN, POLK COUNTY, FLORIDA
MARCH 2025**

**PREPARED BY
REED APPRAISAL COMPANY
1102 SOUTH FLORIDA AVENUE
P.O. BOX 7627
LAKELAND, FLORIDA 33807-7627**

FILE NO.: 2025-009

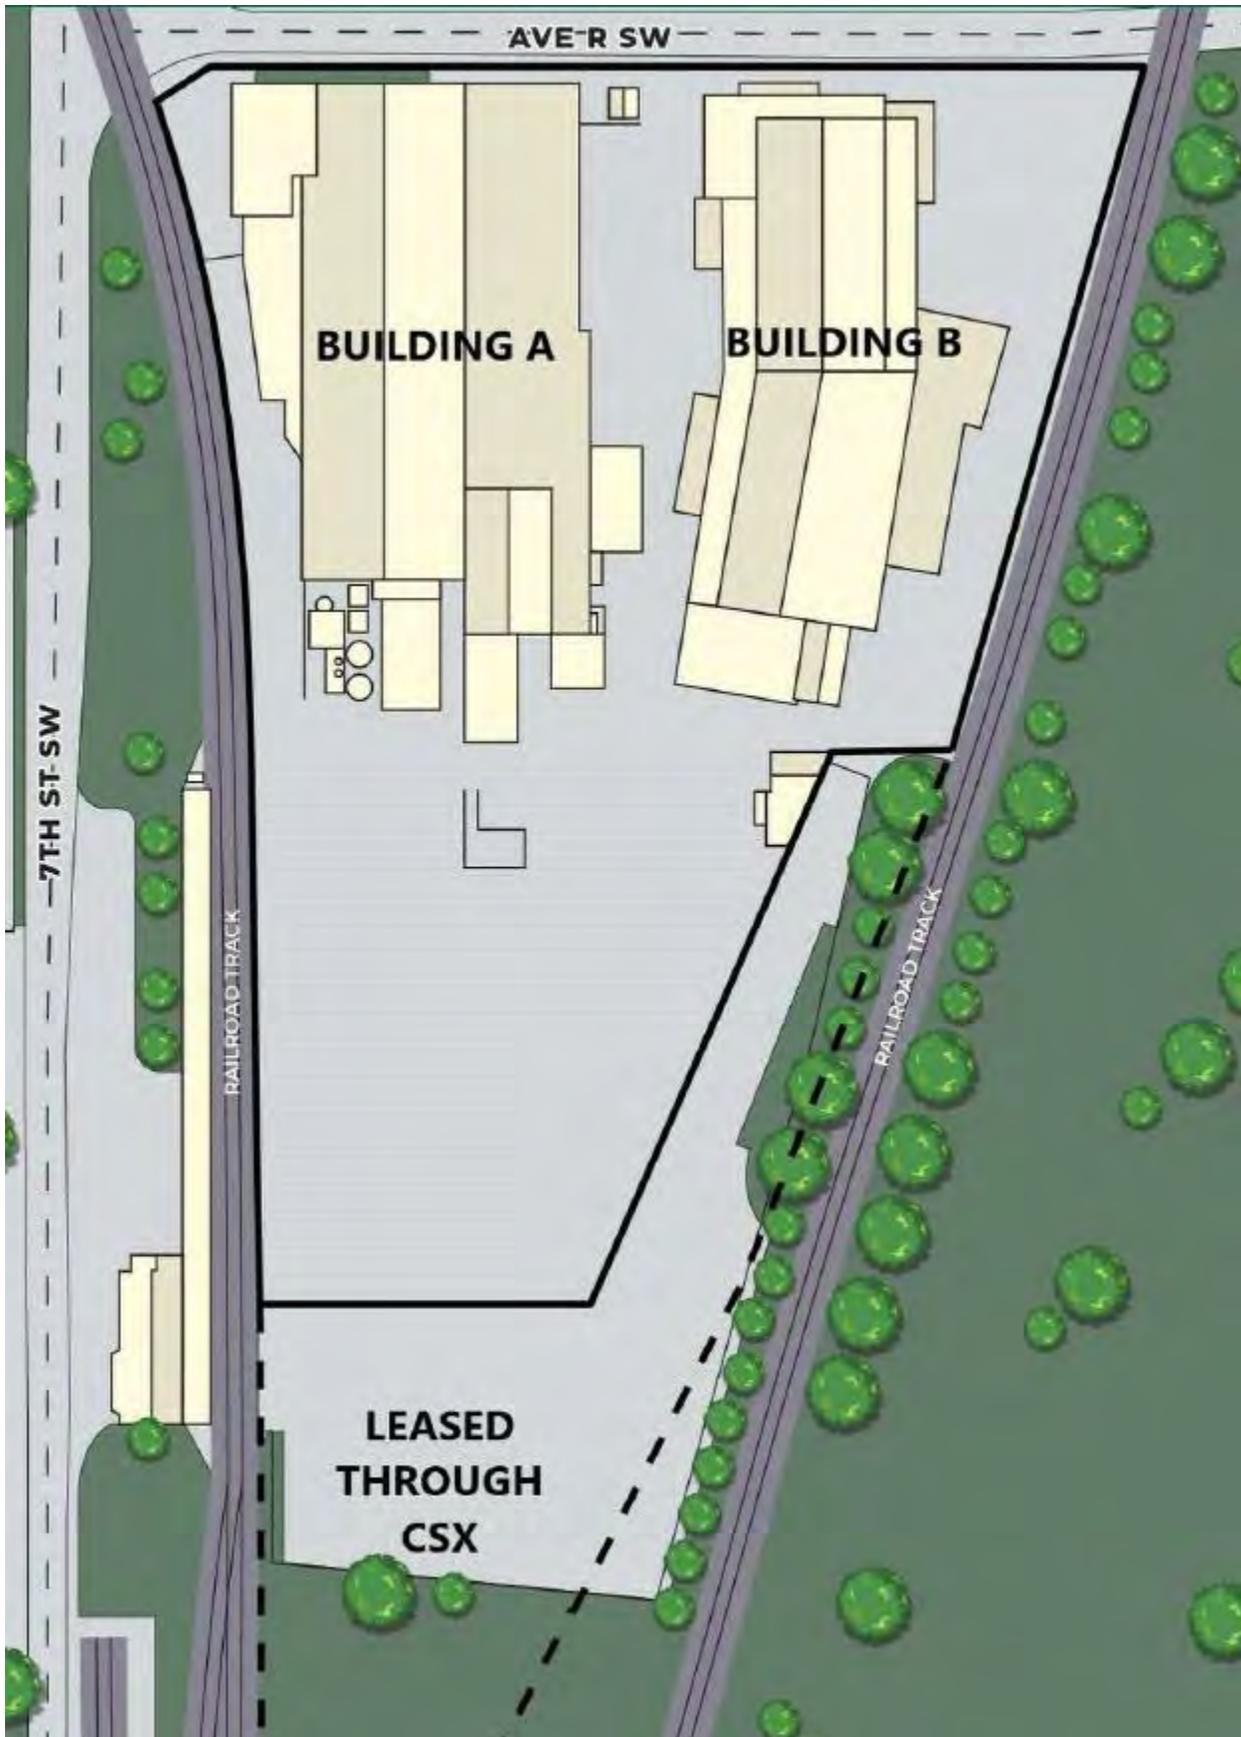
LISTING BROKER'S SITE PLAN

Site Summary – 5.23 acres (227,690 sq. ft. based on PCPA records), irregular shape, all useable uplands (not mapped in Flood Zone or National Wetlands Inventory); 505' ± north boundary on south side of Avenue R SW (northwest corner of subject at western terminus of Ave. R SW and southeast corner of CSX railroad and 7th St. SW; northeast corner of subject at southwest corner of CSR spur), 730' ± eastern boundary on west side of CSX spur and other CSX owned land (400' ± north section + 330' ± south section), 680' ± western boundary on east side of CSX railroad; typical utilities and services available; an irregular 1.98 acres adjacent to the southern portion of the subject is leased from CSX on net terms, cancellable by either party with 30 days notice, *not included in appraisal*; maps and photographs with exhibits

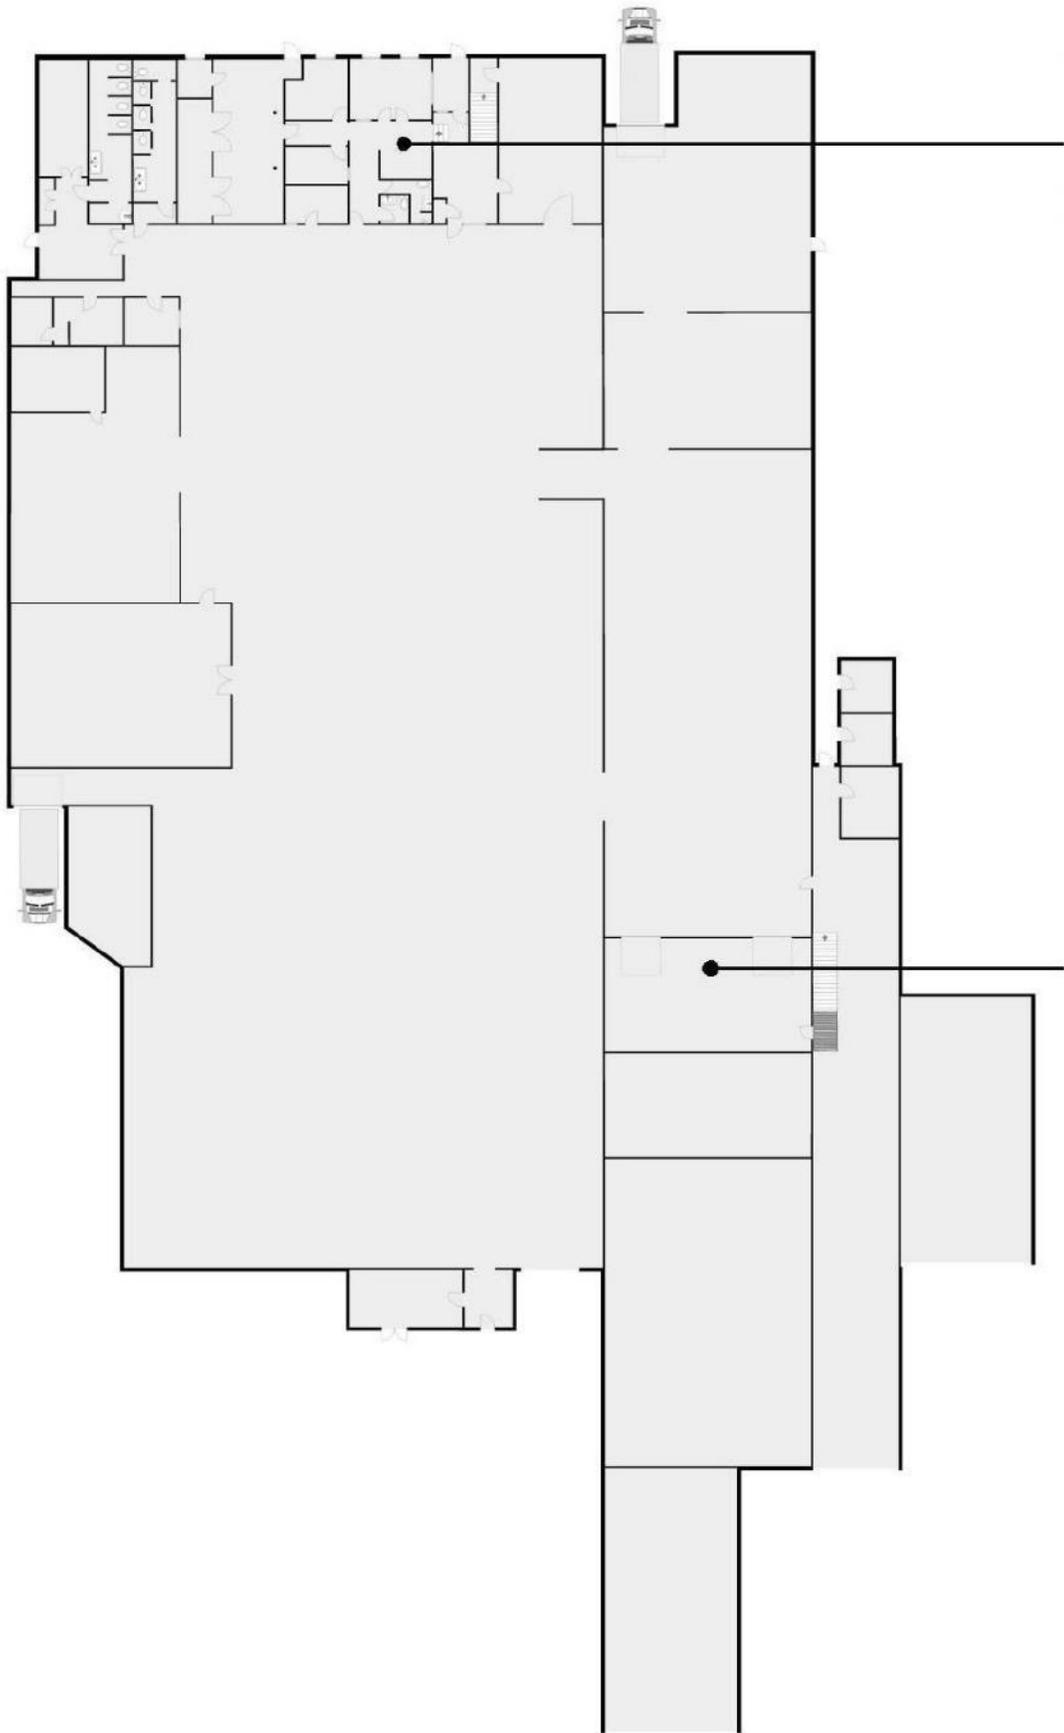
BUILDING A/650 SKETCH

Building A/650: Built in 1947 with later additions, mostly steel frame with metal cover, some concrete block, brick and wood frame with cement board siding, 42,830 functional sq. ft. (91% warehouse) with a total of 54,882 sq. ft.; 3 phase 480 volt, 1600 amp electrical service:

FIRST FLOOR

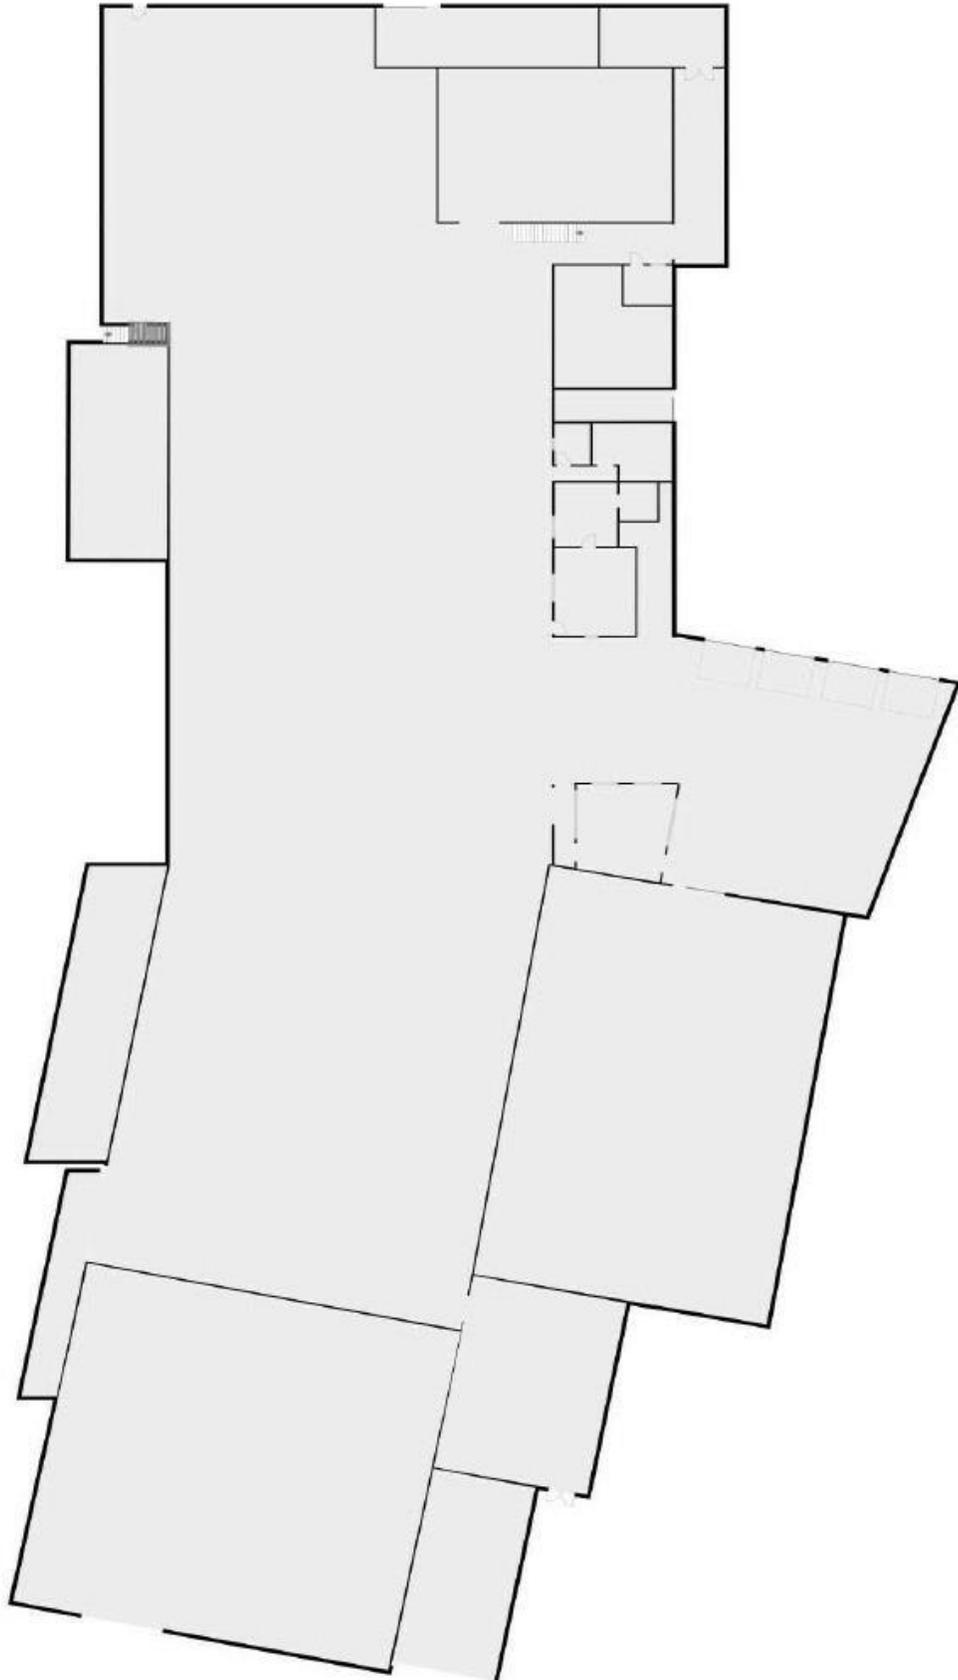
BUILDING B/500 SKETCH

Building B/500: Built in 1926 with later additions, mostly wood frame with metal, wood and vinyl cover/siding, some steel frame with metal cover and concrete block, 37,386 functional sq. ft. (80% warehouse) with a total of 53,839 sq. ft.; 3 phase 480 volt, 800 amp electrical service:

FIRST FLOOR

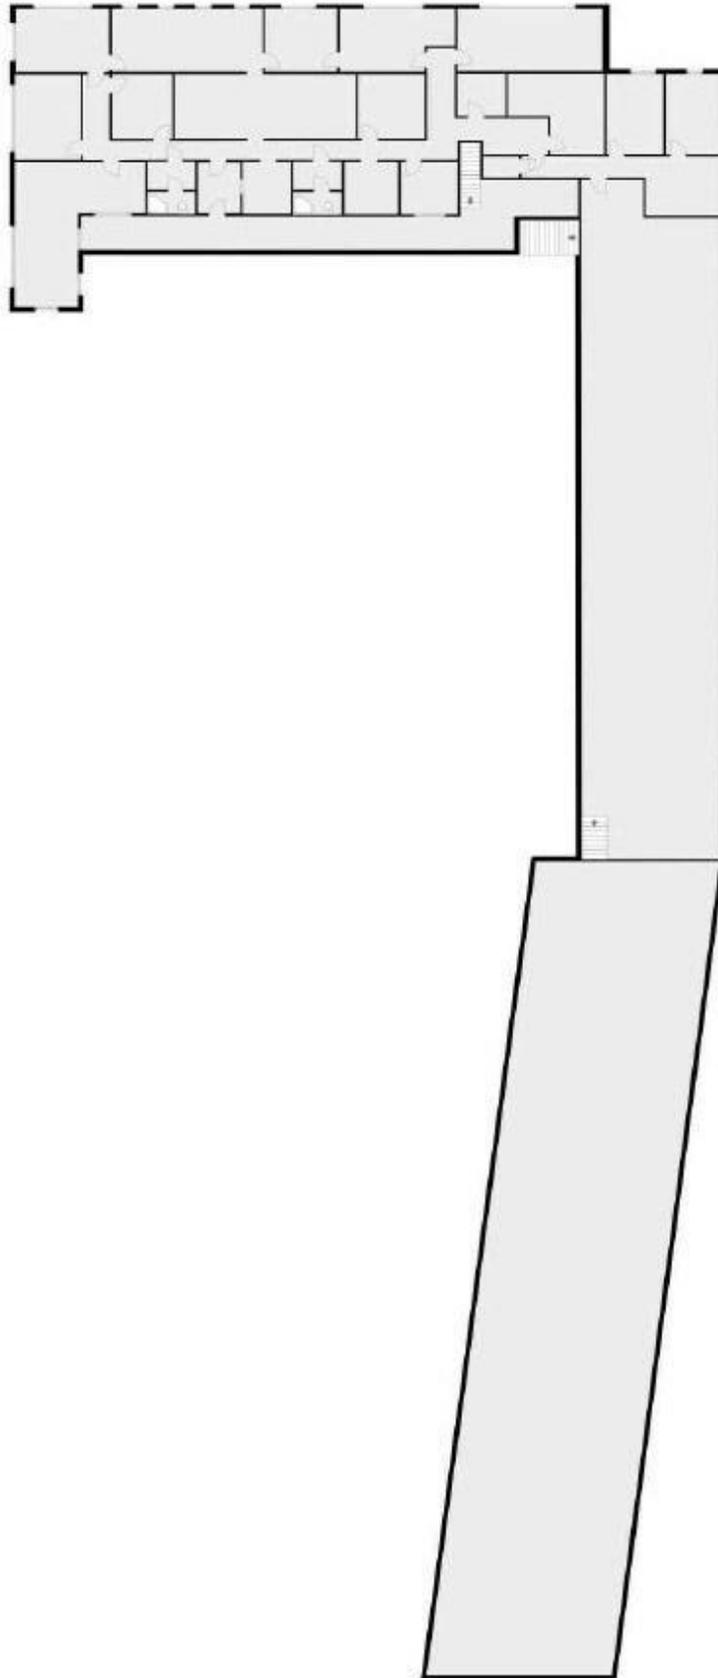
BUILDING B/500 SKETCH

SECOND FLOOR OFFICE & MEZZANINE

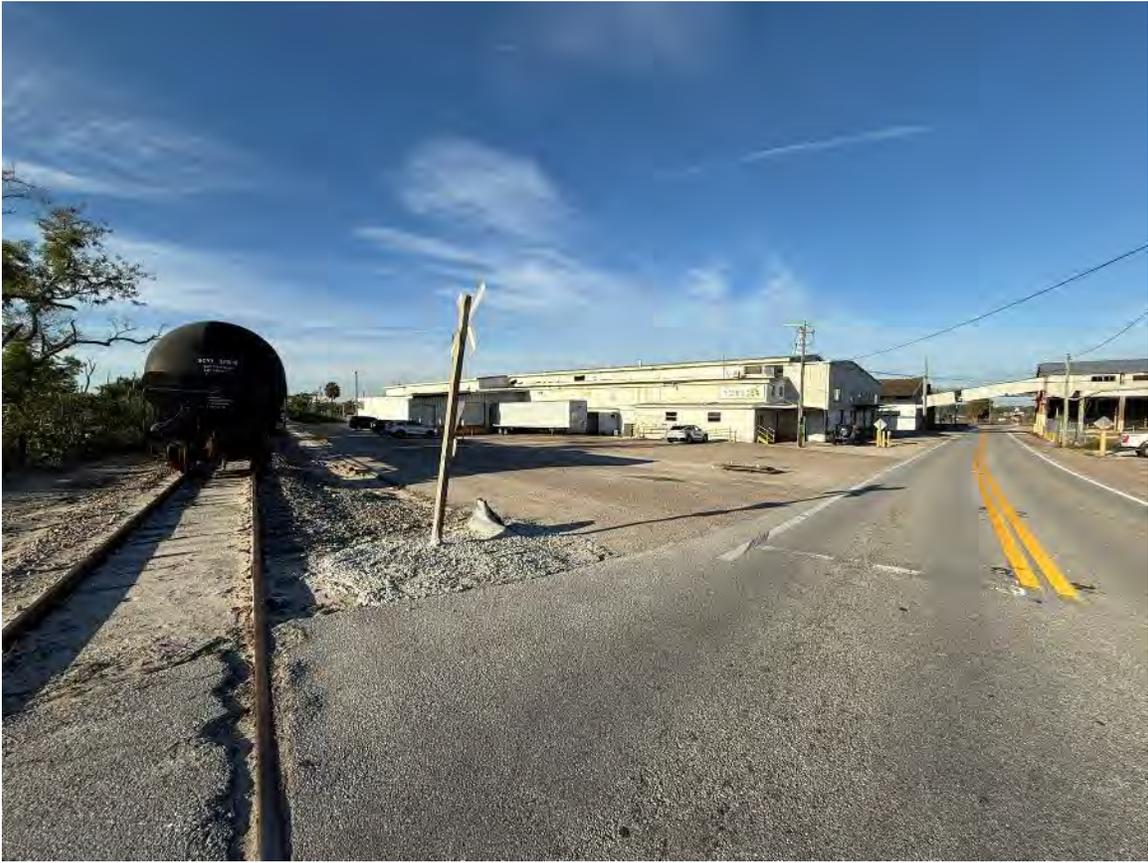
2 – South Between A/650 (Right) and B/500 (Left) from Ave. R SW

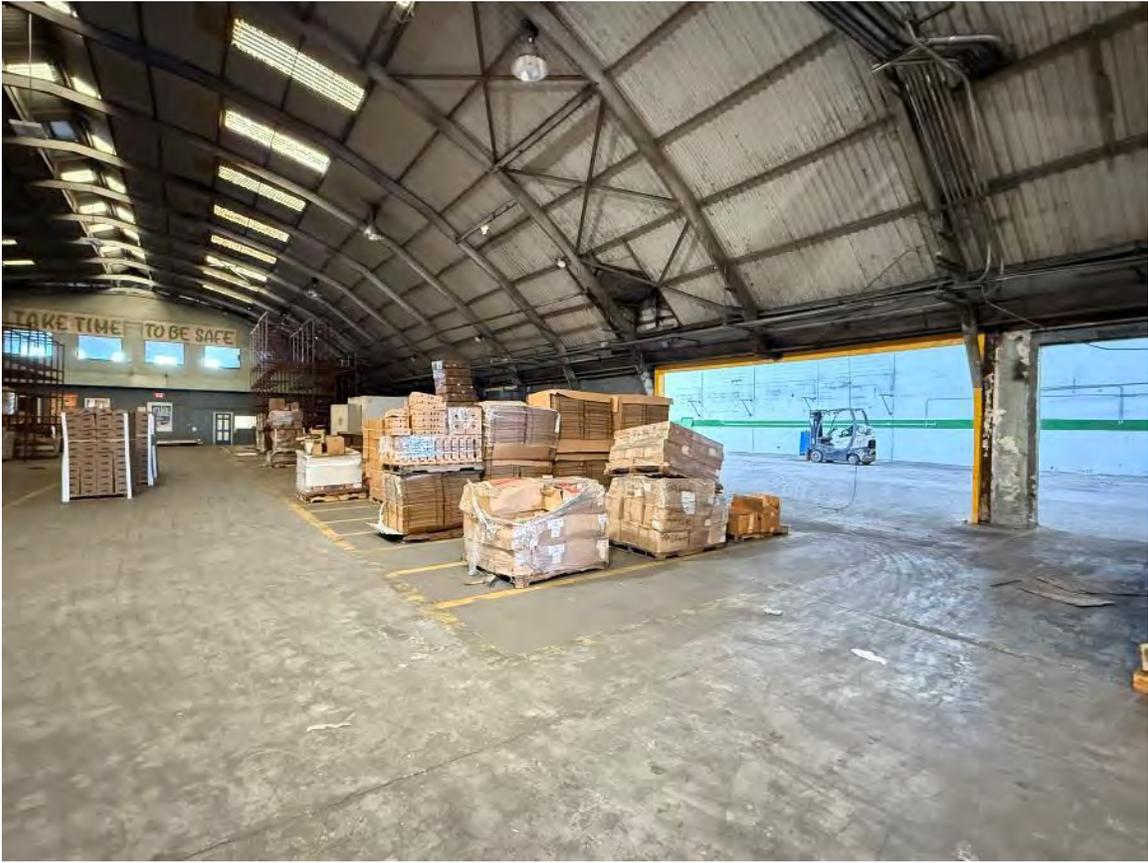
9 – Warehouse – Arch (Connections to Cooler Panels Removed at Right)

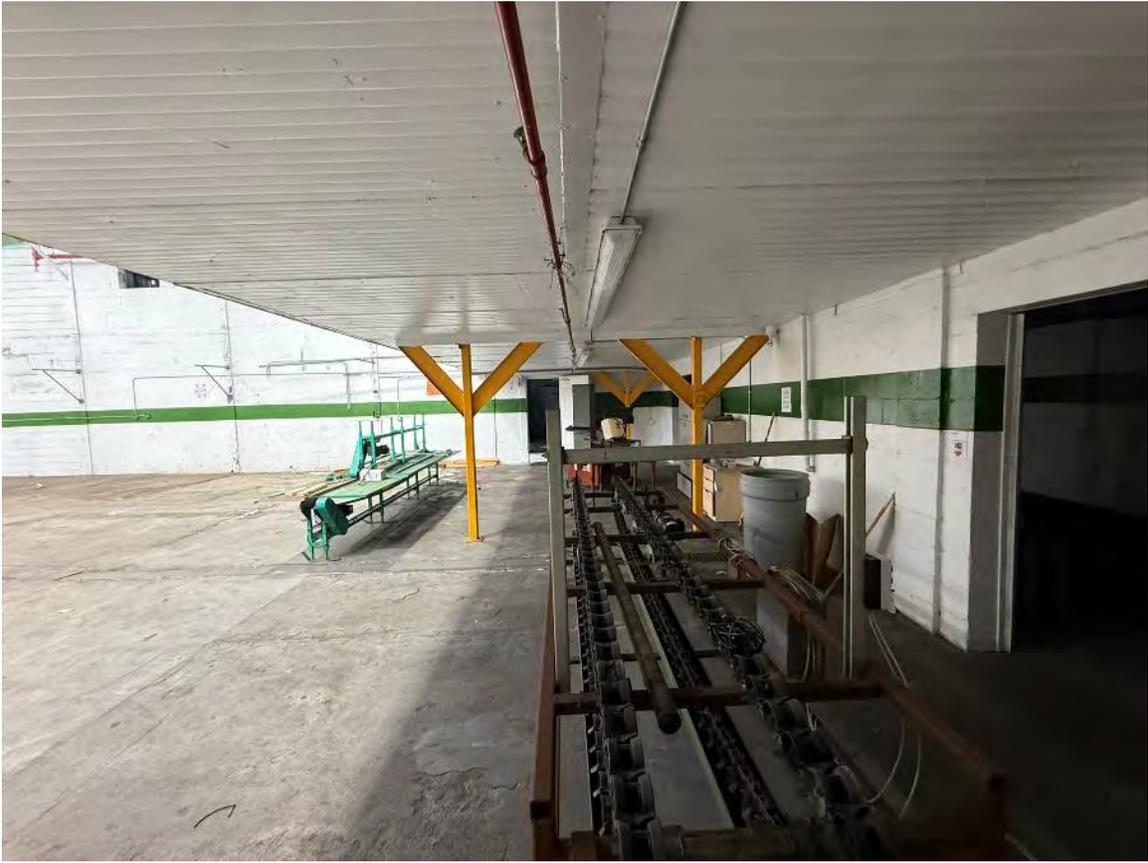
13 – Warehouse – Low Clear Below Additional Office

Warehouse - 2nd Floor Additional Office	1,760	above the low/8.5' clear area, rough condition, needs refurbishing or demo to increase clearance/warehouse functionality
Small Offices - E	230	2 x 115 sq. ft. rooms/former offices rough shell/gutted
Partially Enclosed - ESE	1,060	17' ± clear, 20' wide x 53' deep, no overhead door/S wall, S 20' of E side open/canopy
Narrow & Partially Enclosed	2,304	15.5' ± clear, 18' wide x 128' deep, no overhead door/S wall, S 30' of E side open/canopy, some rough floor
Partially Enclosed - S	1,482	27' ± clear, no overhead door/S wall, lower section of SE portion open
Buildout on S Side of Warehouse - Arch	<u>380</u>	2 rooms, very rough shell/gutted
Additional Building Areas	12,052	
Total Building Area	54,882

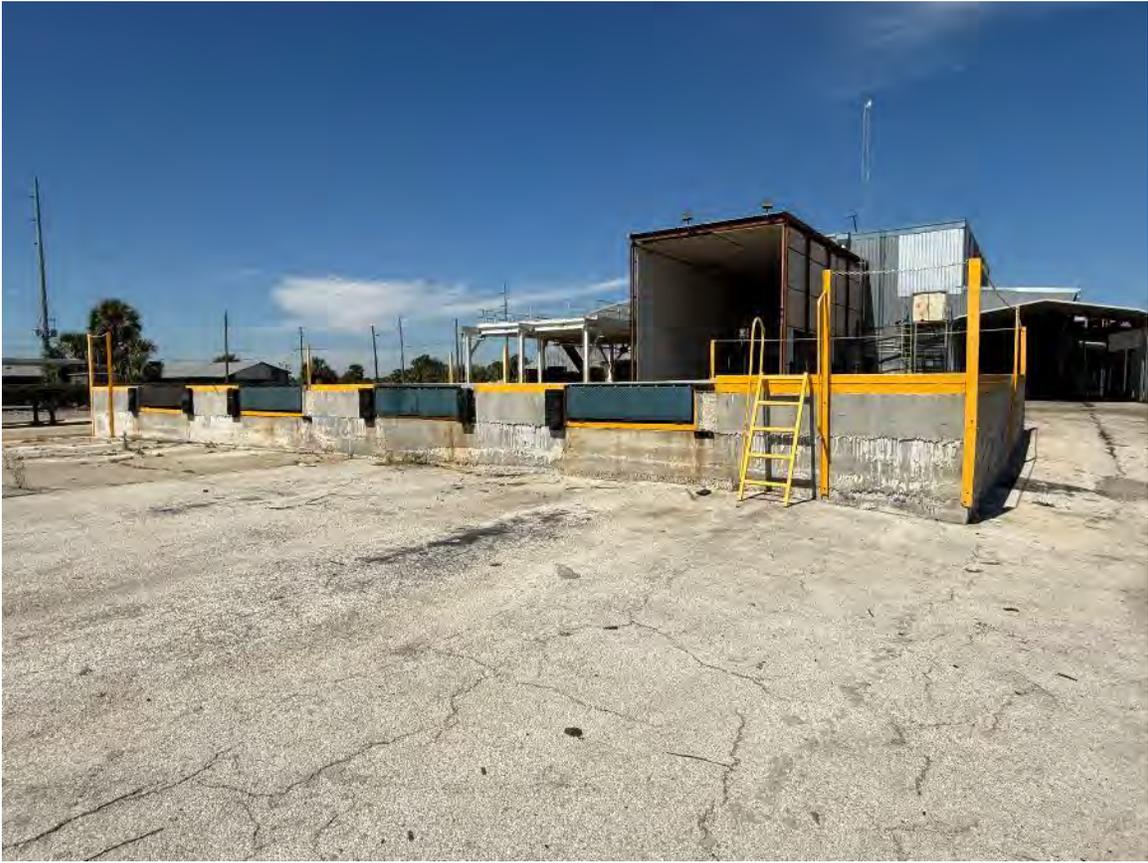
There is a dock high platform with four positions and a forklift ramp to the south of the Building A which is not covered. Although dock high loading is available, without modifications, the facility is most functional for ground level/drive-in access (ramps within building connecting most warehouse floor height changes).

35 – Loading Dock South of Building A/650
