WETLAND DELINEATION / DETERMINATION REPORT COVER FORM

Project Name: Hwy 20

Proposed Use:
Residential Development

4901 Hwy 20

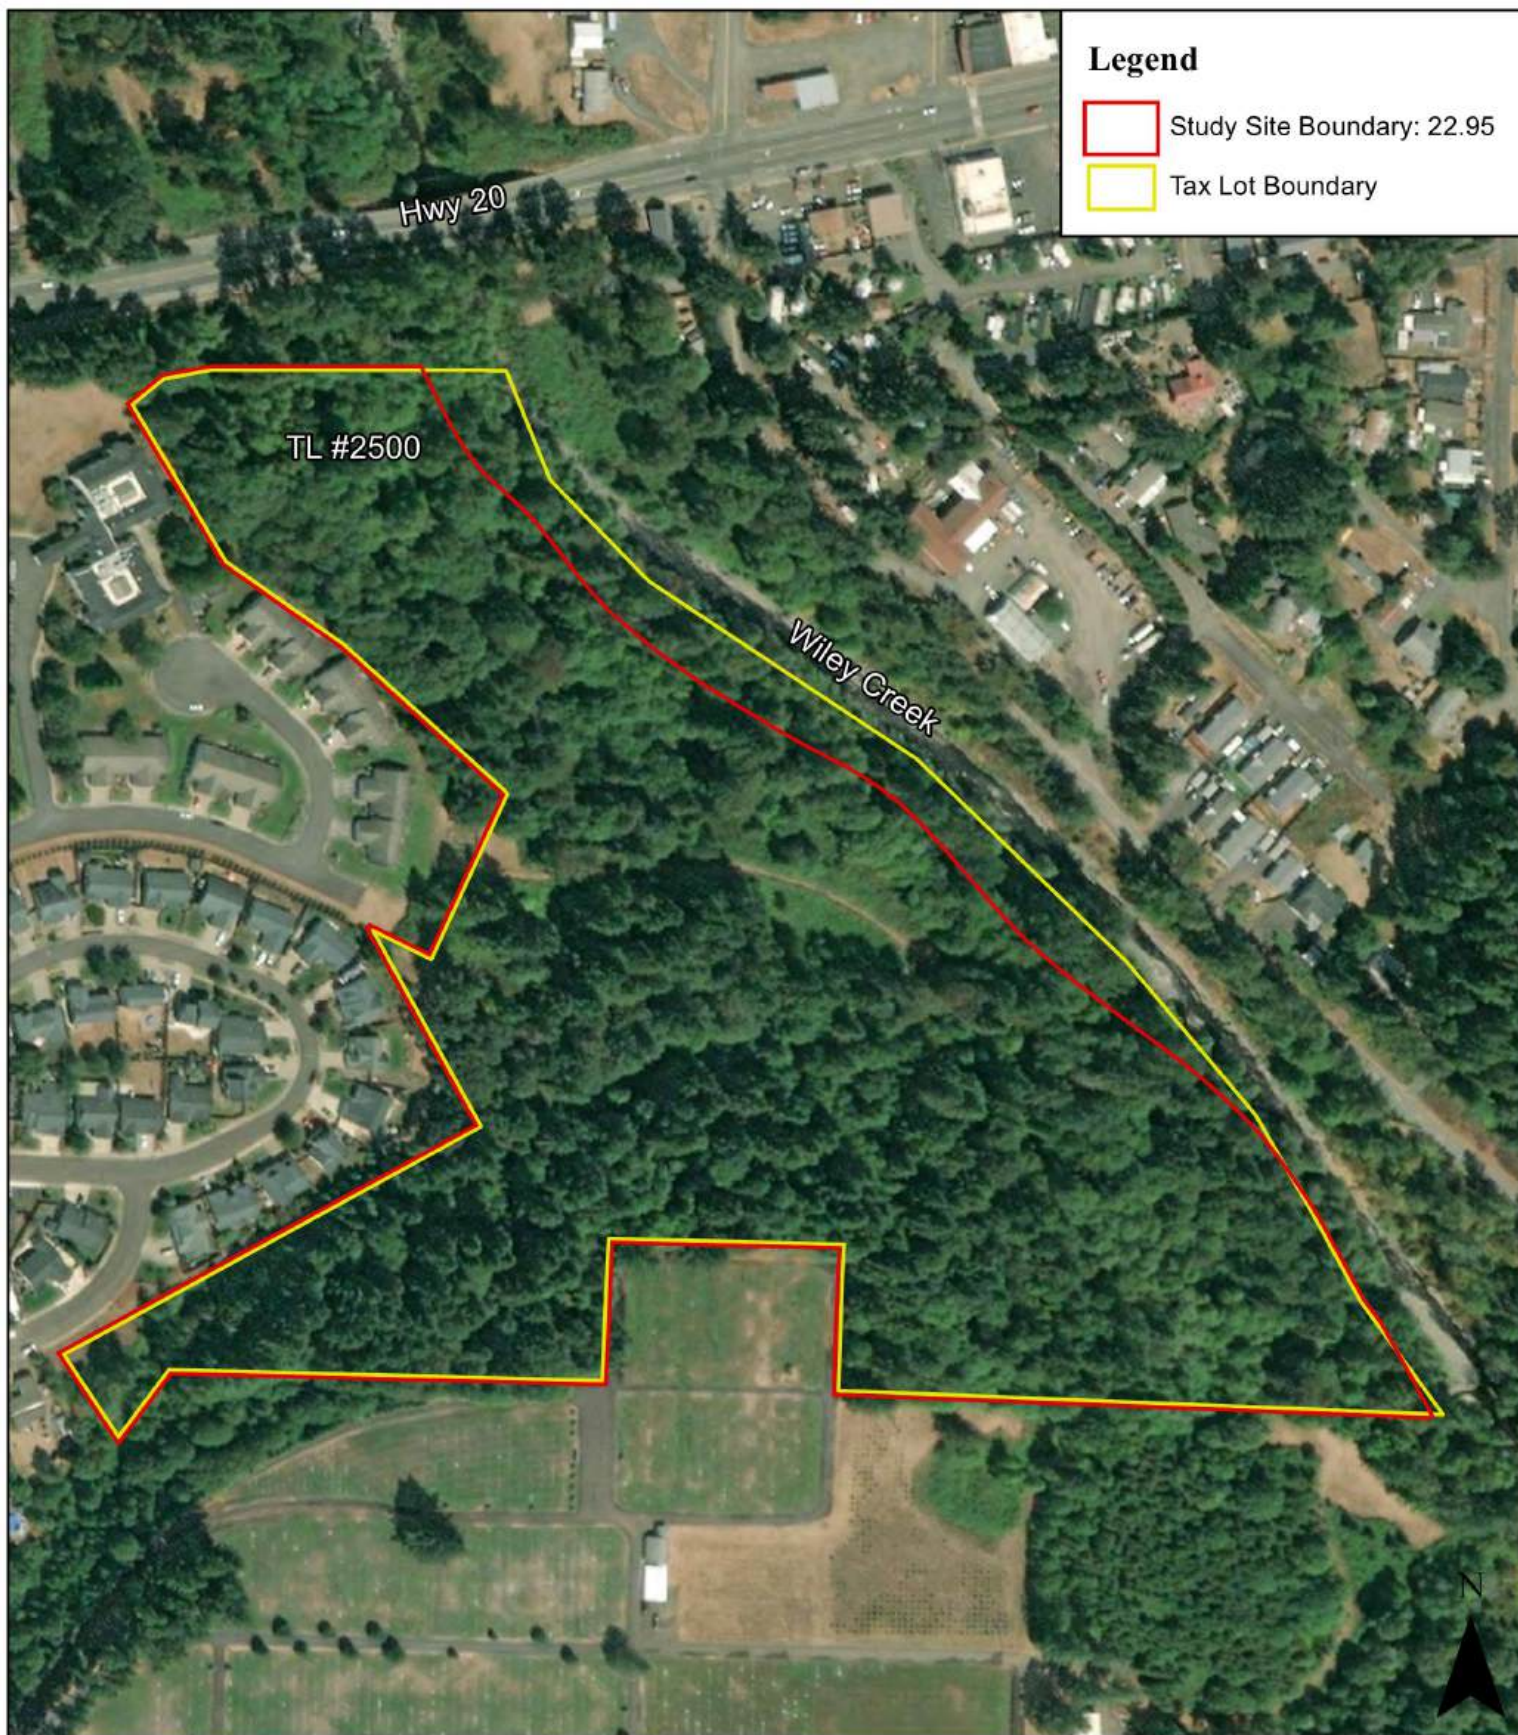
FIGURE 5A: RECENT AERIAL IMAGE

Aerial photographs for the time period between 1994 and 2021, available from Google Earth, were reviewed to assess site history. In the earliest available aerial photograph (Figure 5b), there appears to be much less undergrowth through the site and a larger clearing through the center but is otherwise much in the same conditions as it was during fieldwork (Figure 5a).

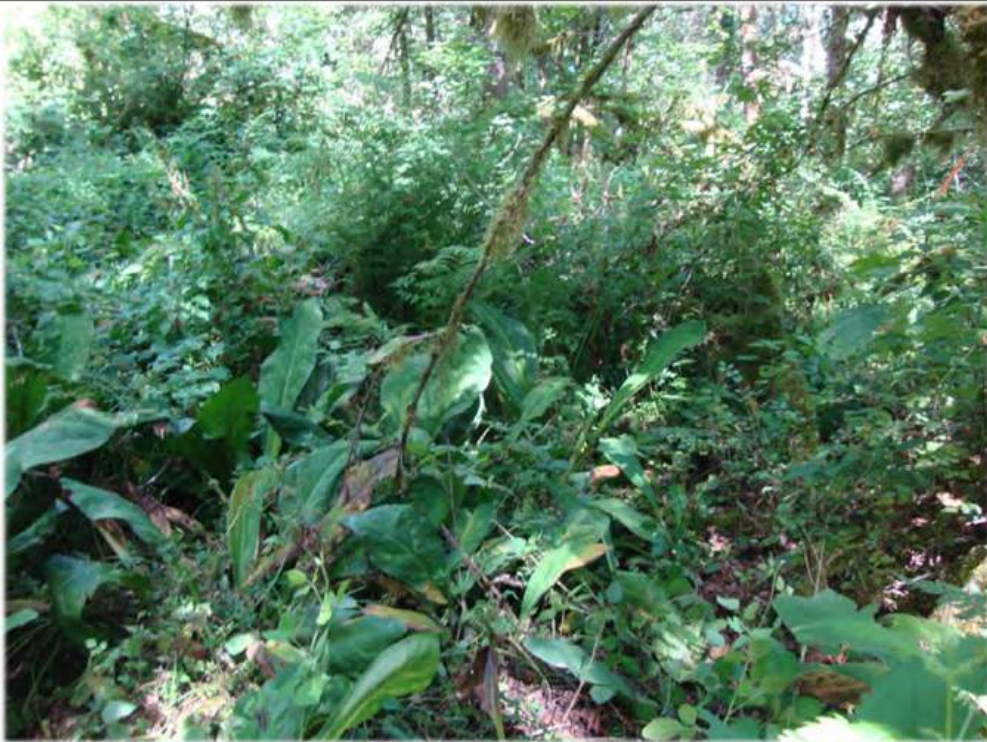
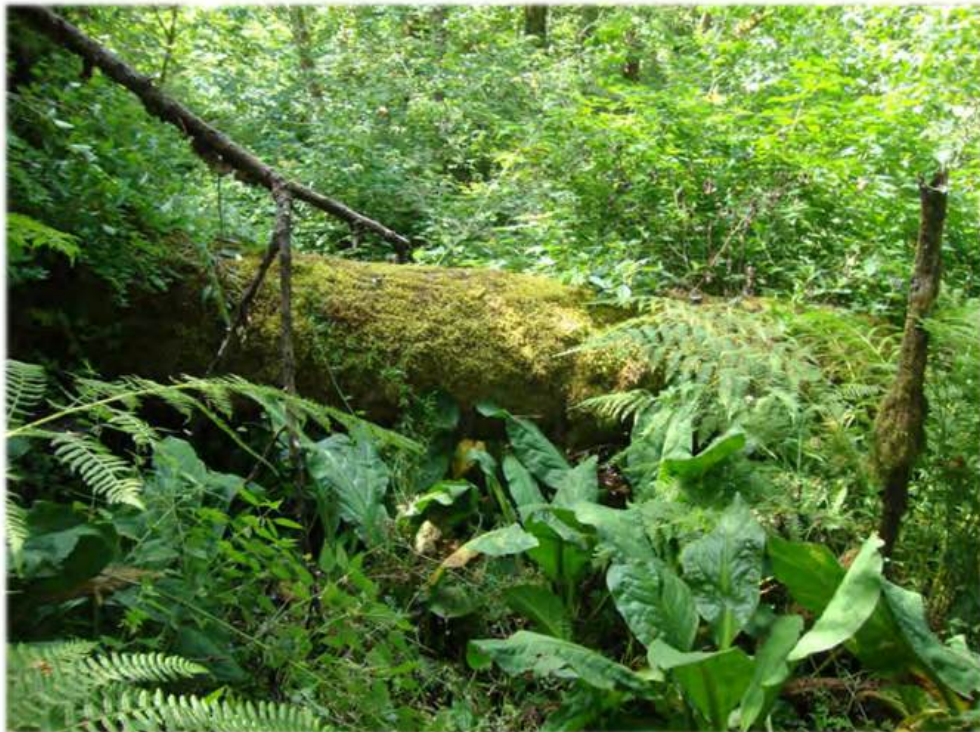
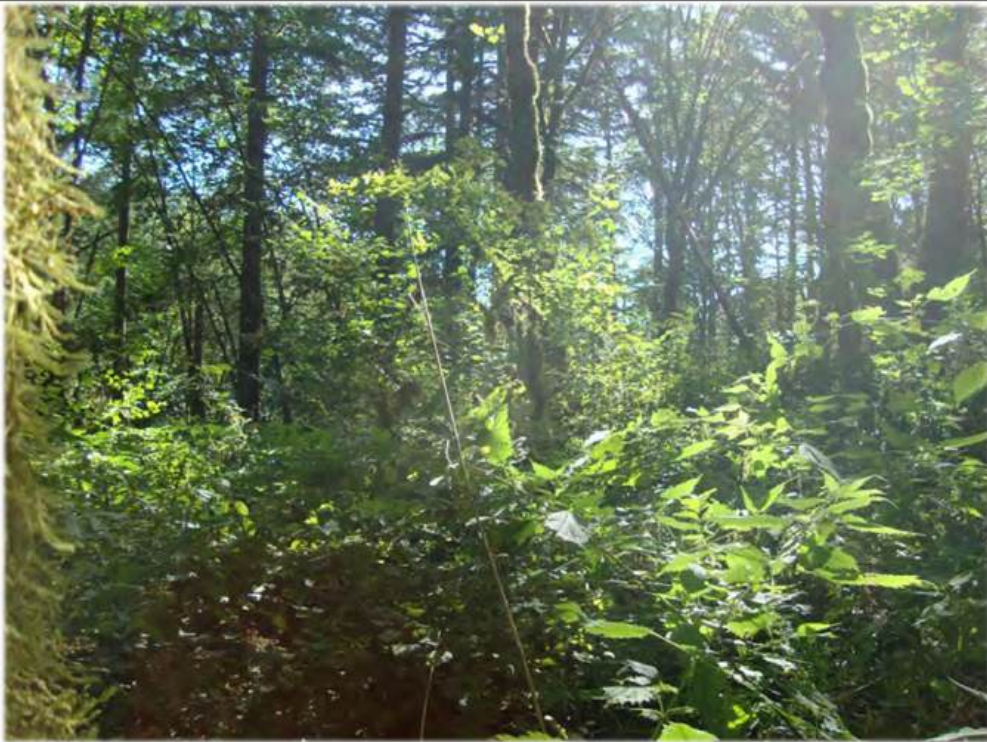
Photo Point 2. From Wetland 1 facing northwest toward wetland area.

Photo Point 2. From Wetland 1 facing south toward wetland area.

Photo Point 2. From Wetland 1 facing northeast toward adjacent upland.

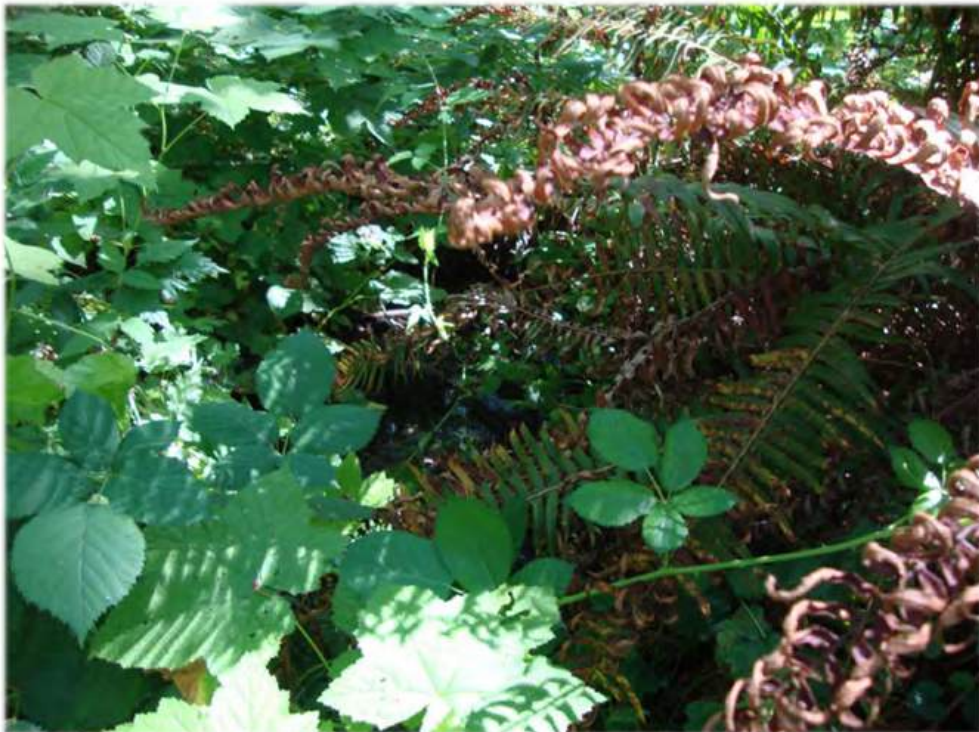
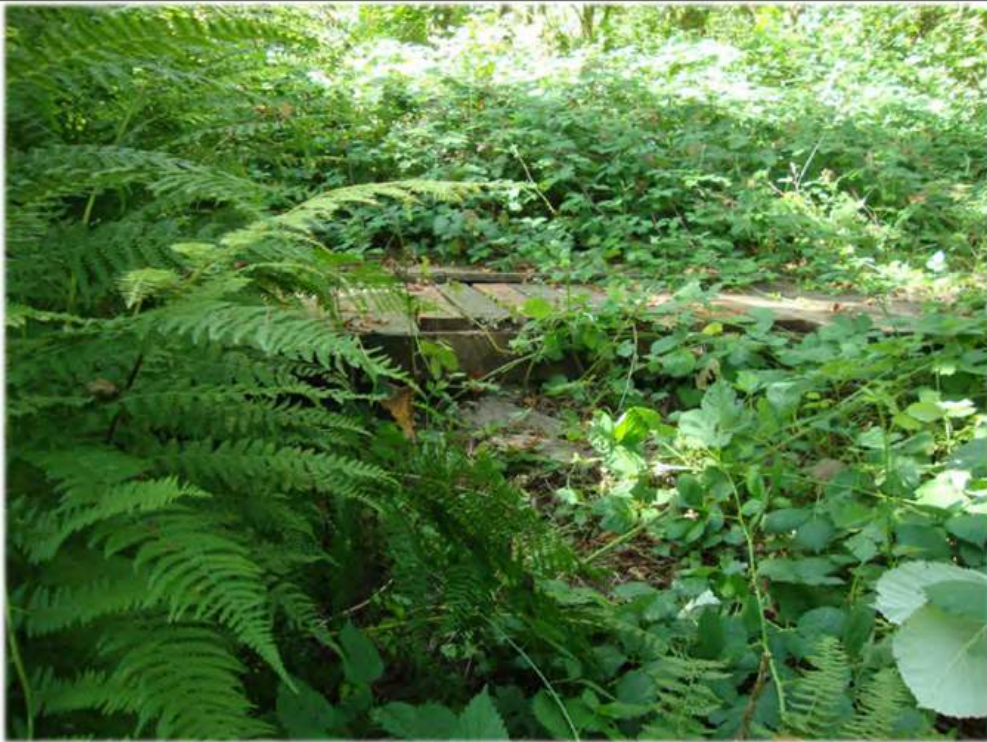
Photo Point 3. From Stream 1 facing northeast, downstream.

Photo Point 3. From Stream 1 facing west, upstream, at small footbridge.

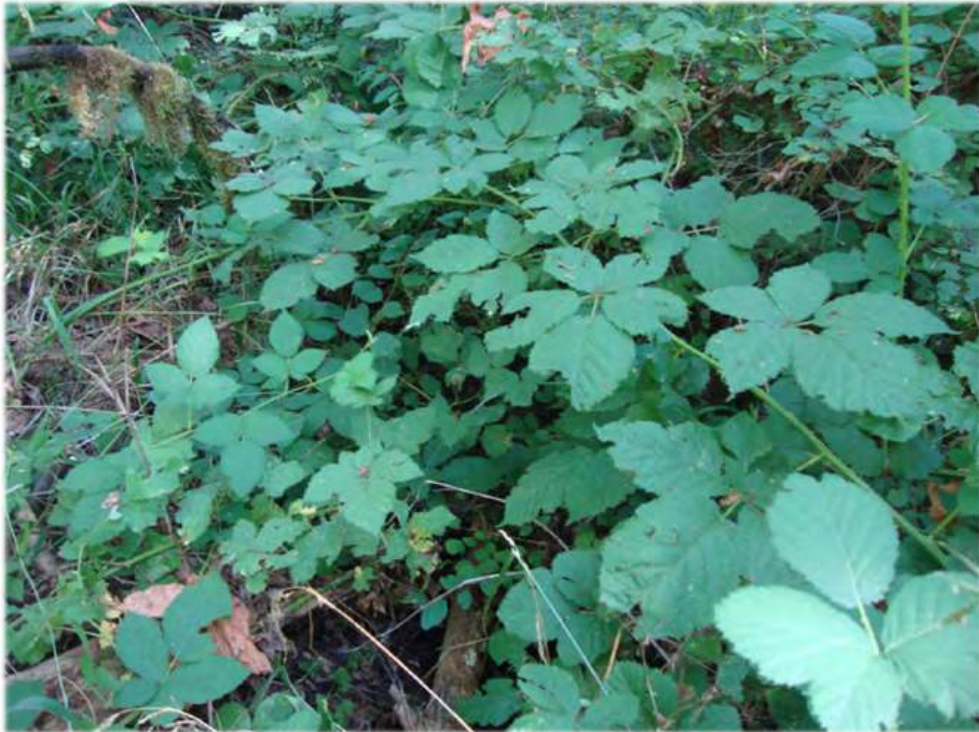
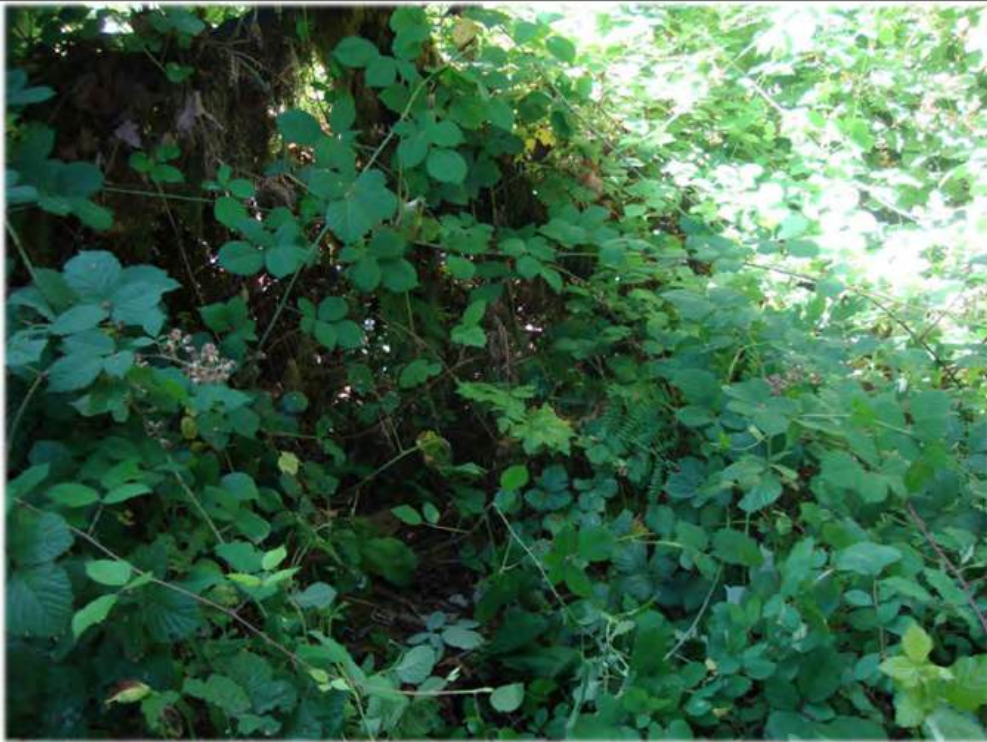
Ephemeral Drainage: A small drainageway emerged from the culvert outlet that drained Wetland 1. The drainage was approximately 1-2 feet wide and a few inches deep. It did not have a defined bed or bank or any other indicator of OHWM. It was partially vegetated by western swordfern (FACU), Himalayan blackberry (FAC), trailing blackberry, and false brome (NOL). The sample plot established in the drainage bottom (Sample Plot 4) did not yield hydric soil indicators; soils were brown (7.5 YR 3/3) gravelly loam. No wetland hydrological indicators were observed within the feature.

Photo Point 4. From the culverted outlet of Wetland 1 facing south toward wetland.

Photo Point 4. From the culverted outlet of Wetland 1 facing north toward ephemeral stream.

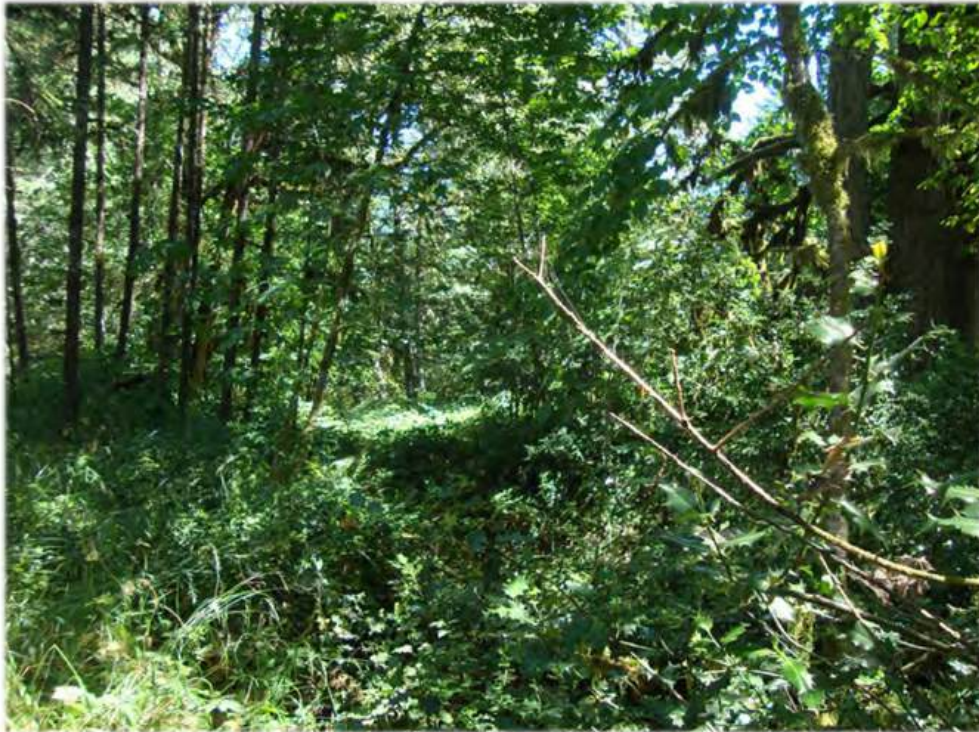
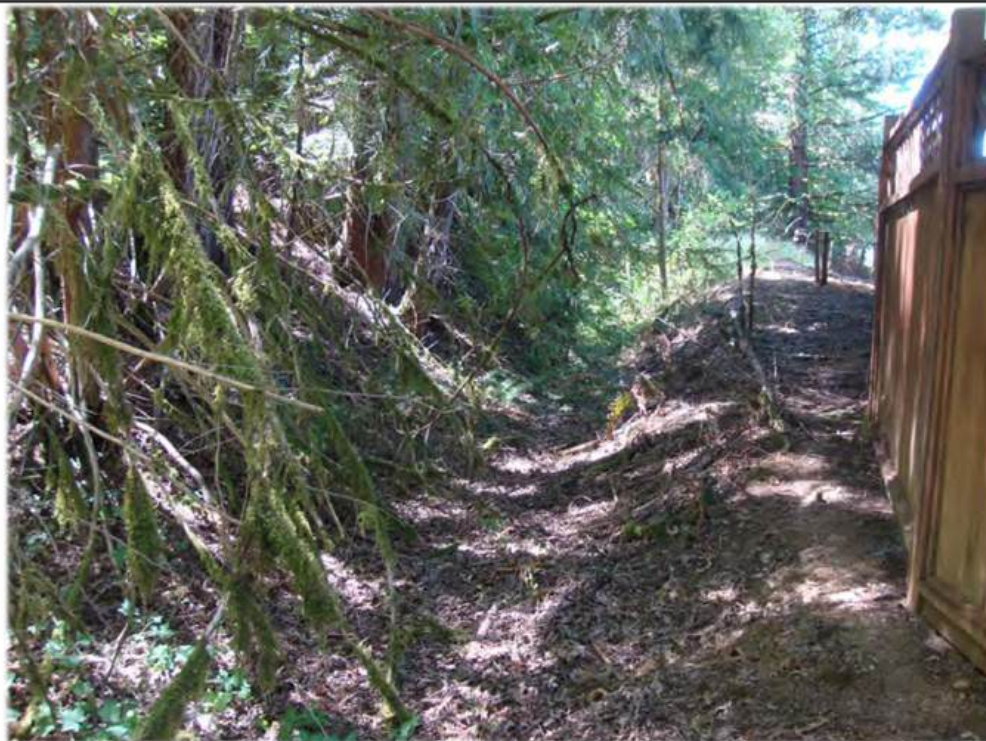
Upland ditch: The upper portion of the manmade ditch containing Wetland 2 did not meet wetland criteria nor were any indicators of OHWM observed. It was approximately 4 feet wide and 4 feet deep and sparsely vegetated by trailing blackberry, English ivy, false brome, and western swordfern. Soils were very dark grayish brown to brown (10 YR 3/3) silt loam with no redoximorphic features.

Photo Point 7. At the upper end of the ditch along the southwestern boundary facing northeast.

Photo Point 7. At the upper end of the ditch along the southwestern boundary facing southwest.

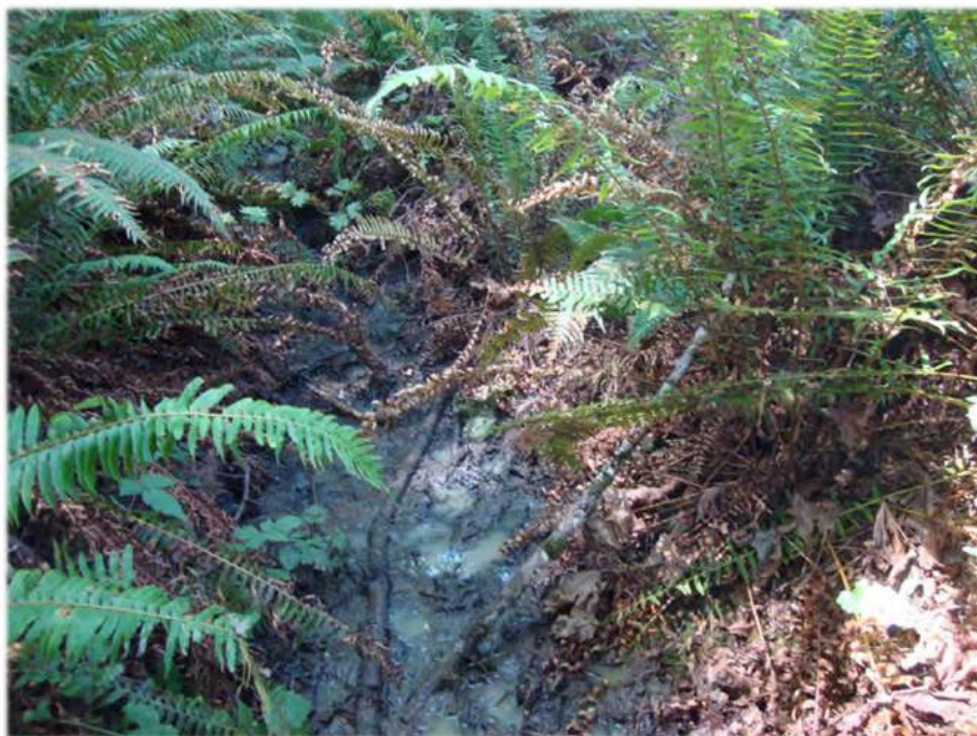
Photo Point 8. From the lower end of the ditch (Wetland 2) facing southwest toward wetland portion of ditch.

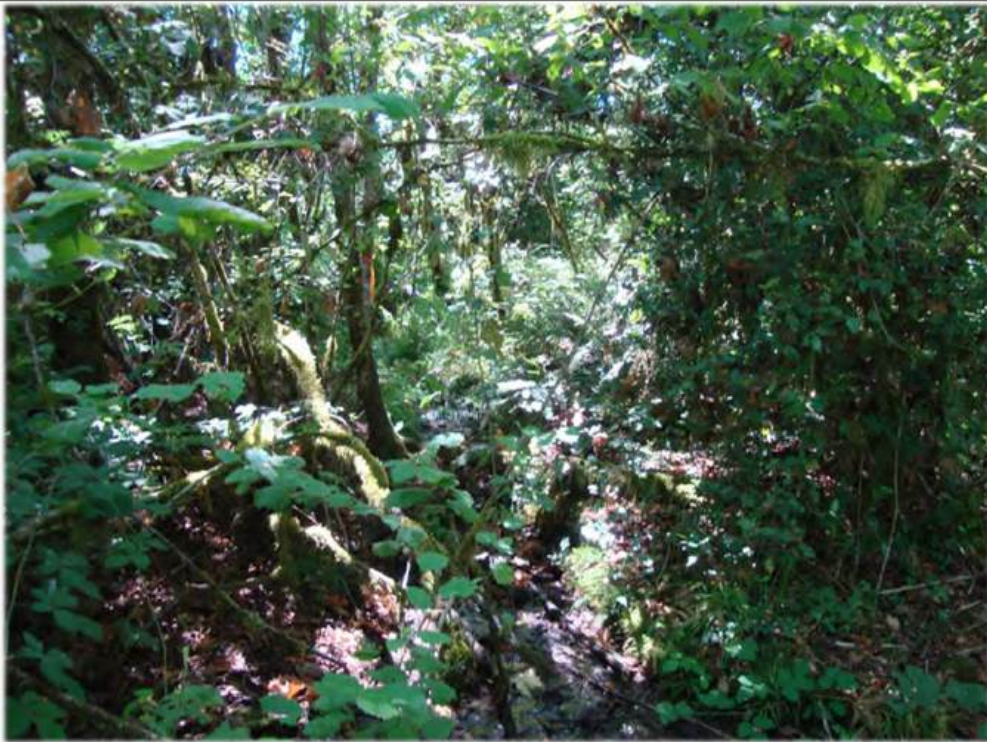
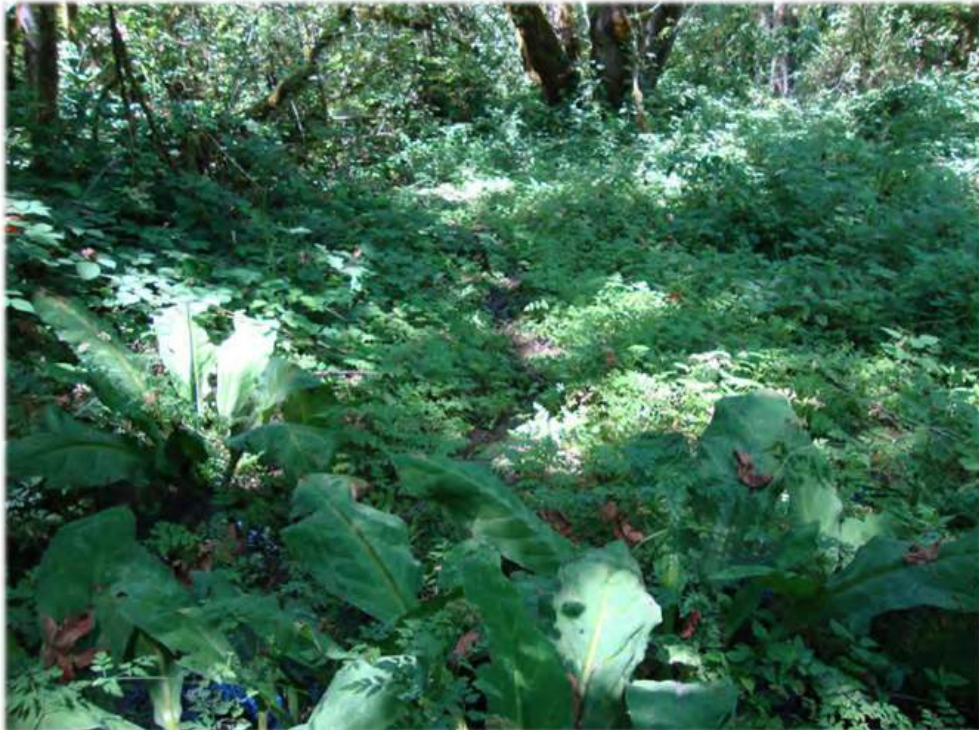
Photo Point 10. From the convergence of Stream 2 and Wetland 3 facing southwest toward stream.

Photo Point 10. From the convergence of Stream 2 and Wetland 3 facing north toward wetland.

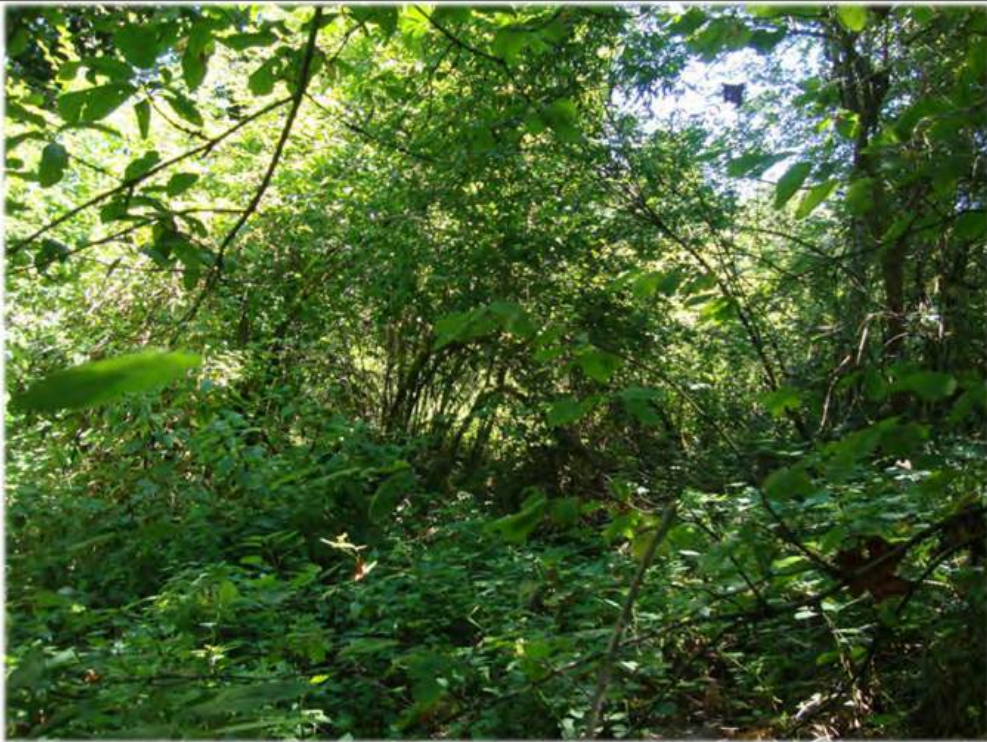
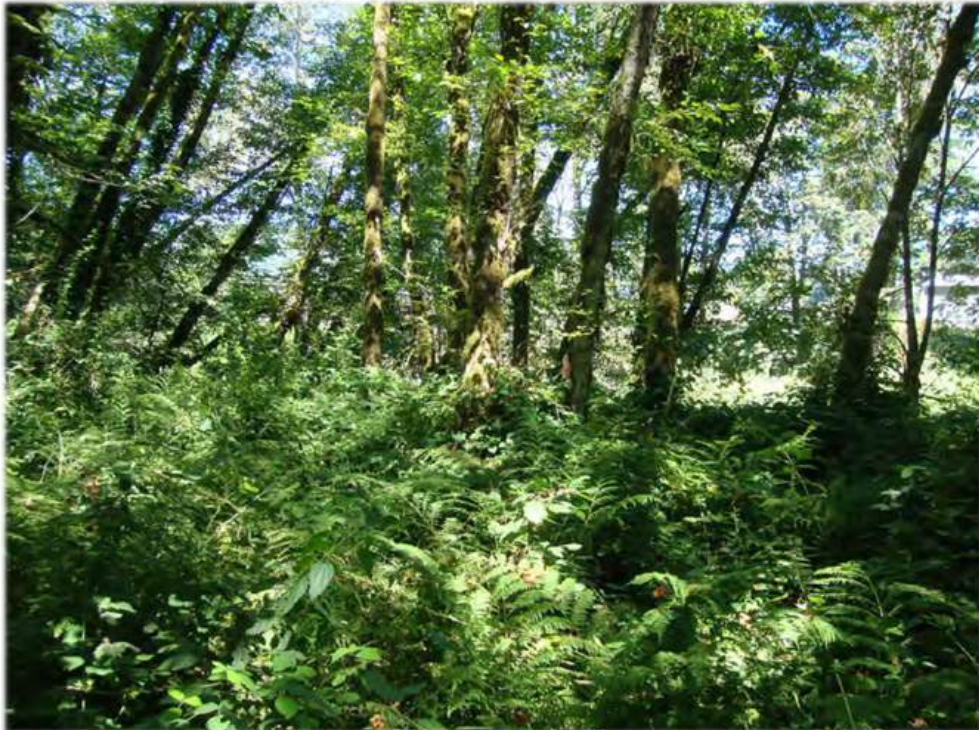
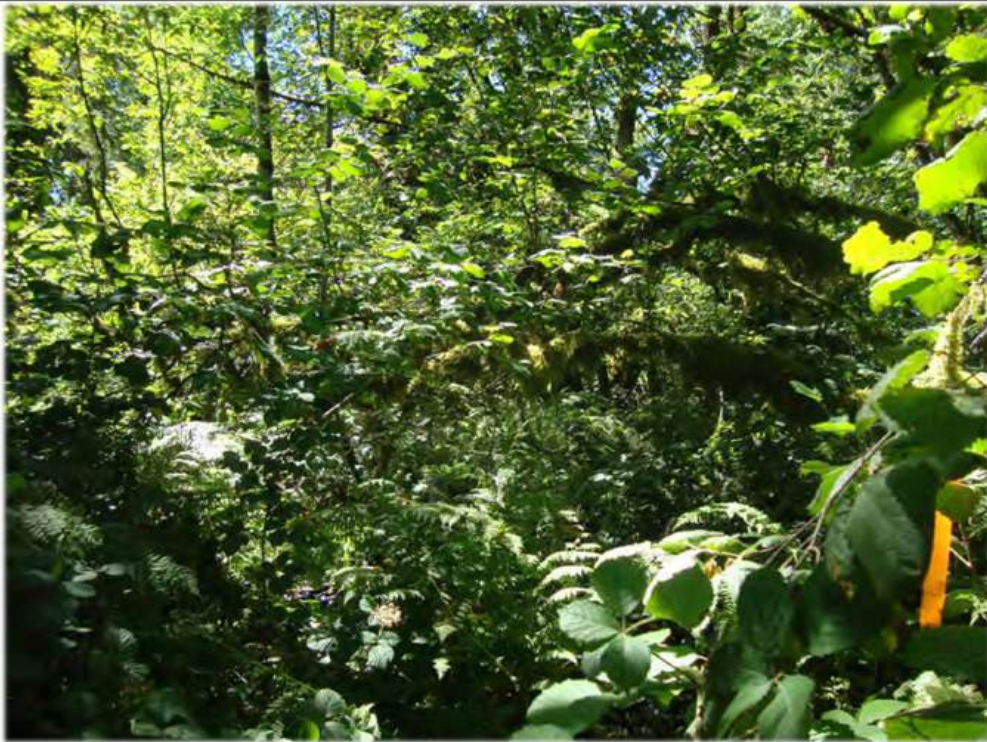
Photo Point 11. From Wetland 3 at the northern boundary facing northeast. Wetland continues offsite.

Photo Point 11. From Wetland 3 at the northern boundary facing northwest. Wetland continues offsite.

Photo Point 11. From Wetland 3 at the northern boundary facing southwest toward wetland area.

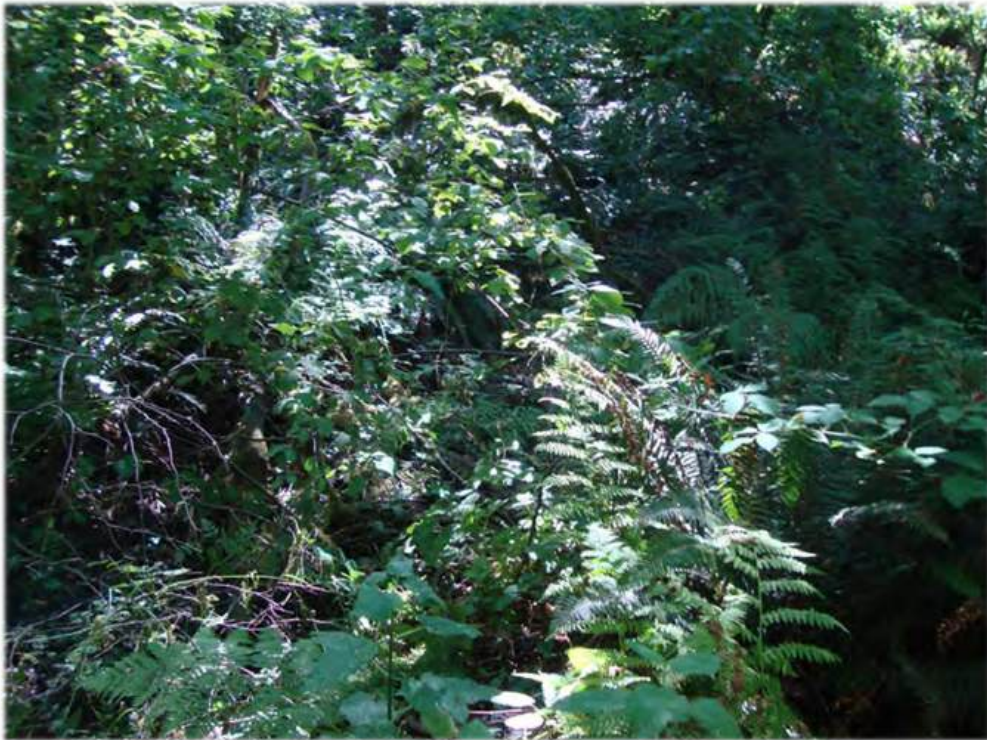
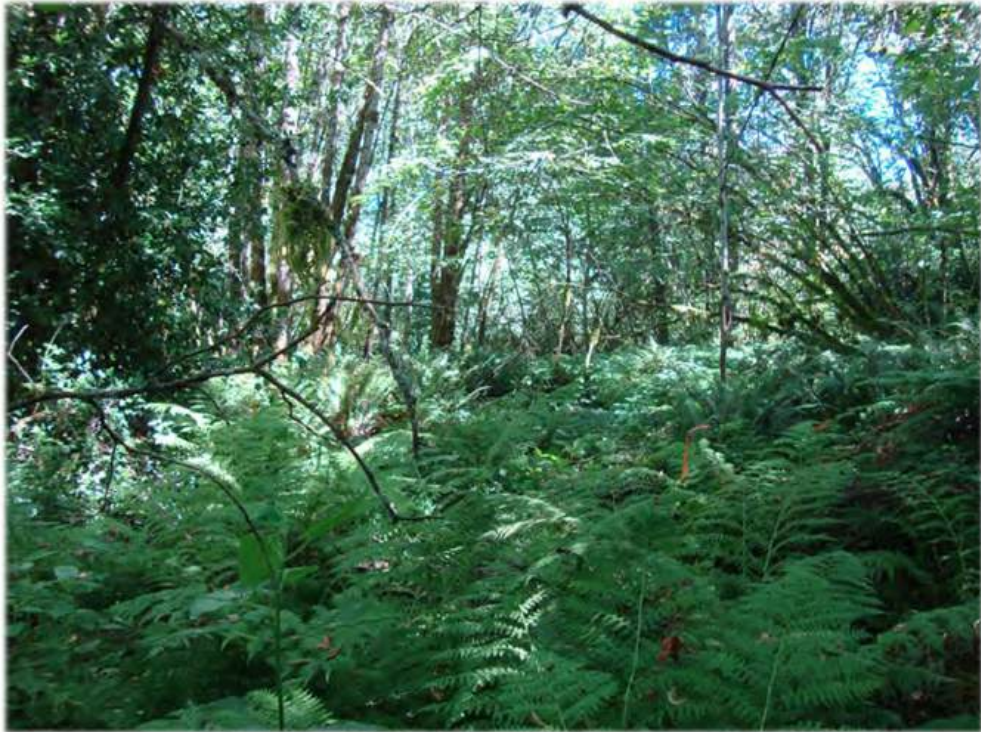
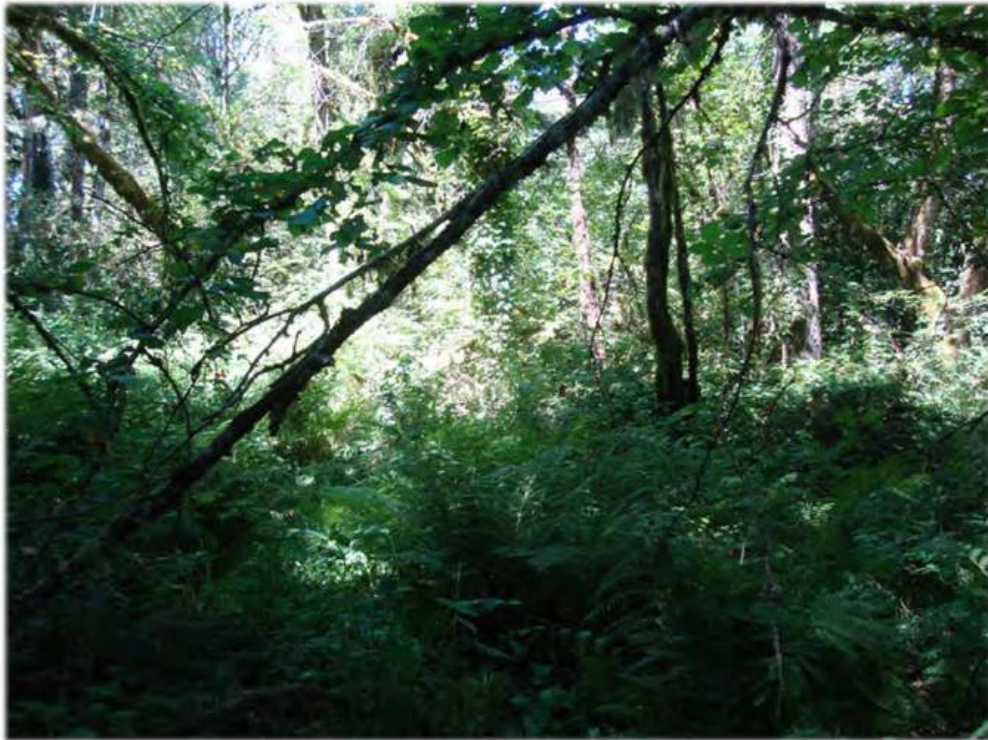
Photo Point 12. From Wetland 3 facing northwest toward wetland area.

Photo Point 12. From Wetland 3 facing northeast toward wetland area.

Photo Point 12. From Wetland 3 facing southeast toward adjacent upland.
