Jurisdictional Wetland Determination Report

Site address:
218 Twin Rocks Road,
Sterling Township
Wayne County, PA

Date of site visit:
January 26, 2023

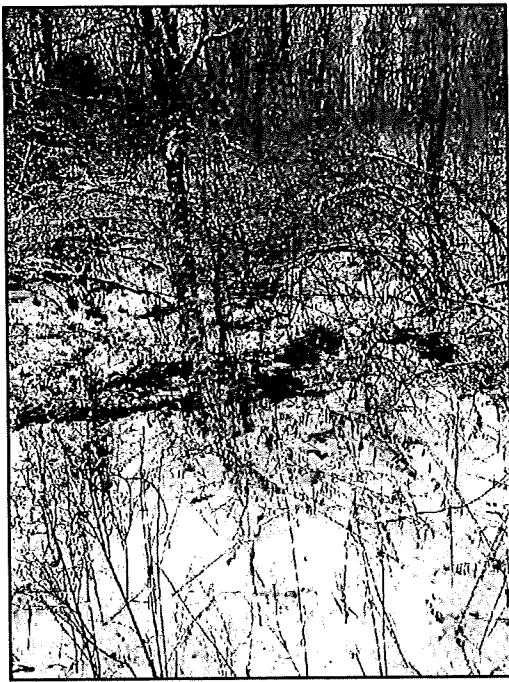
Photo 1

Remarks: (Explain alternative procedures here or in a separate report.)
Meets all three criteria.

See Photo 1.

Meets rapid, dominance and prevalence test.

Soil mapped on site is Volusia, Volusia soil has Chippawa inclusions. Soil found on site was Chippawa

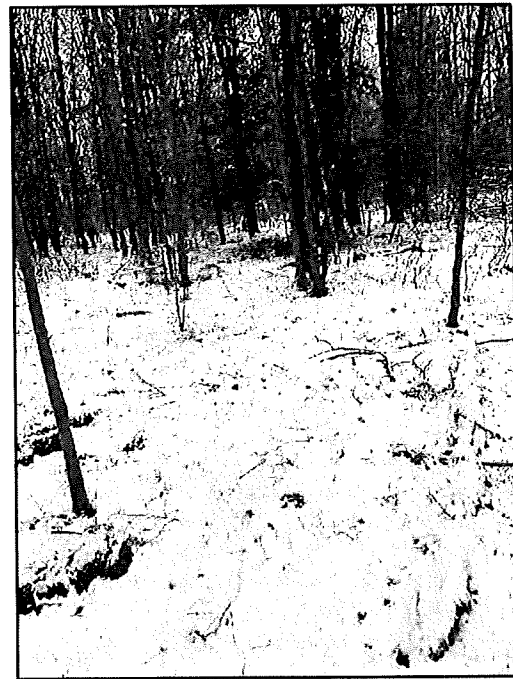
Photo 2

Remarks: (Include photo numbers here or on a separate sheet.)
 See photo 2
 Does not meet the rapid, dominance, or prevalence tests

Chroma of matrix is >2; no mottles or gleying immediately below the surface
