Young Heart

THIS SIMPLE GEORGIAN STRUCTURE IS STILL GOING STRONG, THANKS TO A LOT OF TLC.

THE MAGIC WINDOW BARN

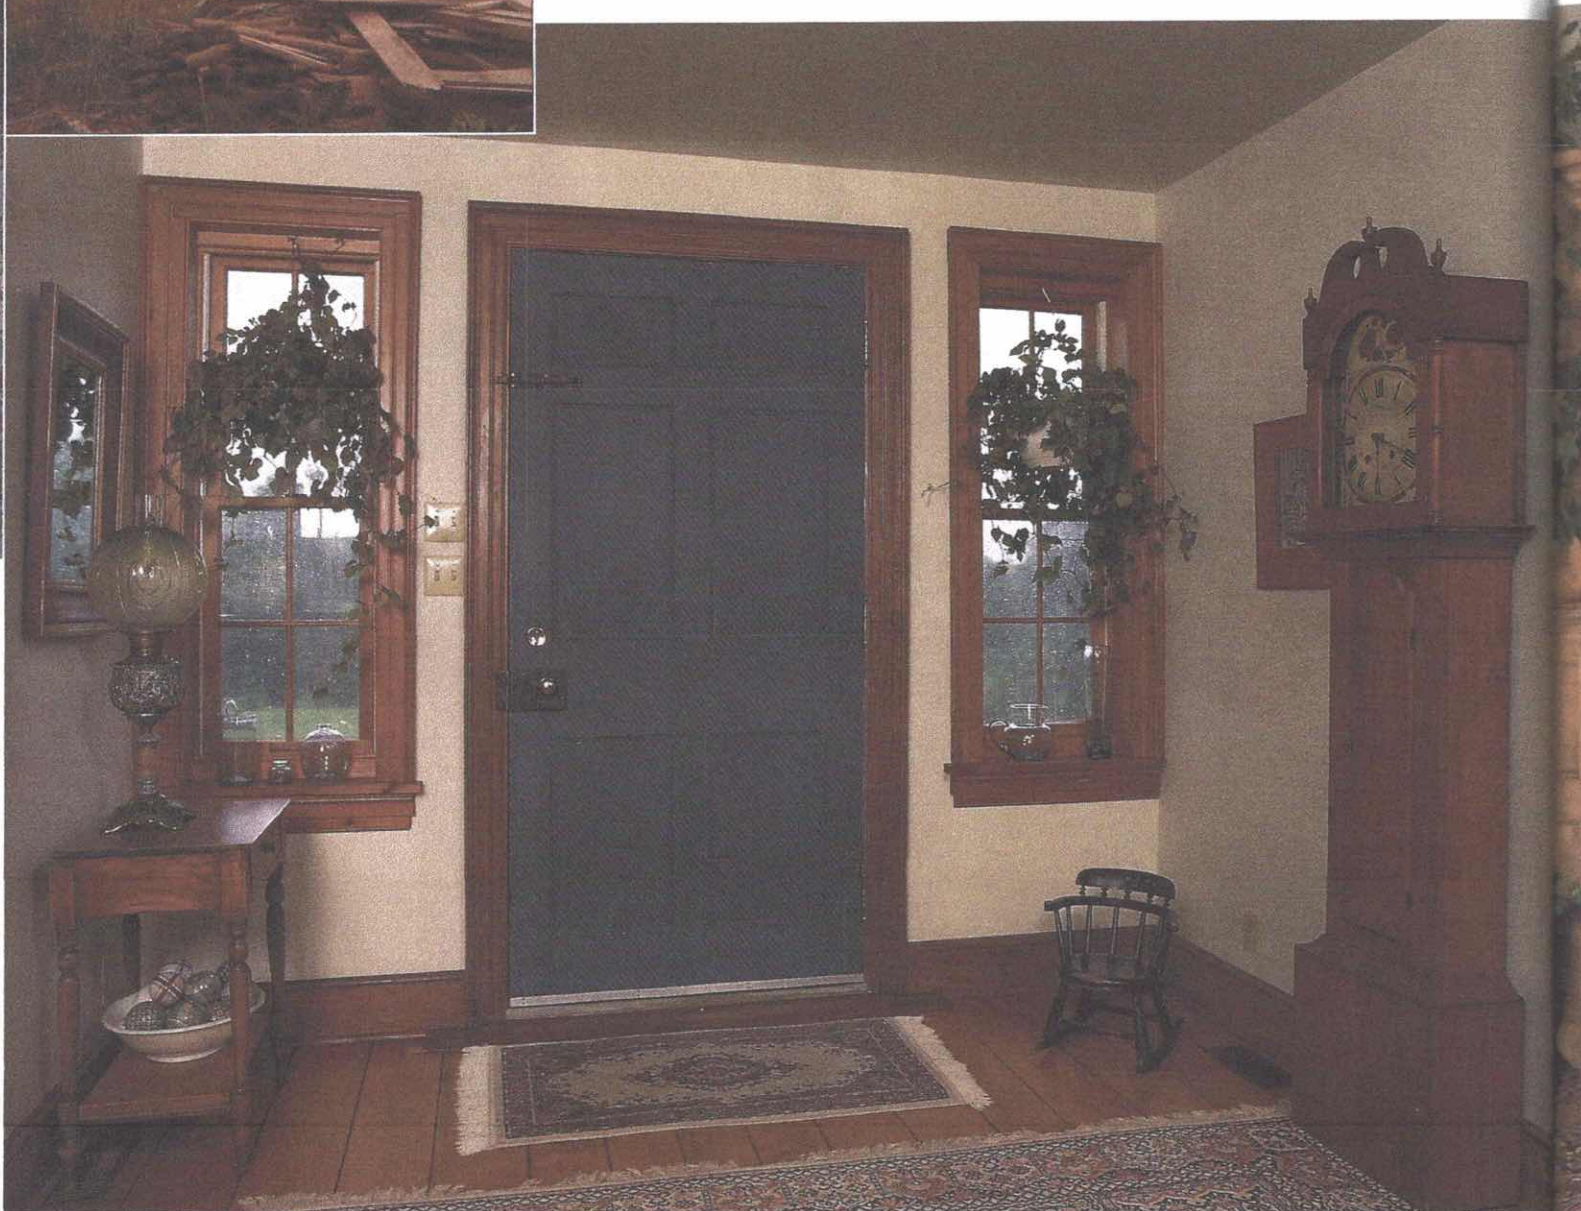
Records indicate that this early Georgian style house was built in 1804, the second brick home to be constructed in Thorold Township in Ontario. A tail wing was added on in 1854 (see "before" picture, opposite).

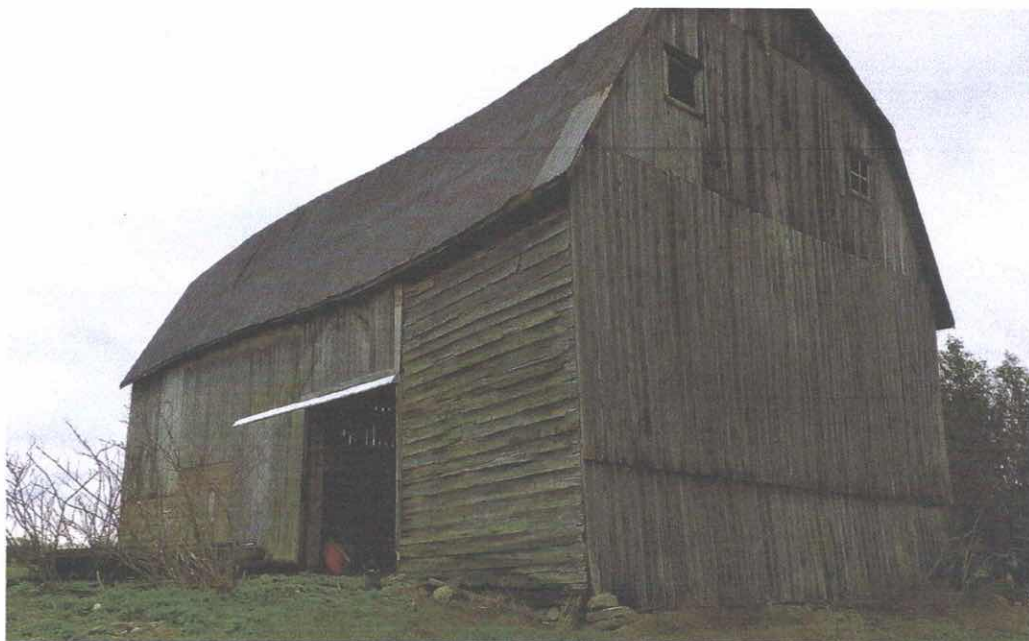
FIGURE 68 The Hagar barn is plain outside, but inside reveals an astonishingly big swing beam. Martha Amanda was looking through the open north door.

Little six-year-old Martha Amanda Hagar (1813–1877) was playing in the new swing beam barn her big brother (James Hagar, 1796–1891) and a master builder were almost done building (Figure 68).

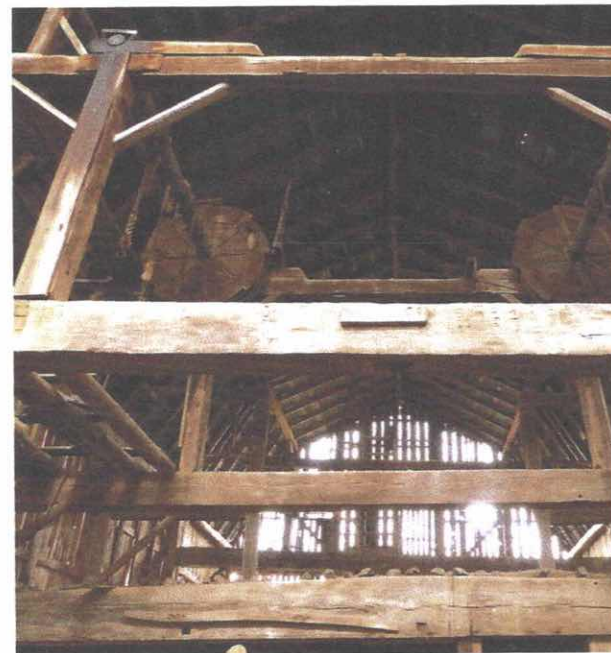
FIGURE 71 This odd renovation was perhaps done in the 1800s to gain precious mow space and install a wagon-rack-lifting wheel.

It took a while to forensically determine how earlier owners had altered the barn to a gambrel roof (Figure 70 and Figure 71). The barn started as a vertical queen post barn, with a swing beam bent cross-section as shown. Later, the roof was peeled off and a beam installed transversely on top of, and about 3 ft beyond, the existing purlin beams. These beams then supported short posts extending to still-higher new purlin beams for a gambrel roof.

In Figure 71, notice the two vertical queen posts blackened from oil used to lubricate the axles of the wagon-rack-lifting wheel. Between the blackened queens and angle braces, empty mortises provided evidence of a former tie beam. Former diagonal braces are missing,

as the empty mortise slots are below the braces. Rafter from the old gable roof were removed, shortened and reinstalled on the upper slope of the gambrel roof. Sawn rafters were installed on the lower slope of the gambrel roof.

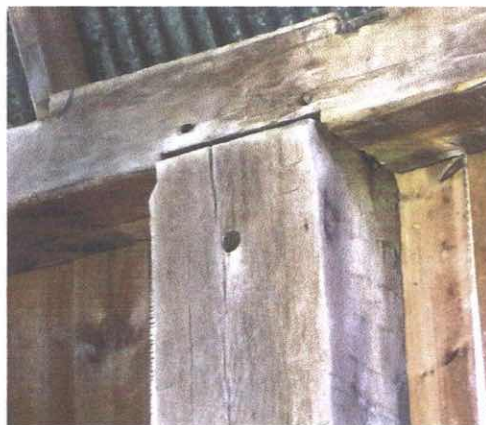
FIGURE 73 Hoisting pin holes were larger than pin holes in mortise-and-tenon joints because large pins were needed to withstand the stress of lifting heavy bents.

Early-era barns often had hoisting pin holes at the top of the end posts (Figure 73). Bents were assembled flat on the ground, then winched up into their final vertical positions using block-and-tackle devices attached to pins placed in these hoisting pin holes. Lifting devices may have been needed for early barns since there were fewer people around to help out. Barns installed later did not have hoisting pins, likely relying on building bees with dozens of people to tilt up bents using pike poles and plenty of person power.

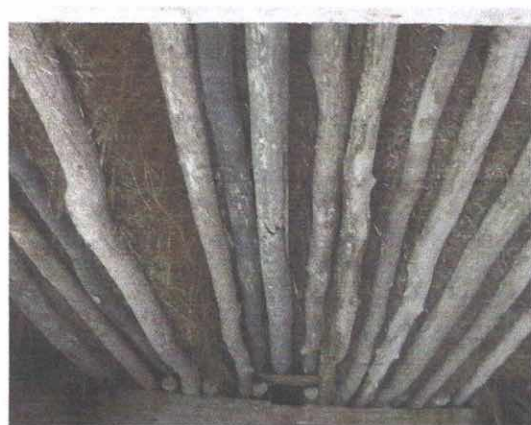
FIGURE 74 This crude mow of loose hay resting on the swing beam and beam of adjacent bent was likely built 70+ years ago, when loose hay was still common.

Slender tree logs were placed longitudinally on top of the swing beam and a beam of an adjacent bent, 12.5 ft away, to form a crude mow for loose hay above (Figure 74). The beam of the adjacent bent is badly deflected from years of loading. It also sits at a lower elevation than the swing beam, meaning the floor of this mow sloped downward away from the swing beam. Several other barns had similar downwardly sloped mows. This may have been by design to help ensure loose hay or straw didn't slide off the mow to the threshing floor.

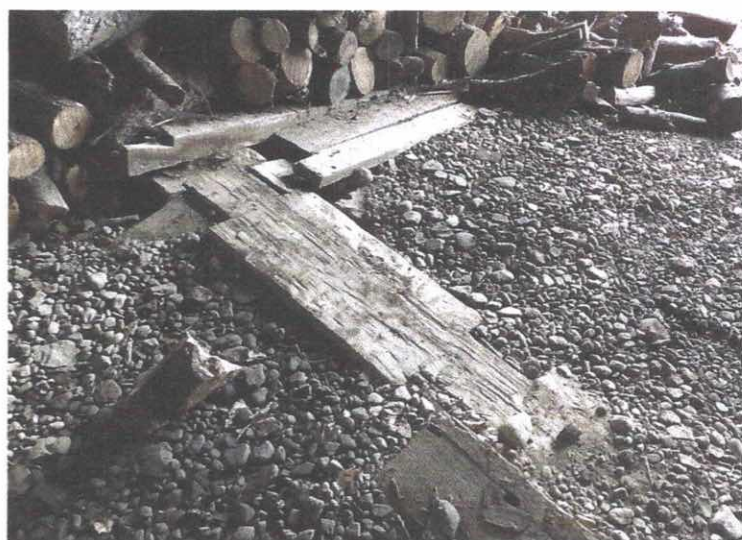
FIGURE 75 A 12 × 12 in. sill beam runs longitudinally the centre length of the barn, with 6 × 6 in sleeper beams transversely, 3 ft on centre.

Because this is a ground barn, sill and sleeper beams lie under the (former) wooden plank floor. Sills would typically sit on large fieldstones to both distribute weight loads to the ground and keep sills dry off the ground. They were often made from white oak as it could stand up to wet conditions. Just like joists vary in size and spacing and run in different directions depending on the house size and orientation, sleeper beam configurations also varied depending on beam size, spacing, barn size and orientation. Figure 75 shows remnants of the floor, buried in gravel at a later date, likely because the floor got worn out or because the owners wanted to discourage critters from living underneath.
