Phase I Environmental Site Assessment for Hibiscus Pointe Candlelight Blvd., Brooksville, FL

WGI Project No. 9899.00

Report Issuance Date: August 2, 2023 Report Expiration Date: January 24, 2024

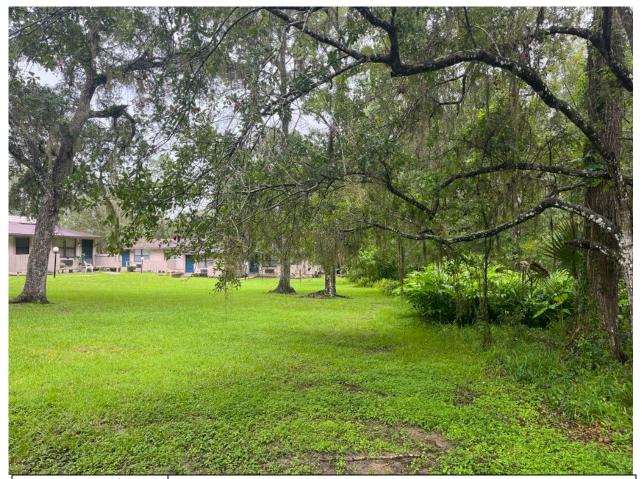
Photo Number: 1 Photo date: 7/31/2023

Typical view along the eastern property boundary. To the right is the subject property, to left are adjacent apartment complexes.

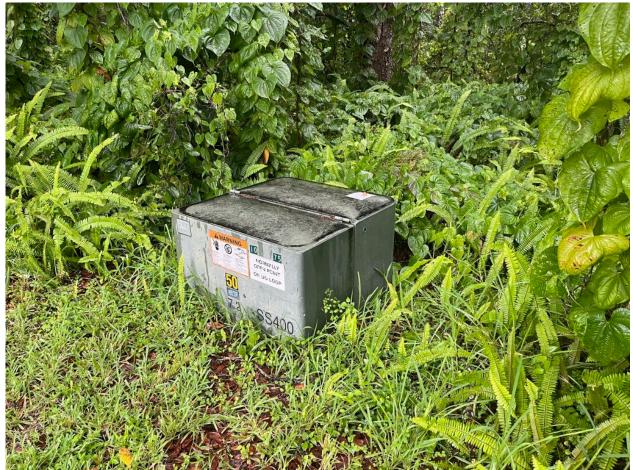
Photo Number: 2 Photo date: 7/31/2023 Direction: SW

View of electrical box observed near the eastern property boundary.

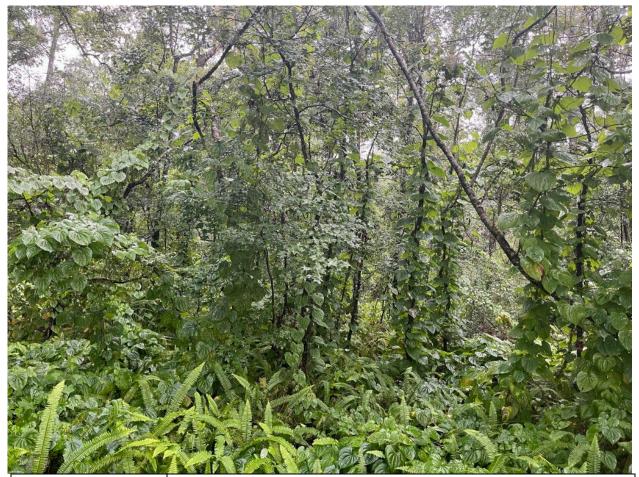
Photo Number: 3
Photo date: 7/31/2023

Typical view of the interior subject property. Dense vegetation was observed throughout the entire subject property.

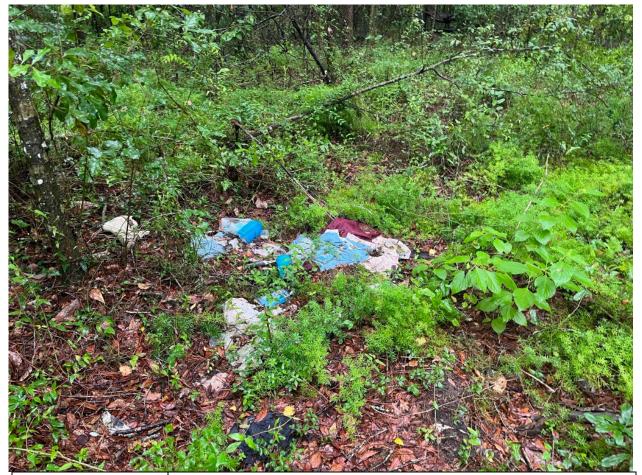
Photo Number: 4
Photo date: 7/31/2023
Direction: S

View of household garbage observed on subject property. Garbage consisted of articles of clothing, plastic bottles, and grocery bags.

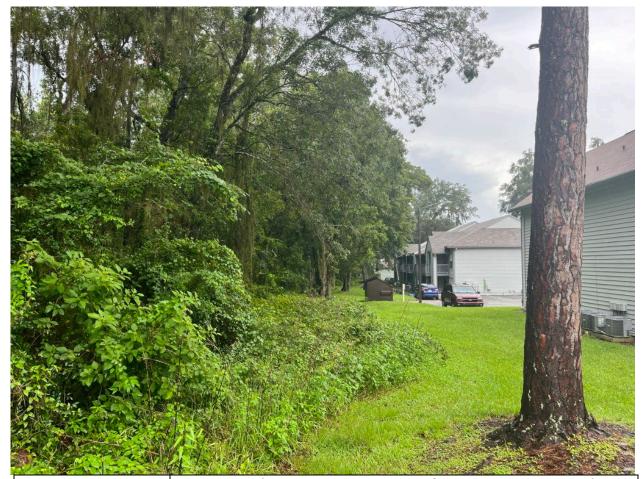
Photo Number: 5 Photo date: 7/31/2023

Typical view of western property boundary. Subject property is to the left and adjacent apartment complex is to the right.

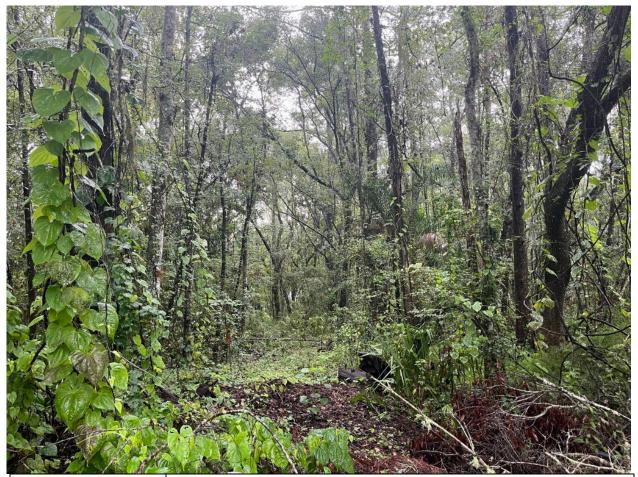
Photo Number: 6
Photo date: 7/31/2023

Typical view of interior vegetation taken from the western side of the subject property.

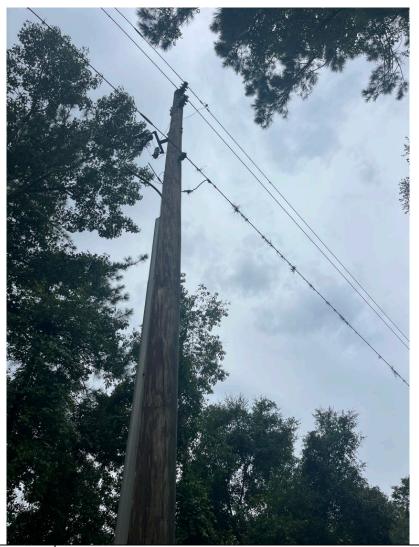
Photo Number: 8
Photo date: 7/31/2023
Direction: SW

View of power pole associated with power line along southern property boundary.

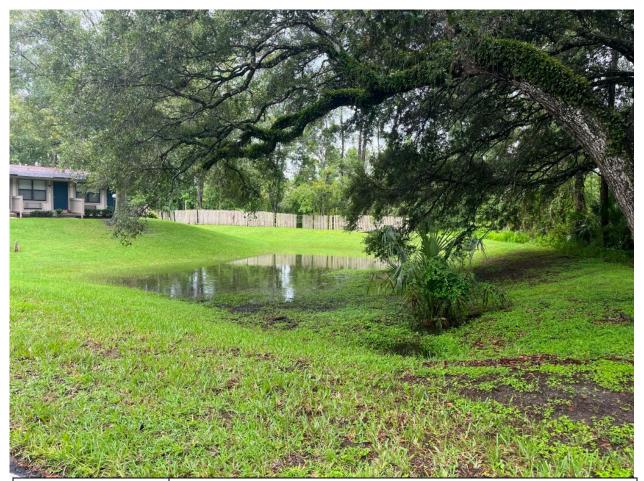
Photo Number: 9 Photo date: 7/31/2023

View of stormwater collection area offsite, located adjacent to the southeast corner of the subject property.

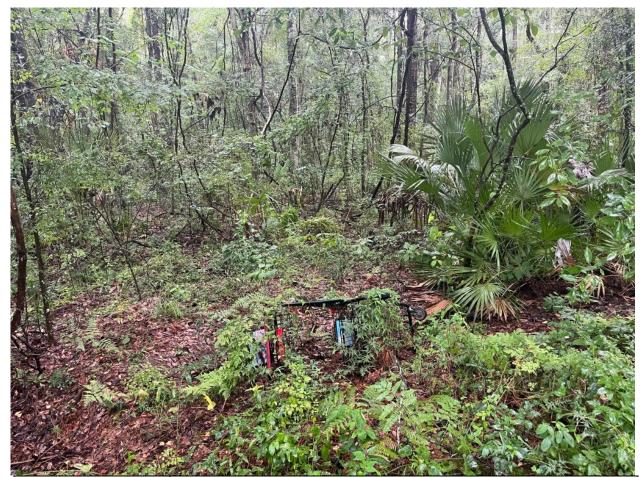
Photo Number: 10 Photo date: 7/31/2023 Direction: W

View of additional debris observed on subject property.
