I. Project Description

On 25 March 2024, E-Tech Consultant's, Inc., (E-Tech) completed a pedestrian survey and wetland delineation on two adjacent parcels of land totaling ±5-acres of land Parcel ID #'s 21-3N-23-0000-0017-030A and 21-3N-23-0000-0017-0300. The site is located within Crestview, Okaloosa County, Florida (Attachment I).

VII. Conclusion

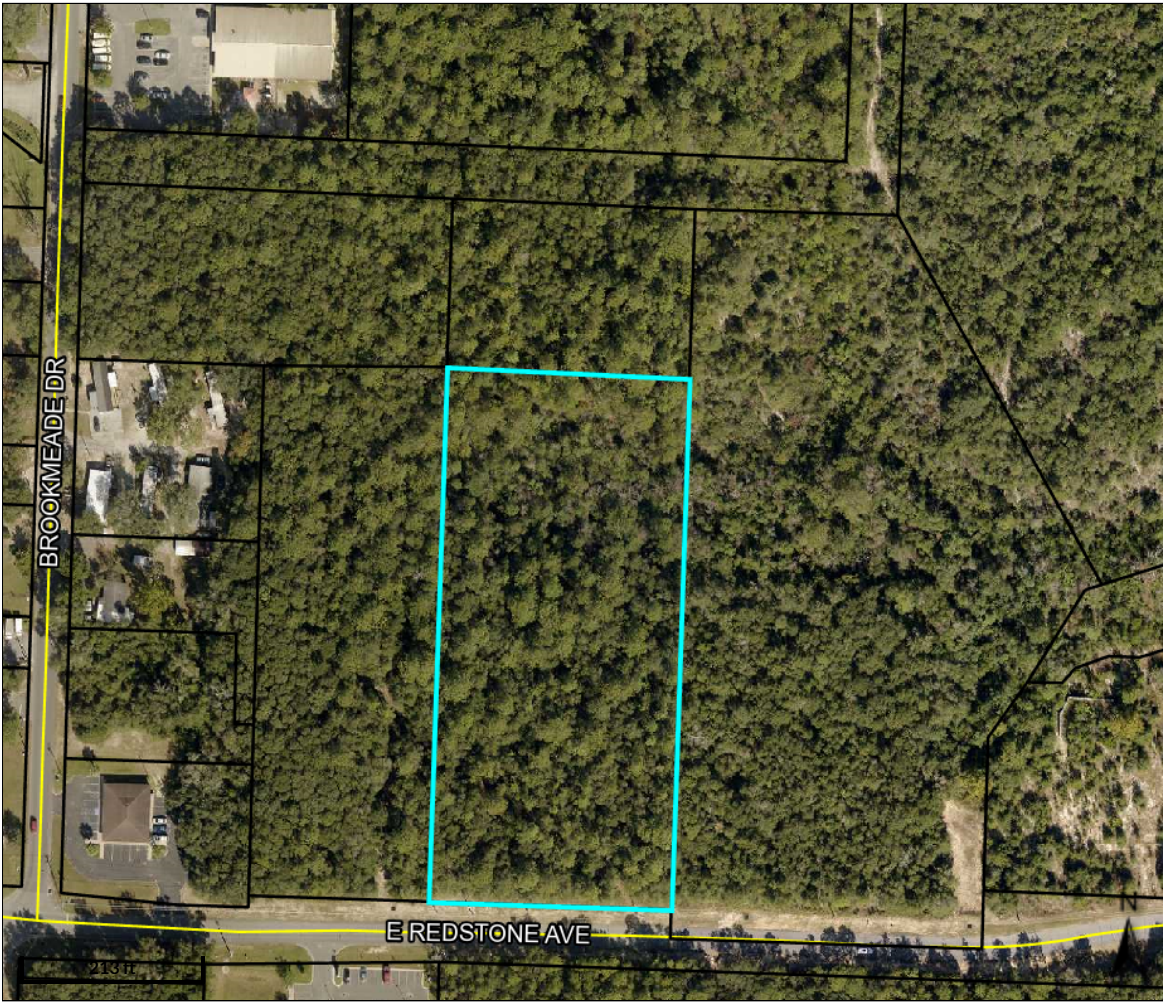
Parcel ID	21-3N-23-0000-0017-030A	Physical Address	BROOKMEADE DR CRESTVIEW	Land Value	\$324,488	Last 2 Sales							
Acres (GIS)	3.78	Mailing Address	BROOKMEADE PROPERTIES LLC	Ag Land Value	\$0	Date	4/8/2008	Price	\$100	Reason	QUAL/CREDIBLE,VERIF/DOC/EVIDEN	Qual	U
Property Class	VACANT COMMERCIAL	Address	25 BAY DR NE FT WALTON	Building Value	\$0	Date	8/18/2004	Price	\$200000	Reason	N/A	Qual	Q
Taxing District	3		BEACH, FL 32548	Just Value	\$324,488								
				Assessed Value	\$224,610								
				Exempt Value	\$0								
				Taxable Value	\$224,610

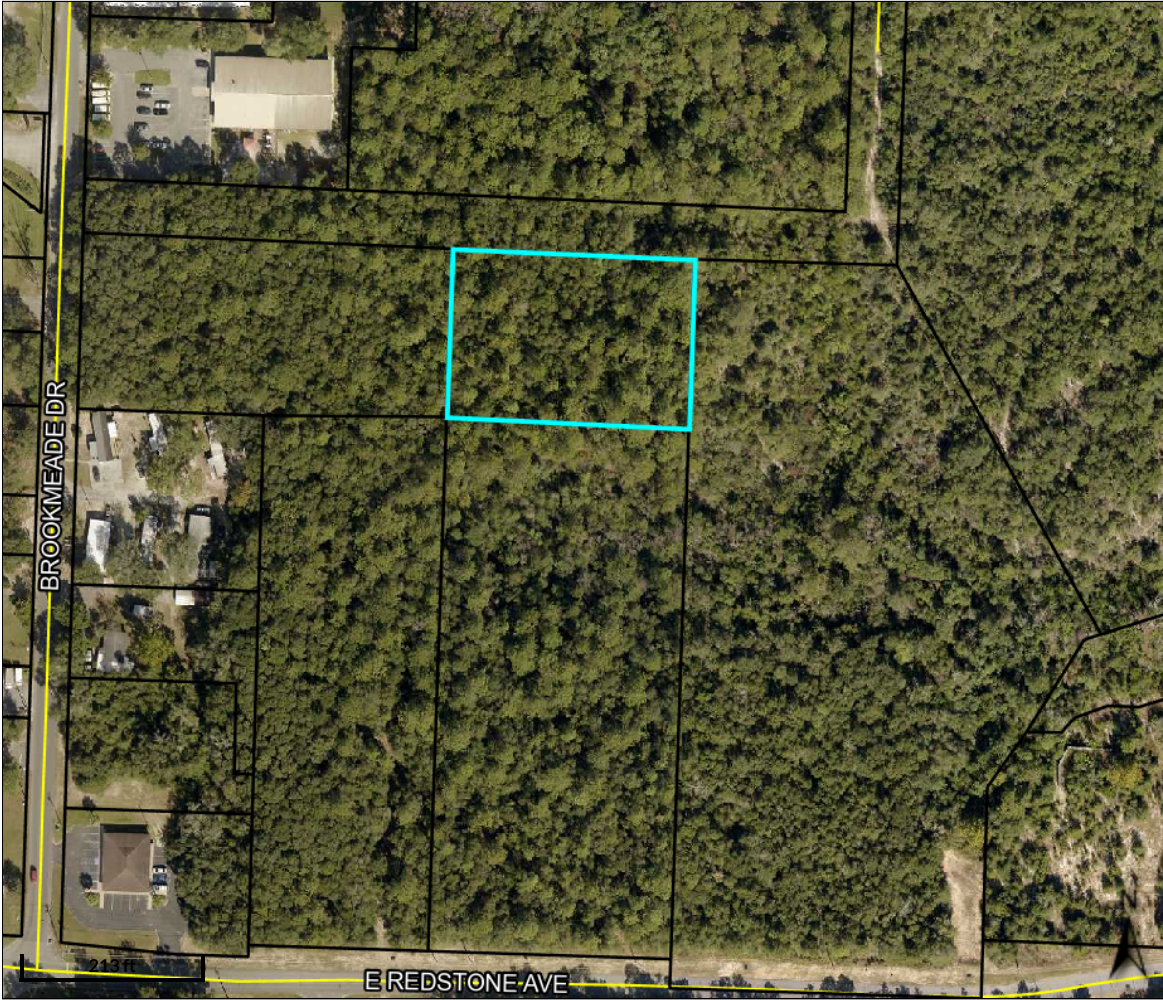
Parcel ID	21-3N-23-0000-0017-0300	Physical Address	BROOKMEADE DR CRESTVIEW	Land Value	\$23,299	Last 2 Sales			
Acres (GIS)	1.20	Mailing Address	BROOKMEADE PROPERTIES LLC	Ag Land Value	\$0	Date	4/8/2008	Price	\$100
Property Class	VACANT	Address	25 BAY DR NE FT WALTON BEACH, FL 32548	Building Value	\$0	Date	8/18/2004	Price	\$200000
Taxing District	1			Misc Value	\$0	Reason	N/A		Qual
				Just Value	\$23,299				U
				Assessed Value	\$23,299				Q
				Exempt Value	\$0				
				Taxable Value	\$23,299

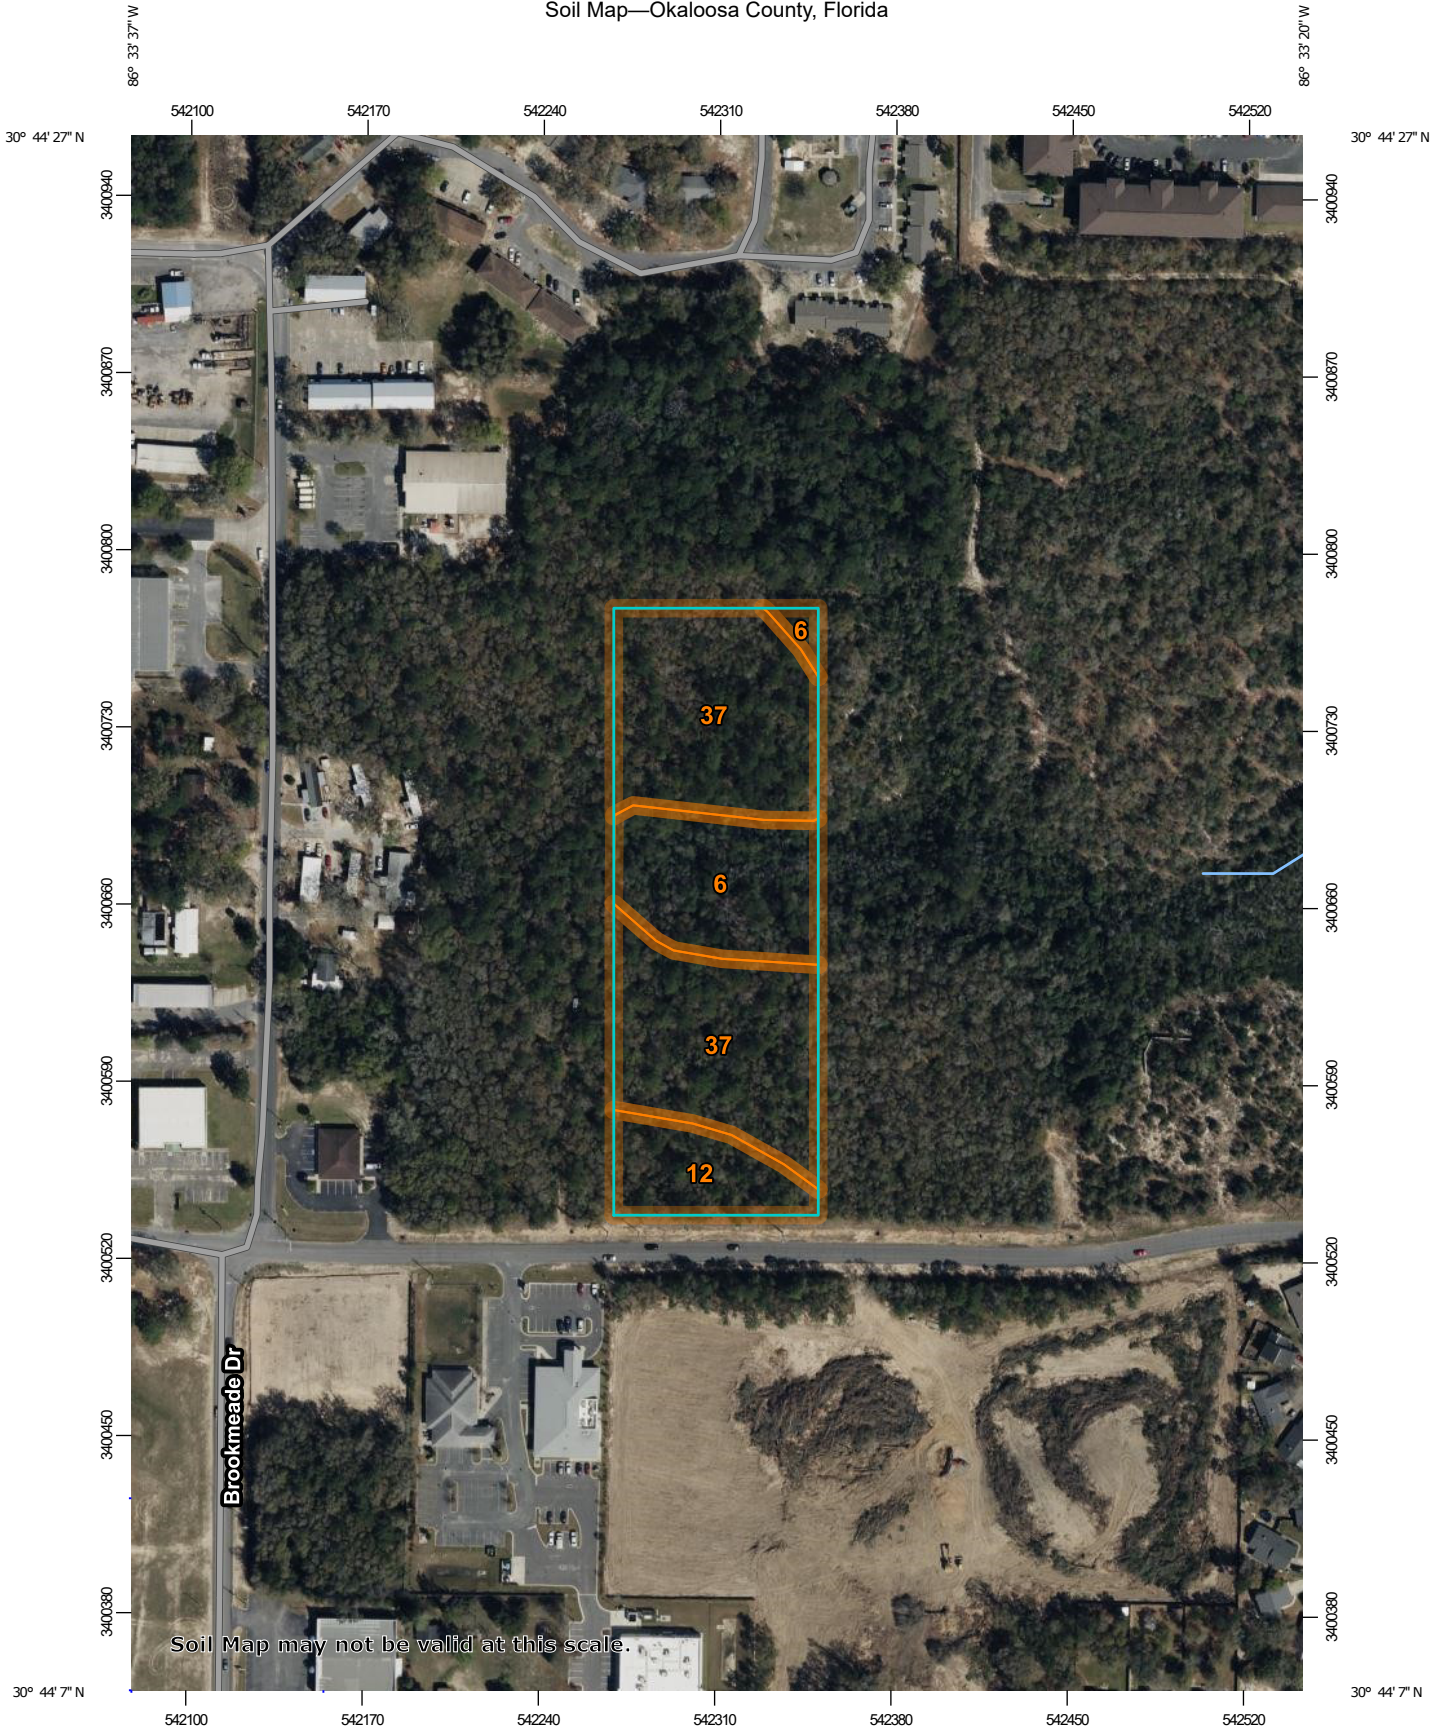
Soil Map—Okaloosa County, Florida

Prior to completing the site inspection, E-Tech staff reviewed a web soil survey of Walton County produced by the Natural Resource Conservation Service (Attachment III). Three soil types were listed to exist onsite: Dorovan muck, frequently flooded (Map Unit 6), Lakeland sand, 0 to 5 percent slopes (Map Unit 12), and Bonifay sand, 5 to 8 percent slopes (Map Unit 37). Dorovan muck, frequently flooded is best described as occurring in flood plains on marine terraces. This soil type is very poorly drained with a water table depth of 0 inches. Flooding and ponding are frequent the available water capacity is very high.

Lakeland sand, 0 to 5 percent slopes is best described as occurring in hills on marine terraces. This soil type is excessively drained with a water table depth of more than 80 inches. The available water capacity is low.

Bonifay sand, 5 to 8 percent slopes is best described as occurring in knolls and ridges on marine terraces. This soil type is well drained with a water table depth of more than 80 inches. The available water capacity is very low.

The native soil structure of these parcels appears to match the description of the soils mapped.

Map Unit Symbol	Map Unit Name	Acres in AOI	Percent of AOI
6	Dorovan muck, frequently flooded	1.1	23.8%
12	Lakeland sand, 0 to 5 percent slopes	0.6	12.8%
37	Bonifay sand, 5 to 8 percent slopes	3.1	63.4%
Totals for Area of Interest		4.8	100.0%

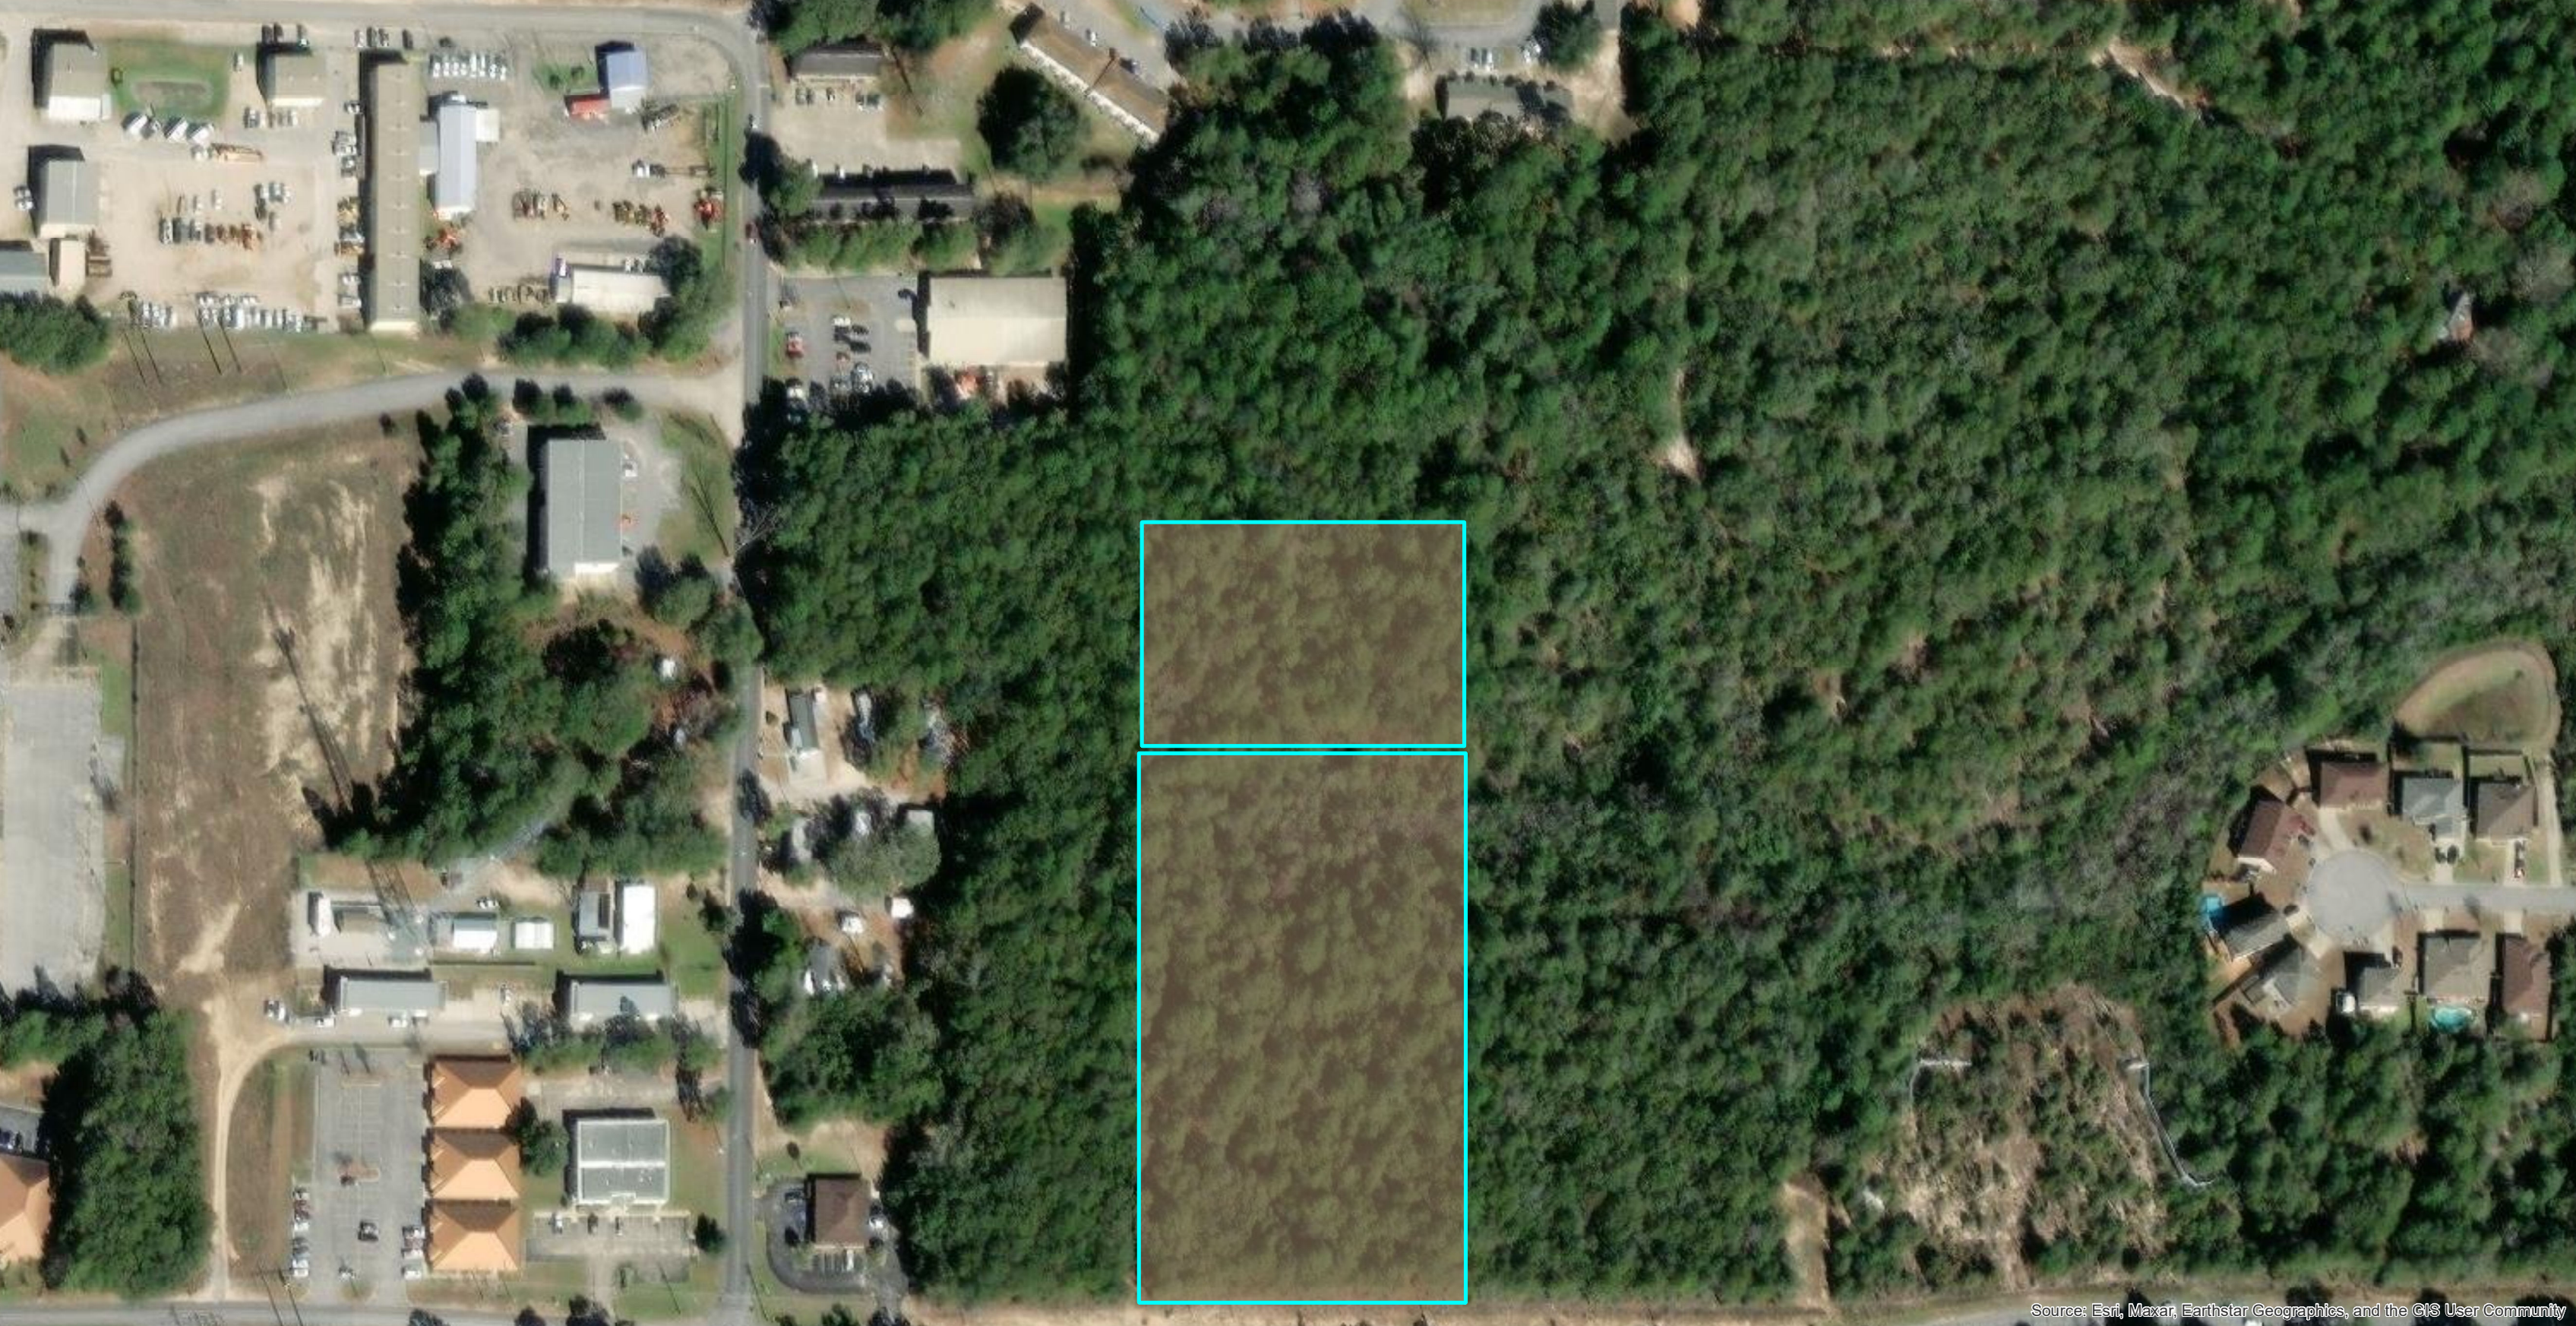
Titi swamp wetlands were identified onsite and delineated pursuant to the 1987 *Corps of Engineers Wetlands Delineation Manual* and the Florida Department of Environmental Protection's (DEP) *Wetland Delineation Manual*, Chapter 62-340, F.A.C. (Flagging Map

Attached). Both DEP and the U.S. Army Corps of Engineers (CE) regulate these wetlands. Any proposed impacts to these wetlands will require permits from both agencies.

According to the Okaloosa County Comprehensive Plan and Land Development code **Chapter 2.10, Policy 2.7** Vegetative buffer strips shall be retained for twenty-five feet from the ordinary high-water line or mean high water line, whichever is appropriate, of all natural watercourses, water bodies or wetlands to prevent erosion and trap the sediment from overland runoff.

- a.** For both tidal and non-tidal wetlands, the first 25 feet from the mean high-water line or the ordinary high-water line; and
- b.** For tidal influenced wetlands an additional 25-foot buffer zone, with the total 50-foot buffer zone measured from the mean high-water line.
