Waters of the U.S. Memo

Lexington County Parcel

TMS# 6896-03-040

December 2025

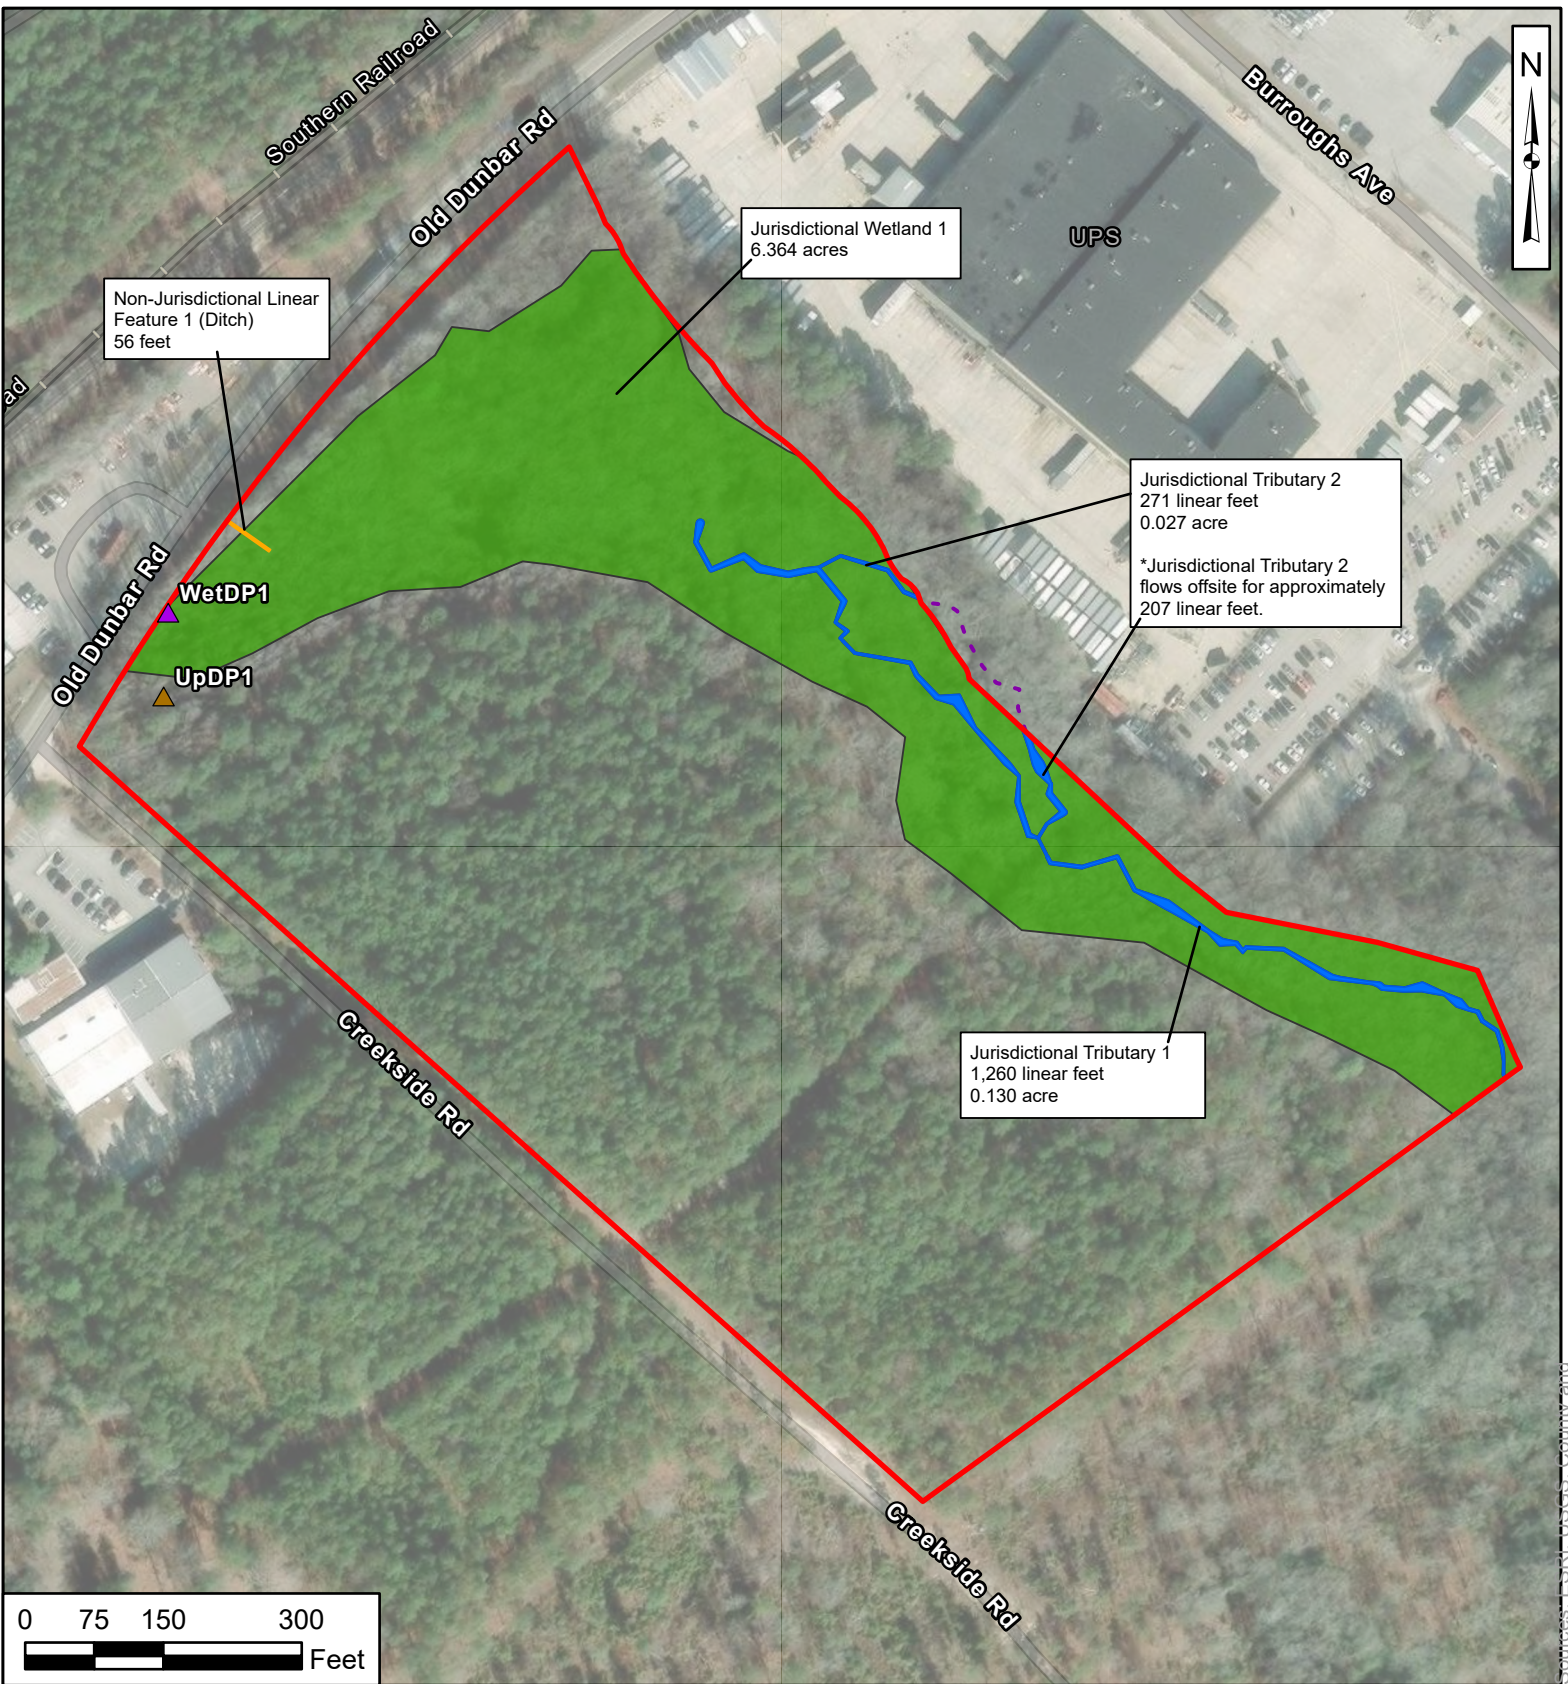
APPENDIX A
WATERS OF THE U.S. MAP
WETLAND DATA DETERMINATION FORMS

One forested wetland, two tributaries to Congaree Creek, and one excavated ditch were observed during field reconnaissance on December 16, 2025. Please see Appendix A, Figure 1 for the location and extent of delineated features within the PSA.

<p>Mead & Hunt Mead & Hunt 878 S Lake Drive Lexington, SC 29072 Tel. 803.996.2900 www.meadhunt.com</p>		LEXINGTON COUNTY PARCEL		WATERS OF THE U.S. MAP			
		TMS# 006896-03-040					
		SOURCE: NAIP Aerial Imagery (2024)					
		DRAWN BY: OGR	FIGURE 1				
DATE: 12/18/2025	QAQC BY: SOG	<p>LEGEND</p> <table style="width: 100%; border: none;"> <tr> <td style="width: 50%; border: none;"> <ul style="list-style-type: none"> ▭ Project Study Area ▭ Jurisdictional Wetland — Streamline ▬ Jurisdictional Tributary </td> <td style="width: 50%; border: none;"> <ul style="list-style-type: none"> ▲ Upland Datapoint ▲ Wetland Datapoint ▬ Non-Jurisdictional Linear Feature (Ditch) </td> </tr> </table>				<ul style="list-style-type: none"> ▭ Project Study Area ▭ Jurisdictional Wetland — Streamline ▬ Jurisdictional Tributary 	<ul style="list-style-type: none"> ▲ Upland Datapoint ▲ Wetland Datapoint ▬ Non-Jurisdictional Linear Feature (Ditch)
<ul style="list-style-type: none"> ▭ Project Study Area ▭ Jurisdictional Wetland — Streamline ▬ Jurisdictional Tributary 	<ul style="list-style-type: none"> ▲ Upland Datapoint ▲ Wetland Datapoint ▬ Non-Jurisdictional Linear Feature (Ditch)

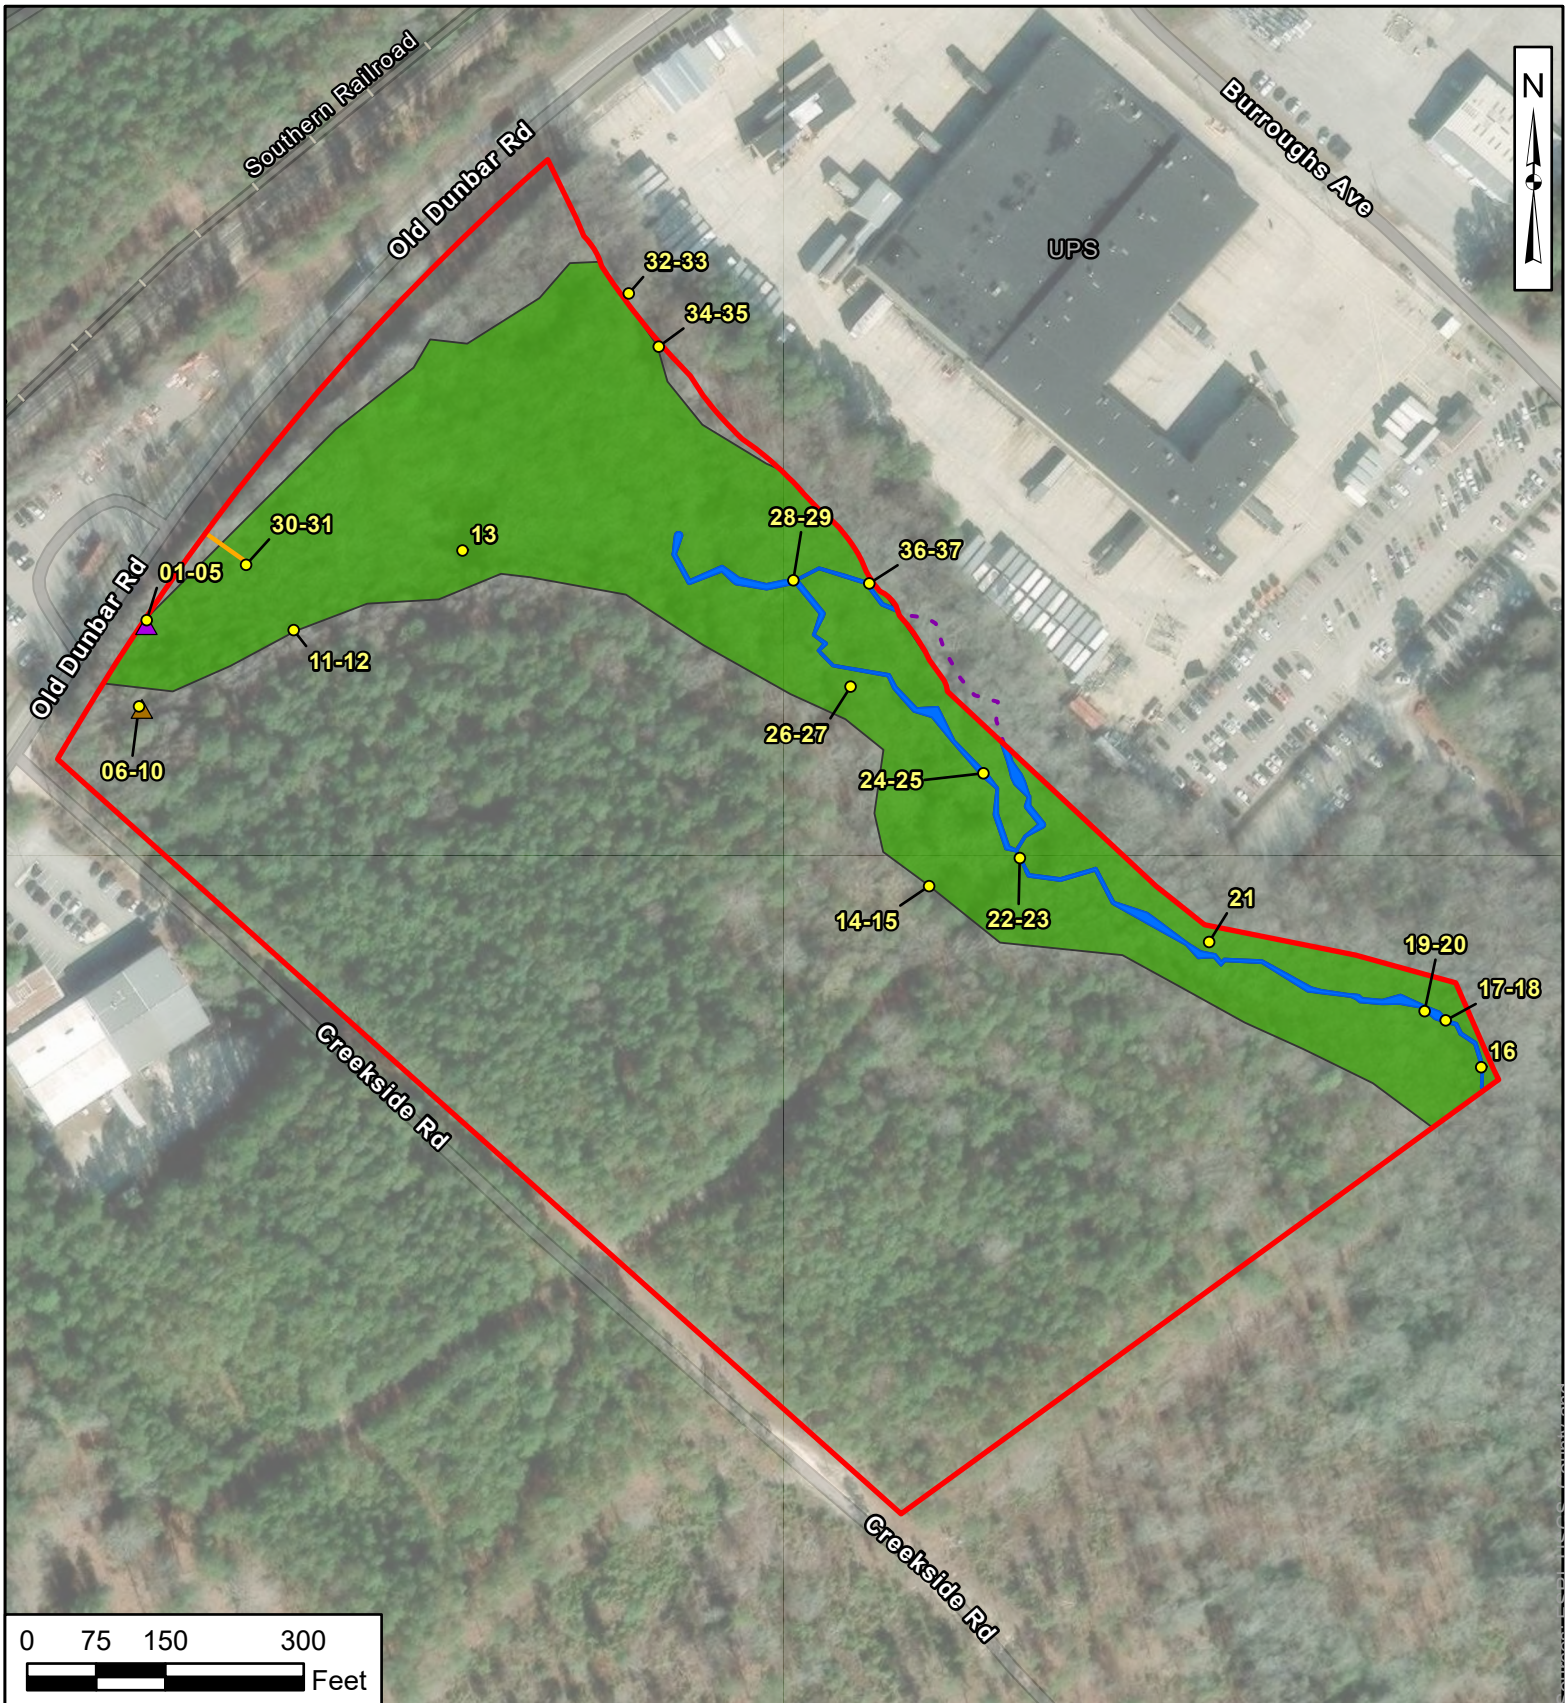
APPENDIX B
PHOTO LOCATION MAP
PHOTOLOG

<p style="font-size: 8px; margin-top: 5px;">Mead & Hunt 878 S Lake Drive Lexington, SC 29072 Tel. 803.996.2900 www.meadhunt.com</p>		LEXINGTON COUNTY PARCEL TMS# 006896-03-040		PHOTO LOCATION MAP			
		<small>SOURCE: NAIP Aerial Imagery (2024)</small>				LEGEND <div style="display: flex; justify-content: space-between; font-size: 8px;"> <div style="width: 45%;"> <ul style="list-style-type: none"> Project Study Area Jurisdictional Wetland Streamline Jurisdictional Tributary Upland Datapoint </div> <div style="width: 45%;"> <ul style="list-style-type: none"> Wetland Datapoint Non-Jurisdictional Linear Feature (Ditch) Photo </div> </div>	
		<small>DRAWN BY: OGR</small>	<small>FIGURE 2</small>				
		<small>DATE: 12/18/2025</small>	<small>QAQC BY: SOG</small>

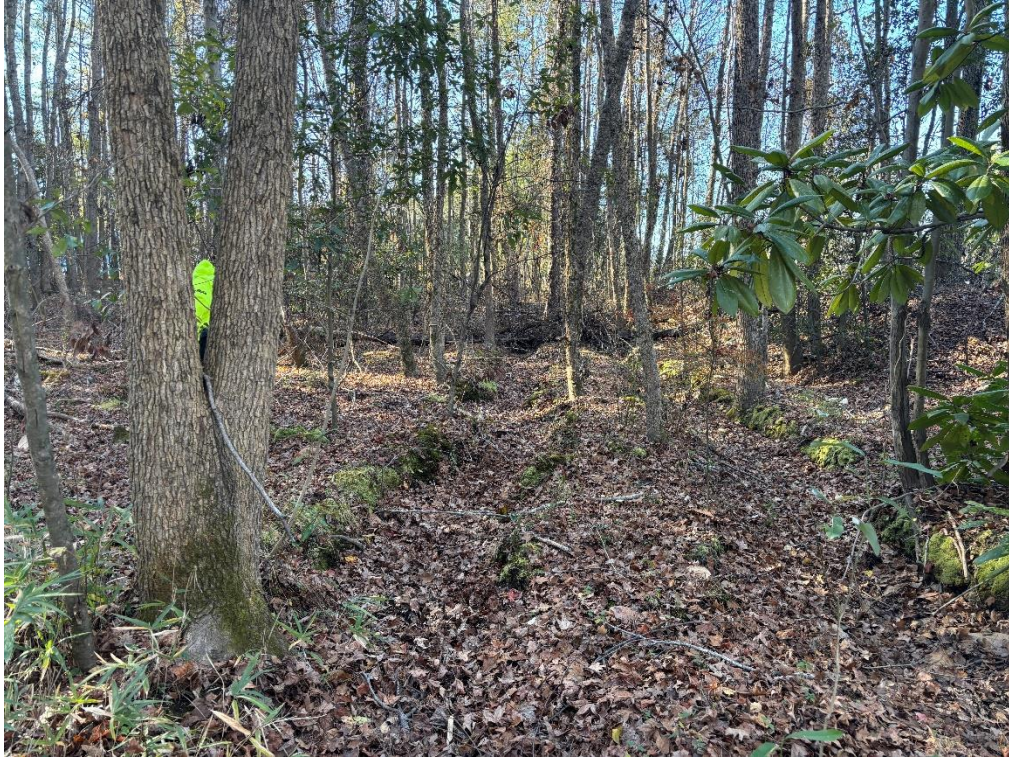
<p>Date: 12/16/2025</p>
	<p>Taken By: Olivia Roach</p>
	<p>Photograph 01</p>
	<p>Description: View of Jurisdictional Wetland 1, facing north towards roadside berm. Photograph is taken in the NW corner of the study area where Wetland Datapoint 1 was taken.</p>
 	<p>Date: 12/16/2025</p>
	<p>Taken By: Olivia Roach</p>
	<p>Photograph 02</p>
	<p>Description: View of Jurisdictional Wetland 1, facing east. Photograph is taken in the NW corner of the study area where Wetland Datapoint 1 was taken.</p>

Wetland 1 is a palustrine, forested wetland associated with roadway drainage and the floodplain of Tributary 1 and Tributary 2, located south of Old Dunbar Road and east of Creekside Road. Approximately 6.364 acres of the wetland is located within the PSA. The overstory of Wetland 1 is dominated by sweetgum (*Liquidambar styraciflua*), red maple (*Acer rubrum*), and other broadleaf hardwood species. Understory vegetation is sparse and includes redbay (*Tamala borbonia*), Chinese privet (*Ligustrum sinense*), American holly saplings (*Ilex opaca*), switchcane (*Arundinaria tecta*), and Japanese honeysuckle (*Lonicera japonica*). Primary and secondary wetland hydrology indicators within Wetland 1 include: high water table, saturation, drainage patterns, water-stained leaves, geomorphic position, and the FAC-neutral test. Hydric soil indicator Umbric Surface was also observed in the wetland. Wetland 1 is depicted on the USFWS NWI Wetland Mapper as a freshwater forested wetland (PFO1A). Representative photographs of Wetland 1 are included in Appendix B, Photographs 01-05, 12-13, 15, 21-23, 31, and 33-34.

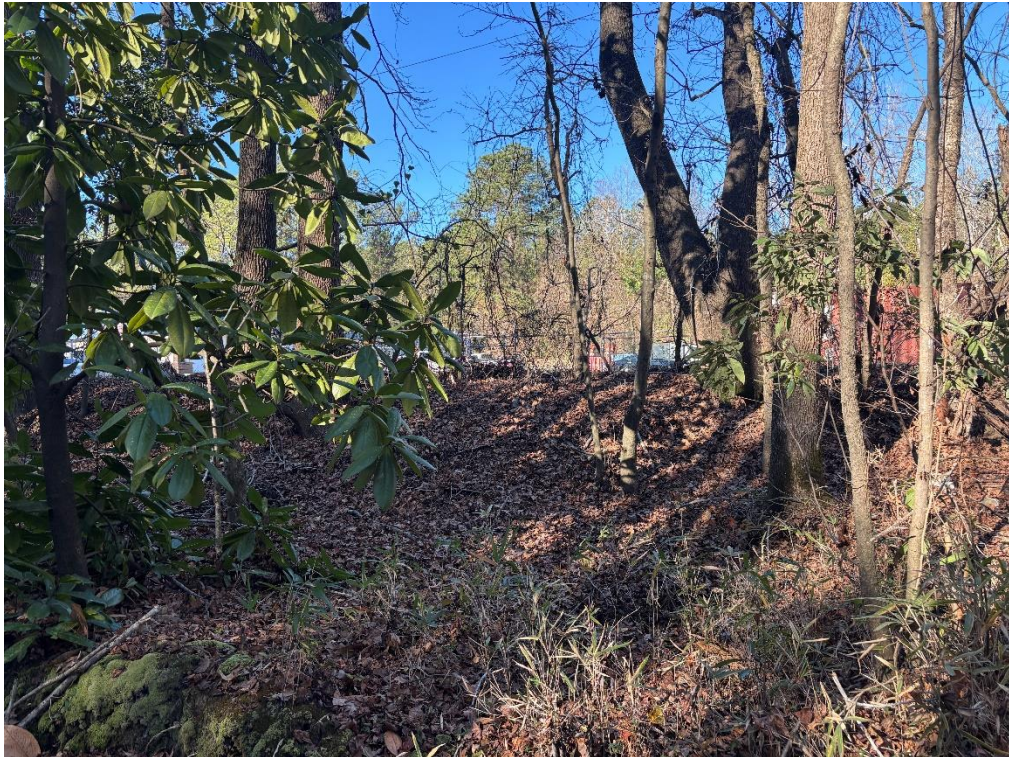
<p>Date: 12/16/2025</p>
	<p>Taken By: Olivia Roach</p>
	<p>Photograph 03</p>
	<p>Description: View of Jurisdictional Wetland 1, facing south towards terraced upland area. Photograph is taken in the NW corner of the study area where Wetland Datapoint 1 was taken.</p>

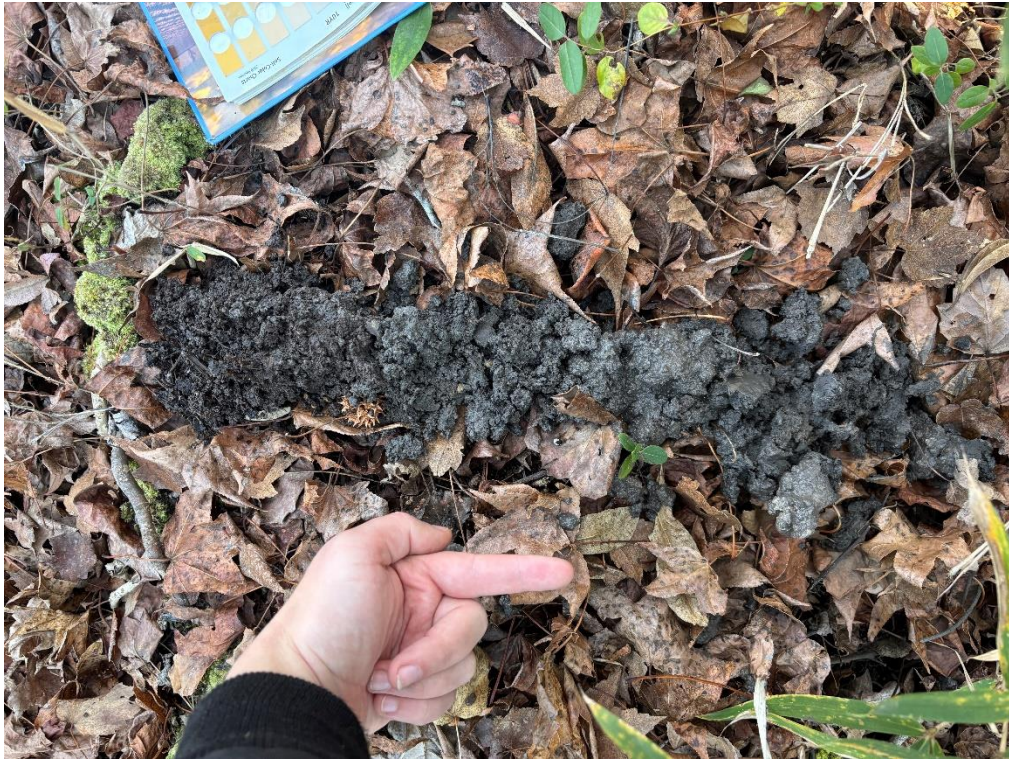
<p>Date: 12/16/2025</p>
	<p>Taken By: Olivia Roach</p>
	<p>Photograph 04</p>
	<p>Description: View of Jurisdictional Wetland 1, facing west towards roadside berm. Photograph is taken in the NW corner of the study area where Wetland Datapoint 1 was taken.</p>

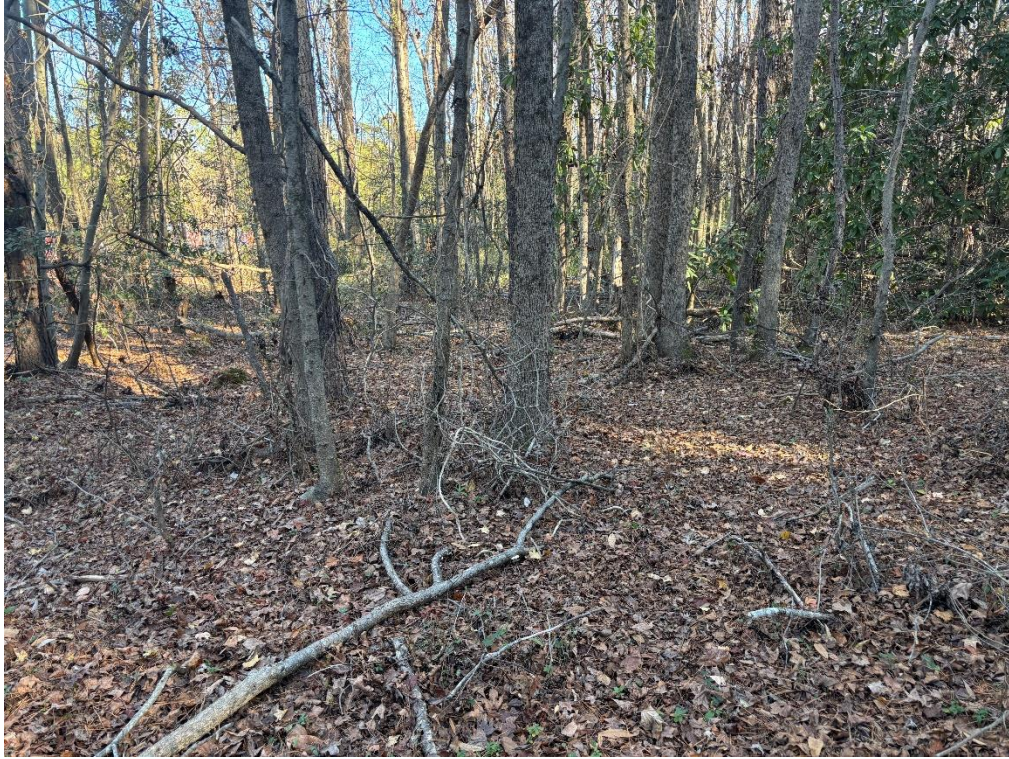
<p>Date: 12/16/2025</p>
	<p>Taken By: Olivia Roach</p>
	<p>Photograph 06</p>
	<p>Description: View of upland area, facing north towards Old Dunbar Road. Photograph is taken in the NW corner of the study area where Upland Datapoint 1 was taken.</p>

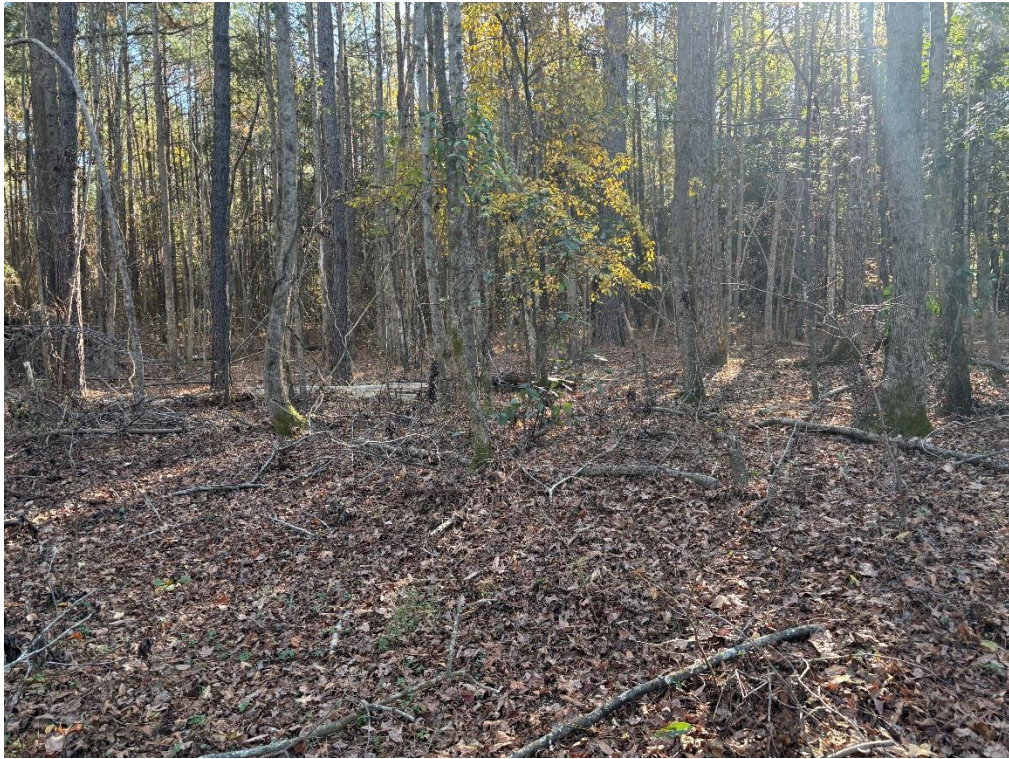
<p>Date: 12/16/2025</p>
	<p>Taken By: Olivia Roach</p>
	<p>Photograph 07</p>
	<p>Description: View of upland area, facing east. Photograph is taken in the NW corner of the study area where Upland Datapoint 1 was taken.</p>

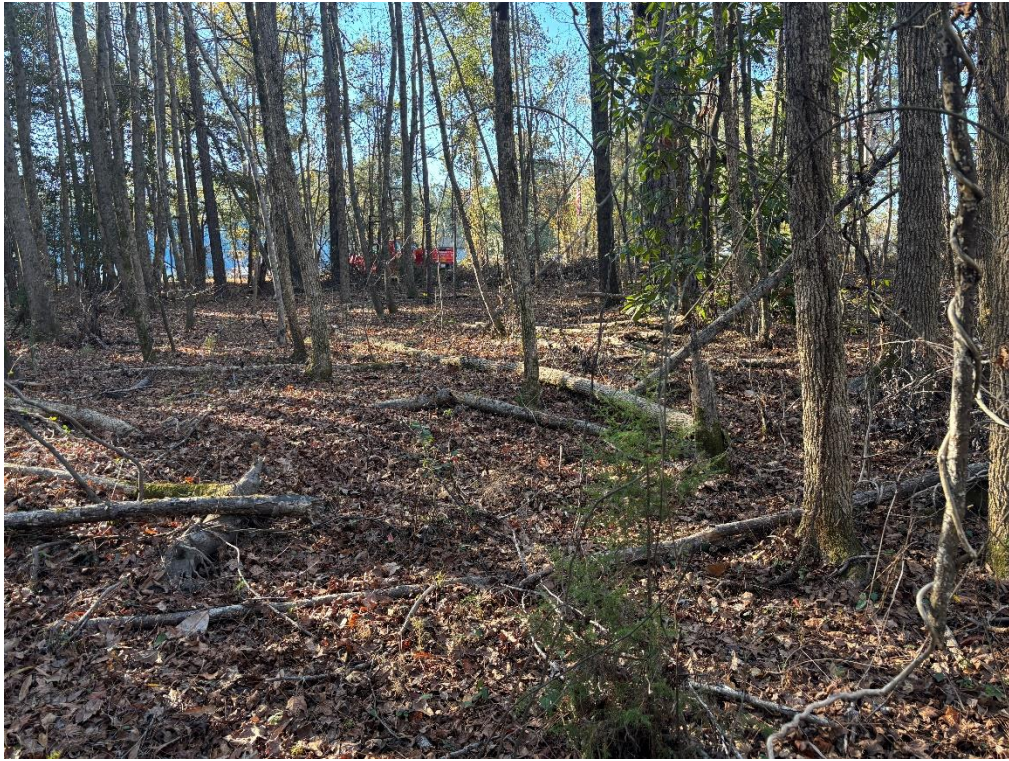
<p>Date: 12/16/2025</p>
	<p>Taken By: Olivia Roach</p>
	<p>Photograph 08</p>
	<p>Description: View of upland area, facing uphill (south). Photograph is taken in the NW corner of the study area where Upland Datapoint 1 was taken.</p>

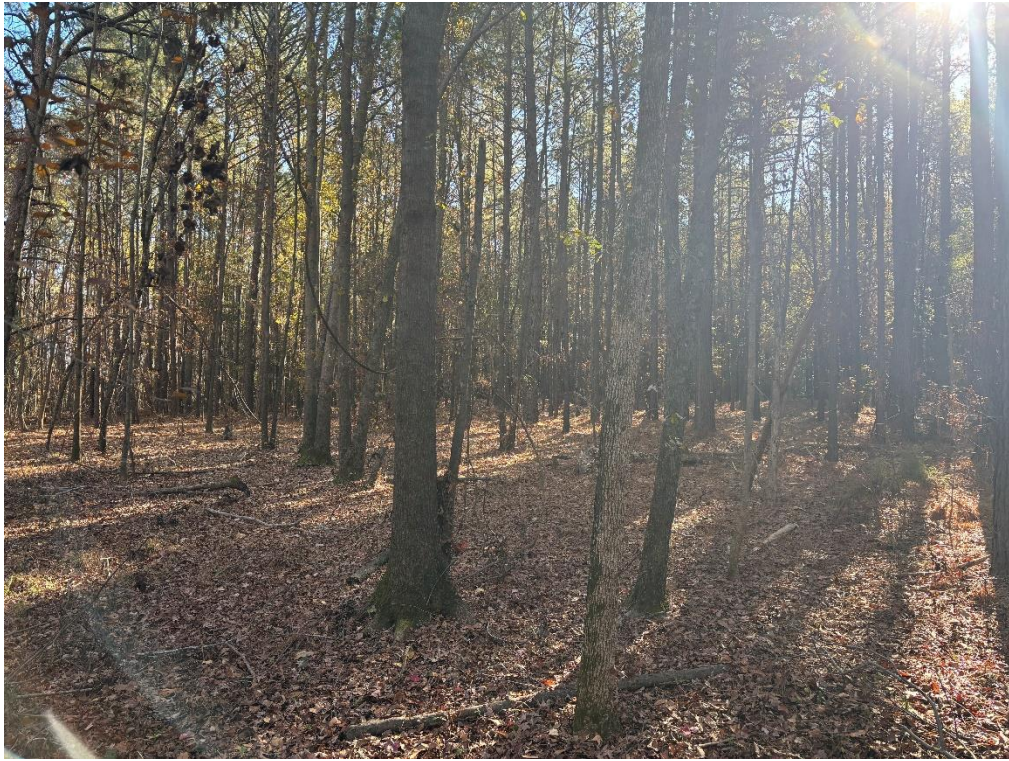
Date: 12/16/2025
	Taken By: Olivia Roach
	Photograph 09
	Description: View of upland area, facing west towards Creekside Road. Photograph is taken in the NW corner of the study area where Upland Datapoint 1 was taken.
 	Date: 12/16/2025
	Taken By: Olivia Roach
	Photograph 10
	Description: View of soil sample at Upland Datapoint 1 in the NW corner of the study area.

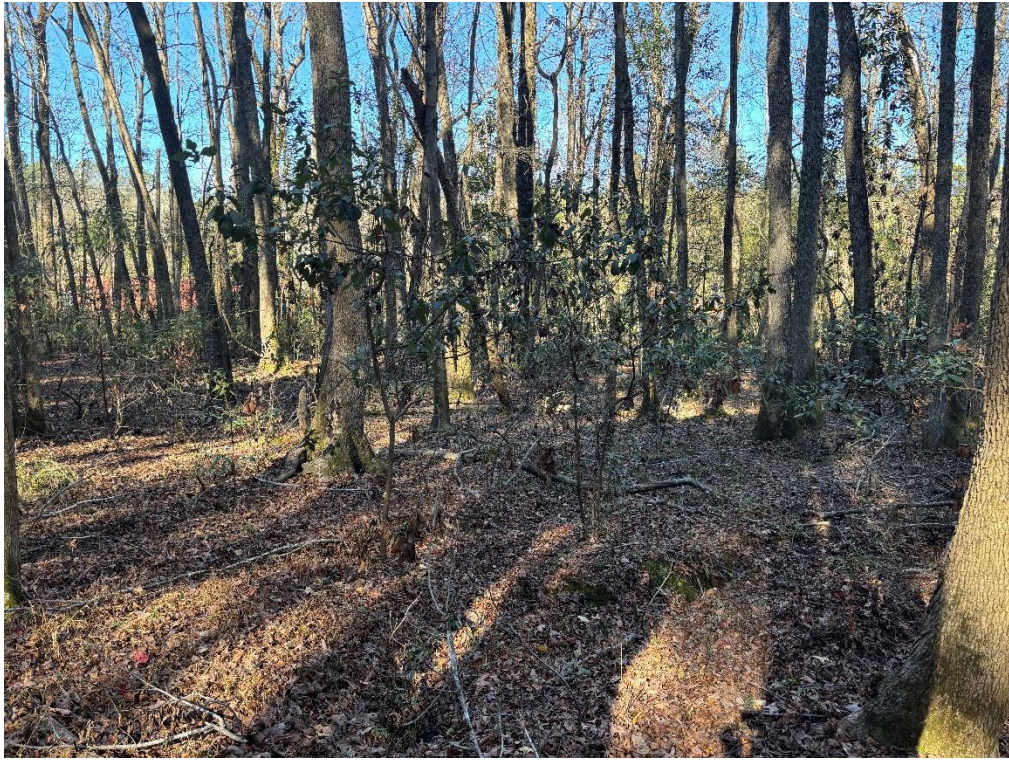
Date: 12/16/2025
	Taken By: Olivia Roach
	Photograph 11
	Description: View of upland area facing south from Jurisdictional Wetland 1 boundary.

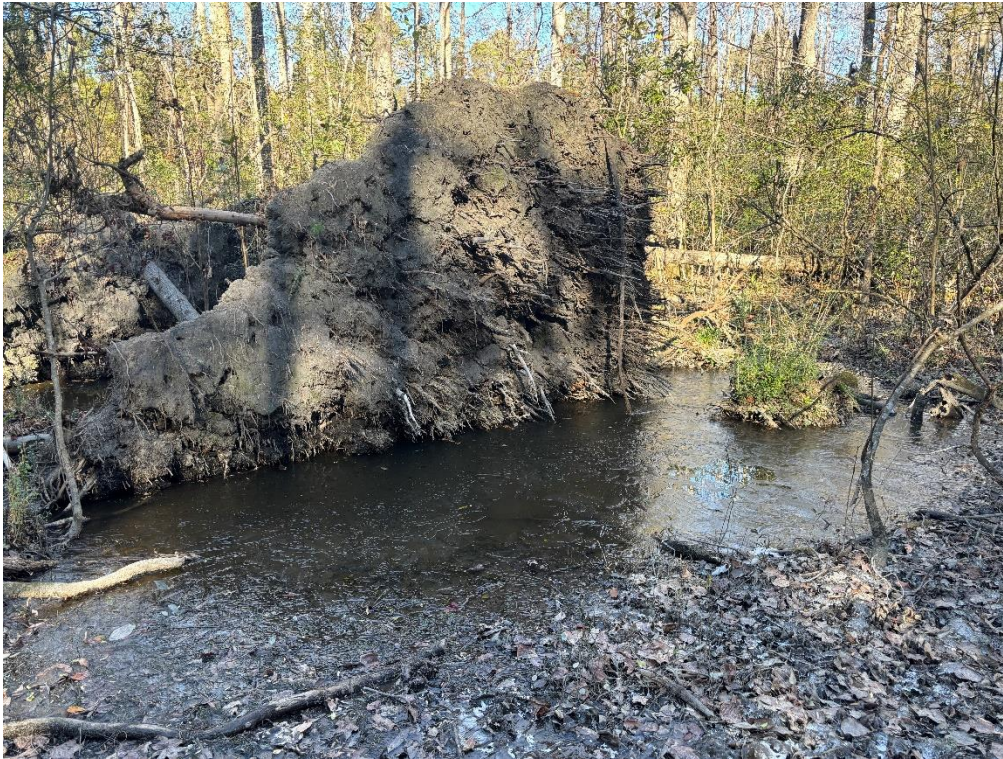
Photograph 13

Description:
View of pooling
water within
Jurisdictional
Wetland 1,
facing north.

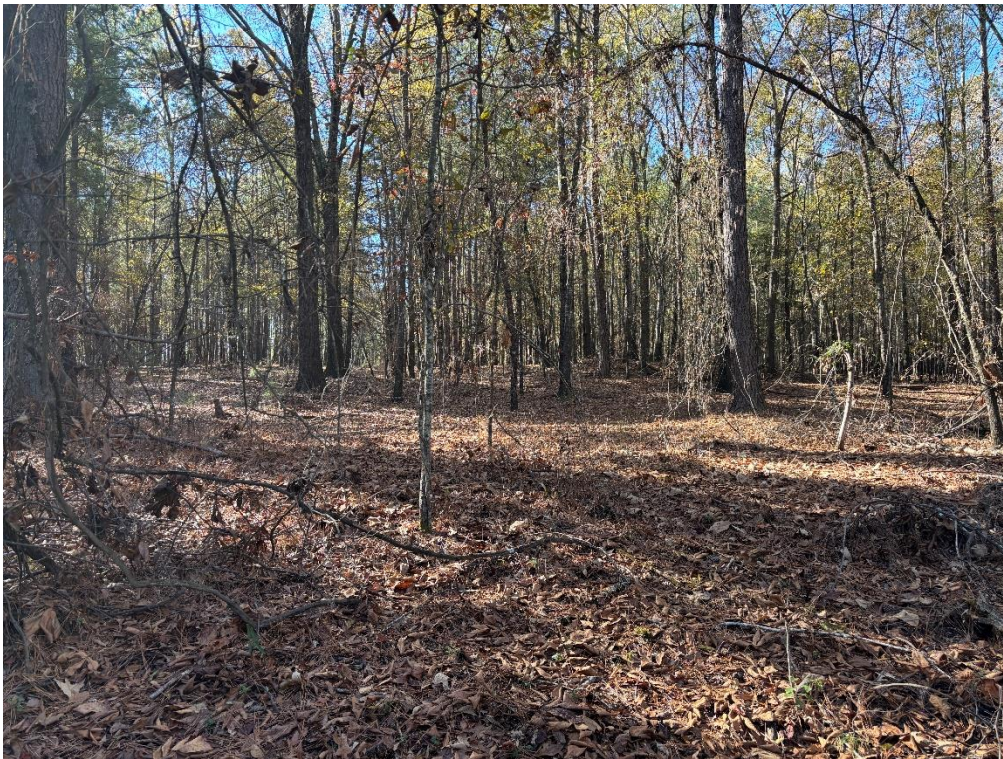
Description:
View of upland
area facing
southwest from
Jurisdictional
Wetland 1
boundary.

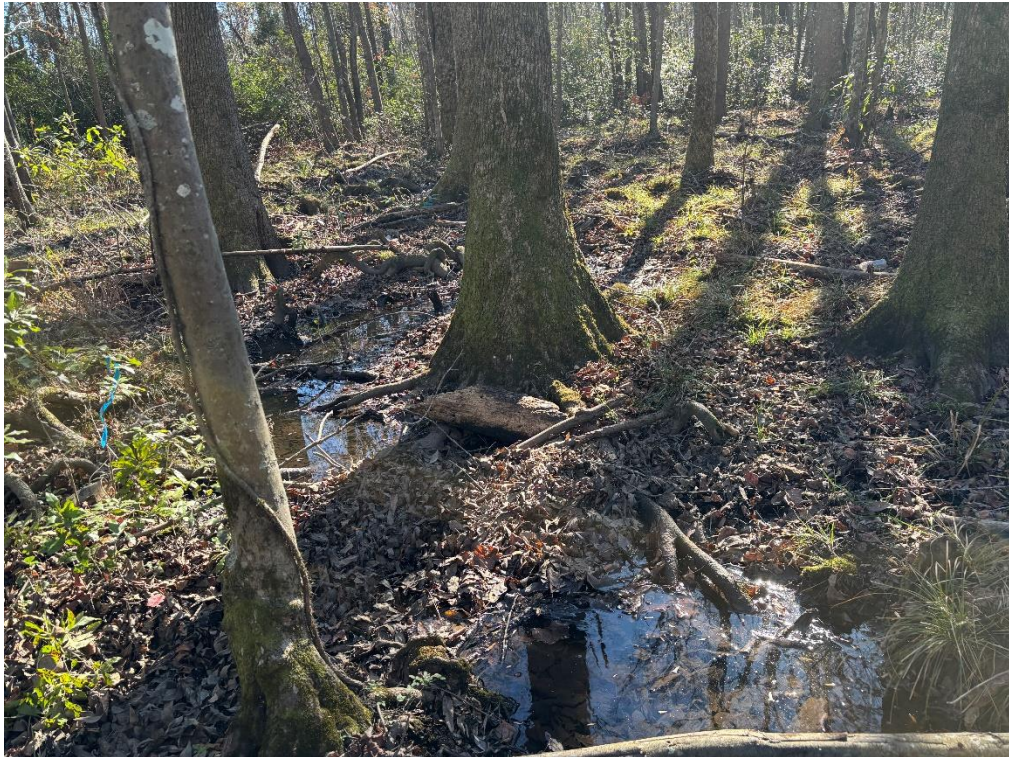
<p>Date: 12/16/2025</p>
	<p>Taken By: Olivia Roach</p>
	<p>Photograph 15</p>
	<p>Description: View of wetland area facing down gradient. Photograph is taken along the boundary of Jurisdictional Wetland 1 facing northeast.</p>
 	<p>Date: 12/16/2025</p>
	<p>Taken By: Olivia Roach</p>
	<p>Photograph 16</p>
	<p>Description: View of Jurisdictional Tributary 1, facing upstream. Photograph is taken near the southeast corner of the study area, facing north.</p>

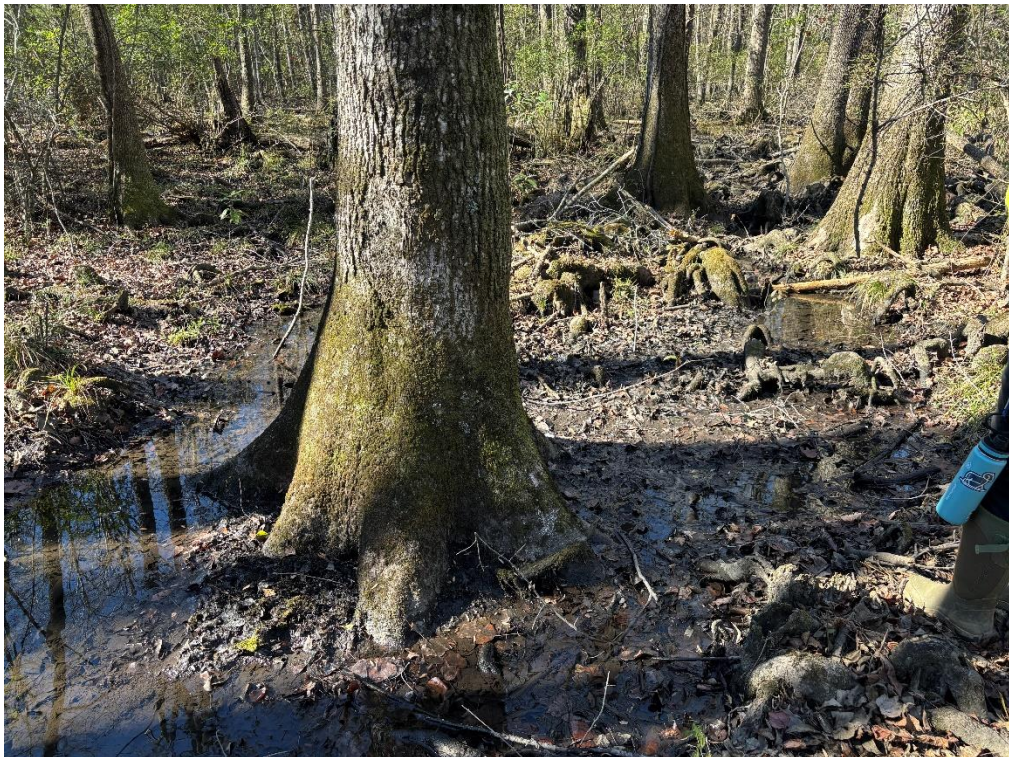
Date: 12/16/2025
	Taken By: Olivia Roach
	Photograph 17
Description: View of Jurisdictional Tributary 1, facing upstream. Photograph is taken near the southeast corner of the study area, facing northwest.

Tributary 1 is an unnamed tributary to Congaree Creek and originates within the PSA as a channelized portion of Wetland 1. Beyond the PSA, Tributary 1 drains southeast into Congaree Creek. Within the PSA, Tributary 1 is approximately 1-12 feet in width. Approximately 1,260 linear feet (0.130 acre) of the water is located within the PSA. During field investigations, the stream channel exhibited low flow, strong sinuosity, and a substrate consisting primarily of silty loam and organic material. Tributary 1 exhibits an ordinary high-water mark, headcuts,

inundation, and semi-aquatic life such as crayfish and amphibians. Exposed, large roots were present within the streambed and bank. Within the PSA, the stream accepts drainage from forested Wetland 1, which concentrates drainage from precipitation, drainage from the neighboring UPS facility, and roadside drainage from Old Dunbar Road. Tributary 1 is depicted on USGS topographic mapping as an intermittent stream. Representative photographs of Tributary 1 are included in Appendix B, Photographs 16-20, 22, 24-29.

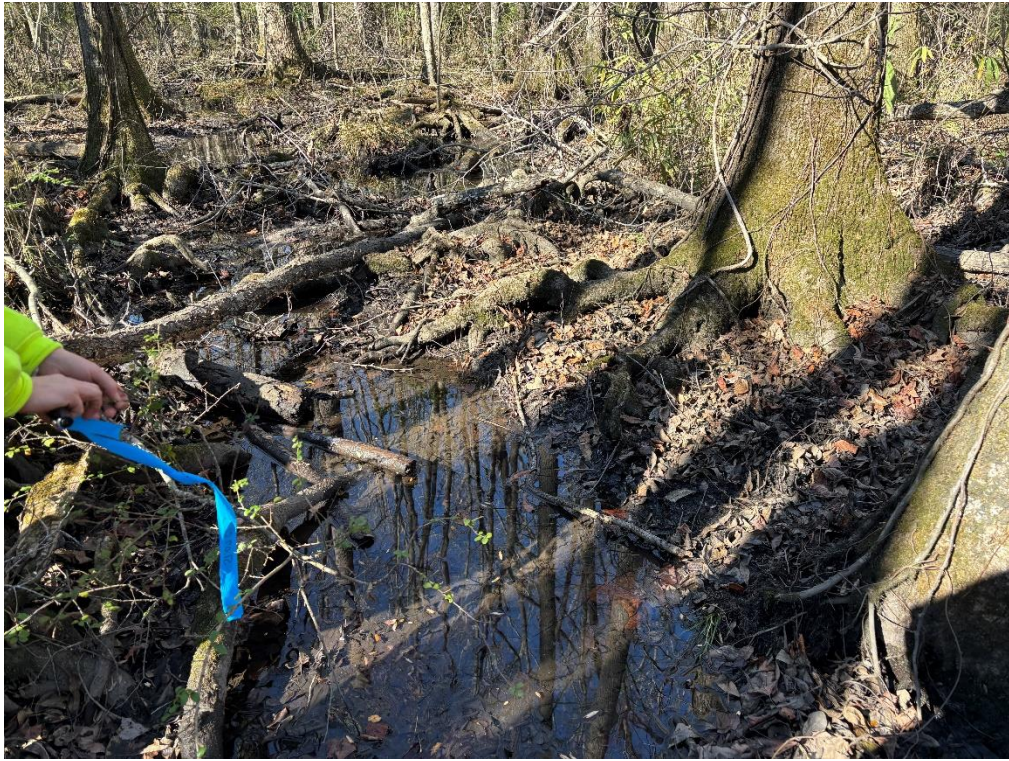
Date: 12/16/2025
	Taken By: Olivia Roach
	Photograph 18
Description: View of Jurisdictional Tributary 1, facing downstream. Photograph is taken near the southeast corner of the study area, facing southeast.

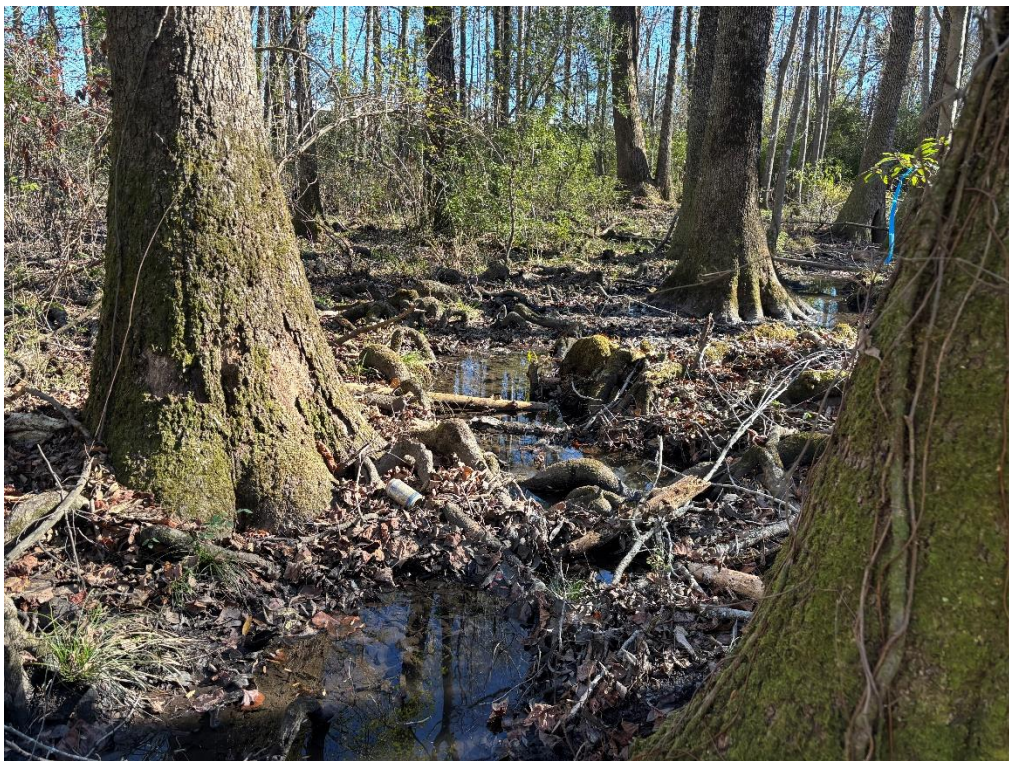
<p>Date: 12/16/2025</p>
	<p>Taken By: Olivia Roach</p>
	<p>Photograph 19</p>
	<p>Description: View of Jurisdictional Tributary 1, facing upstream. Photograph is taken near the southeast corner of the study area, facing northwest.</p>

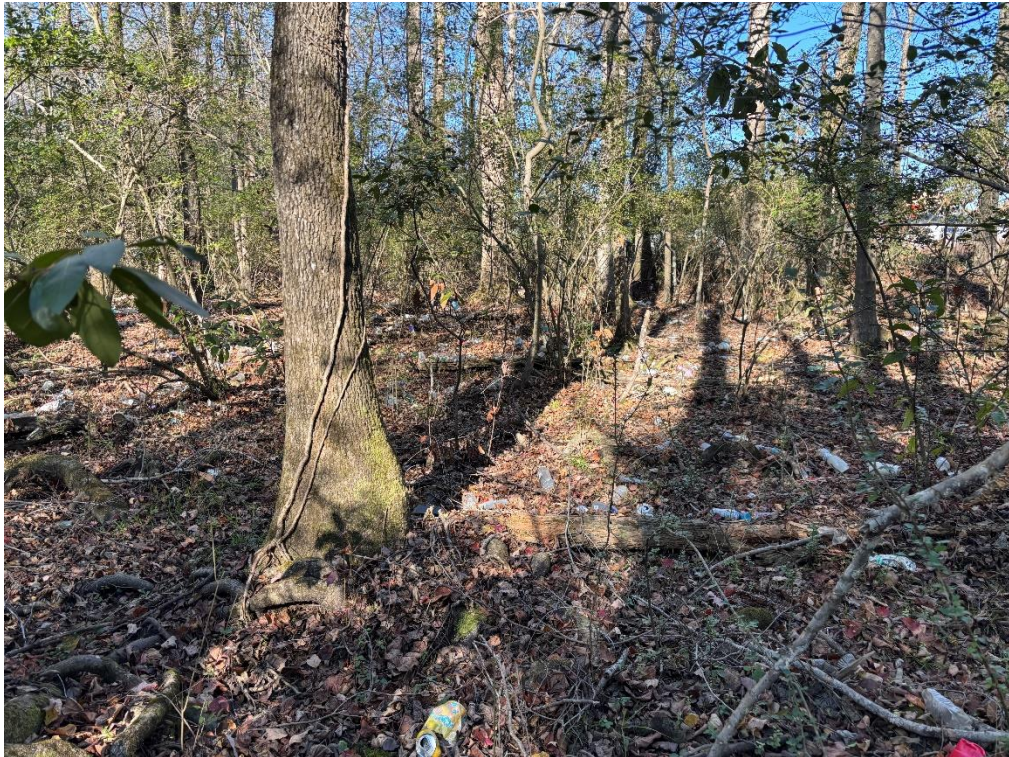
<p>Date: 12/16/2025</p>
	<p>Taken By: Olivia Roach</p>
	<p>Photograph 20</p>
	<p>Description: View of Jurisdictional Tributary 1, facing downstream. Photograph is taken near the southeast corner of the study area, facing southeast.</p>

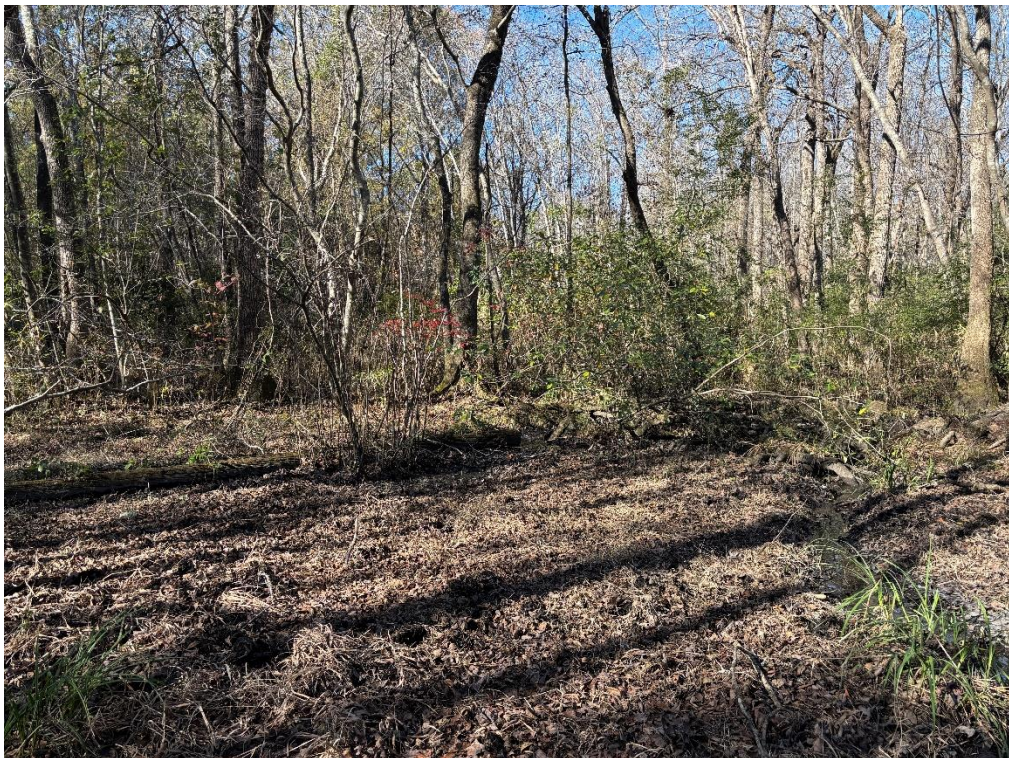
<p>Date: 12/16/2025</p>
	<p>Taken By: Olivia Roach</p>
	<p>Photograph 21</p>
	<p>Description: View of debris within Jurisdictional Wetland 1, facing up gradient. Photograph is taken along the eastern boundary of the wetland near UPS, facing north.</p>

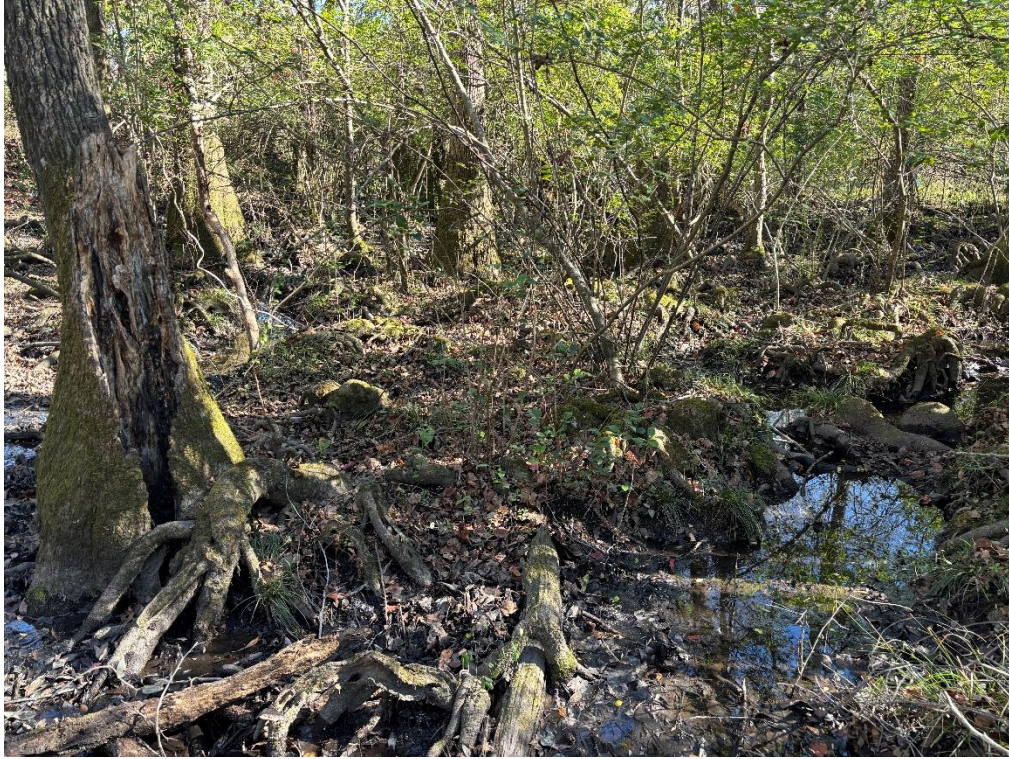
Date: 12/16/2025
	Taken By: Olivia Roach
	Photograph 23
	Description: View of Jurisdictional Tributary 2, within Jurisdictional Wetland 1, facing northeast. Photograph is taken at the confluence of Tributaries 1 and 2.
 	Date: 12/16/2025
	Taken By: Olivia Roach
	Photograph 24
	Description: View of Jurisdictional Tributary 1, facing upstream. Photograph is taken near the northeast boundary of the study area, facing northwest.

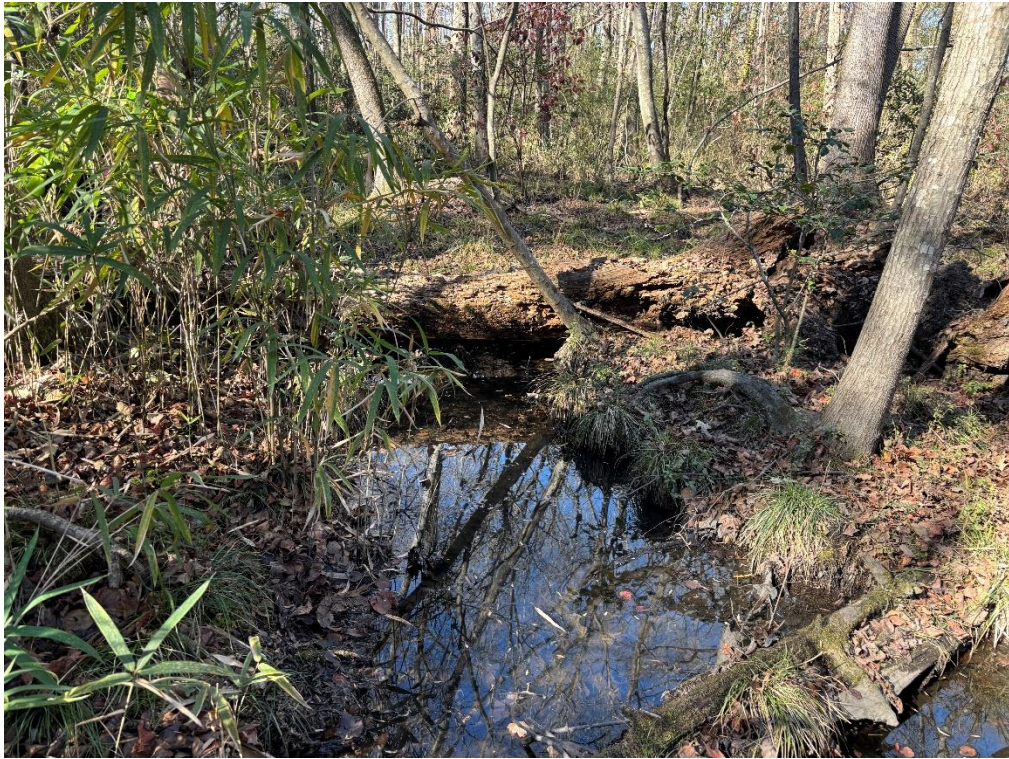
<p>Date: 12/16/2025</p>
	<p>Taken By: Olivia Roach</p>
	<p>Photograph 25</p>
	<p>Description: View of Jurisdictional Tributary 1, facing downstream. Photograph is taken near the northeast boundary of the study area, facing southeast.</p>

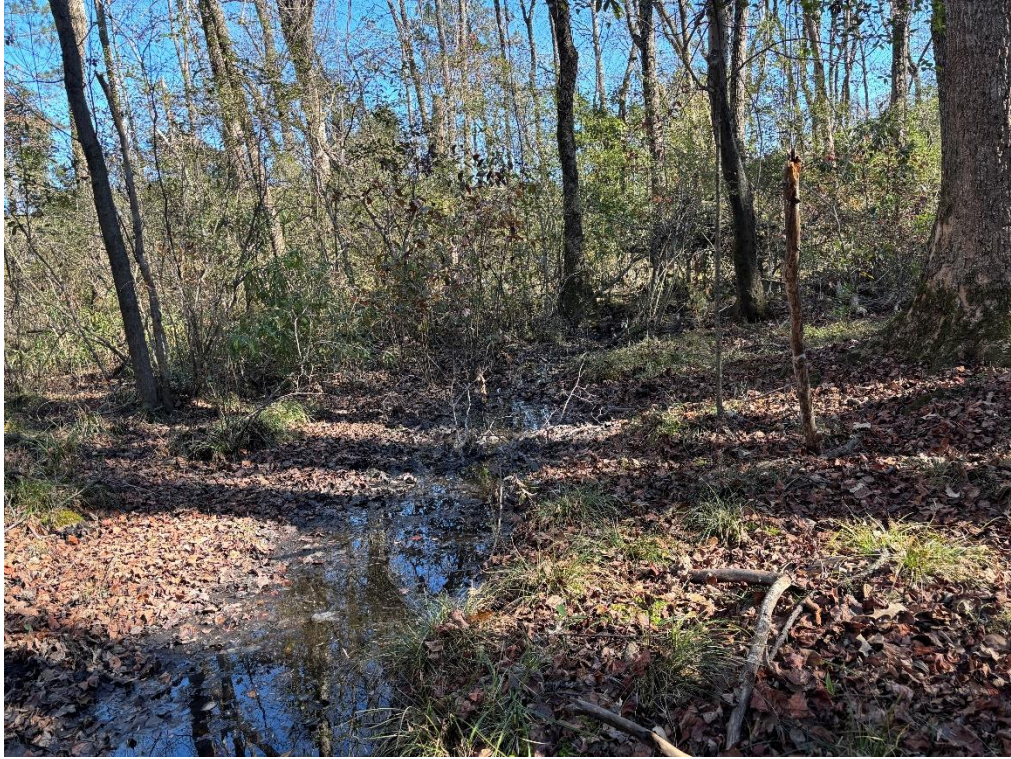
<p>Date: 12/16/2025</p>
	<p>Taken By: Olivia Roach</p>
	<p>Photograph 26</p>
	<p>Description: View of Jurisdictional Tributary 1, facing upstream. Photograph is taken within the north central portion of the study area, facing northwest.</p>
