Waters of the U.S. Memo

Lexington County Parcel

TMS# 6896-03-040

December 2025

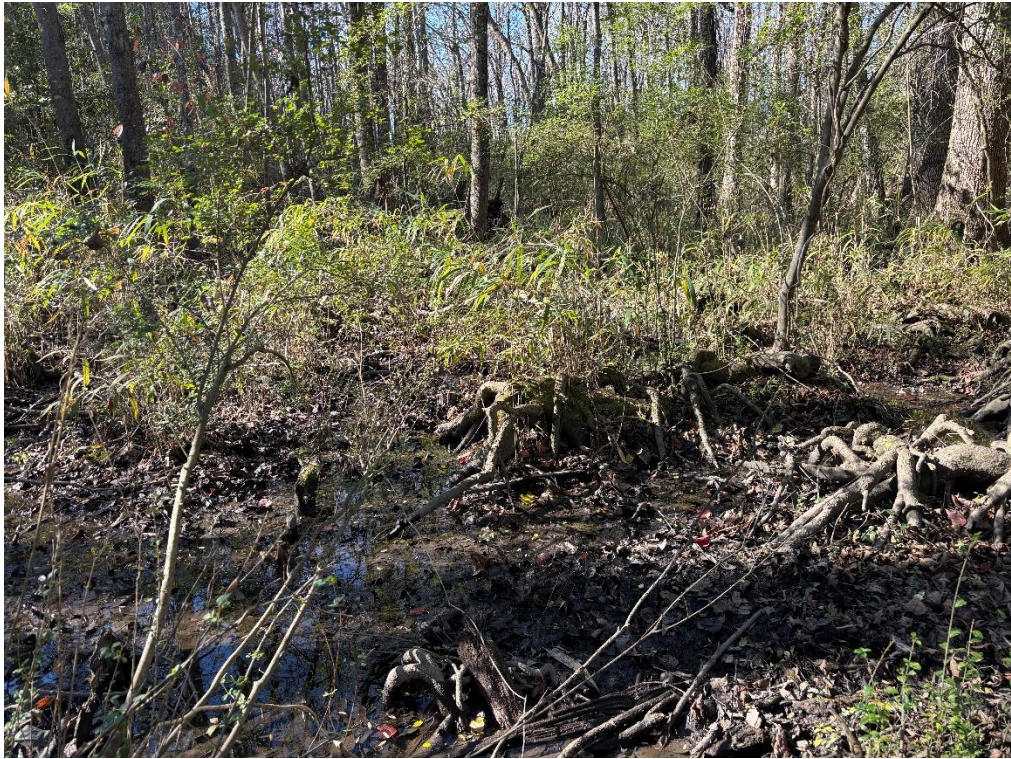
<p>Date: 12/16/2025</p>
	<p>Taken By: Olivia Roach</p>
	<p>Photograph 27</p>
	<p>Description: View of Jurisdictional Tributary 1, facing downstream. Photograph is taken within the north central portion of the study area, facing southeast.</p>

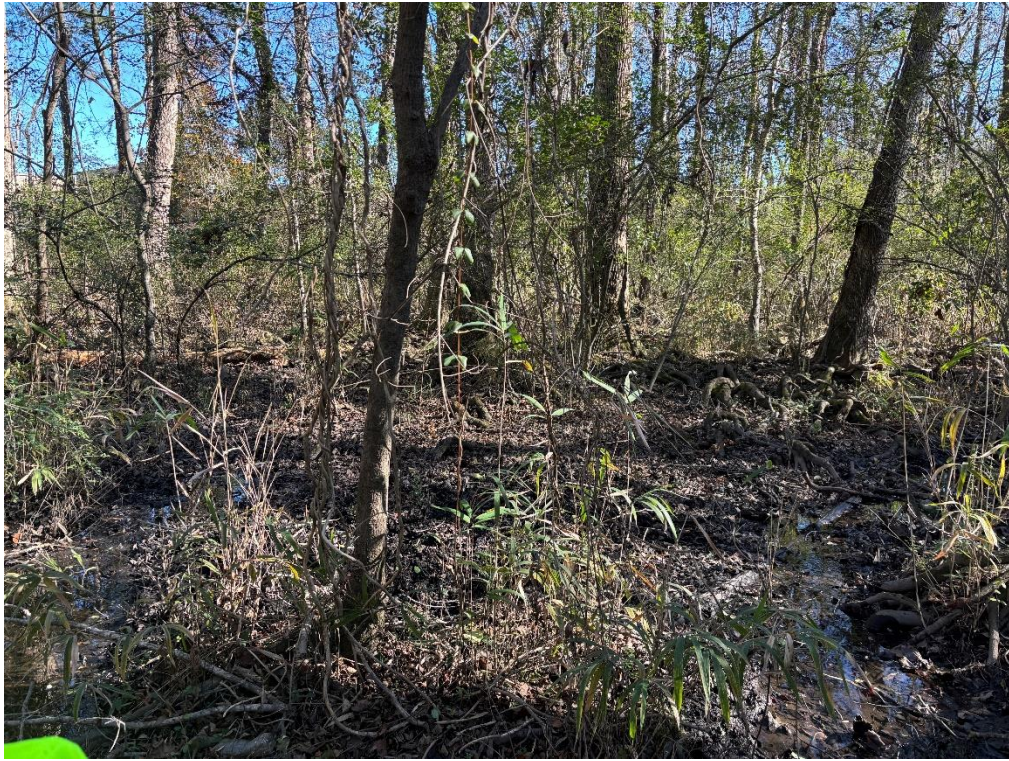
<p>Date: 12/16/2025</p>
	<p>Taken By: Olivia Roach</p>
	<p>Photograph 28</p>
	<p>Description: View of Jurisdictional Tributary 1, facing upstream. Photograph is taken where Jurisdictional Tributaries 1 and 2 diverge in the northern portion of the study area.</p>

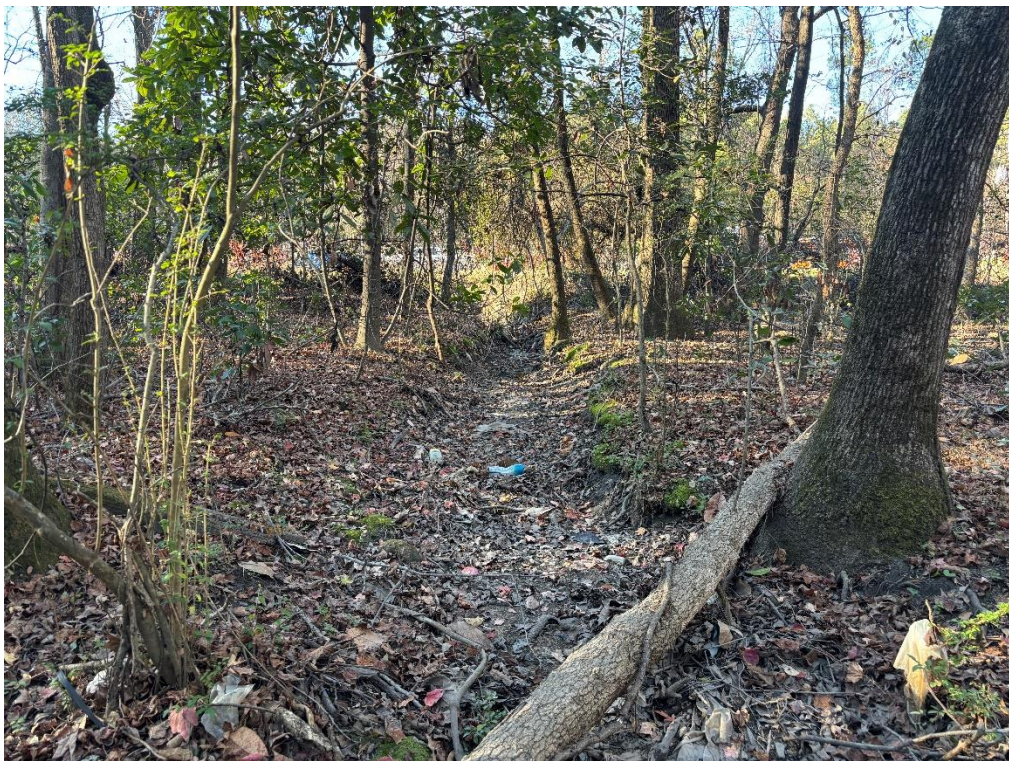
<p>Date: 12/16/2025</p>
	<p>Taken By: Olivia Roach</p>
	<p>Photograph 29</p>
	<p>Description: View of Jurisdictional Tributaries 1 & 2, facing downstream. Photograph is taken where Jurisdictional Tributaries 1 and 2 diverge in the northern portion of the study area.</p>

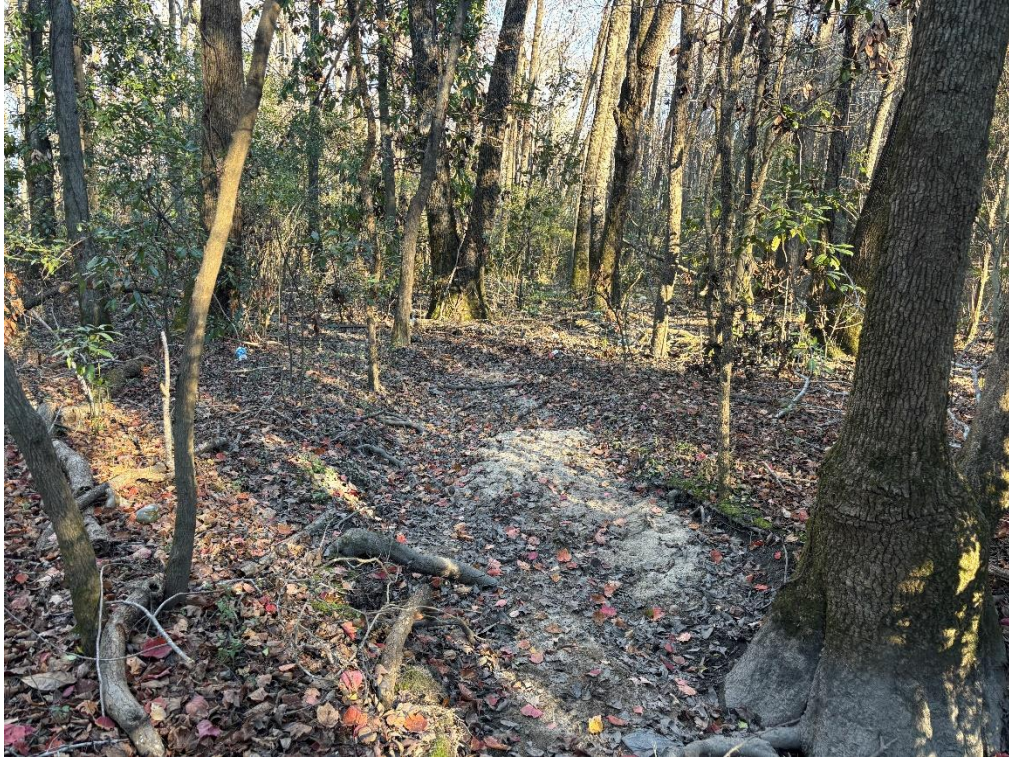
<p>Date: 12/16/2025</p>
	<p>Taken By: Olivia Roach</p>
	<p>Photograph 30</p>
	<p>Description: View of excavated Non-jurisdictional Linear Feature 1 (Ditch). Photograph is taken at the terminus of the feature within Jurisdictional Wetland 1, facing northwest.</p>

Non-Jurisdictional Linear Feature 1 (Ditch) was identified as a linear conveyance for the purpose of roadside drainage and stormwater retention. Ditch 1 appeared to receive drainage from an offsite culvert along Old Dunbar Road, which receives water from drainage ditches on the north side of the road. Within the PSA, approximately 56 linear feet of the ditch is located within the PSA. During field investigations, the stream channel was observed to be dry and did not exhibit an ordinary high-water mark. At its terminus, the ditch appeared to convert to sheet flow into Wetland 1. Representative photographs of Ditch 1 are included in Appendix B, Photographs 30-31.

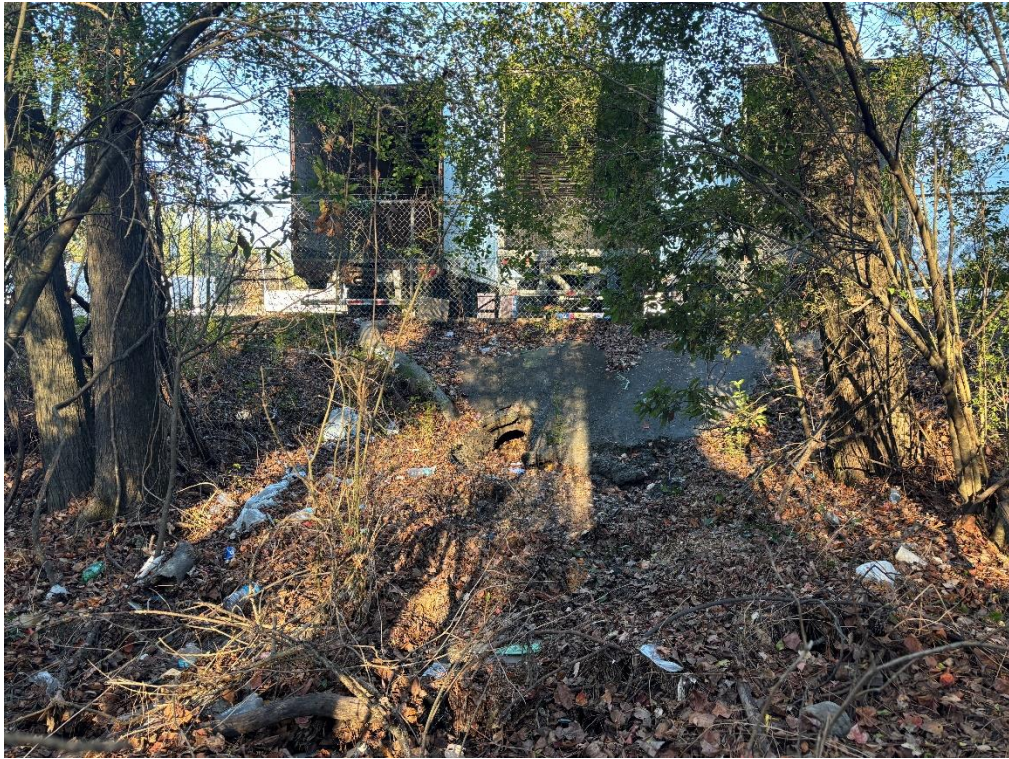
<p>Date: 12/16/2025</p>
	<p>Taken By: Olivia Roach</p>
	<p>Photograph 31</p>
	<p>Description: View of excavated Non-jurisdictional Linear Feature 1 (Ditch) continuing as sheet flow into Jurisdictional Wetland 1, facing southeast.</p>

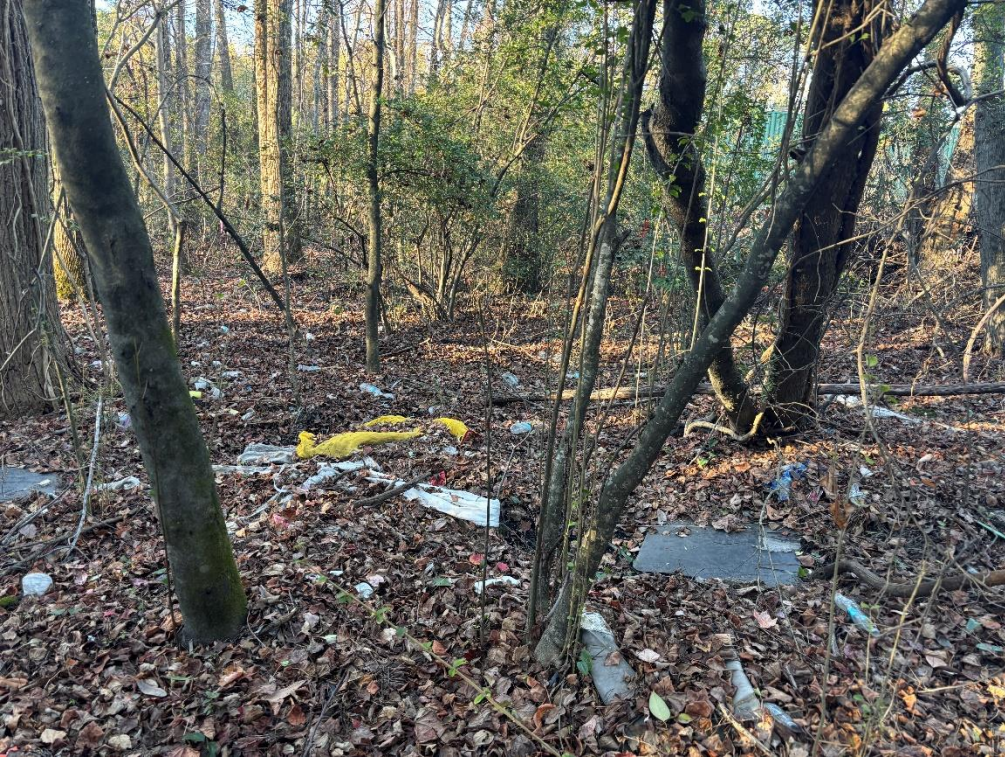
<p>Date: 12/16/2025</p>
	<p>Taken By: Olivia Roach</p>
	<p>Photograph 32</p>
	<p>Description: View of culvert outlet from UPS property. Photograph is taken facing northeast.</p>

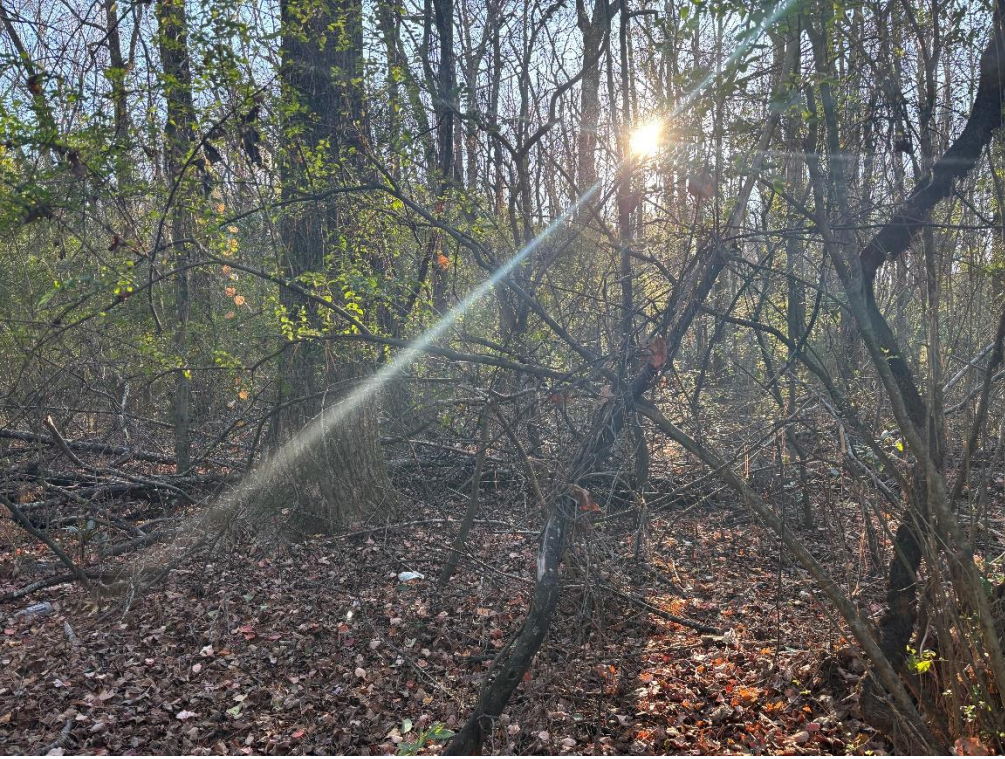
Date: 12/16/2025
	Taken By: Olivia Roach
	Photograph 33
Description: View of debris and drainage patterns within Jurisdictional Wetland 1, facing southwest. Photograph is taken near the UPS facility to the northeast.

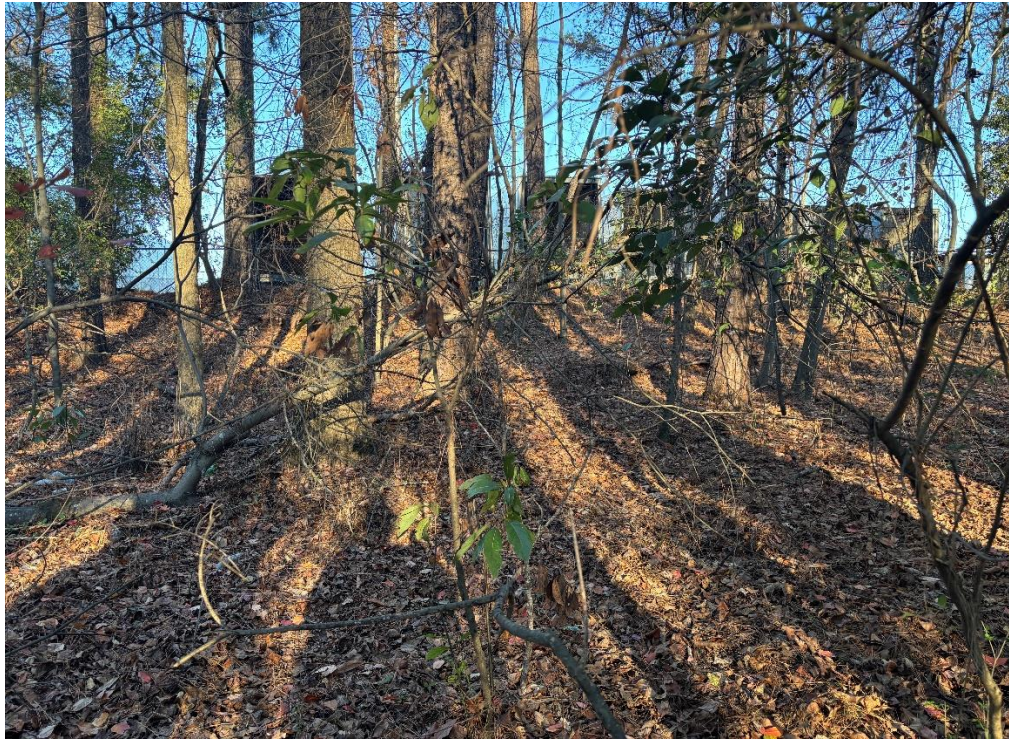
Date: 12/16/2025
	Taken By: Olivia Roach
	Photograph 34
Description: View of Jurisdictional Wetland 1, facing southwest from study area boundary. Photograph is taken facing down gradient.

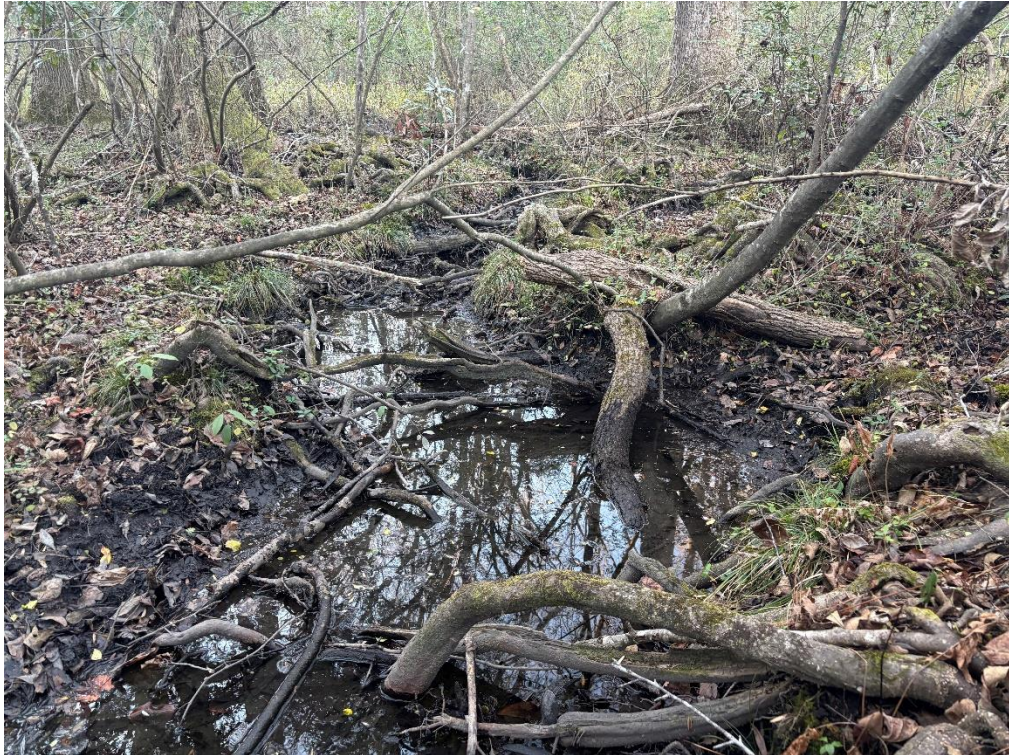
<p>Date: 12/16/2025</p>
	<p>Taken By: Olivia Roach</p>
	<p>Photograph 35</p>
	<p>Description: View of upland area, facing up gradient towards UPS facility to the northeast.</p>
