Phase I Environmental Site Assessment

Harlingen Undeveloped Land

1335 West Memphis Street

September 14, 2023 | Terracon Project No. 88237264

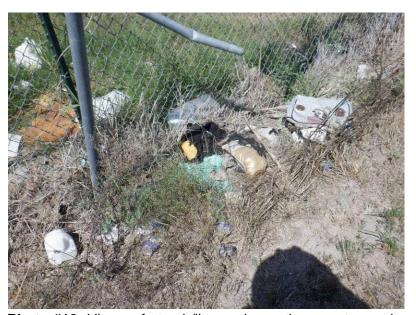
During the site reconnaissance, Terracon observed various trash/debris accumulated on the fence line along the western site boundary. Terracon recommends removing and properly disposing of the trash/debris off-site. The trash and debris does not represent a REC to the site.

Photo #12 View of trash/litter along the western site boundary fence line.

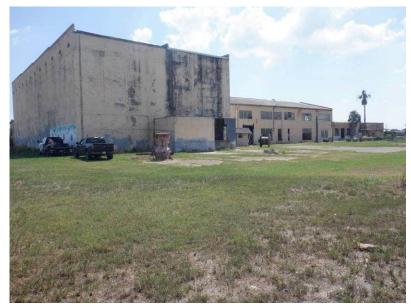
Adjoining properties to the north consist of an electric power substation. Southern adjoining properties consist of a vacant former ice manufacturing facility. Eastern adjoining properties consist of railroad track followed by North Commerce Street. Western adjoining properties consist of residential properties. Indications of RECs were not observed from site boundaries in connection with the adjoining properties.

Photo #13 View of the vacant former ice plant located adjacent south of site.

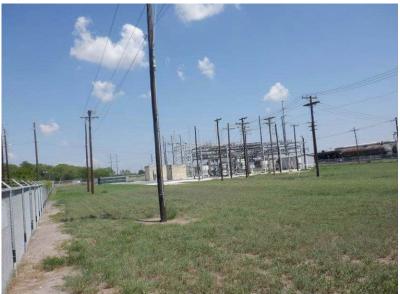
Photo #15 View of the electric power substation located adjacent north of site.

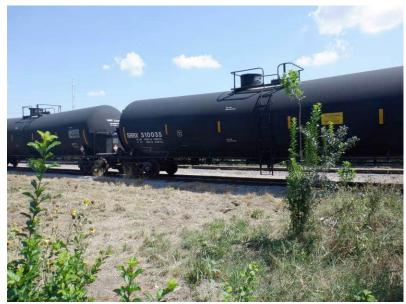
Photo #16 View of railroad tracks located adjacent east of site.
