Re: Preliminary Stream and Wetlands Survey  
Undeveloped Land  
Mulberry Road  
Harrisburg, North Carolina  
H&H Job No.TCD-007

**1.0 Introduction**

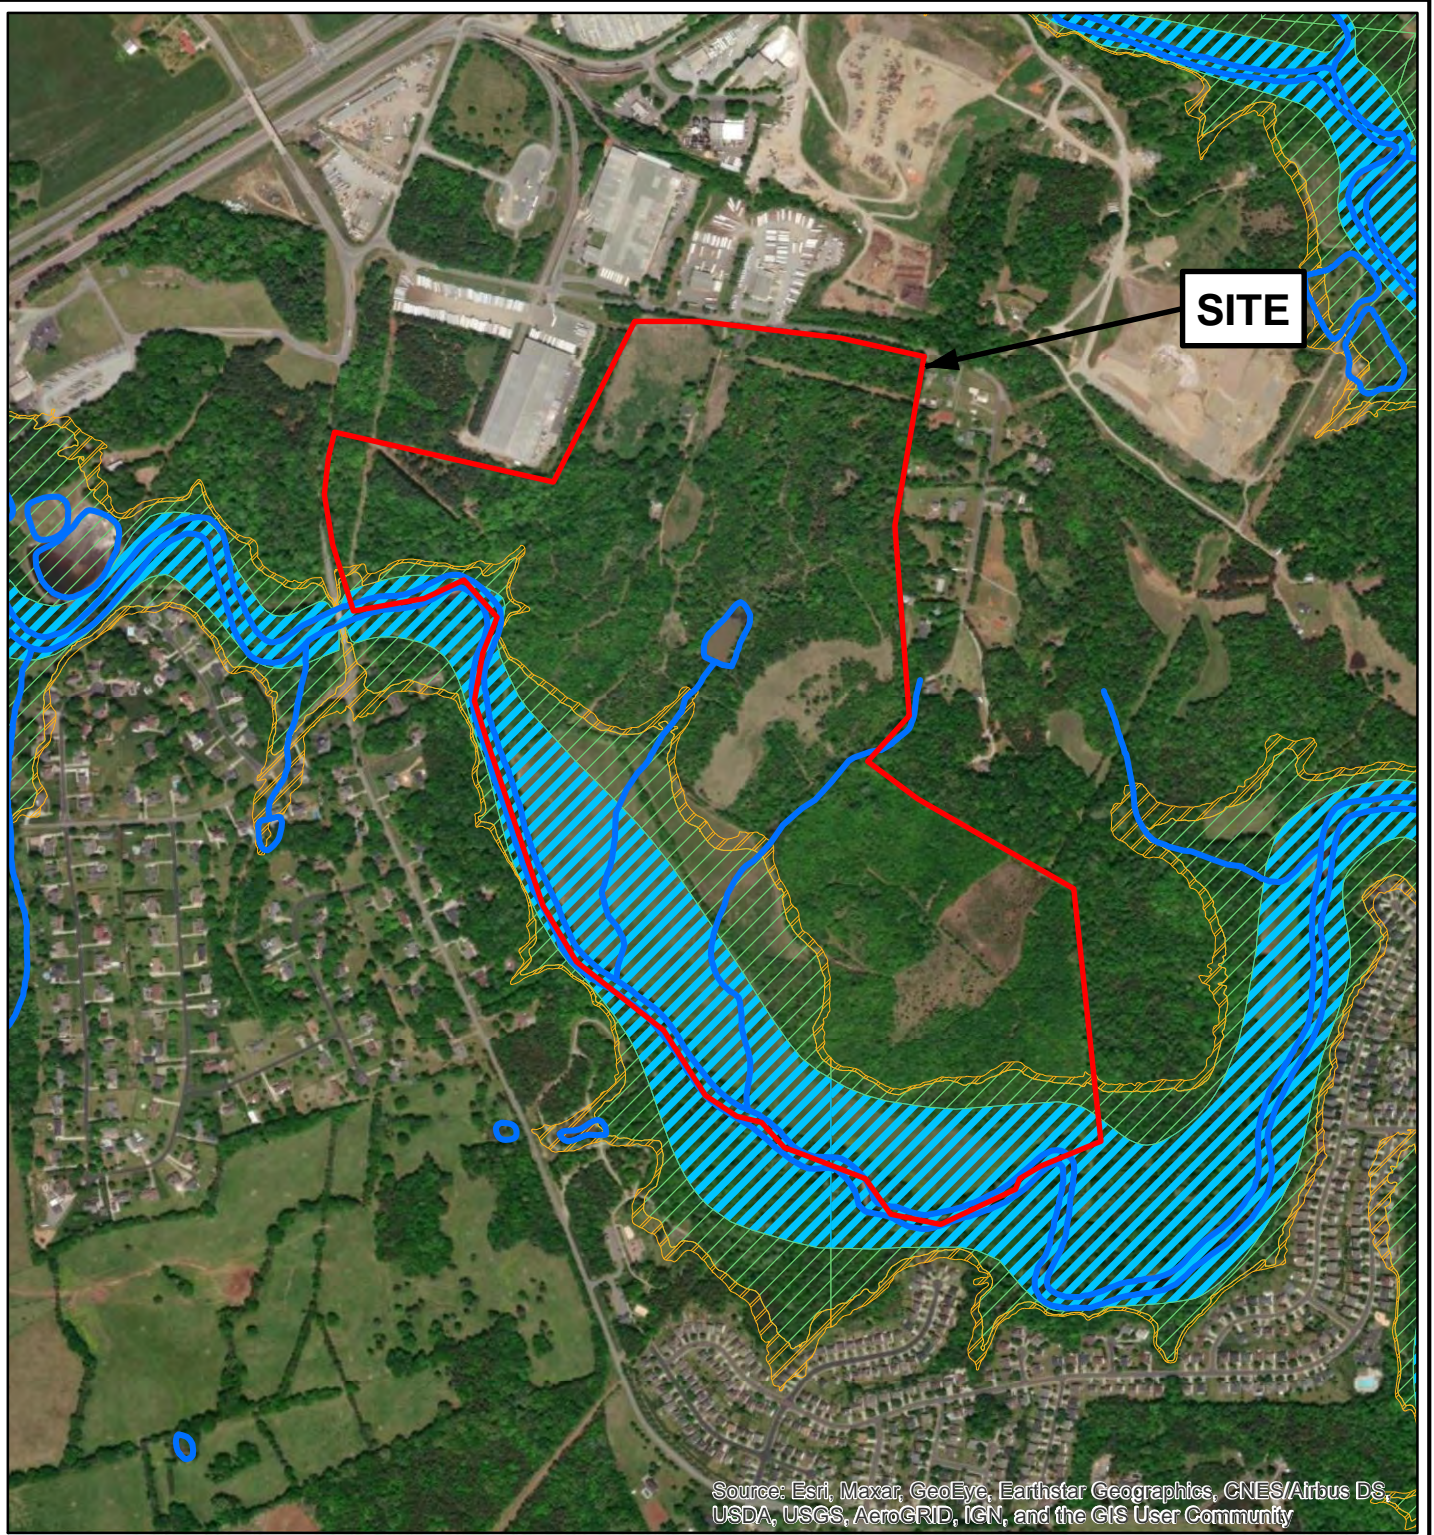
2923 South Tryon Street - Suite 100 Charlotte, North Carolina 28203 704-586-0007 (p) 704-586-0373 (f) License # C-1269 / # C-245 Geology	
DATE: 11/16/2022		REVISION NO: 0	
JOB NO: TCD-007		FIGURE NO: A1

H&H reviewed the Cabarrus County GIS website to determine if surface water bodies or floodplains are depicted on the subject Site. The Cabarrus County GIS website depicts Rocky River as generally forming the Site's southwestern and southern boundaries. The website also depicts a stream channel draining from a dammed pond in the central portion of the Site along with an additional stream channel in the east-central portion of the Site. The Cabarrus County GIS website also depicts the regulatory floodway, and the 100- and 500-year floodplains of Rocky River in the southwestern and southern portions of the Site.

TITLE		<b>CABARRUS COUNTY GIS MAP</b>	
PROJECT		UNDEVELOPED LAND MULBERRY ROAD HARRISBURG, NORTH CAROLINA

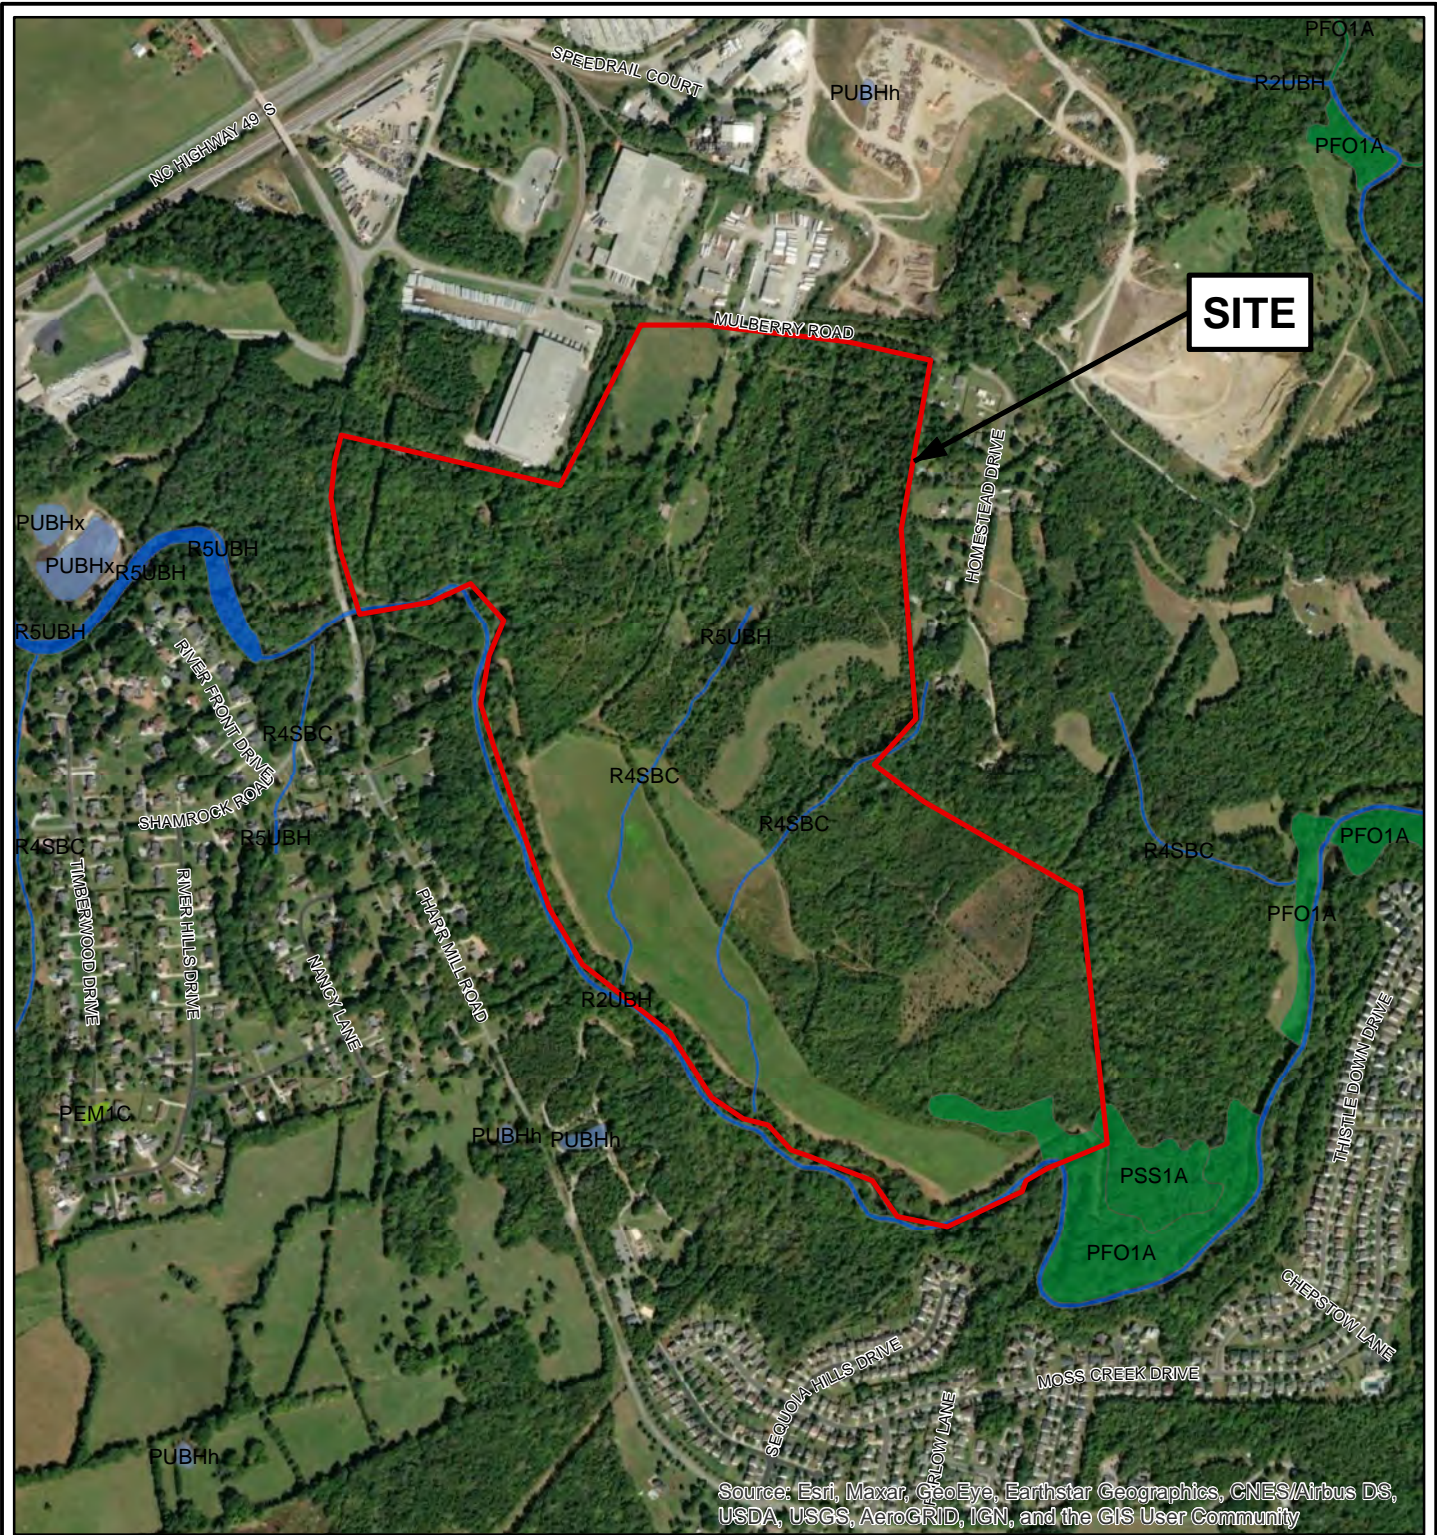
H&H reviewed the NWI map for potential jurisdictional wetlands and surface waters located on the Site. The NWI map depicts Rocky River as generally forming the Site's southwestern and southern boundaries. NWI classifies Rocky River as R2UBH, which is defined as a lower perennial riverine system with an unconsolidated bottom that is permanently flooded. The NWI map also depicts a stream feature in the central portion of the Site, and classifies the upgradient portion as R5UBH and the downgradient portion as R4SBC. R5UBH is defined as an unknown perennial riverine system with an unconsolidated bottom that is permanently flooded. R4SBC is

defined as an intermittent riverine system with a streambed bottom that is seasonally flooded. An additional stream feature is depicted in the east-central portion of the Site and is also classified by NWI as R4SBC. The NWI map also depicts a wetland feature in the southeastern portion of the Site. NWI classifies the wetland area as PFO1A, which is defined as a forested palustrine system that is dominated by broad-leaved deciduous vegetation and is temporarily flooded.

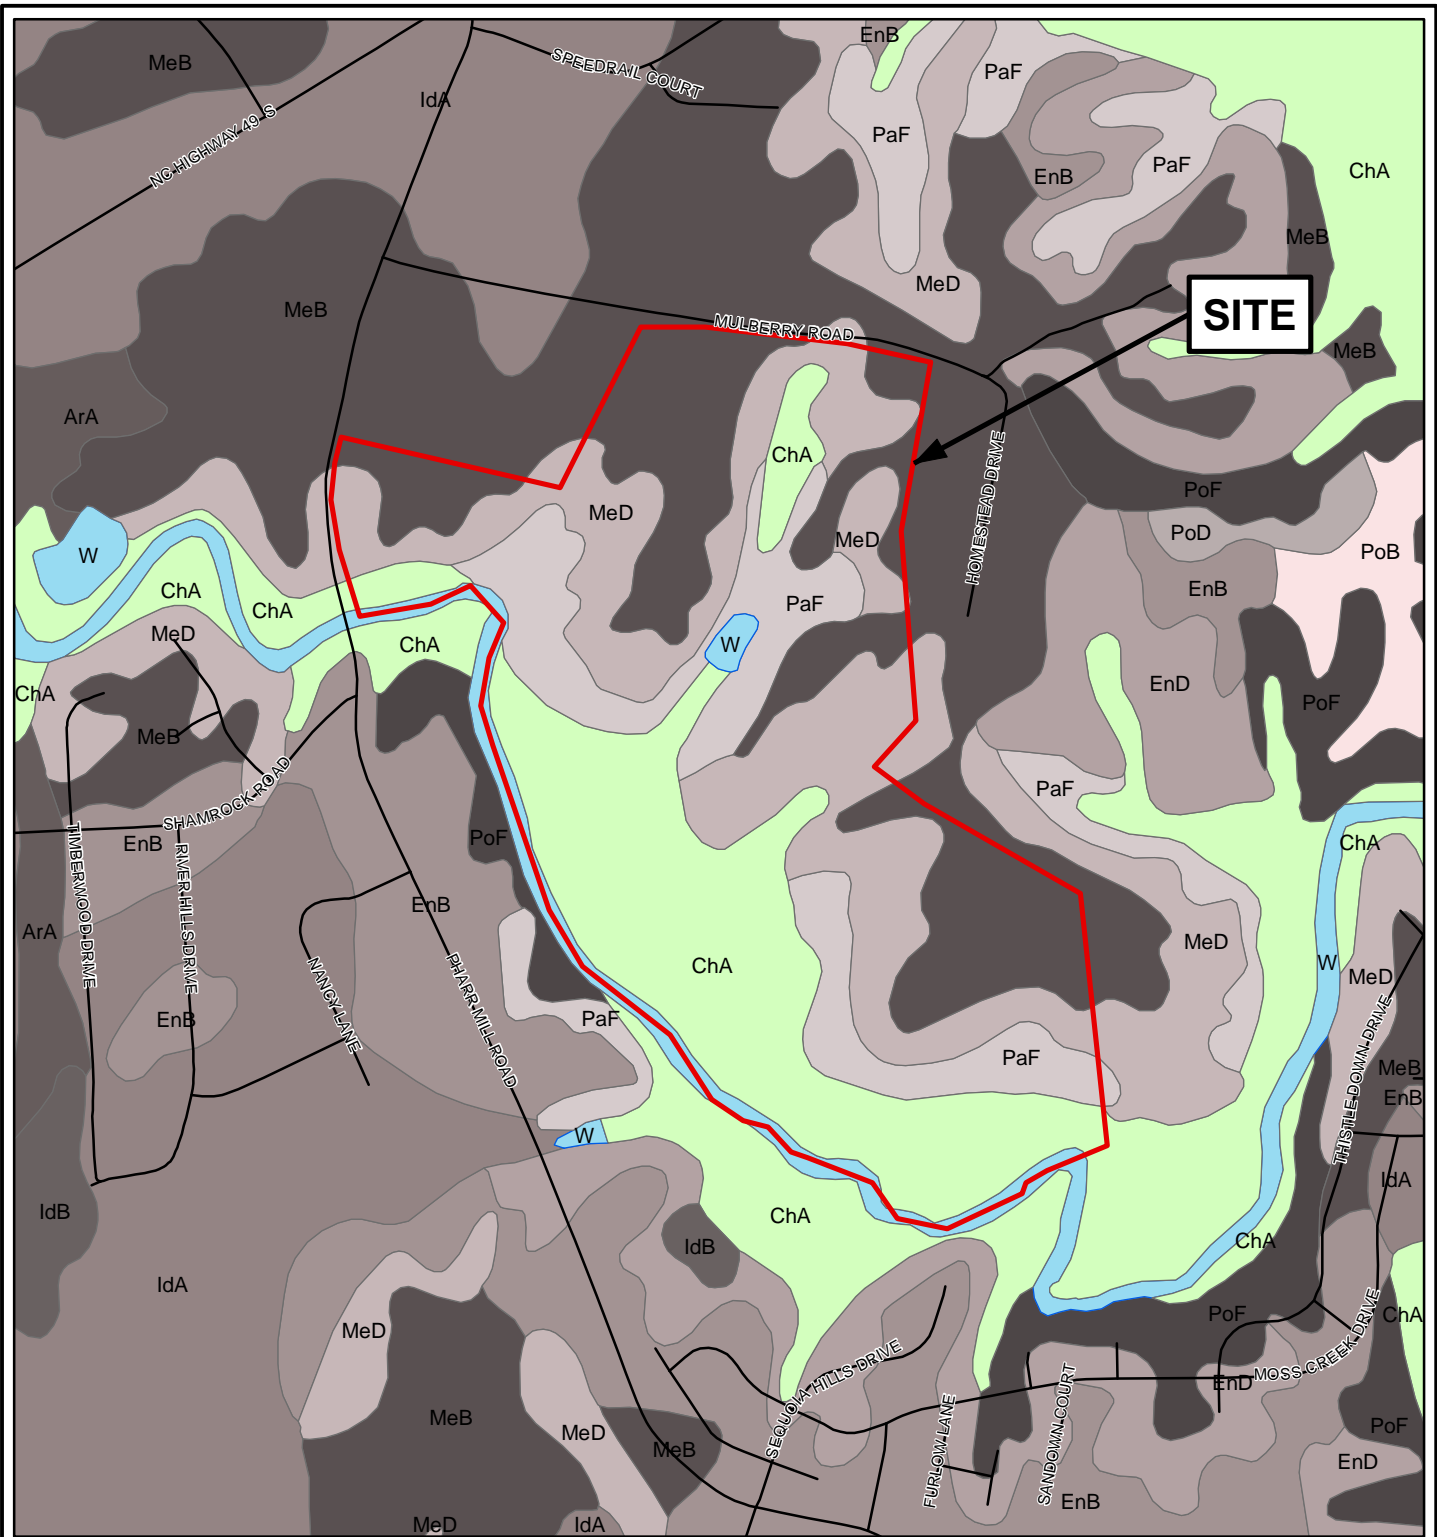
H&H reviewed soil survey information and identified one potentially hydric soil series on the Site: Chewacla loam, 0 to 2 percent slopes, frequently flooded (ChA). The ChA series is depicted in the southwestern and southern portions of the Site, and the north-central portion of the Site. Hydric soil series are sometimes associated with consistently saturated soil such as in wetland areas.

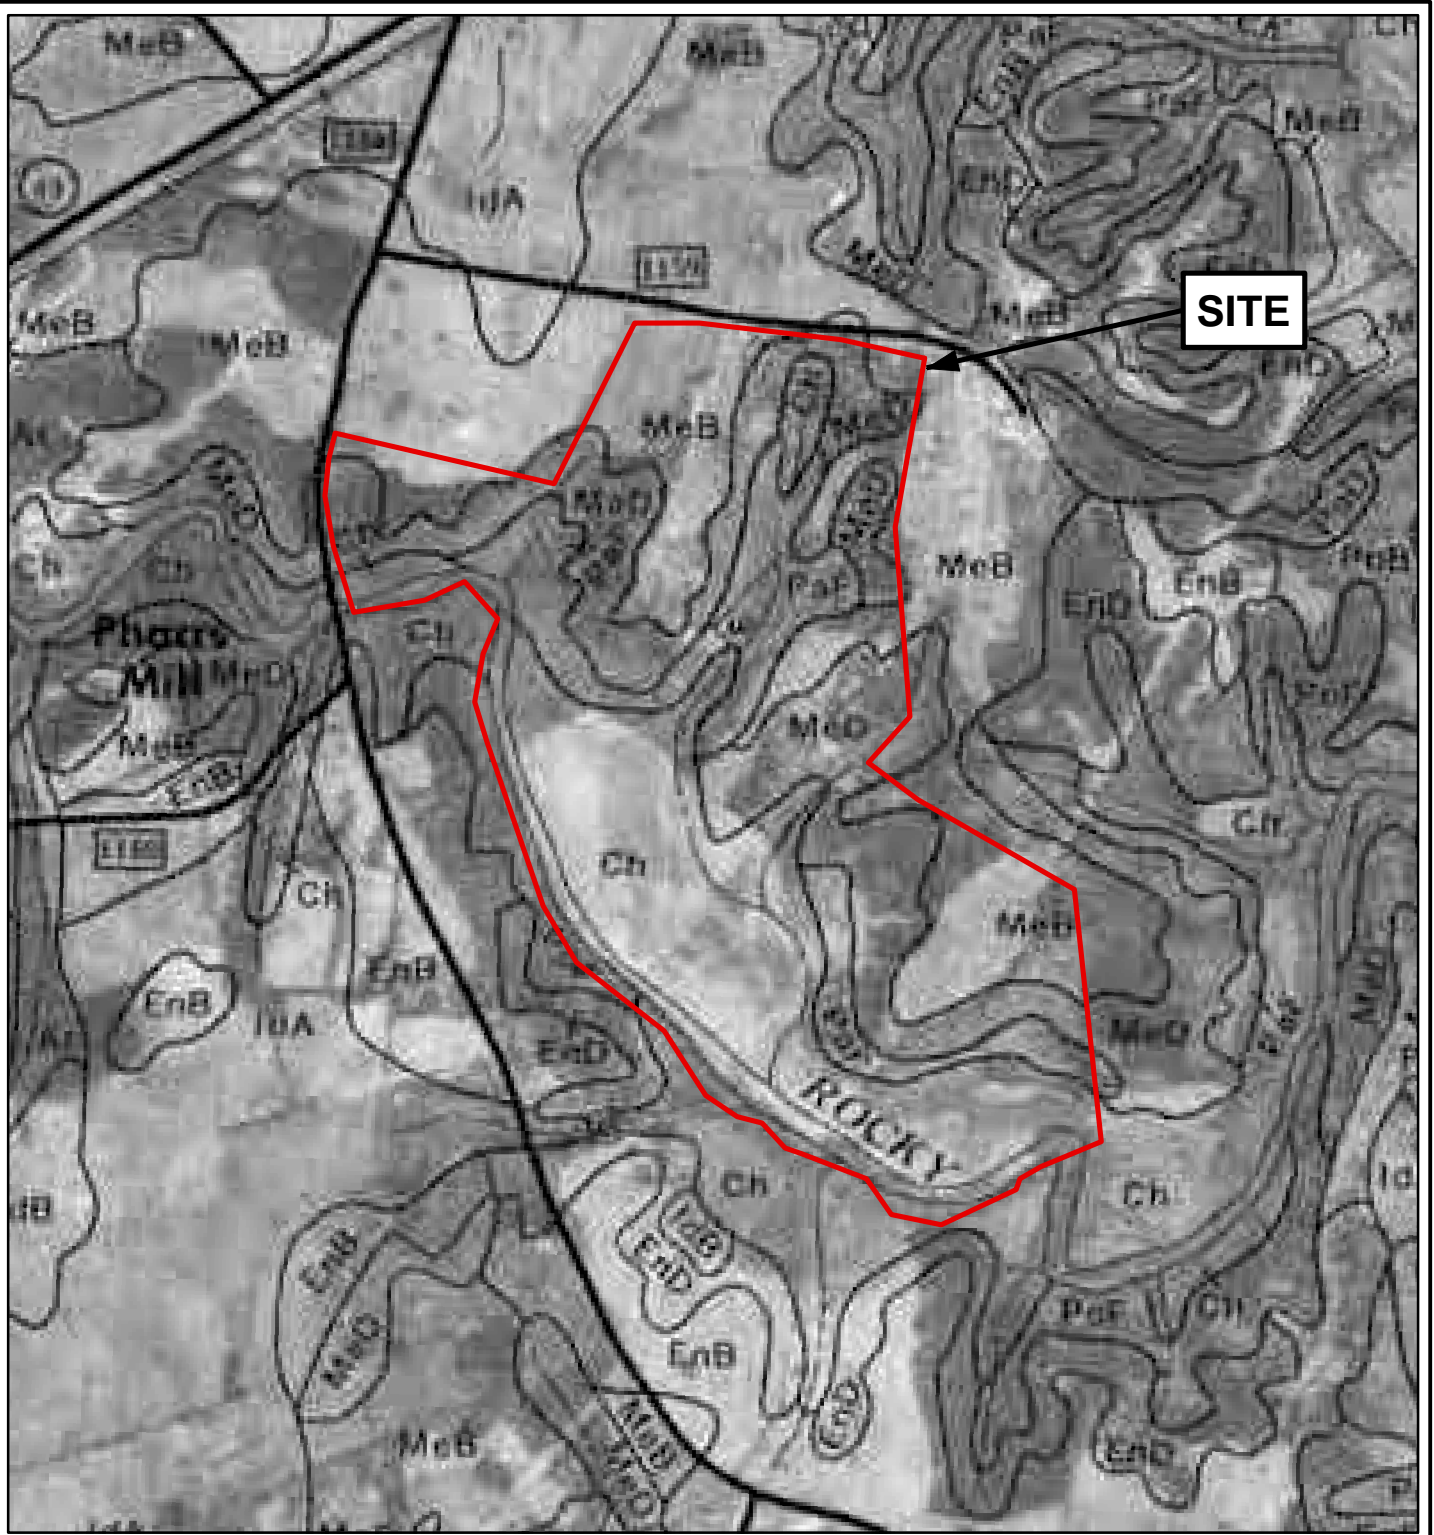
TITLE	<b>PUBLISHED SOIL SURVEY MAP</b>	
PROJECT	UNDEVELOPED LAND MULBERRY ROAD HARRISBURG, NORTH CAROLINA

H&H reviewed soil information on the published soil survey and identified multiple soil series including the potentially hydric soil series ChA on the Site. No other potentially hydric soil series were identified on the Site. The published soil survey also depicts Rocky River along the Site's southwestern and southern boundaries, and three unnamed stream channels in the western, central, and east-central portions of the Site.

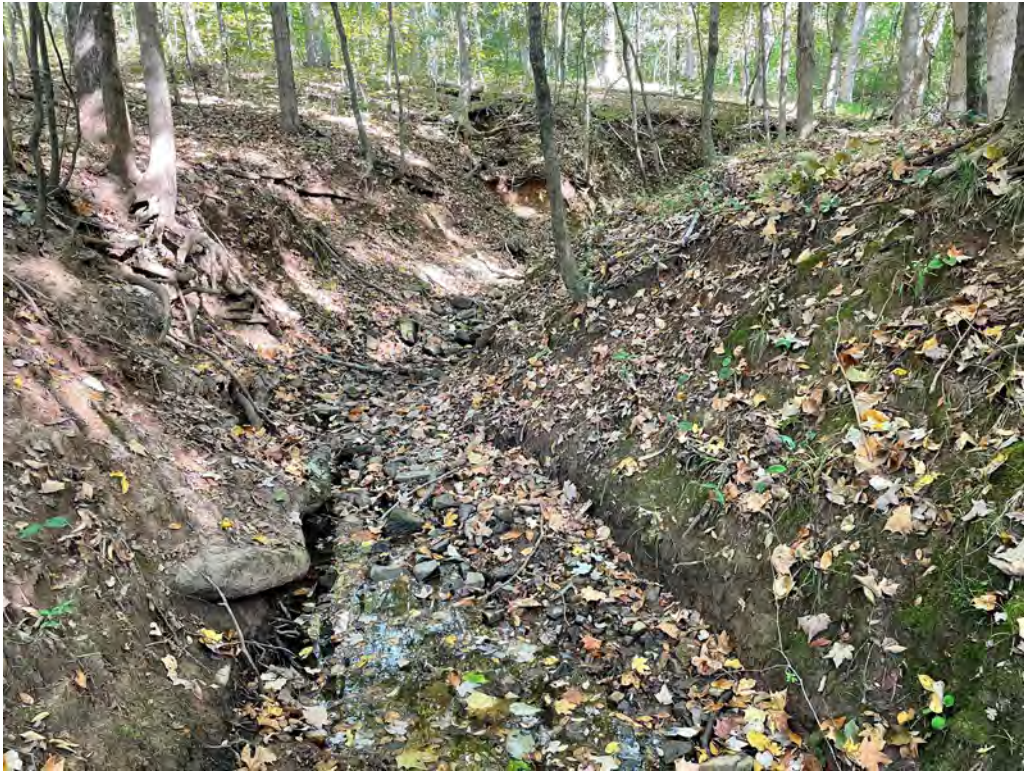
- *Stream Channel "A" (SCA)* – SCA originates in the northwestern portion of the Site where an ephemeral/erosional drainage feature transitions to an intermittent stream at a transitional headcut. At this point, a defined bed and bank and OHWM are present, and SCA appears to seasonally intersect the water table. SCA flows generally to the south before reaching a confluence with Rocky River near the southwestern Site boundary. H&H used DEQ DWR's Stream Identification Form (version 4.11), which indicates that SCA appears to have characteristics consistent with that of an intermittent stream. SCA totals approximately 678 linear feet of on-Site stream length.

Photograph 1: General view of SCA in the western portion of the Site

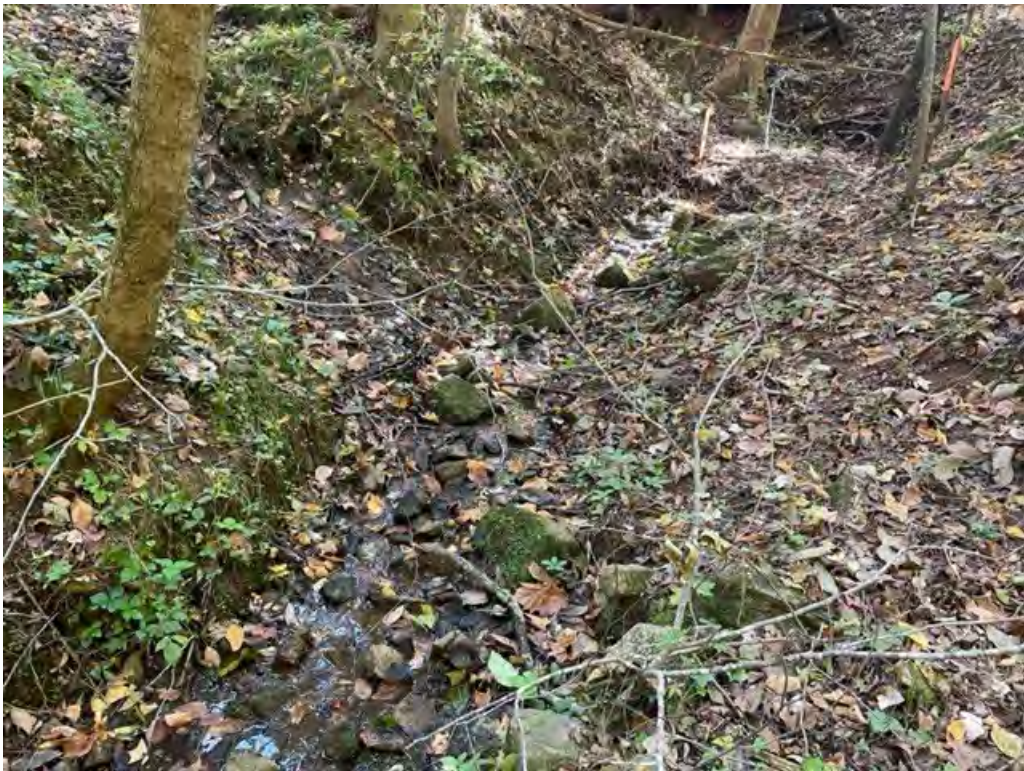
- *Stream Channel "B" (SCB)* – SCB originates in the western portion of the Site where an ephemeral/erosional drainage feature transitions to an intermittent stream at a transitional headcut. At this point, a defined bed and bank and OHWM are present, and SCB appears to seasonally intersect the water table. SCB flows generally to the west before reaching a confluence with SCA. H&H used DEQ DWR's Stream Identification Form (version 4.11), which indicates that SCB appears to have characteristics consistent with that of an intermittent stream. SCB totals approximately 36 linear feet of on-Site stream length.

Photograph 2: General view of SCB in the western portion of the Site

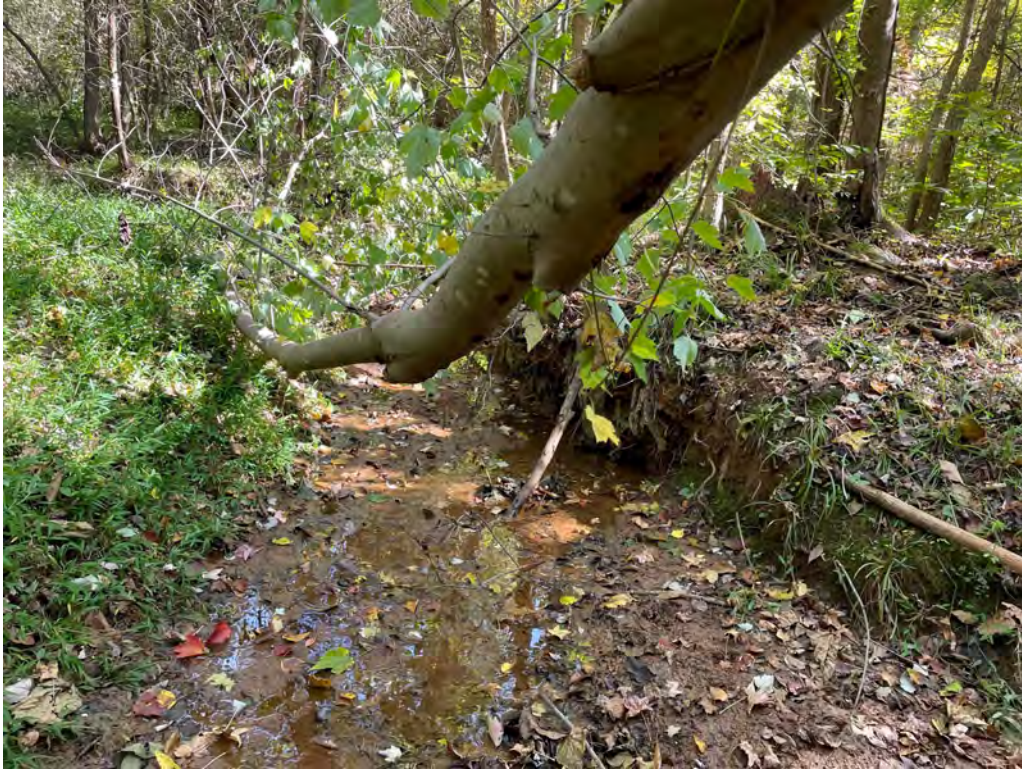
- *Stream Channel “C” (SCC)* – SCC originates in the central portion of the Site downgradient of the northeastern branch of Wetland Area “B” (WAB) when drainage from WAB channelizes and forms a defined bed and bank. At this point, an OHWM is also present and SCC appears to seasonally intersect the water table. SCC flows generally to the south-southwest into WAB where SCC loses bed and bank and OHWM. H&H used DEQ DWR’s Stream Identification Form (version 4.11), which indicates that SCC appears to have characteristics consistent with that of an intermittent stream. SCC totals approximately 124 linear feet on-Site stream length.

Photograph 3: General view of SCC in the central portion of the Site

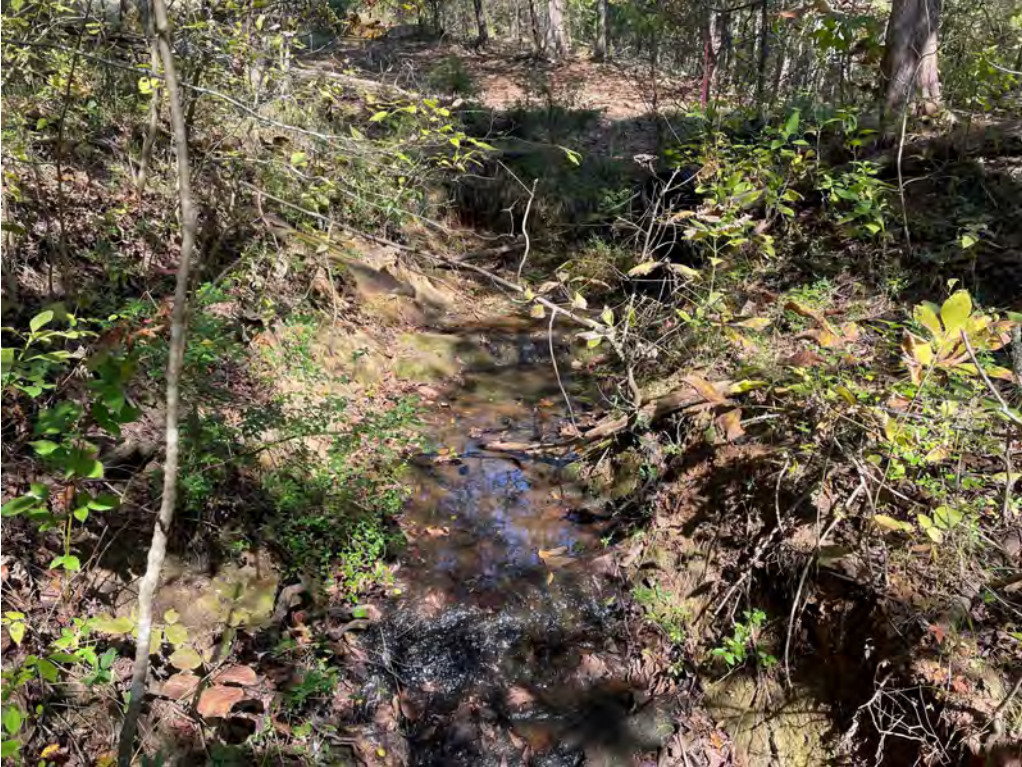
- *Stream Channel “D” (SCD)* – SCD originates in the central portion of the Site downgradient of a culvert pipe. SCD appears to seasonally intersect the water table. SCD flows generally to the south into WAB where SCD loses bed and bank and OHWM. H&H used DEQ DWR’s Stream Identification Form (version 4.11), which indicates that SCD appears to have characteristics consistent with that of an intermittent stream. SCD totals approximately 46 linear feet on-Site stream length.

Photograph 4: General view of SCD in the central portion of the Site

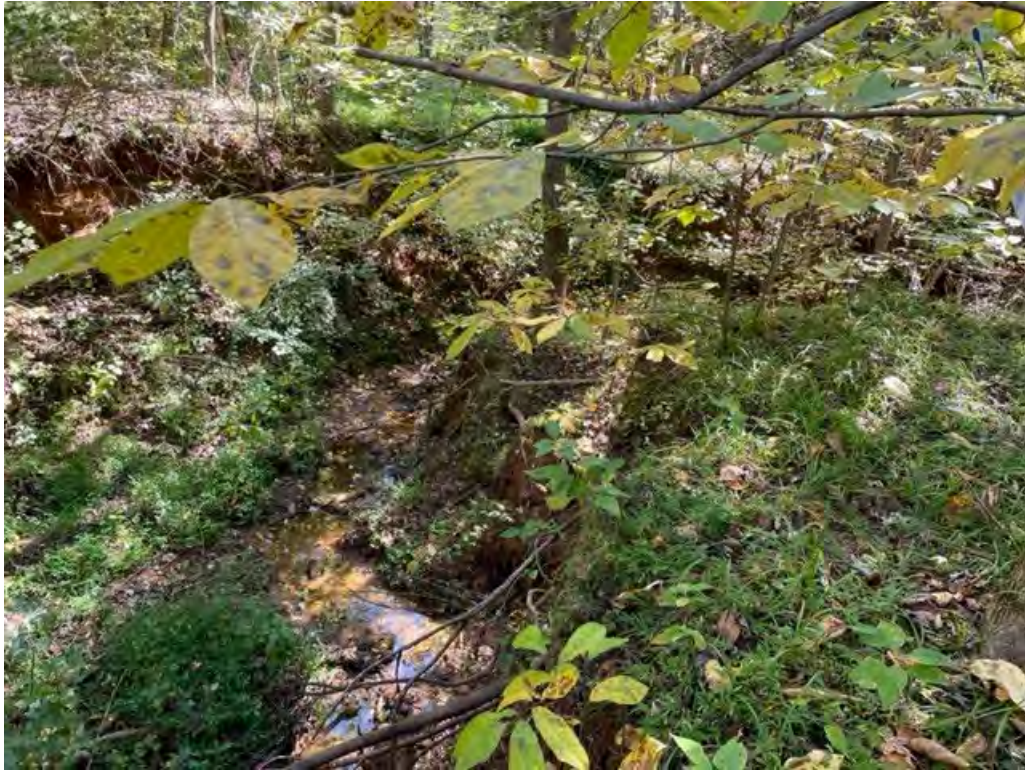
- *Stream Channel “E” (SCE)* – SCE originates in the north-central portion of the Site where an ephemeral/erosional drainage feature transitions to an intermittent stream at a transitional headcut. At this point, a defined bed and bank and OHWM are present, and SCE appears to seasonally intersect the water table. SCE flows generally to the south into Wetland Area “C” (WAC) where SCE loses bed and bank and OHWM. H&H used DEQ DWR’s Stream Identification Form (version 4.11), which indicates that SCE appears to have characteristics consistent with that of an intermittent stream. SCE totals approximately 496 linear feet on-Site stream length.

Photograph 5: General view of SCE in the north-central portion of the Site

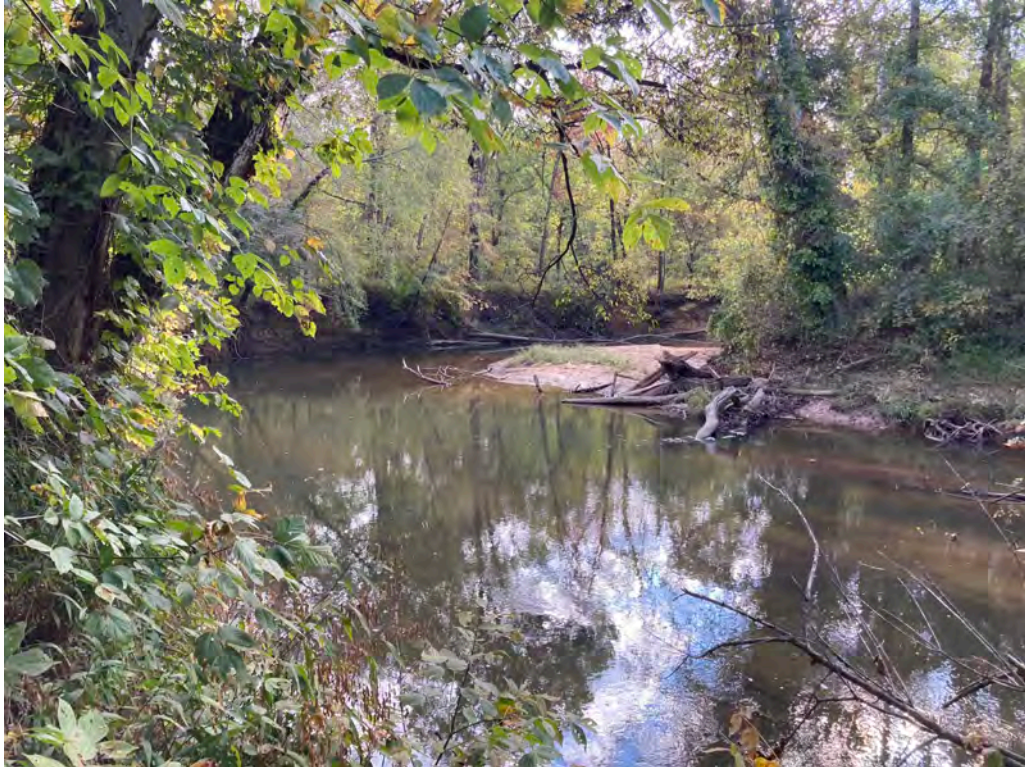
- *Rocky River* – Rocky River originates off-Site to the west and flows in a southeasterly direction, generally forming the Site’s southwestern and southern boundaries. Rocky River totals approximately 5,980 linear feet of on-Site length.

Photograph 6: General view of Rocky River in the southern portion of the Site

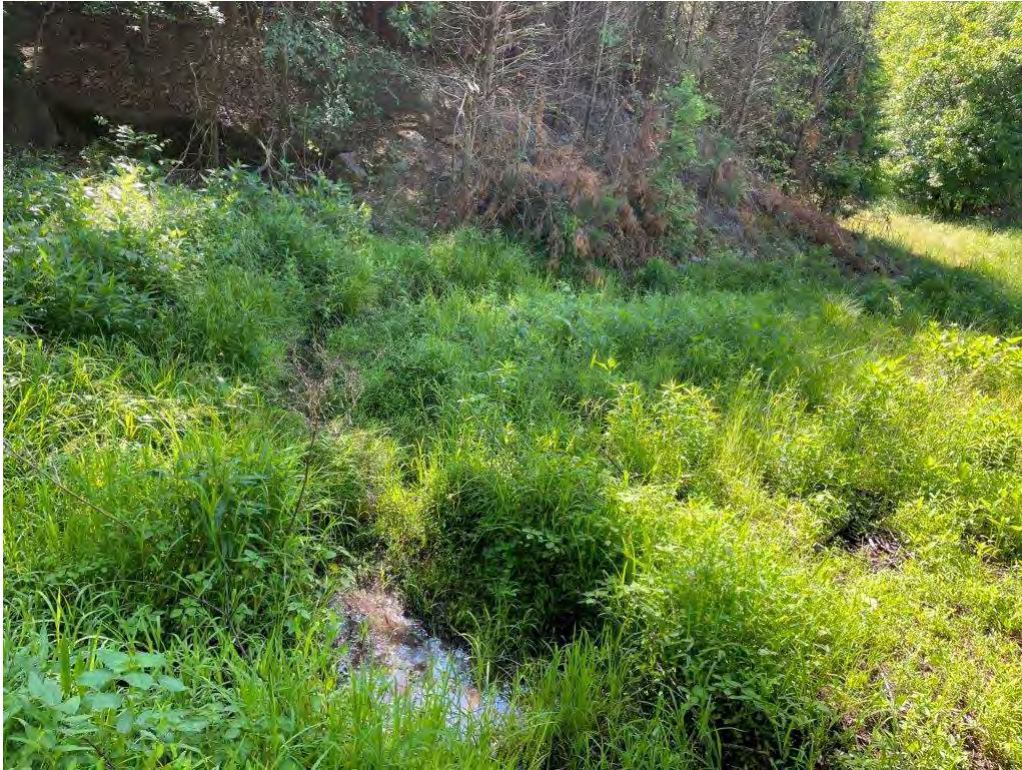
- *Wetland Area "A" (WAA)* – WAA is a linear wetland located in a drainage swale in the western portion of the Site. WAA drains generally in a southern direction into Rocky River and encompasses approximately 0.01 acre of on-Site area. Vegetation consists of herbaceous species.

Photograph 7: General view of Wetland Area "A" in the western portion of the Site

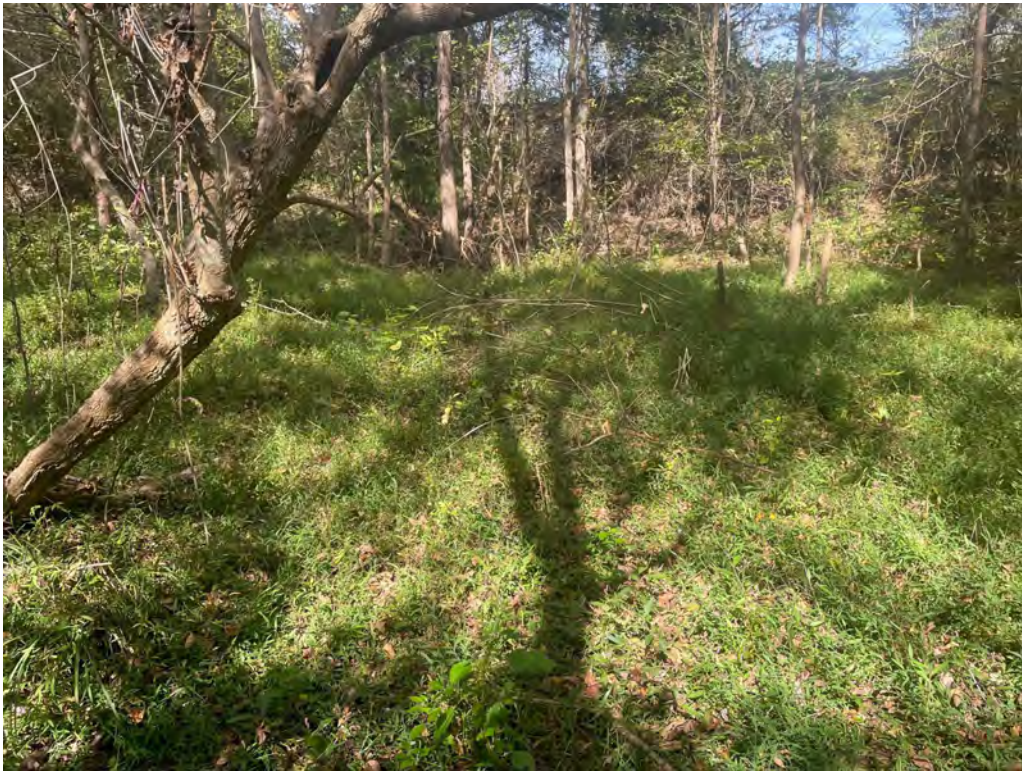
- *Wetland Area "B" (WAB)* – WAB is a depressional wetland located in the central portion of the Site. WAB receives drainage from SCC and SCD. WAB drains generally in a southerly direction and encompasses approximately 0.59 acre of on-Site area. Vegetation consists of deciduous hardwoods and herbaceous species.

Photograph 8: General view of Wetland Area "B" in the central portion of the Site

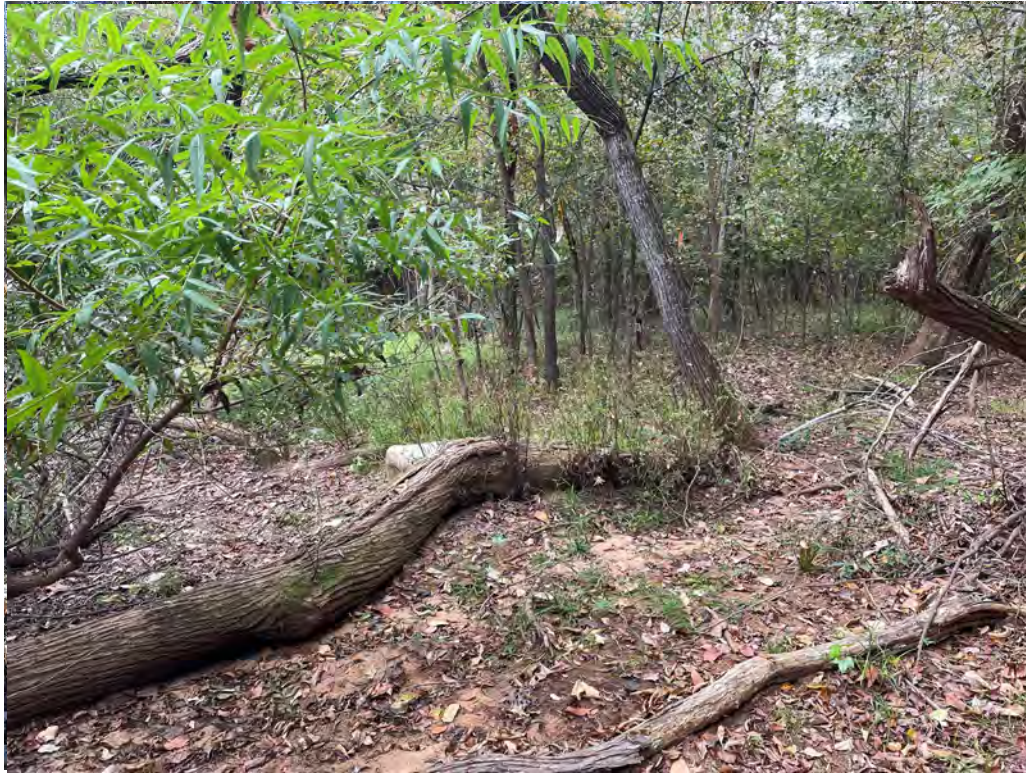
- *Wetland Area "C" (WAC)* – WAC is a fringe wetland located in a depressional area upgradient of Pond "A" in the north-central portion of the Site. WAC receives drainage from SCE and drains generally in a southerly direction into Pond "A". WAC encompasses approximately 1.31 acres of on-Site area. Vegetation consists of deciduous hardwoods and herbaceous species.

Photograph 9: General view of Wetland Area "C" in the north-central portion of the Site

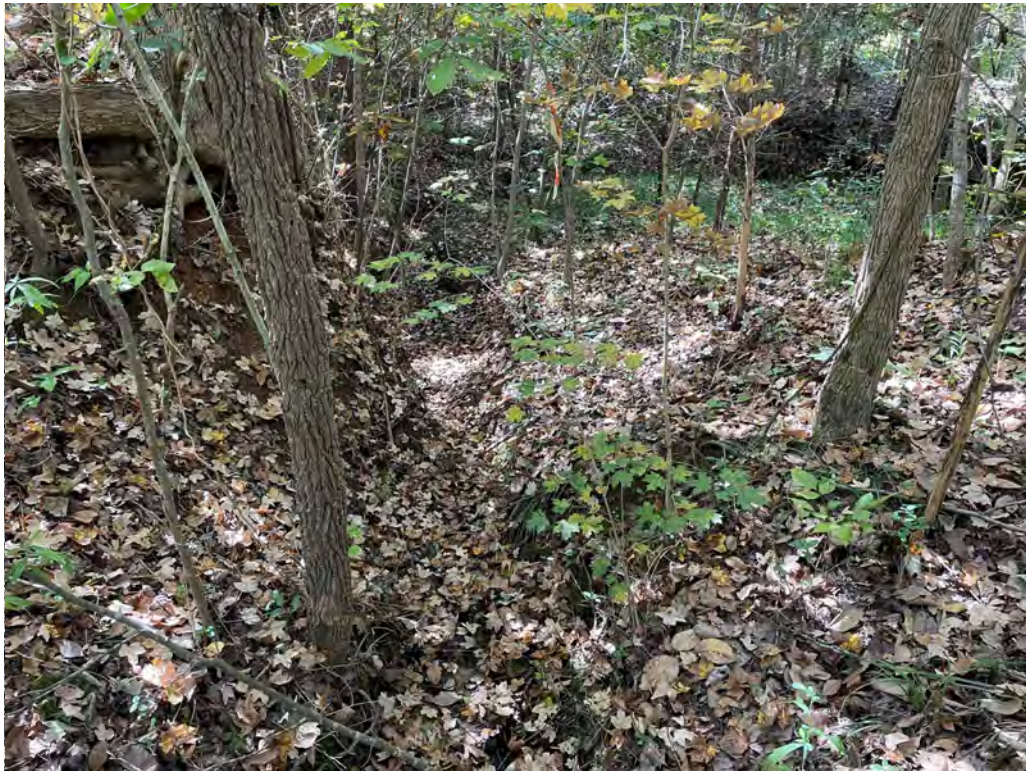
- *Wetland Area “D” (WAD)* – WAD is a linear wetland located in a drainage swale in the north-central portion of the Site. WAD drains generally in a southwesterly direction into SCE. WAD encompasses approximately 0.01 acre of on-Site area. Vegetation consists of deciduous hardwood saplings and herbaceous species.

Photograph 10: General view of Wetland Area "D" in the north-central portion of the Site

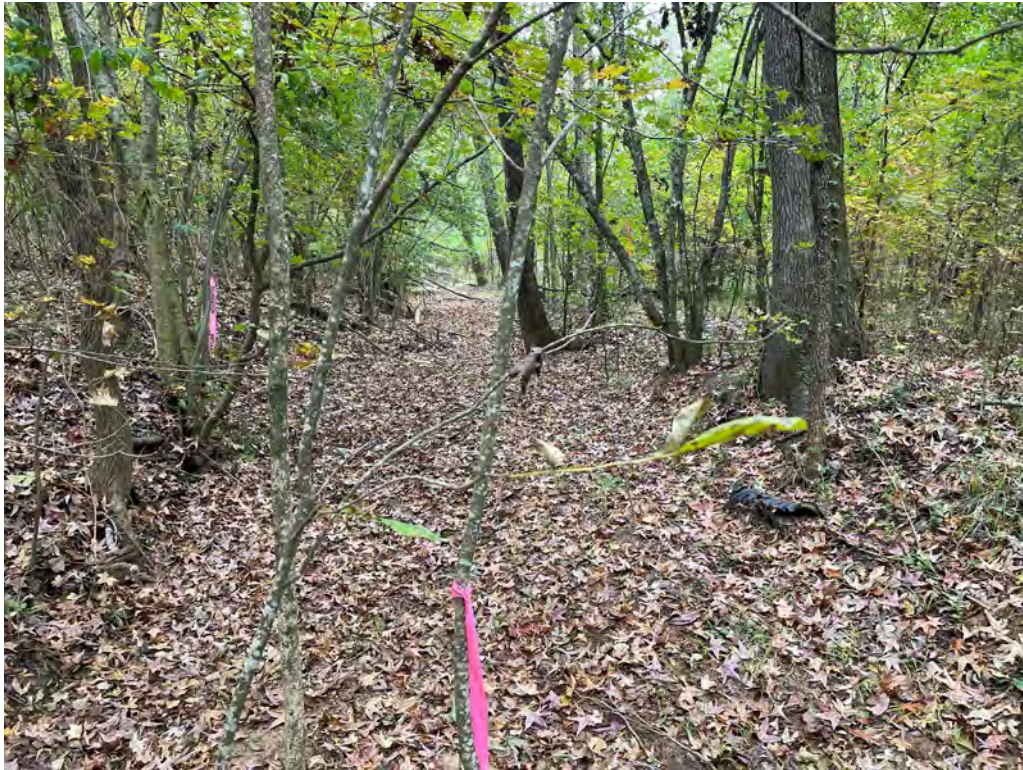
- *Wetland Area “E” (WAE)* – WAE is a linear wetland located in a drainage swale in the east-central portion of the Site. WAE drains generally in a southerly direction and encompasses approximately 0.13 acre of on-Site area. Vegetation consists of deciduous hardwood saplings and herbaceous species.

Photograph 11: General view of Wetland Area "E" in the east-central portion of the Site

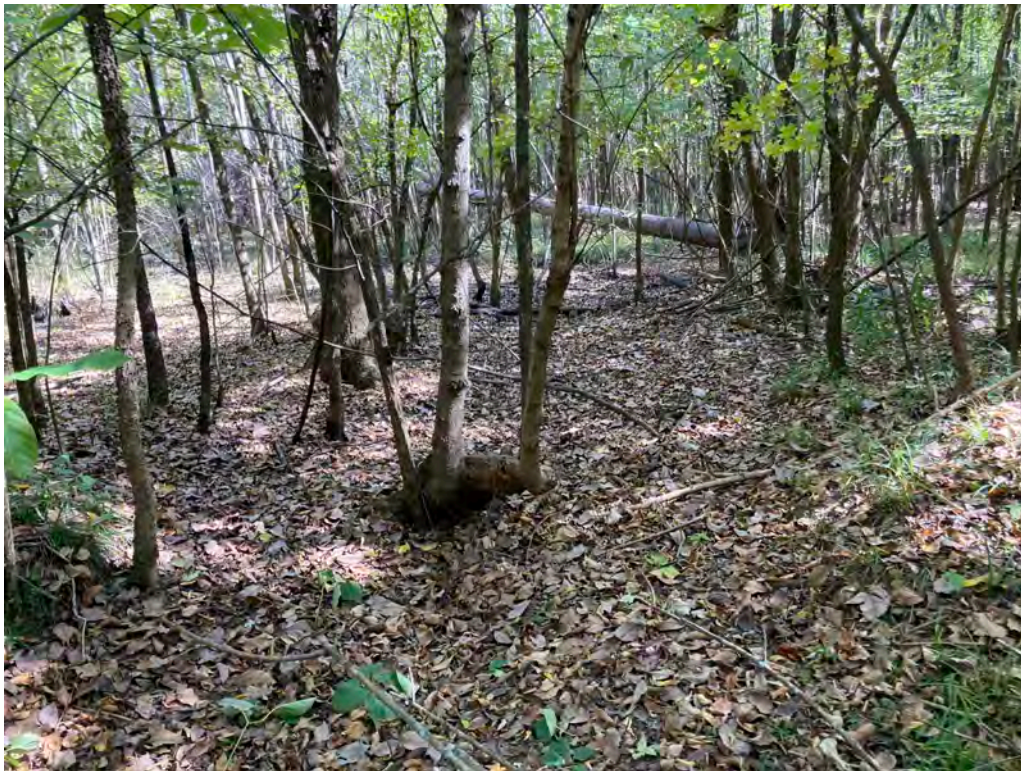
- *Wetland Area “F” (WAF)* – WAF is a depressional wetland located in the south-central and southeastern portions of the Site. WAF drains generally in a southeasterly direction into Rocky River and encompasses approximately 1.55 acres of on-Site area. Vegetation consists of deciduous hardwoods and deciduous hardwood saplings.

Photograph 12: General view of Wetland Area "F" in the southeastern portion of the Site

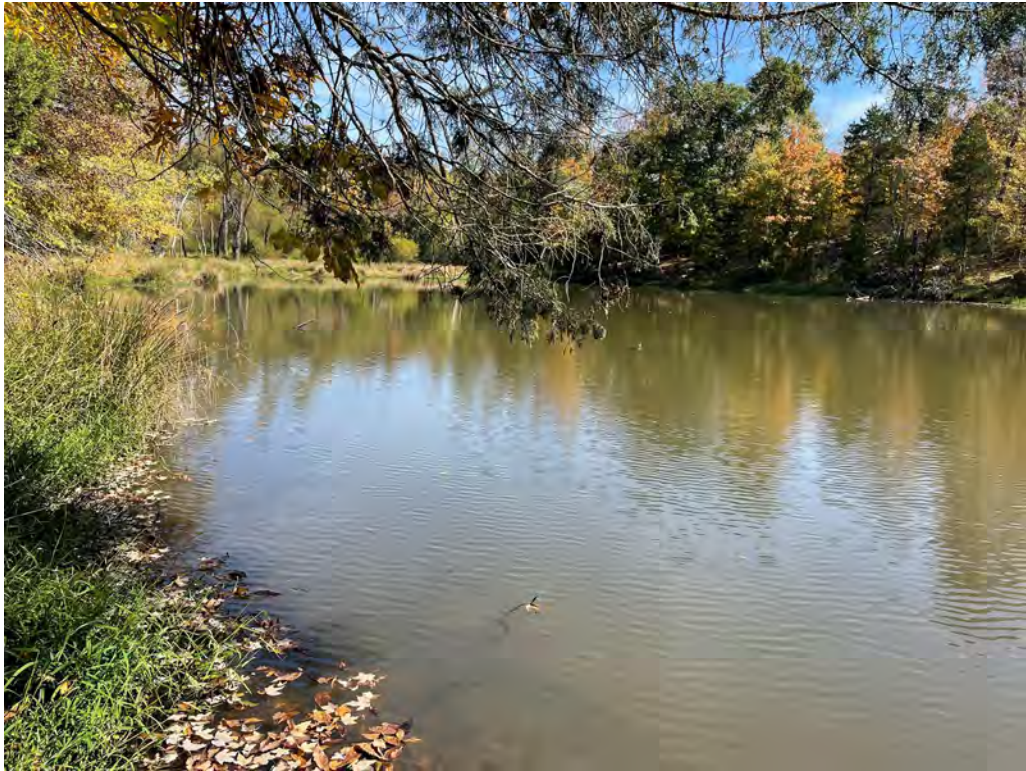
- *Pond “A”* is located in the central portion of the Site. Pond “A” is constructed with a dam and drains through a spillway in a southwesterly direction toward SCD. Pond “A” encompasses approximately 0.88 acre of on-Site area.

Photograph 13: General view of Pond "A" in the north-central portion of the Site

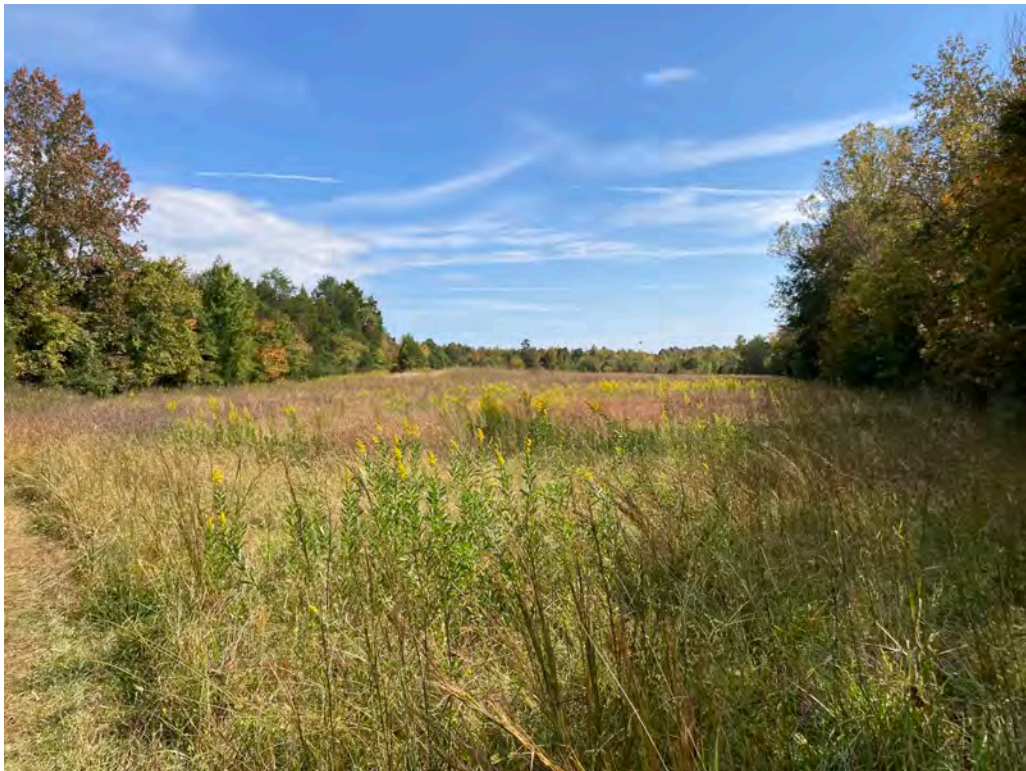
Photograph 14: General view of upland area in the south-central portion of the Site
