Re: Preliminary Stream and Wetlands Survey  
Undeveloped Land  
Mulberry Road  
Harrisburg, North Carolina  
H&H Job No.TCD-007

**1.0 Introduction**

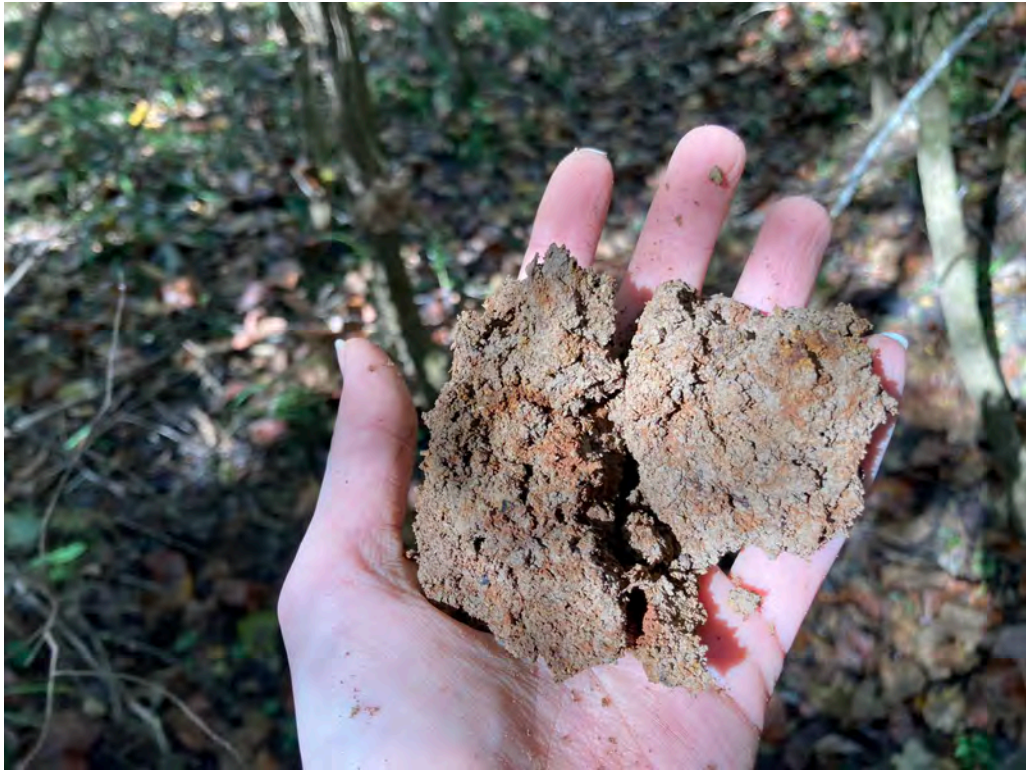
Photograph 15: Hydric soils observed in the central portion of the Site

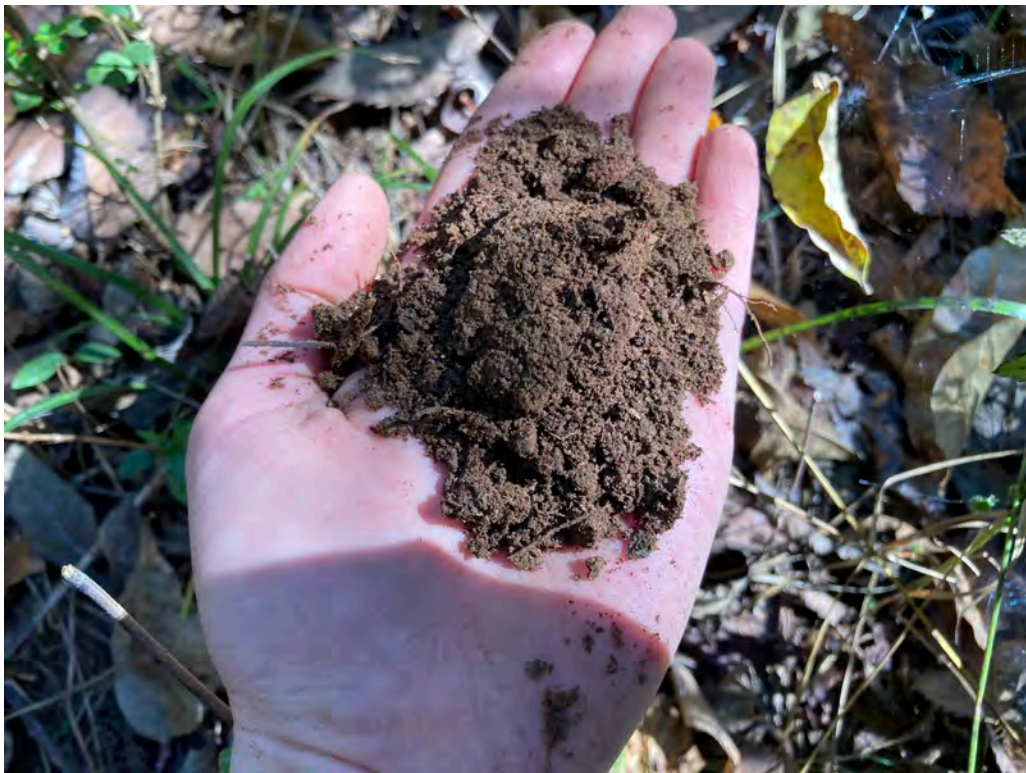
Photograph 16: Upland soils observed throughout the Site
