THE ALLIED REPORT

Inspection # **031224-1456**

Inspection Date: **3/12/2024**

Property Address: **14560 NE 3rd Court**

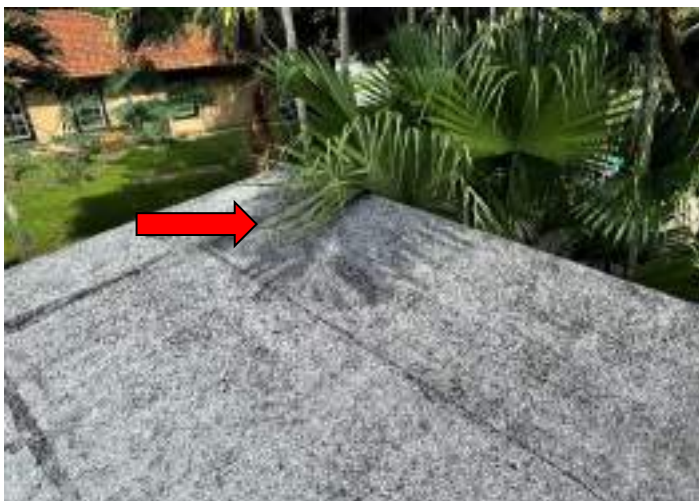
LEAVES, TREE BRANCHES TOUCHING ROOF SURFACE

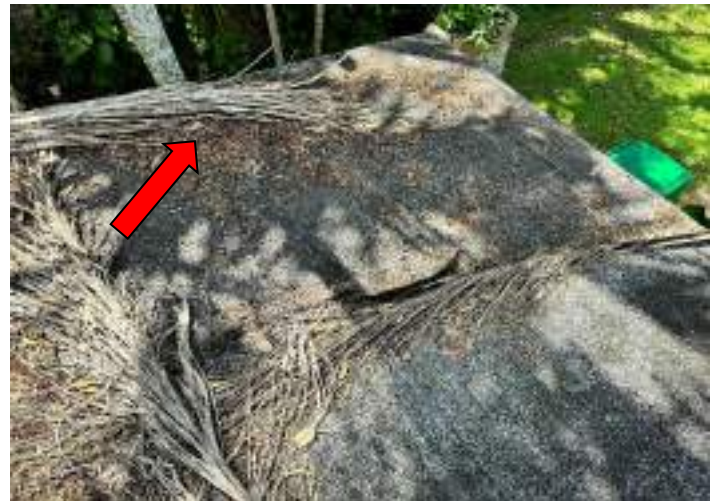
LEAVES, TREE BRANCHES TOUCHING ROOF SURFACE

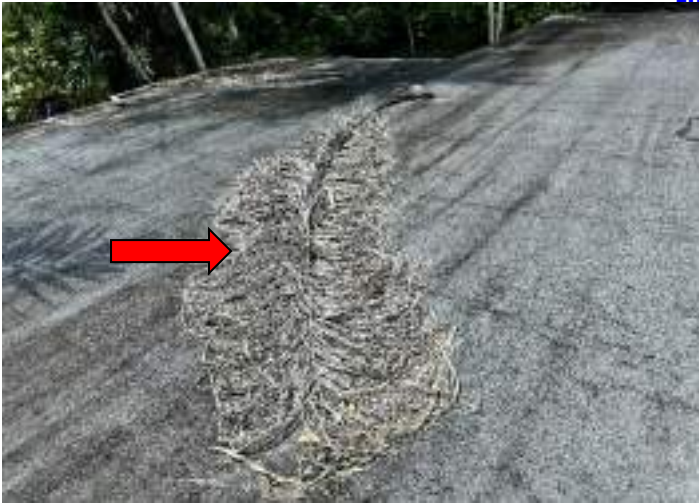
LEAVES, TREE BRANCHES TOUCHING ROOF SURFACE

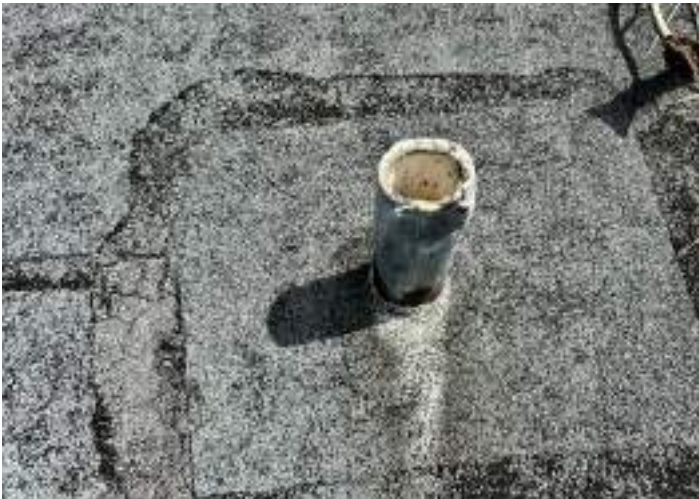
IMPROPERLY TERMINATED VENT PIPE

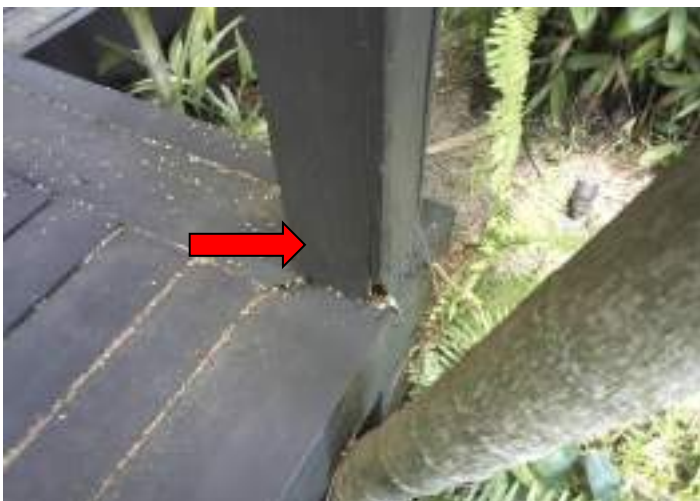
WOOD DECAYING FUNGI (WOOD ROT)

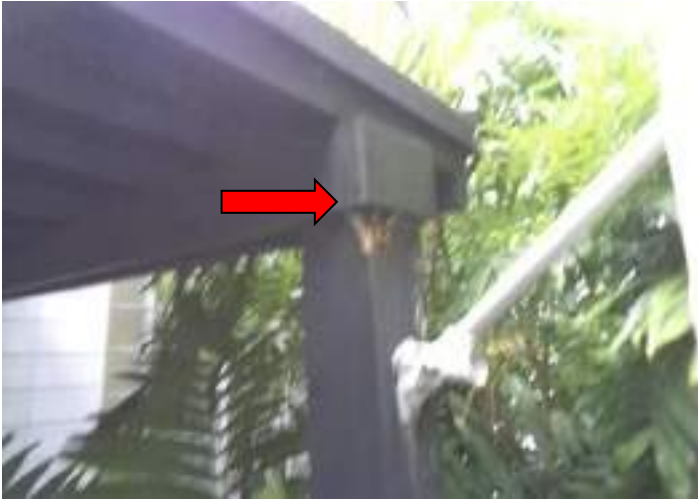
WOOD DECAYING FUNGI (WOOD ROT)

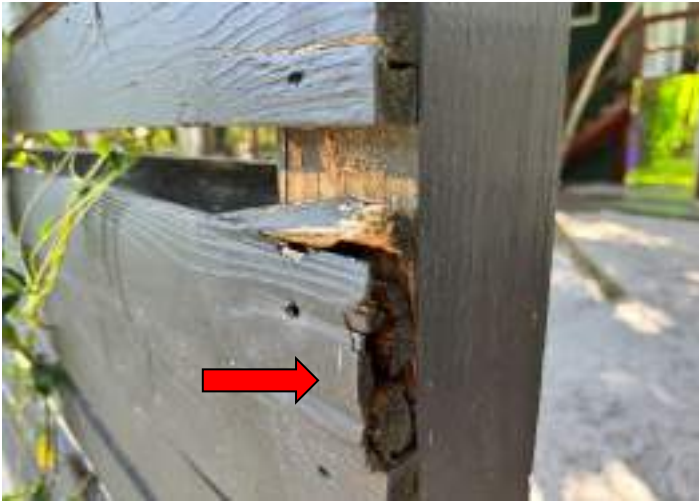
LOOSE WOODEN PLANKS

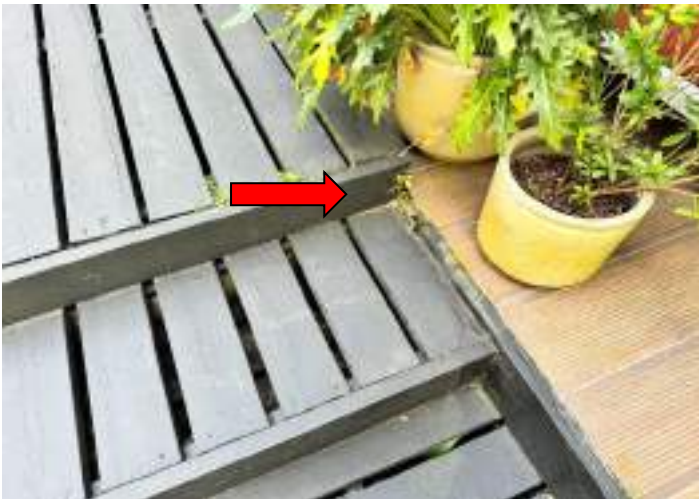
WOOD DECAYING FUNGI (WOOD ROT)

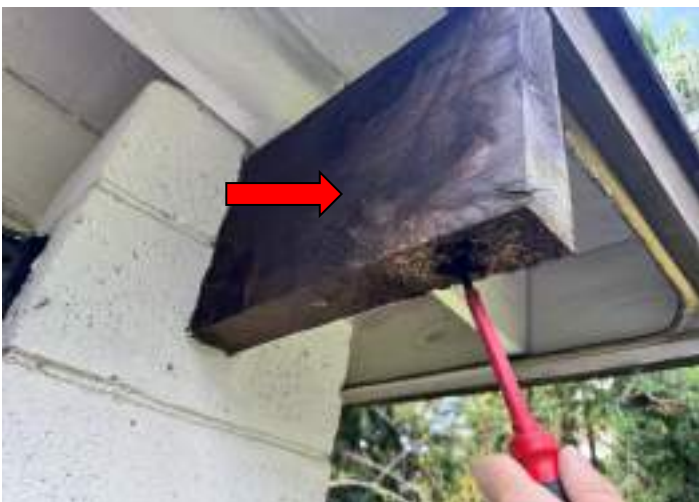
WOOD DECAYING FUNGI (WOOD ROT)

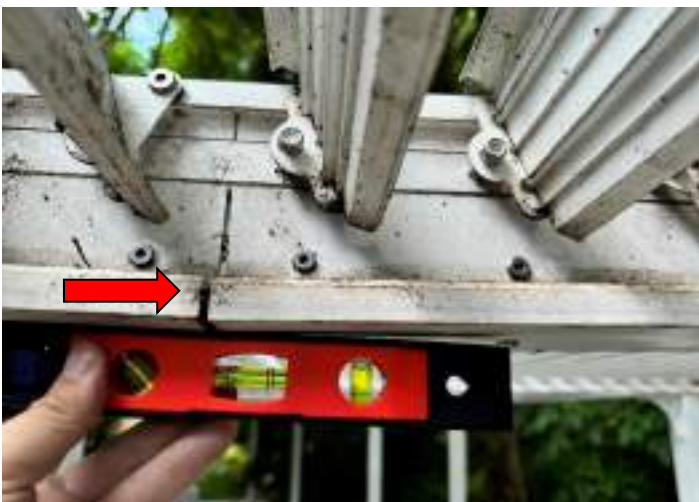
RUST/CORROSION - LOOSE JOINT

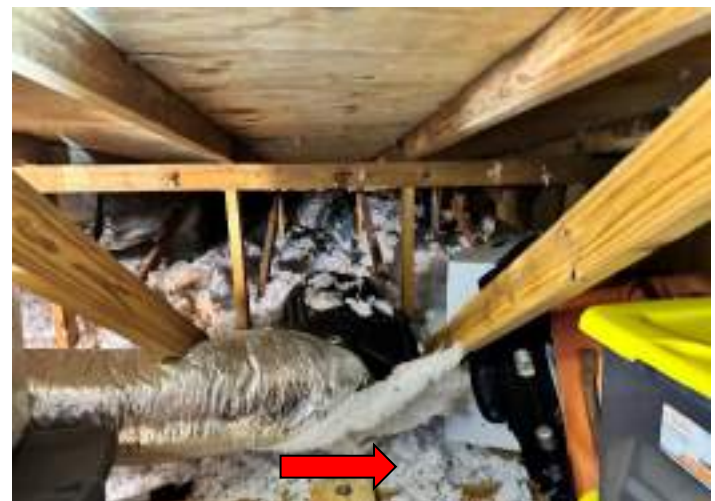
LOW INSULATION LEVEL

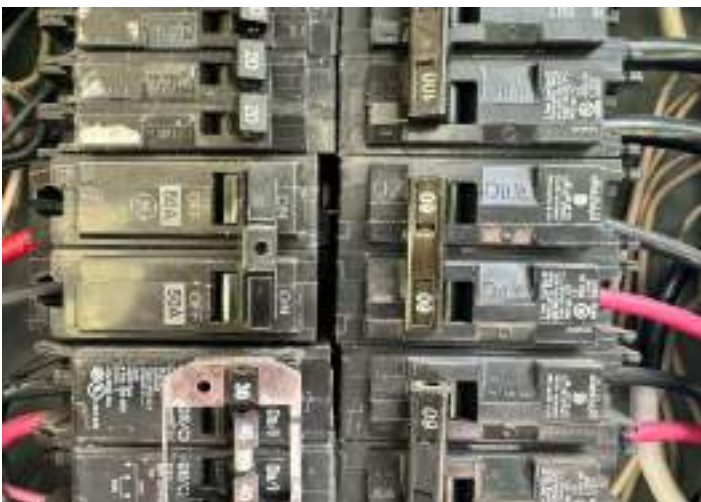
MAIN PANEL

MISMATCHED CIRCUIT BREAKERS

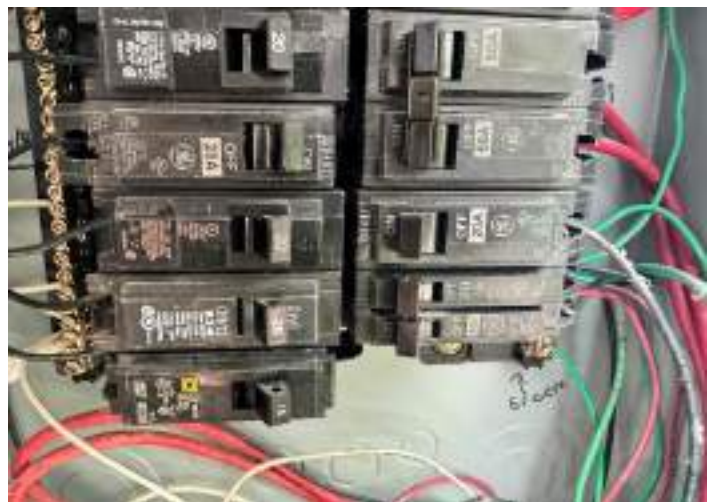
MISMATCHED CIRCUIT BREAKERS

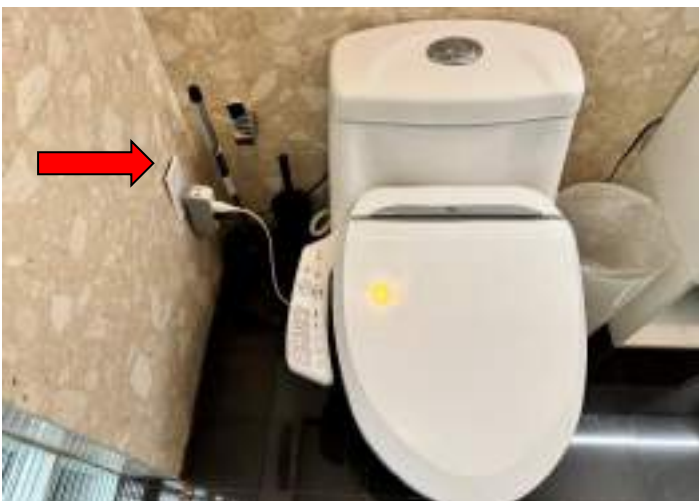
IMPROPERLY SEATED OUTLET

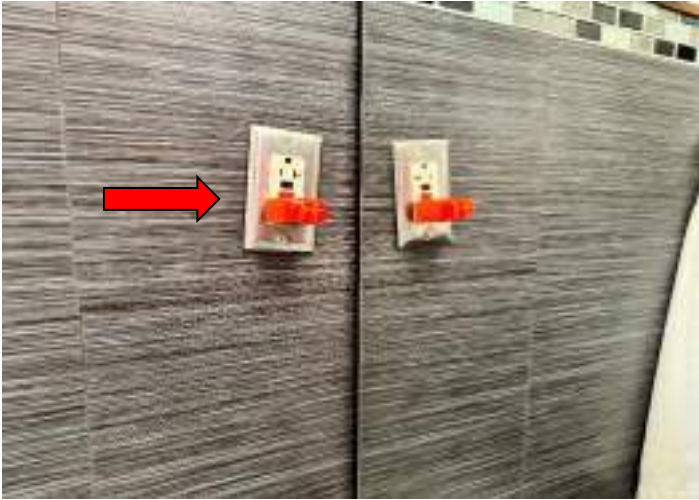
OUTLET NOT GFCI PROTECTED

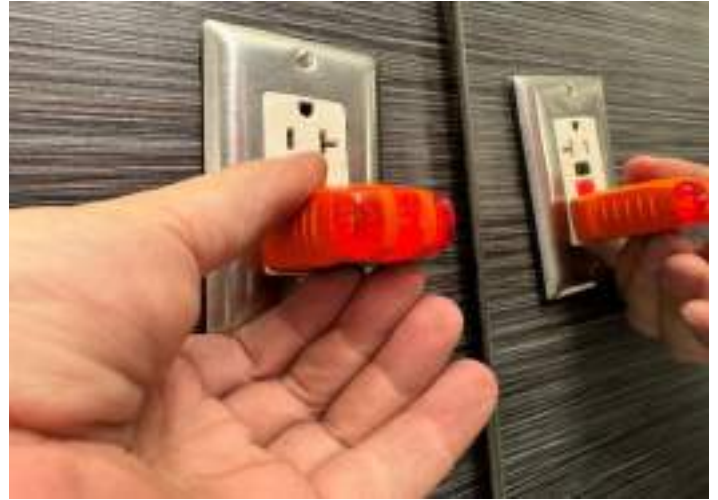
OUTLET NOT GFCI PROTECTED

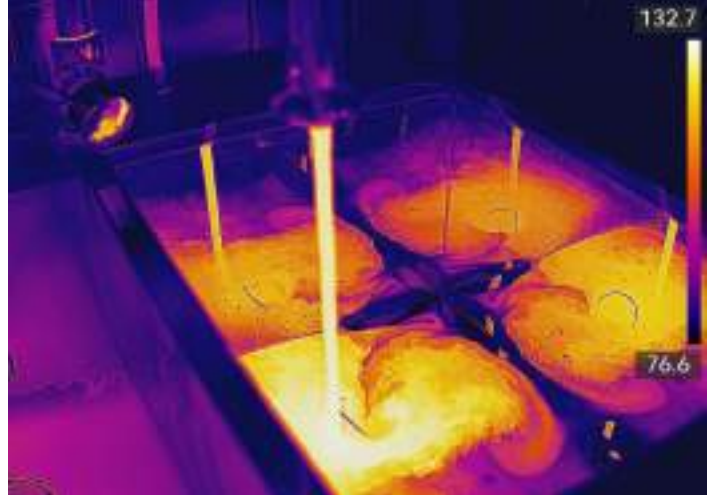
EVIDENCE OF HOT WATER 132.7 F

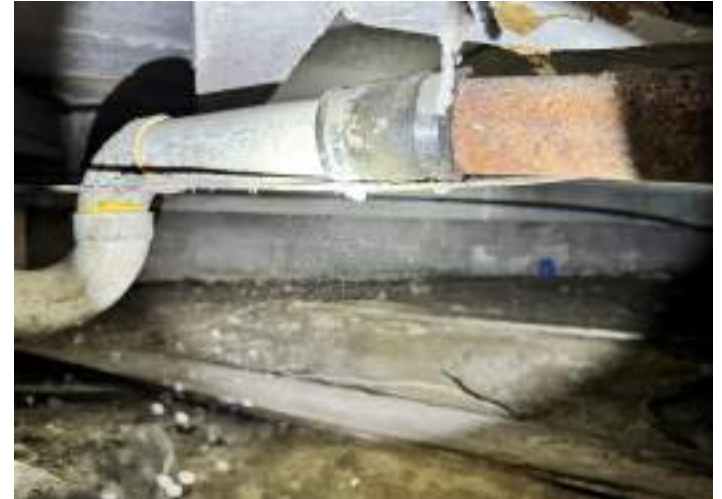
CAST IRON/PVC PIPE

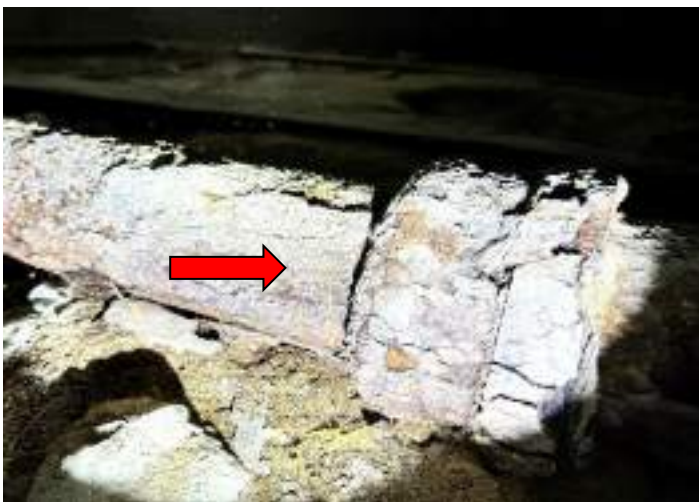
DETERIORATED CAST IRON PIPE

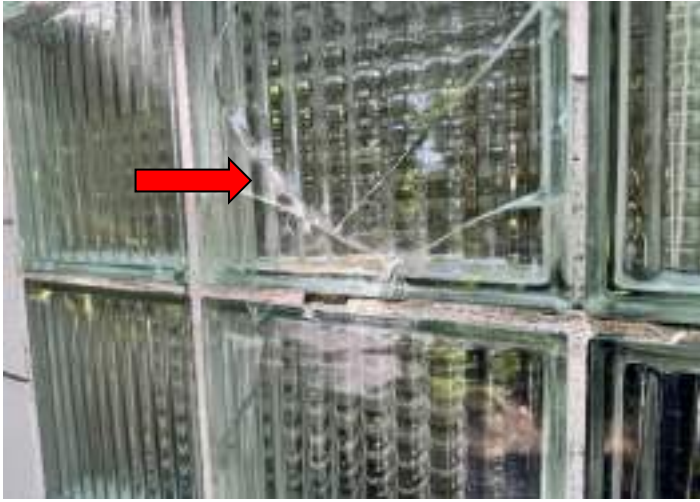
DAMAGED GLASS BLOCKS

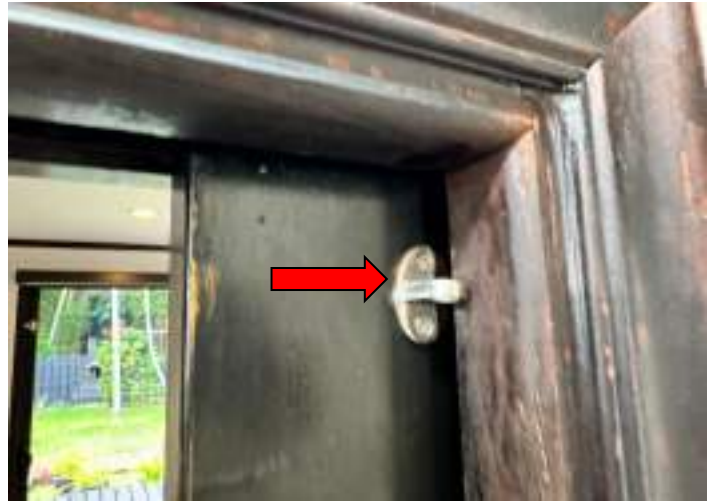
MASTER BATHROOM DOOR NOT FULLY OPEN

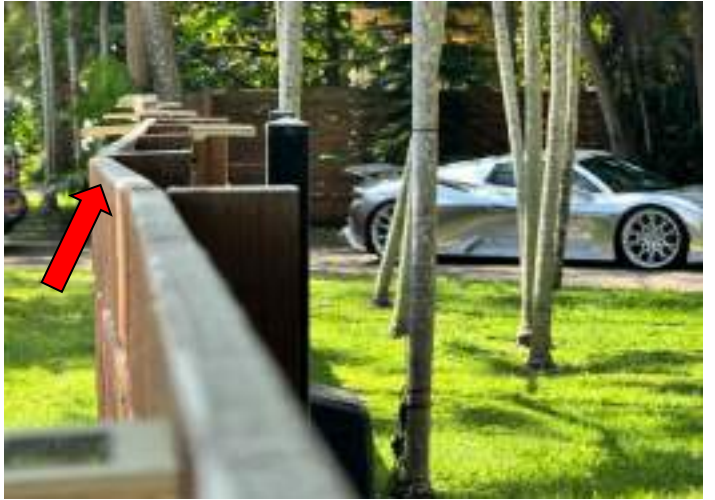
WARPED FENCE

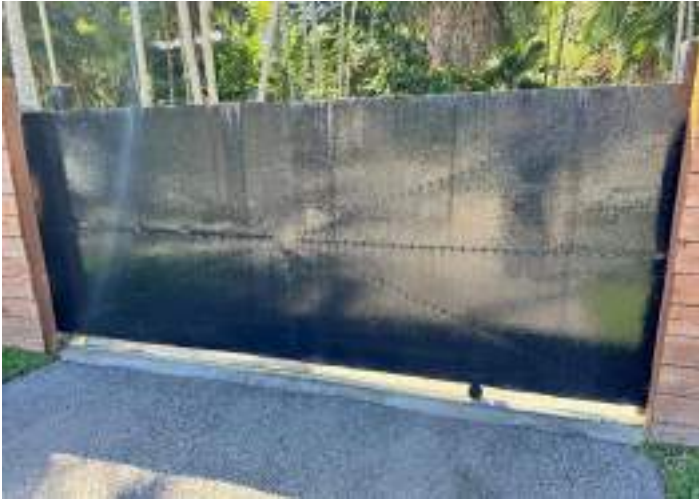
FENCE OVERGROWN

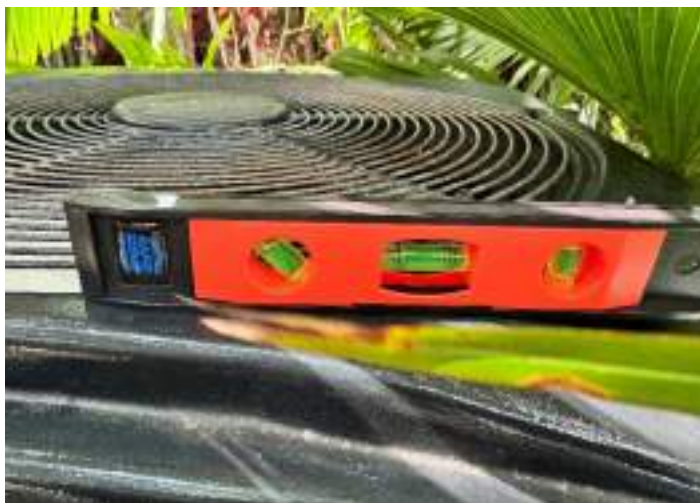
UNEVEN POOL HEATER

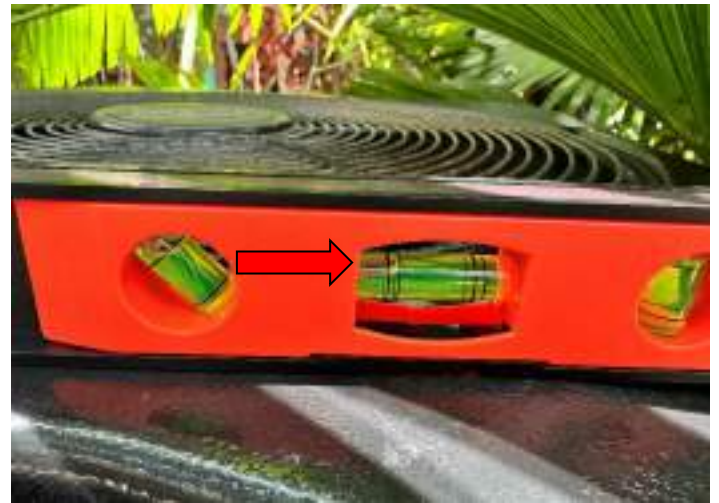
UNEVEN POOL HEATER

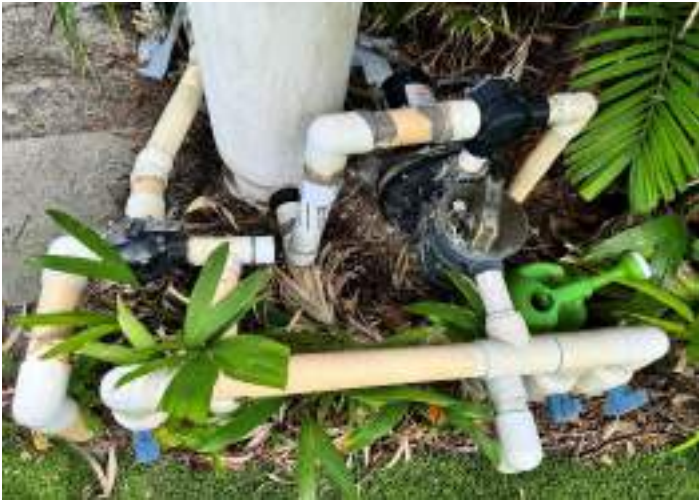
POOL PIPES NOT LABELED

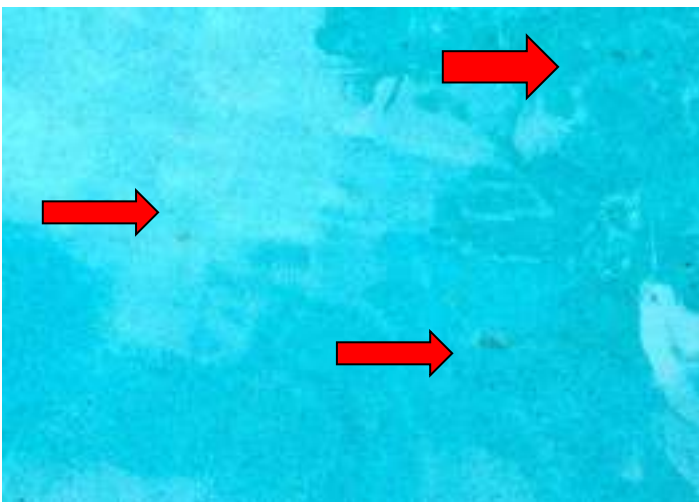
DAMAGED POOL SURFACE
