INSPECTION PERFORMED BY

INSPECTOR:
John Howard
Breakwater Inspections

PREPARED FOR:
Alex Rowe

PROPERTY ADDRESS:
84 School Street, Waldoboro, ME 04572

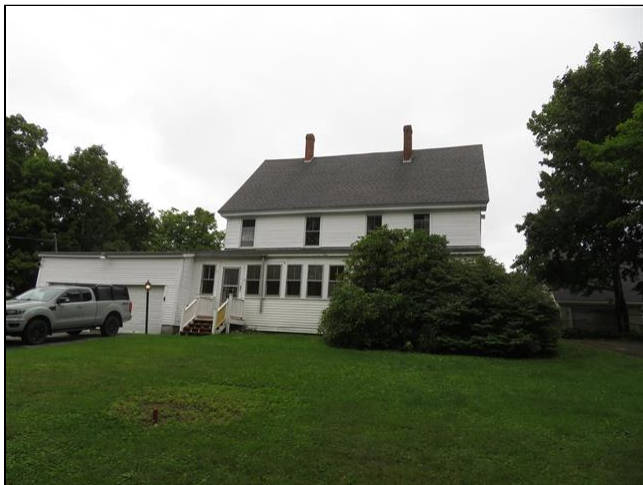
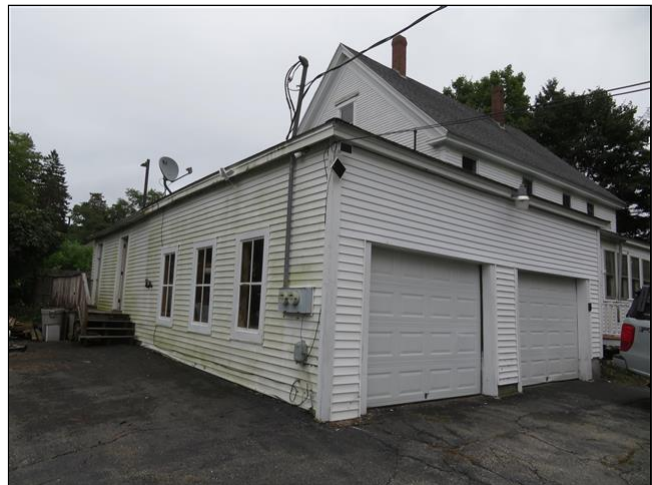
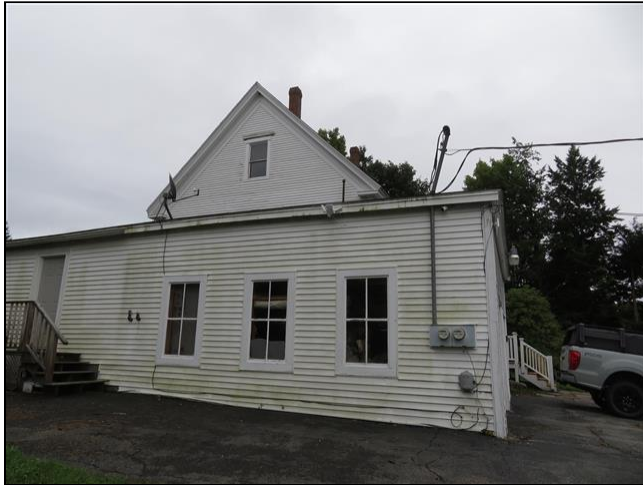
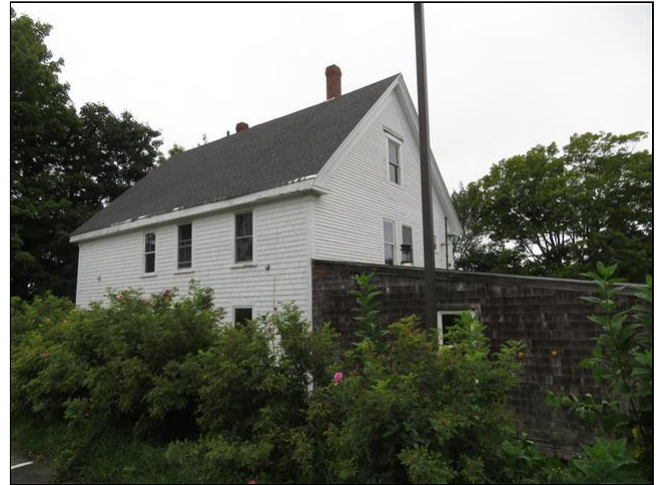
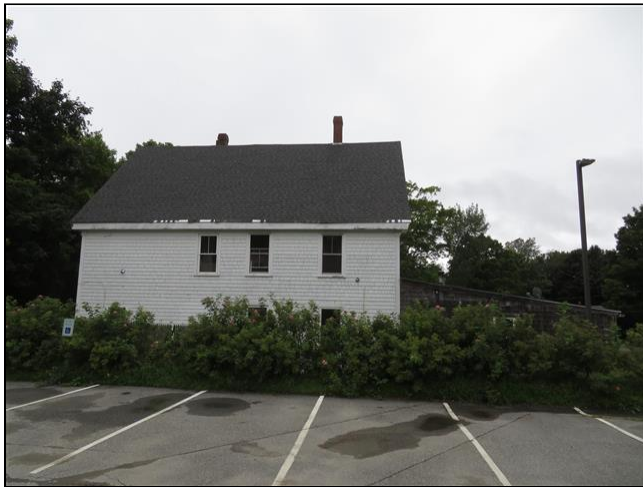
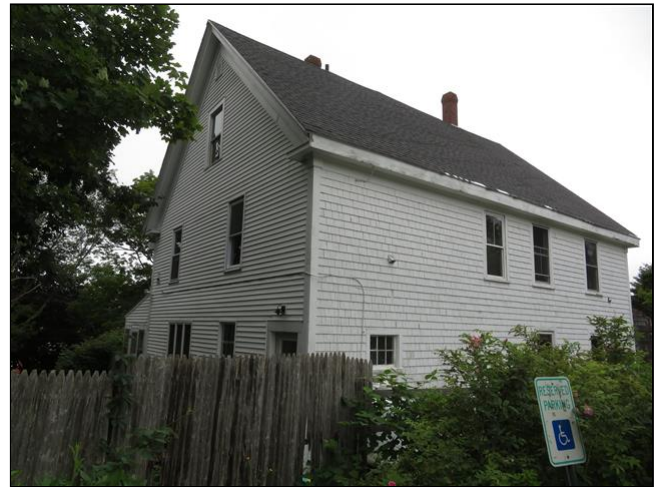
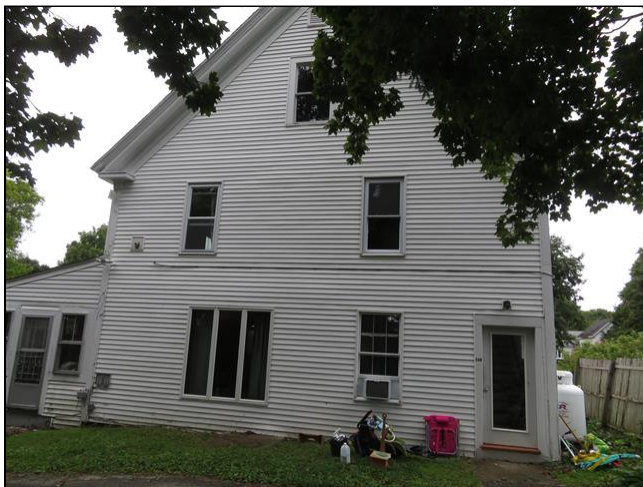
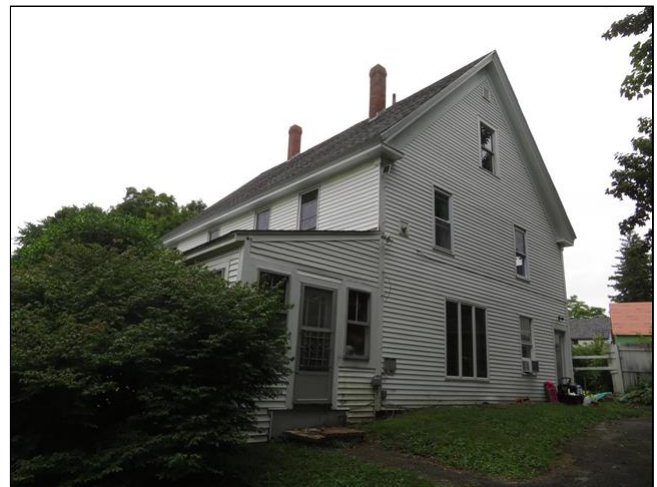
(1) The exterior of the building and the approach to the building were inspected and assessed. Comments regarding each of the components are provided in this section.

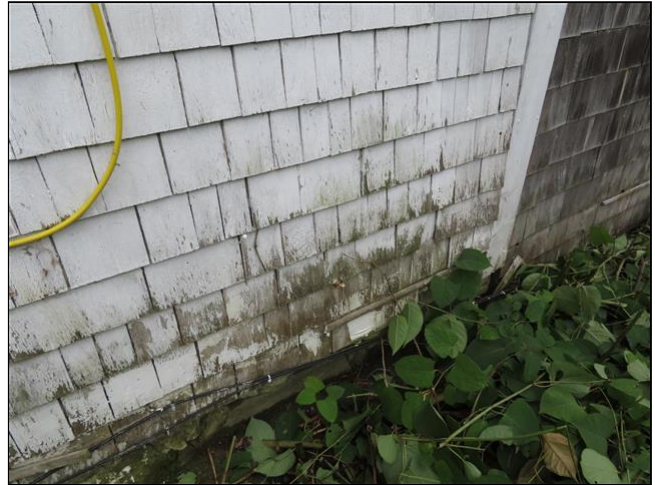
1.2 Item 2(Picture) Rear

(1) The wood siding and trim generally appeared to be in a condition at least as good as would be expected for a building of this age and in this environment. Small areas require some maintenance, particularly with paint. Nothing of significant concern was noted.

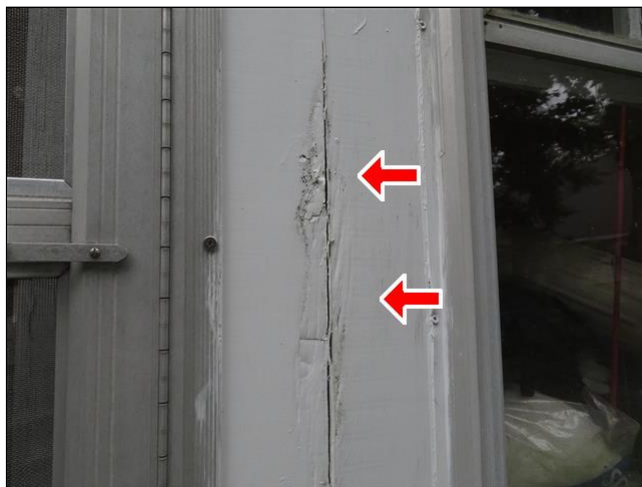
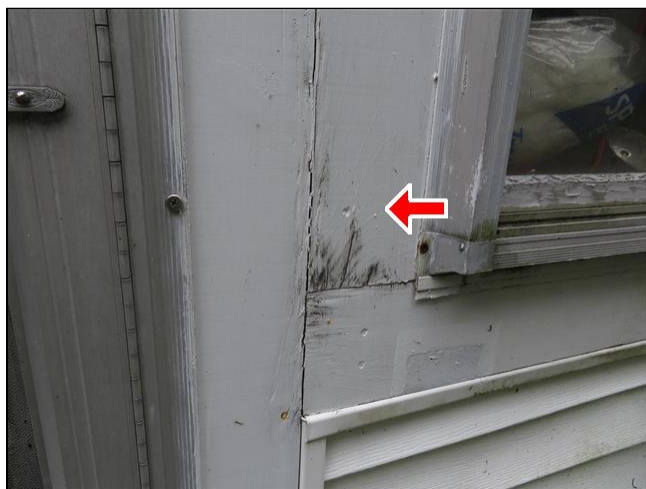
(5) Areas of the trim and exterior were noted to have areas of rot and decay. This is not unusual. Painted or not, wood trim will eventually rot when it is outdoors. Trim maintenance should be regarded as an ongoing activity and tended to from time to time. It is recommended that the issue be further assessed and required repairs effected.

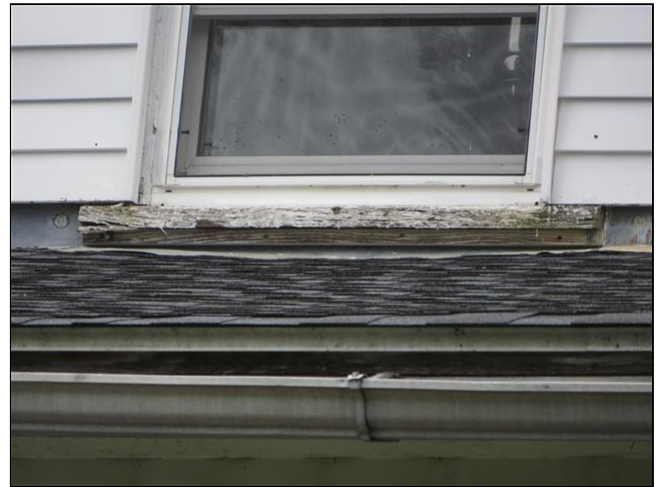
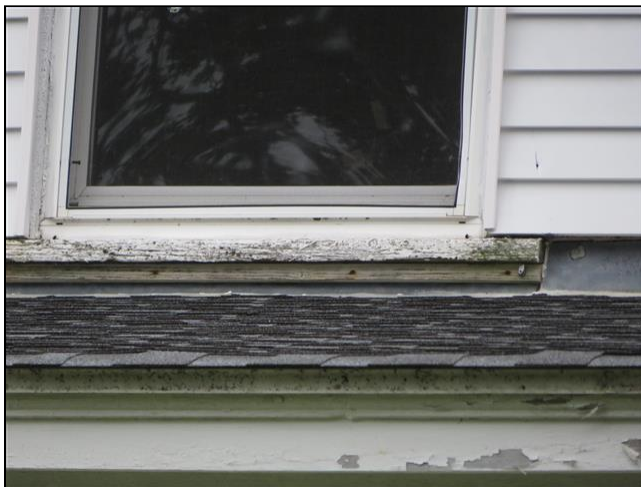
(2) A degree of decay and rot was noted with the front exterior window trim. While the issue did not appear significant at the time of the inspection, continued decay may lead to issues of water intrusion and damage to adjacent components. It is recommended that repairs be effected and that these components be monitored from time to time for further such issues in the future. (Note: The photos are not an exhaustive list of the affected areas, but a representation.)

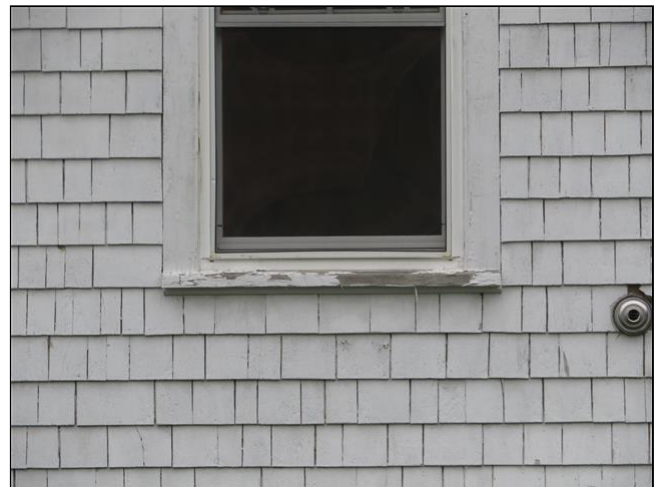
1.3 Item 4(Picture) Rear

(3) There is a crack in one of the rear windows. Cracked or broken windows are considered a potential safety concern as they present the risk of injury. Repairs should be effected to this an all occurrences of cracked glass.

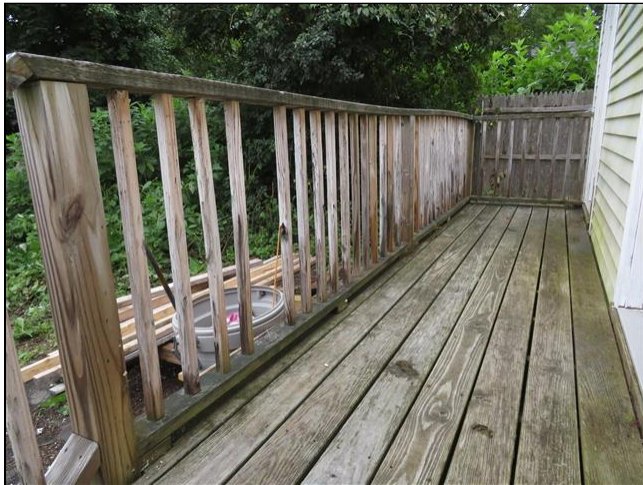
1.5 Item 4(Picture) Left side

(3) The structure under the deck was not visible due to the installation of finishes. No notable issues or concerns presented with the (limited) visible components.

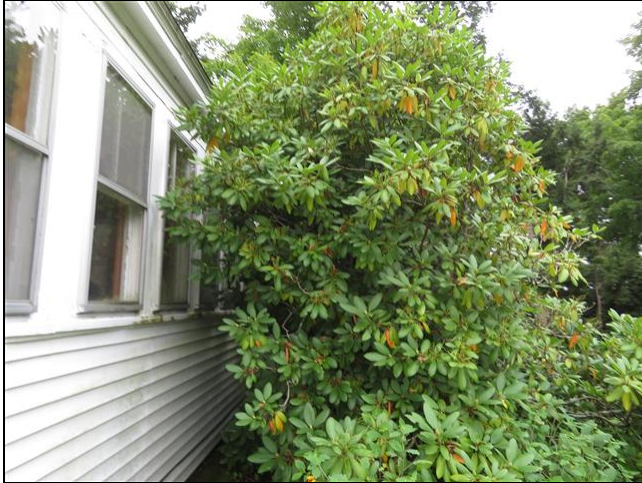
1.6 Item 8(Picture) Front

(5) Vegetation is in contact with the structure or foundation in one or more places. When vegetation is allowed to grow on to or touch a structure it can allow excessive moisture to build up in the area and also facilitate the entry of insects and pests to the structure. Moisture build-up can facilitate the growth of mold, mildew and rot. Vegetation should be kept trimmed and away from contact with buildings. This should be regarded as a normal ongoing maintenance activity.

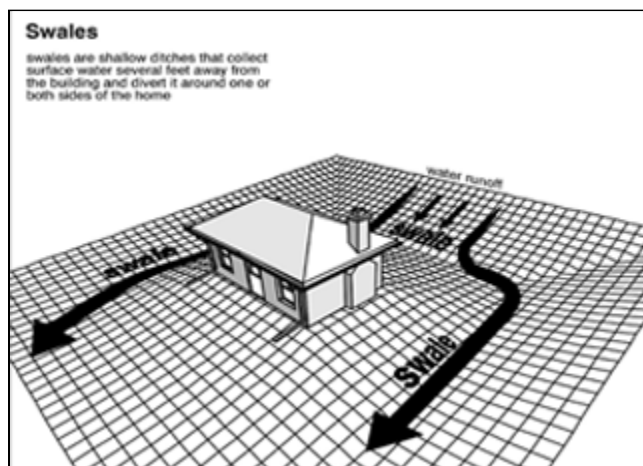
1.6 Item 9(Picture) Illustration

(6) The general grading at the rear of the building was pitched into the building (negative pitch). Ideally grading should be pitched away from the building, or such that the building is higher and the ground drops away (positive pitch). The issue with a negative pitch is that water is guided towards the foundation of the building which can lead to basement moisture issues and potentially foundation erosion issues. Some limited evidence presented in the basement of water intrusion (moisture). The scale and magnitude of the issue suggest that remediation approaches should be considered. Such approaches could include swales, re-grading, and perimeter drainage systems.

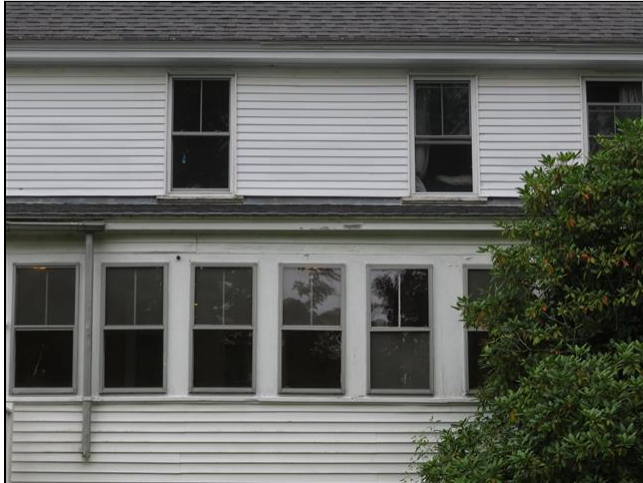
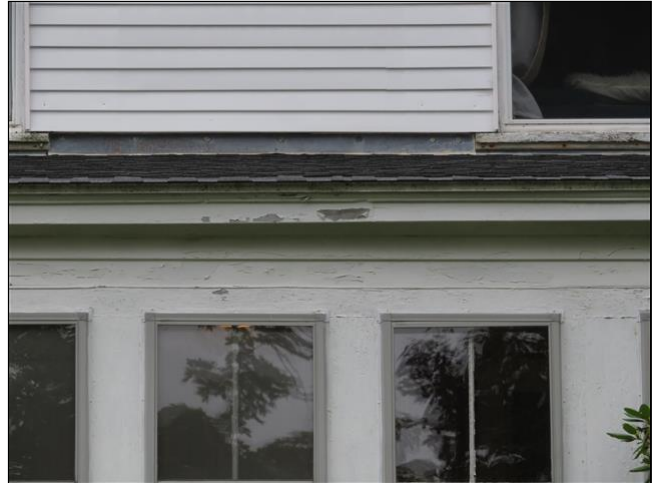
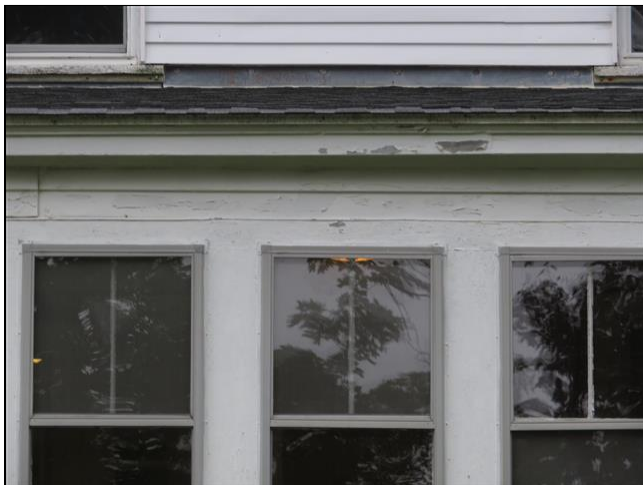
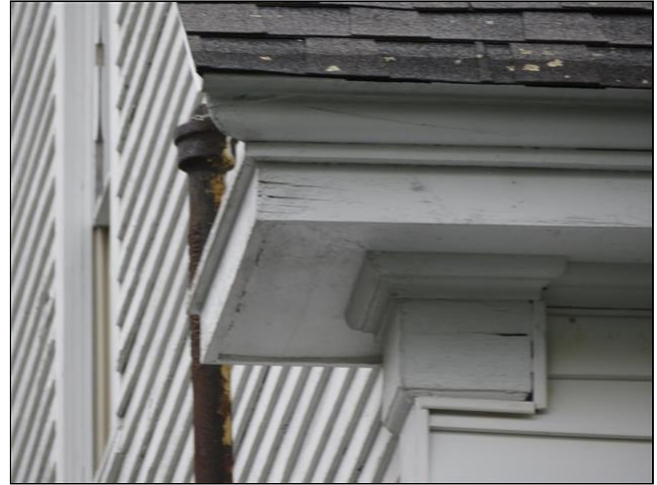
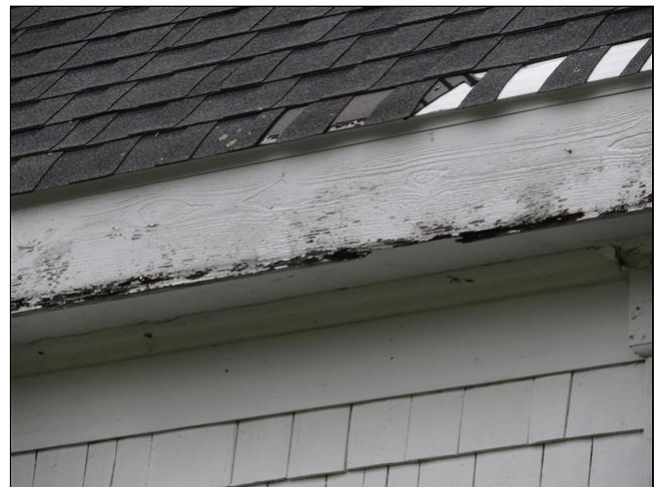
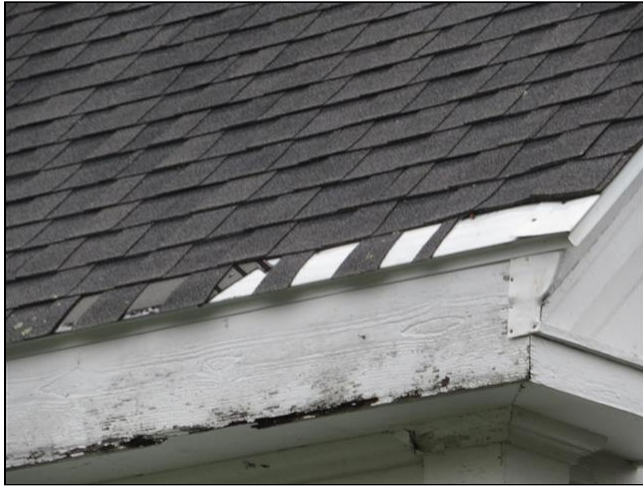
(1) Some minor areas of failing and peeling paint were observed on areas of the fascia and soffit. The extent of the damage that was observed would be regarded as relatively minor. While this type of deterioration of the paint is not unexpected with wood trim, it does require periodic repair and maintenance. When left unattended, the paint will continue to decay exposing the underlying wood which will be at risk for rot and decay. It is suggested that repair and maintenance of the painted wood be considered as a regular ongoing maintenance activity and be attended to. (Note: The photos are not an exhaustive list of the affected areas, but a representation.)

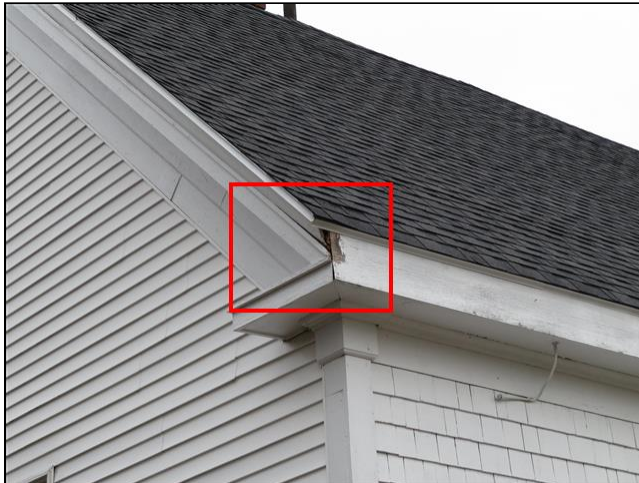
1.7 Item 9(Picture) Rear

(4) Defects (gaps, voids, or opening) were noted in the rear fascia and trim. Such openings can allow pests (insects or rodents) to gain access and nest. There is also a risk of water intrusion that can result in rot or mold issues. It is advisable that repairs be effected.

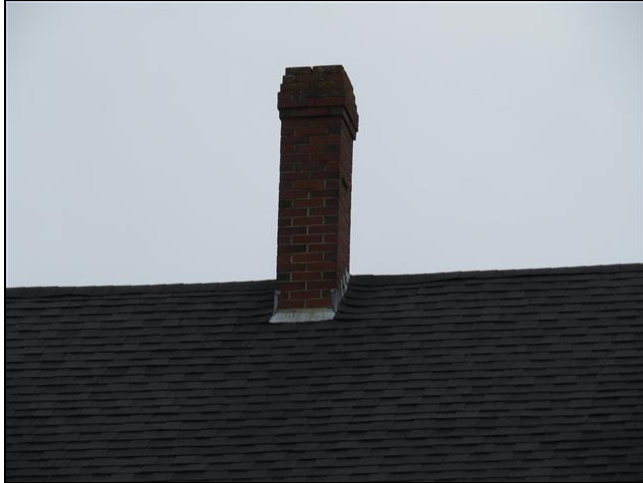
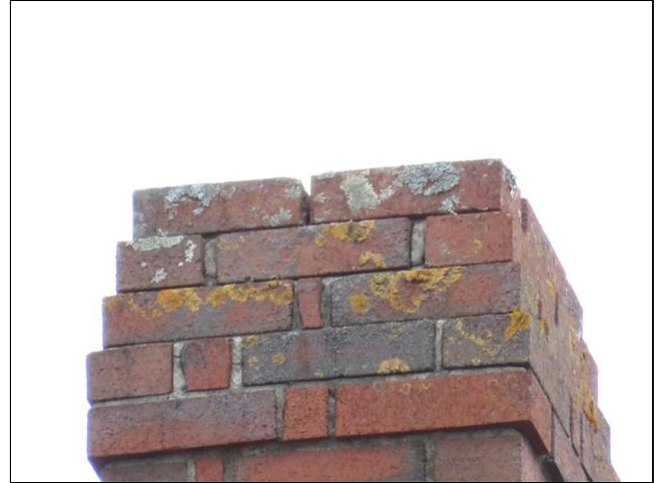
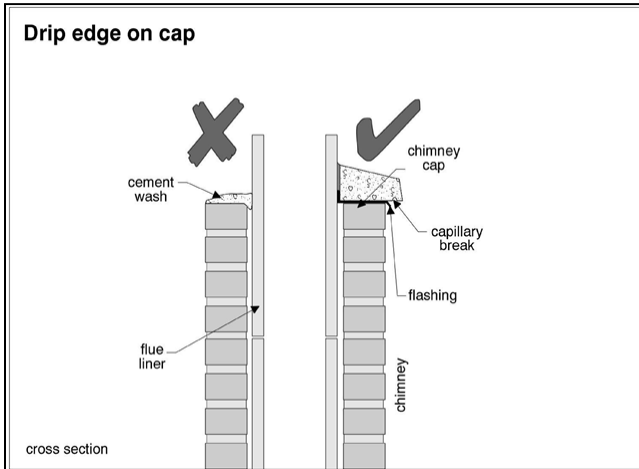
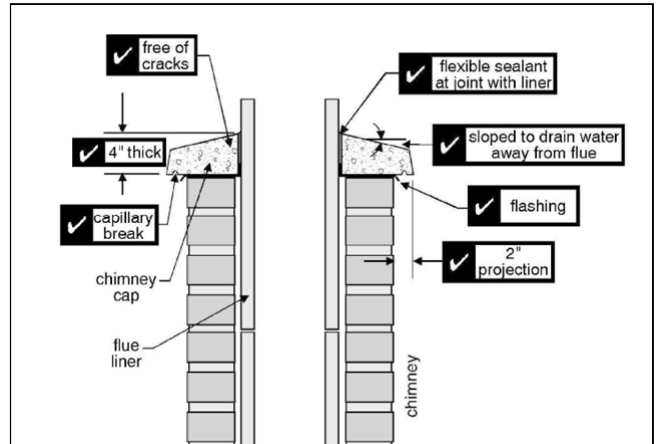
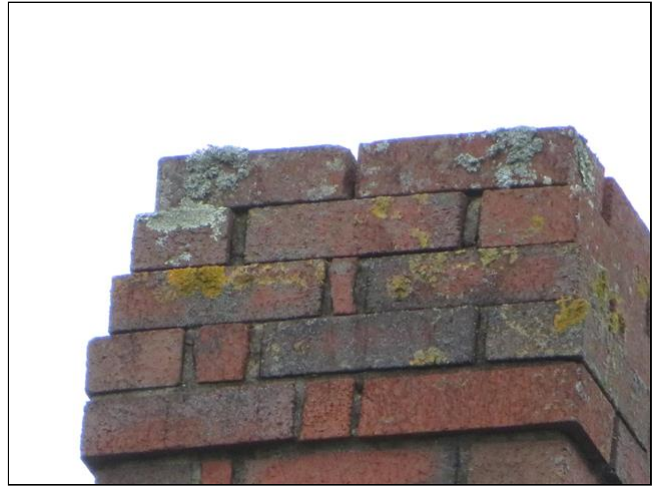
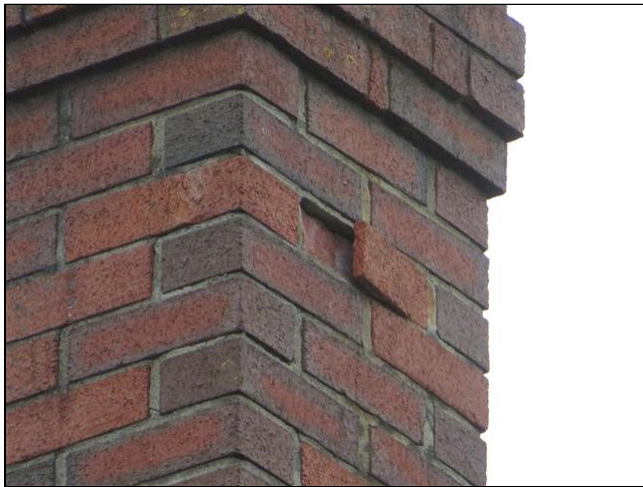
(1) It appeared that the chimney cap may be decayed or otherwise deficient. The chimney cap is an important component that helps prevent water (and snow/ice) from accumulating on top of the chimney. Moisture that accumulates on top of the chimney in the winter time can freeze and further damage the chimney materials. In the warmer months, the moisture can seep into the mortar and brick and degrade the structure. It is recommended that repairs be considered.

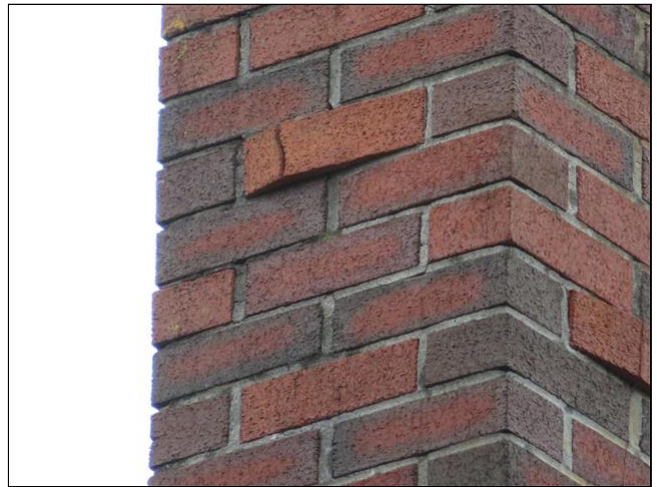
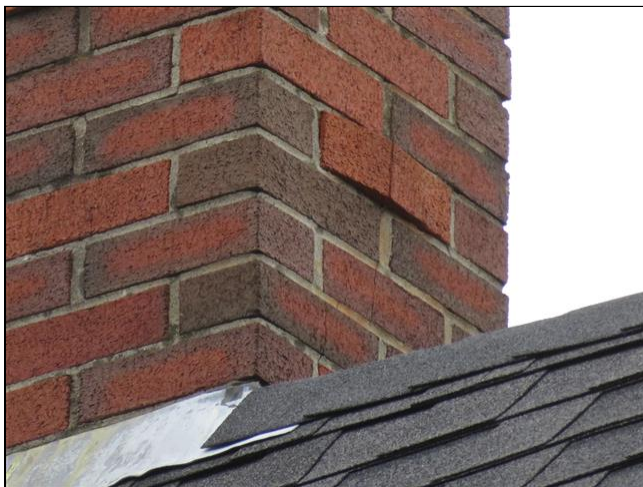
(3) It appeared that the chimney cap may be decayed or otherwise deficient. The chimney cap is an important component that helps prevent water (and snow/ice) from accumulating on top of the chimney. Moisture that accumulates on top of the chimney in the winter time can freeze and further damage the chimney materials. In the warmer months, the moisture can seep into the mortar and brick and degrade the structure. It is recommended that repairs be considered.

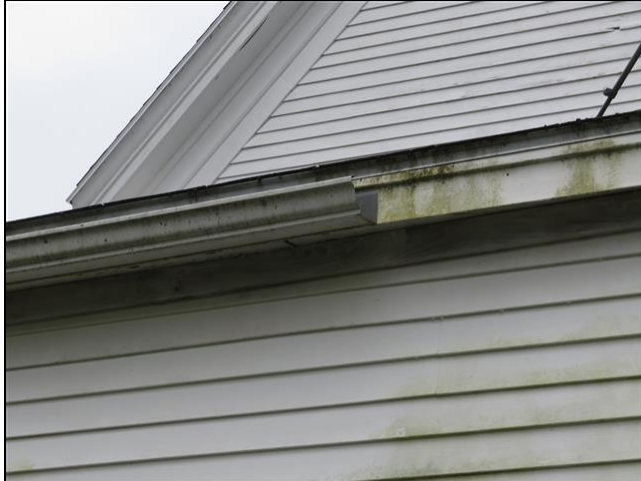
2.4 Item 3(Picture) Left side

(3) The downspouts were observed to drain at the foundation of the building. Best practices suggest that downspouts should be directed to drain 4 to 6 feet away from foundations. Not doing so can lead to the foundation being exposed to excessive water and moisture and might result in water penetration, leaks, and excessive moisture in the basement. It is recommended that modifications and repairs be effected to all such instances.

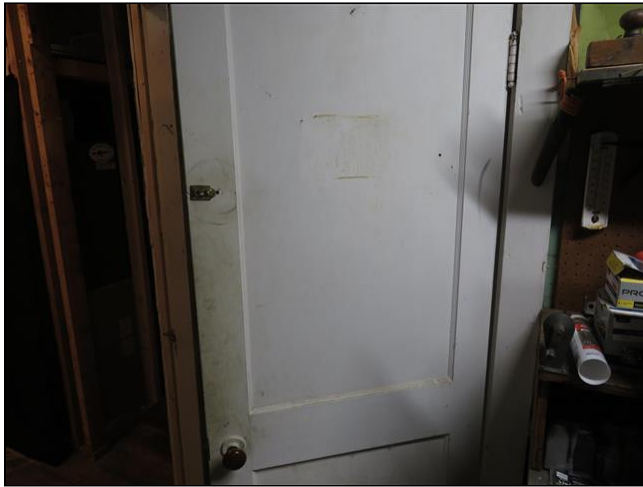
3.7 Item 1(Picture) Attached garage

The occupant door from inside the garage area to inside the living space (including basements and attics) appears potentially not to be a fire rated door. This means that should a fire occur in garage, the occupant door does not afford protection until fireman arrive. By today's standards, and depending upon the area, it is conventionally expected (according to standards) that: *"Openings from a private garage directly into a room used for sleeping purposes shall not be permitted. Other openings between the garage and residence shall be equipped with solid wood doors not less than 1 3/8 inches (35 mm) in thickness, solid or honeycomb core steel doors not less than 1 3/8 inches (35 mm) thick, or 20-minute fire-rated doors."* While the specific requirements of areas may vary, it is recommended that the issue be further assessed (e.g. consult the authority having jurisdiction) and any required repairs effected. Additional discussion of this type of issue can be found in the "General Comments" section of this report in the sub section titled "Life and Safety Issues and Considerations".

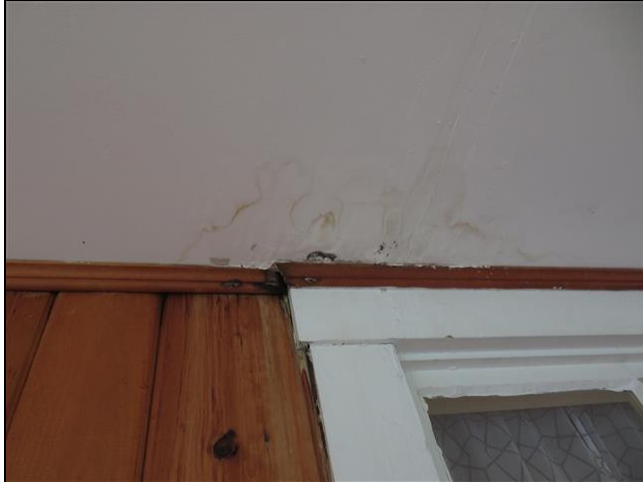
4.1.A Item 1(Picture) Front room

(2) Stains were noted on the front room ceiling that appeared to potentially be from a water leak. Testing the stains for moisture levels indicated that their moisture level was similar to the surrounding area suggesting that the cause of the staining is not active. That said, it is recommended that the area be monitored for future activity/progression.

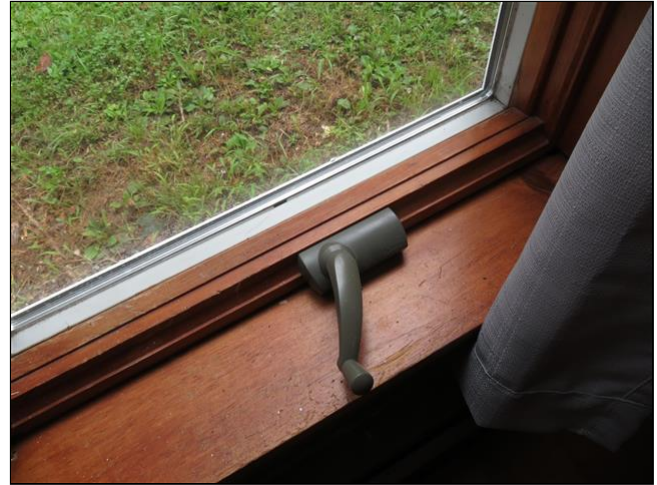
4.5.A Item 2(Picture) Living room

The mechanisms that operate the windows in the living room was in a state of disrepair. It is recommended that the mechanism (and all other inoperable mechanisms) be repaired or replaced.

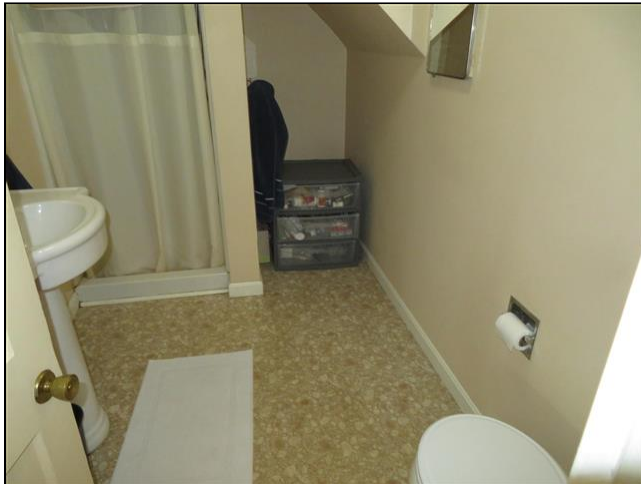
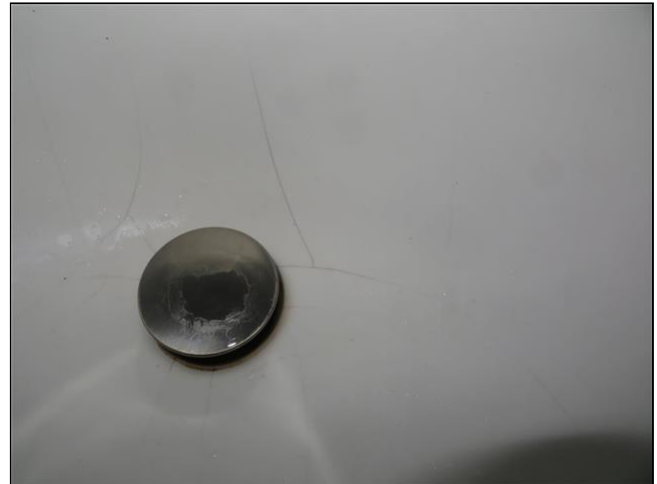
4.8.A Item 1(Picture) Hall bath

(2) A bathroom sink in the hall bath was noted to be cracked and/or broken. It is recommended that the sink be replaced.

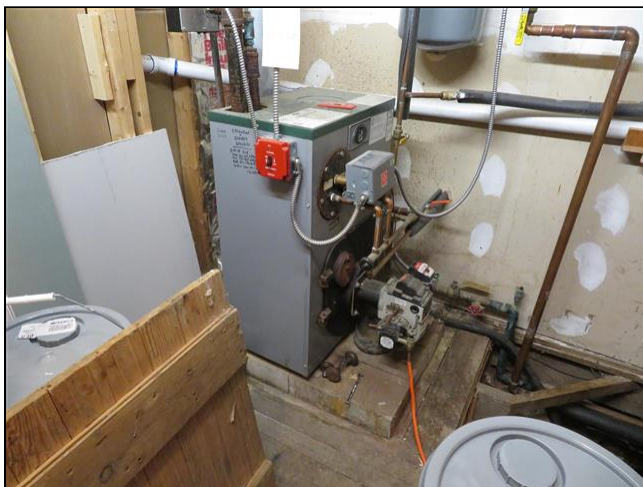
4.21.A Item 1(Picture) Utility room

No issues or concerns of significance were observed with the boiler or operation to the extent that it was tested and observed. Industry sources suggest that the boiler was manufactured in 2011. It is not unreasonable to expect boilers to last in the range of 35 to 45 years, although some can last substantially longer, and others fail sooner.

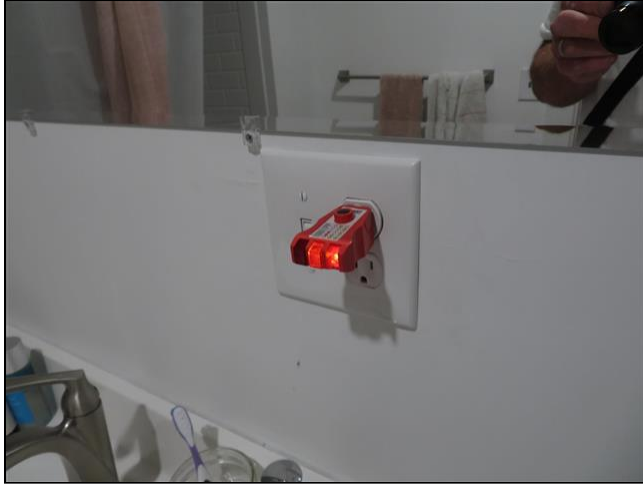
4.17.B Item 2(Picture) Bath

(2) The receptacle noted in the bath was not GFCI (Ground Fault Circuit Interruption) protected. Receptacles in wet areas (such as kitchens, bathrooms, garages, outside, and unfinished basements) can pose shock hazards if they are not on GFCI-protected circuits. It is advisable that repairs or modifications be made by installing GFCI protection to this receptacle (and all other required receptacles).

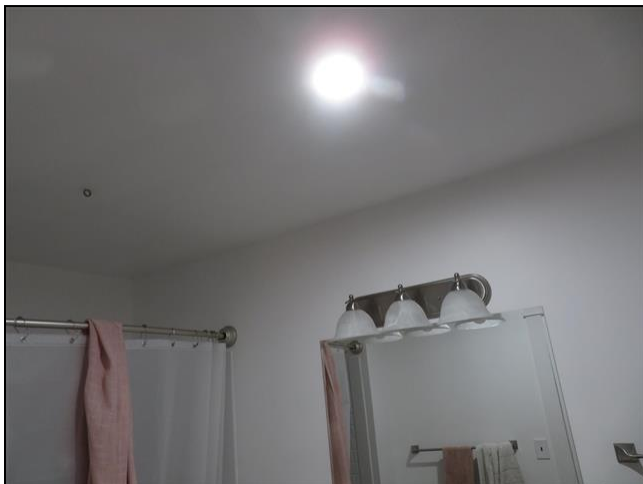
4.19.B Item 1(Picture) Bathroom

(1) The hall bath did not have an exhaust or ventilation fan. They are particularly beneficial when there are no windows, and in fact are required. Bathrooms can introduce a substantial amount of moisture into the air in a home, and excess air moisture can potentially lead to issues relating to mold, mildew and unhealthy indoor air quality. It is recommended that a bathroom exhaust fan be installed.

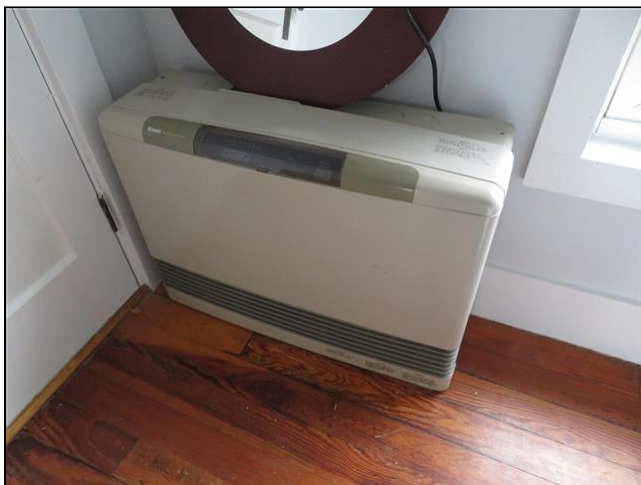
4.23.B Item 1(Picture) Bedroom

(1) No issues or concerns of significance were observed with the direct vent wall heater or operation to the extent that it was tested.

Industry sources suggest that the heater appears to have been manufactured in 2004. It is not unreasonable to expect heaters of this type to last in the range of 20 to 35 years, although some can last substantially longer, and others fail sooner.

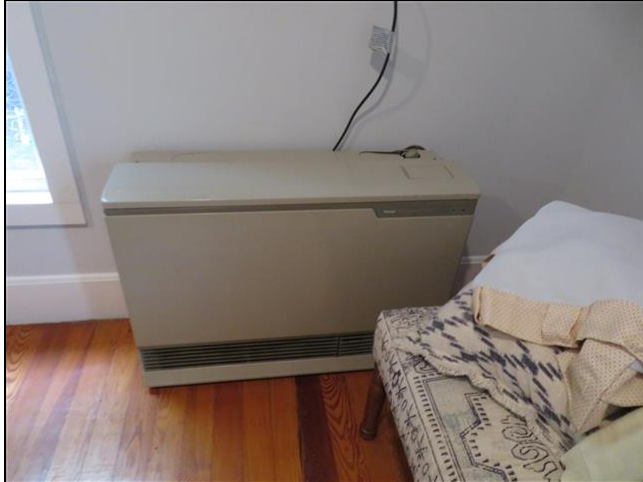
4.23.B Item 2(Picture) Living room

(2) No issues or concerns of significance were observed with the direct vent wall heater or operation to the extent that it was tested.

Industry sources suggest that the heater appears to have been manufactured in 2004. It is not unreasonable to expect heaters of this type to last in the range of 20 to 35 years, although some can last substantially longer, and others fail sooner.

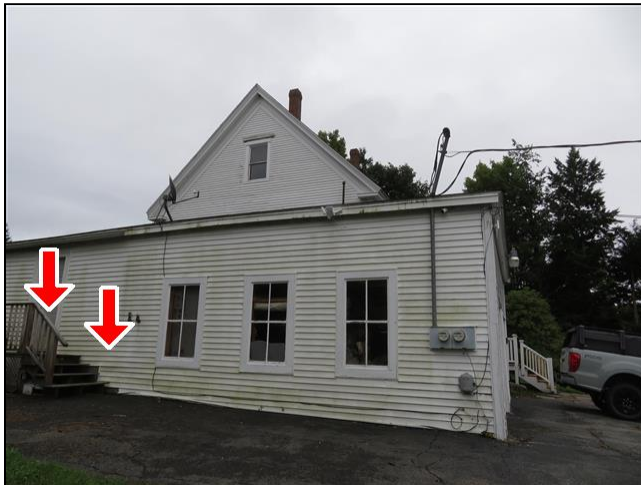
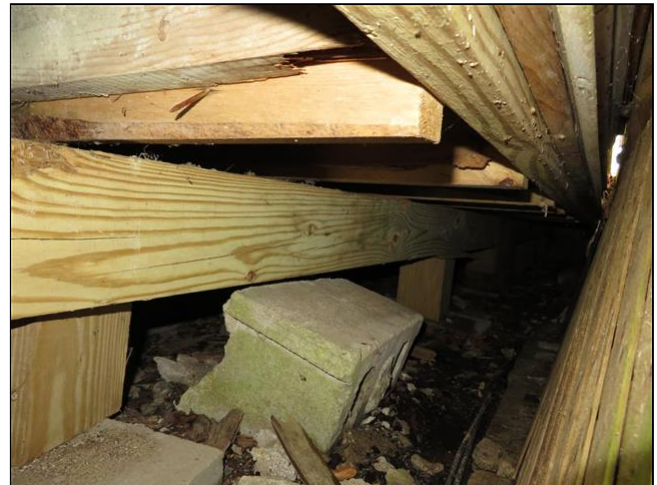
(8) The visibility of the left foundation was limited or extremely limited due to limited access. The areas that were visible were assessed and inspected. There are areas of the foundation that could not be seen and it is possible that issues and defects were not visible.

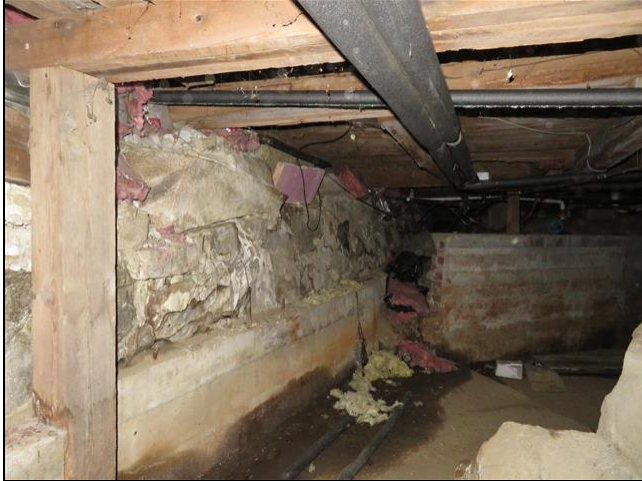
5.1 Item 3(Picture) Crawlspace

(9) Minor evidence of water intrusion was noted in the crawlspace. While not significant, it is recommended that means be undertaken to mitigate the issue. Water intrusion into a basement or crawlspace area through the walls can, over time, lead to the degradation of the integrity of the foundation walls. Such measures may include ensuring the proper operation of the gutters in the adjacent exterior area, ensuring that water cannot accumulate around the foundation, and ensuring the that exterior perimeter drainage is working.

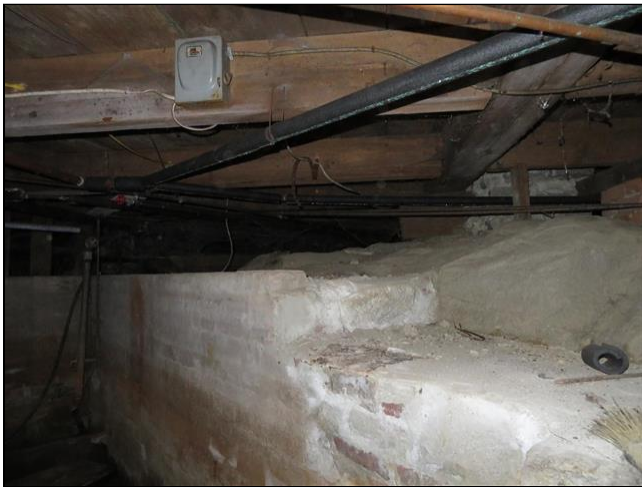
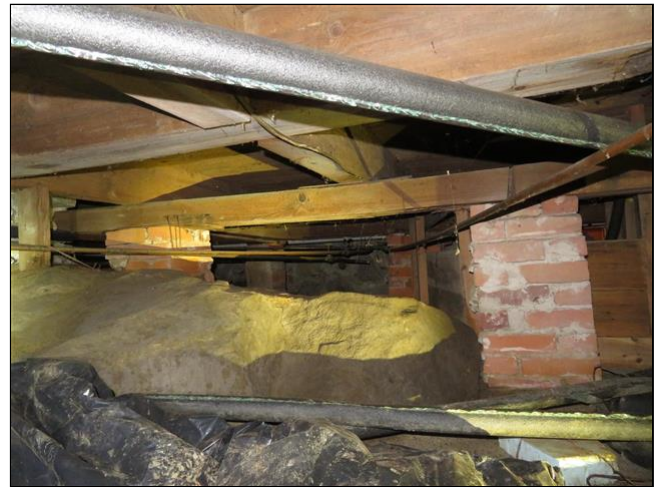
5.1 Item 4(Picture) Crawlspace

(10) There was limited access to the foundation area under the building. The part of the building had a basement or crawlspace area that was generally not accessible, or the access was extremely limited. There are structural components, systems, and utilities that were not accessible or generally not accessible and could not be adequately inspected.

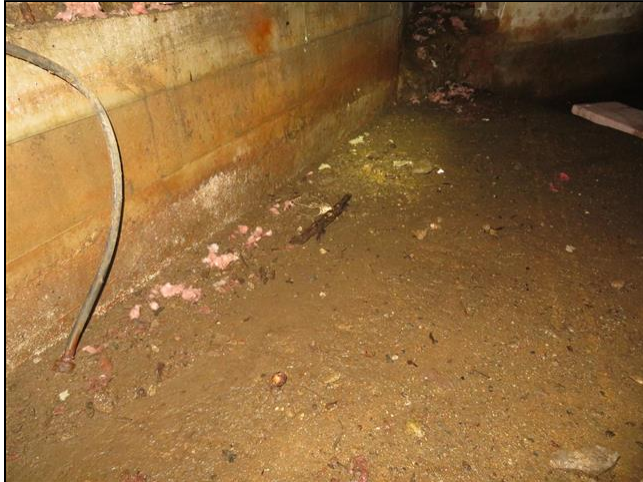
5.1 Item 6(Picture) Basement

(11) Evidence of water intrusion was noted in the basement. While not a large scale issue, it is recommended that means be undertaken to mitigate the issue. Water intrusion into a basement or crawlspace area through the walls can, over time, lead to the degradation of the integrity of the foundation walls. Such

measures may include ensuring the proper operation of the gutters in the adjacent exterior area, ensuring that water cannot accumulate around the foundation, and ensuring the that exterior perimeter drainage is working.

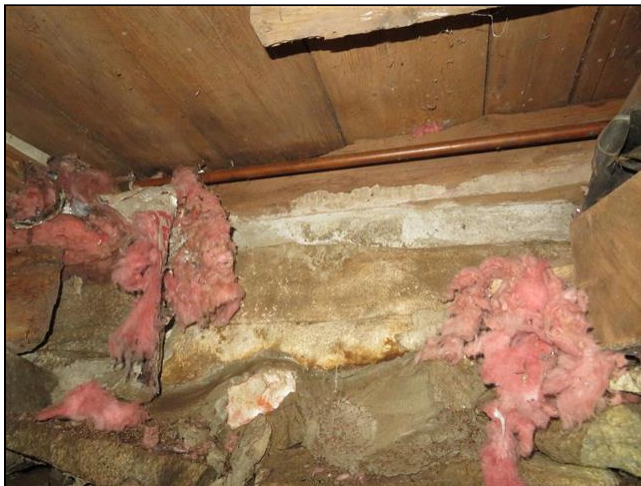
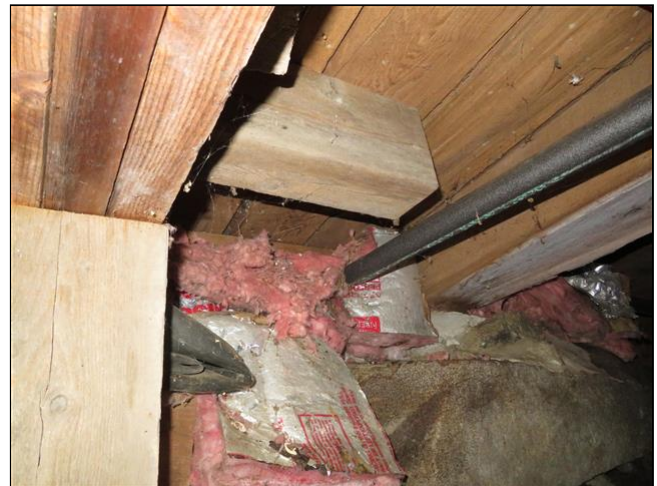
5.1 Item 7(Picture) Basement

(12) Evidence of pests were observed in the basement. Patterns and disturbance in materials (insulation) consistent with nesting or intrusion were noted. Other evidence was also noted in the form of sebum trails or other disturbances. This appearance of nesting materials is similar in appearance to those made by mice. It is recommended that means be undertaken to remove the pests from the building, and that the nesting and other areas be cleaned and removed. Further, it is recommended that the damaged insulation be replaced.

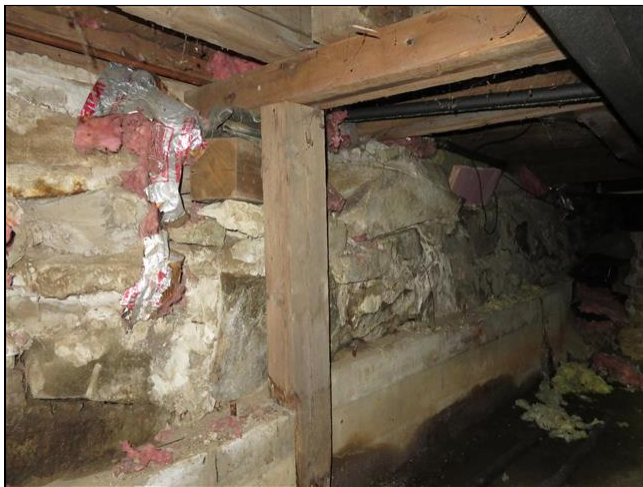
5.3 Item 1(Picture) Crawlspace

(2) The condition of the area of the foundation that was viewable appeared at least as good as to be expected for a building of this age and in the environment. No significant breaches, damage, abnormalities, or issues were noted.

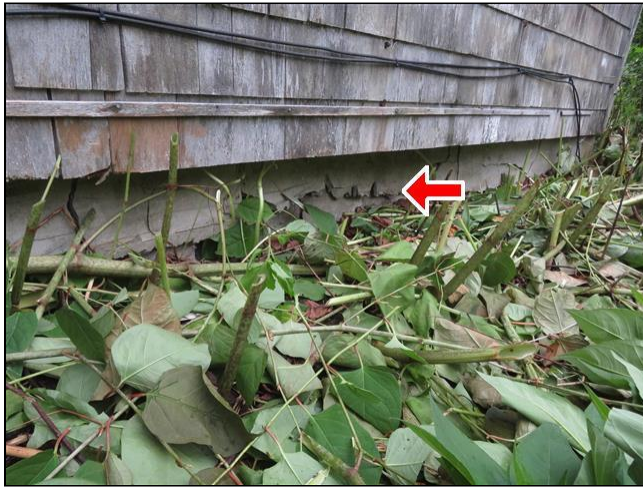
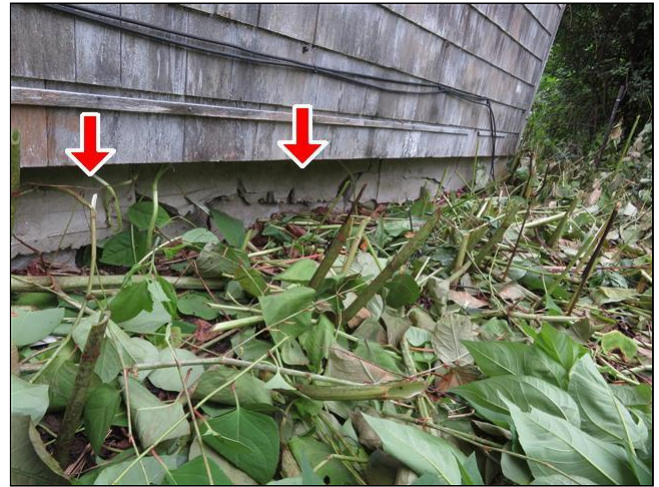
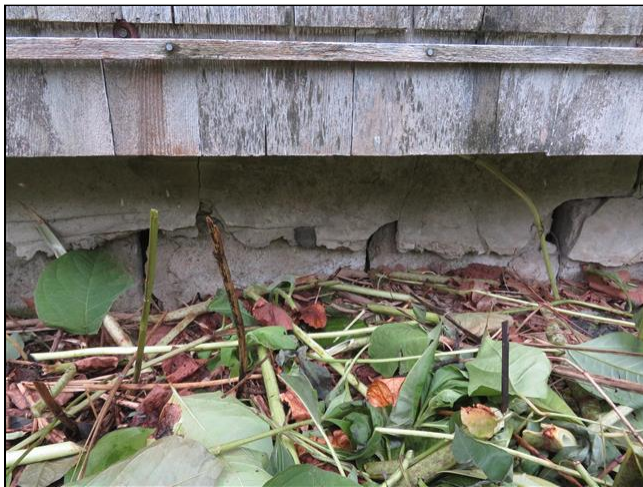
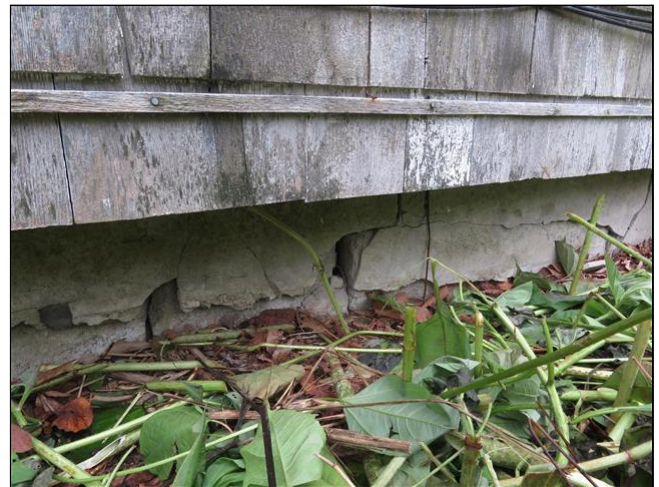
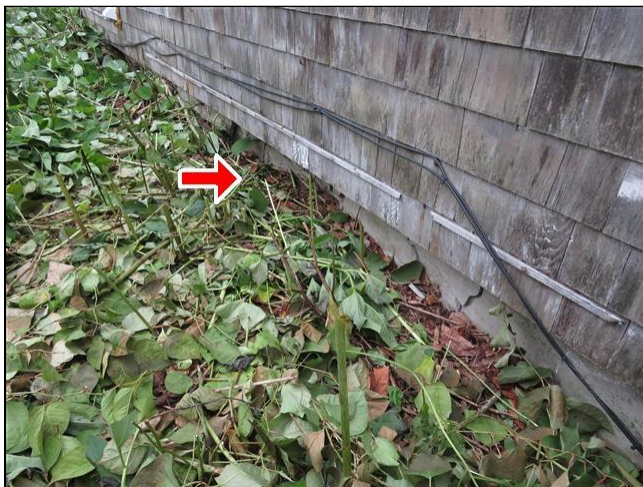
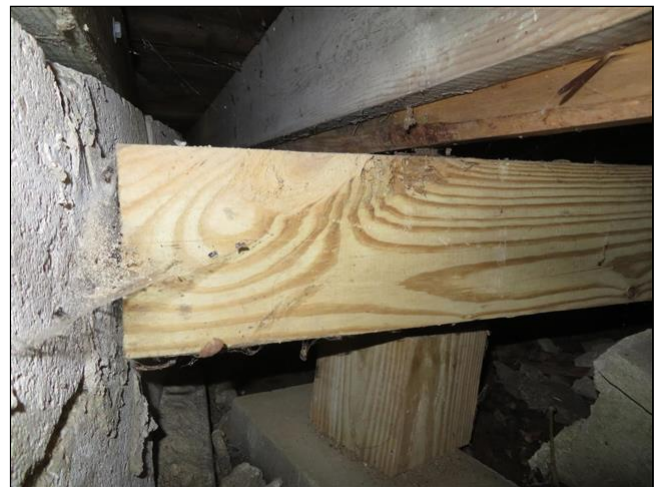
(3) A deformity was noted in the rear of the foundation under the garage. The cause was not evident. The appearance of the deformity was not dissimilar to one cause by a lateral force pushing in on the wall. There was inadequate access from the interior to determine the extent of the significance of the deformity.

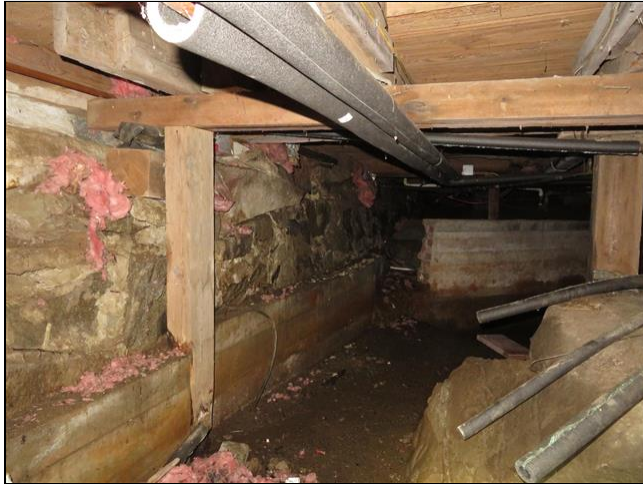
5.4 Item 1(Picture) Crawlspace

Some degree of water damage was noted at the bottom of the columns in the crawlspace. This damage likely occurred from moisture or water on the floor. Measures should be taken to minimize the exposure of the columns to moisture. There are situations where sump pumps can be helpful. Managing the potential intrusion of water into the area is also recommended. This can mean exterior perimeter drainage. Additionally, replacing the columns with the worst damage should be considered.

It is important that wood not come in contact with concrete or soil/dirt, as the wood will absorb moisture. To that end, it would be an idea to install a plastic barrier under the columns to separate them from direct contact with the floor.
