INSPECTION PERFORMED BY

INSPECTOR:
John Howard
Breakwater Inspections

PREPARED FOR:
Alex Rowe

PROPERTY ADDRESS:
84 School Street, Waldoboro, ME 04572

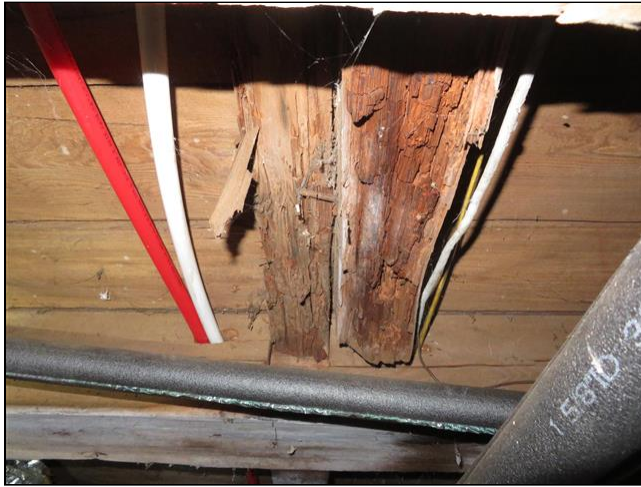
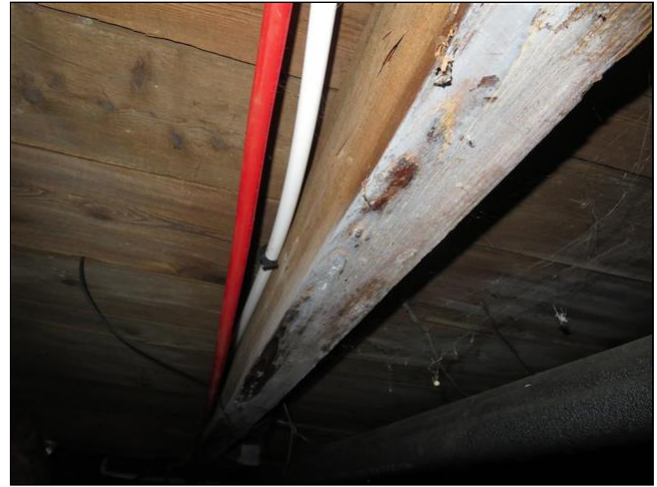
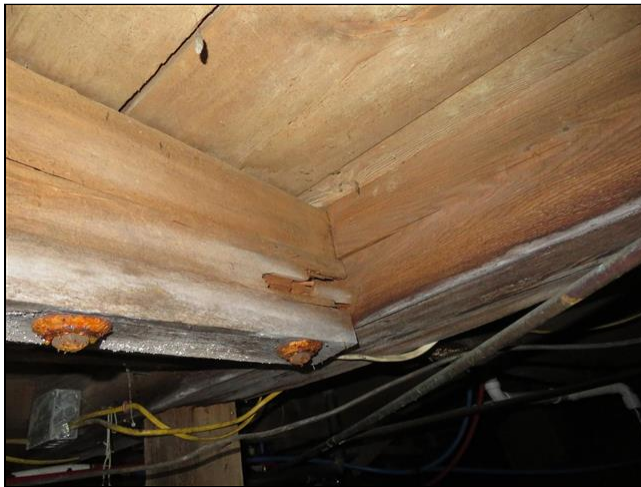
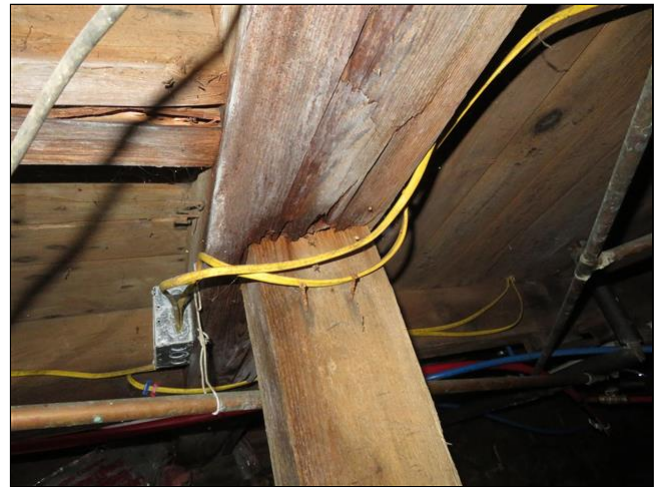
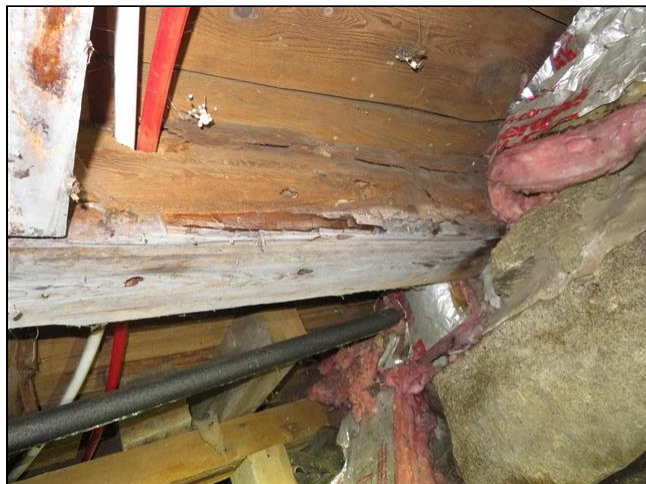
5.5 Item 1(Picture) Crawlspace

(2) Some of the floor joists (basement ceiling structure) presented with some degree of decay. The degree of damage was notable and appeared extensive. There is a risk that the damage may have resulted in structural compromise. It is recommended that the issue be further assessed and required repairs effected.

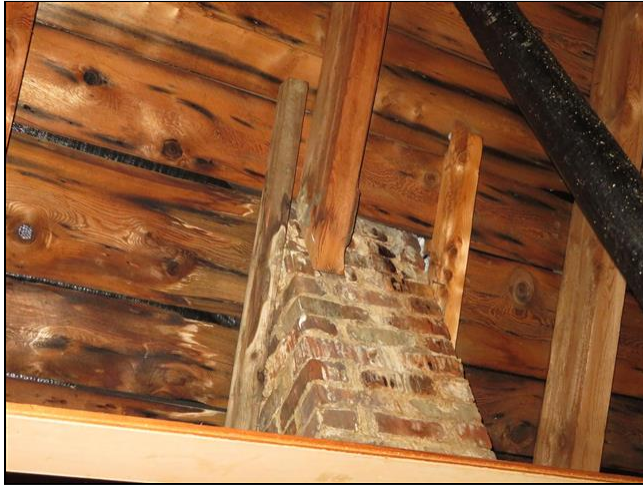
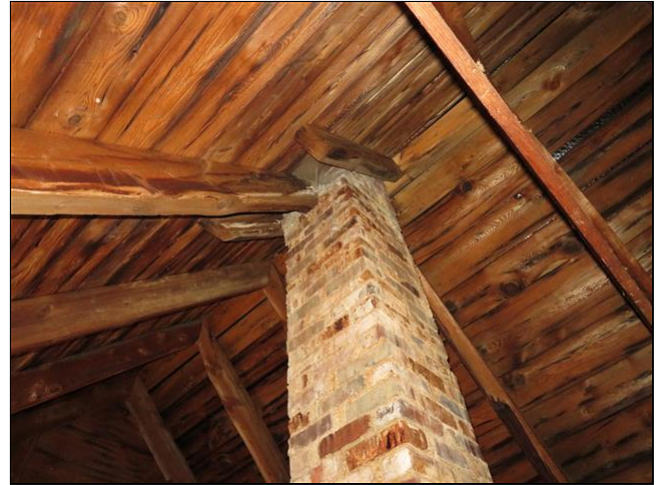
5.7 Item 3(Picture) Attic

(2) Areas of the attic displayed signs of water staining. While the stains appeared dry, and potentially not active, there appeared to be evidence of past water penetration. Water or moisture penetration into attic spaces can result mold, mildew, rot, and in extreme cases; structural compromise. The area should be monitored and re-assessed to determine if there is potentially an active defect.

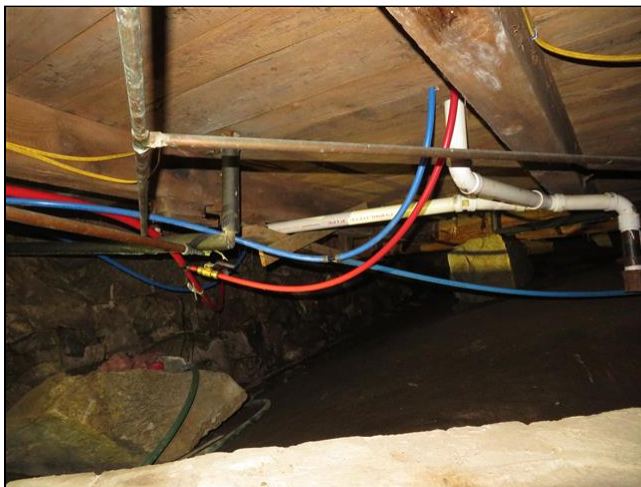
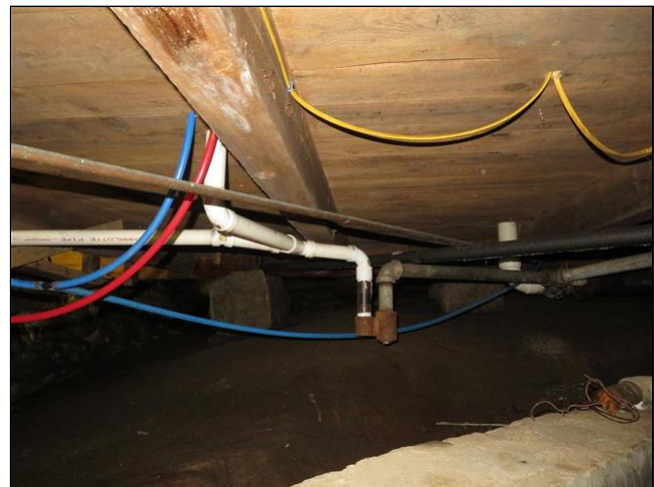
6.1 Item 1(Picture) Crawlspace

The drain system in the basement/crawlspace is not installed and secured in a way that is consistent with best practices or plumbing standards. There is a risk that the drain system could shift and the a leak could occur. It is recommended that repairs be effected.

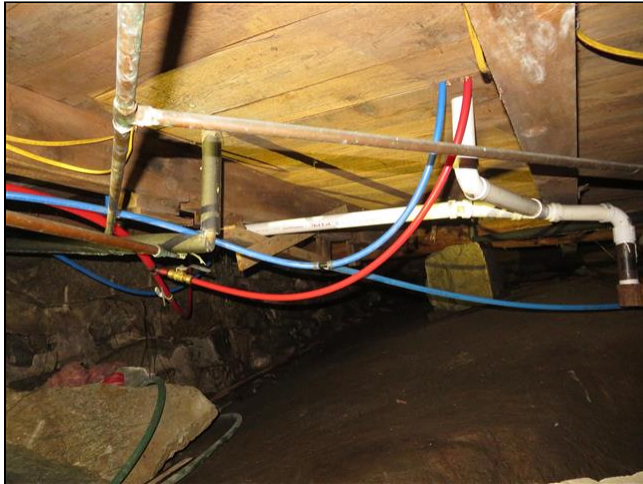
6.2 Item 1(Picture)

A plumbing supply line was noted that was not adequately secured or secured in a way that is consistent with best practices and accepted standards. Pipes that are not adequately installed or secured are at risk for damage or leaking from excessive stress, movement, or mechanical damage (jarring). It is recommended that the lines be appropriately secured.

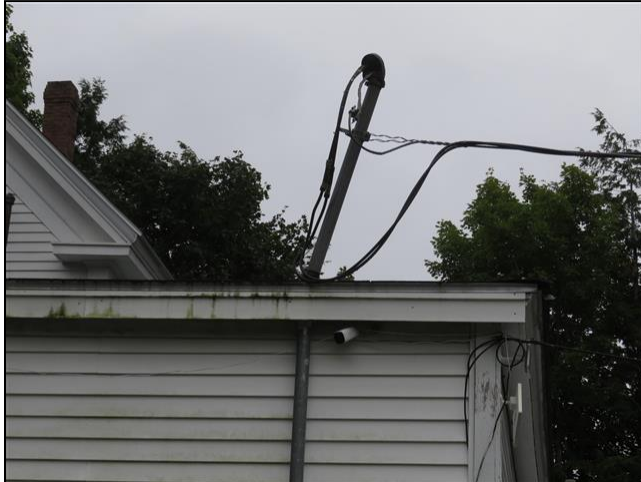
7.1 Item 1(Picture) Left side

The service drop is connected to the property by means of mast. While a common and acceptable approach, the mast is required to be sufficiently strong to support the weight (tension) of the service drop wire the connects to the utility pole. In this case, the mast was noted to be leaning and not adequately supported.

The common approach to this issue is to secure the mast with a guy wire. It is advisable that the issue be further assessed and repairs effected as required.

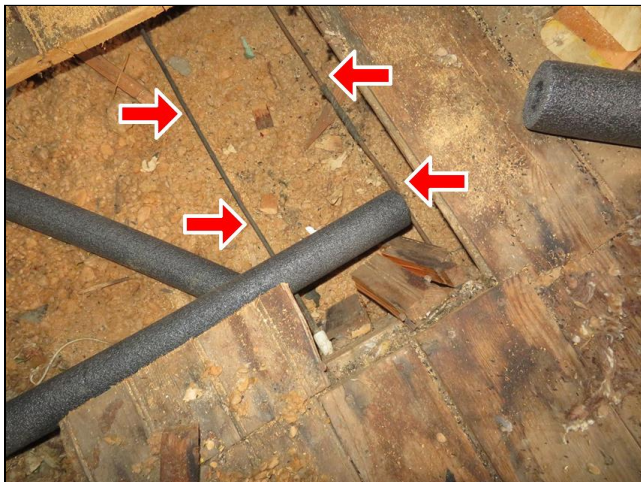
7.2 Item 1(Picture) Attic

(2) There was "Knob and Tube" wiring present in the attic. When tested the wire was observed to not be live. It is possible that the wire is on a switch leg, and switched off, but still in use. It is also possible that there may be knob and tube wiring present in areas that are concealed and not accessible. Further assessment is advised to determine if the wire is in use. As a rule knob and tube is considered obsolete and generally not safe. While there are arguments that it is acceptable if intact and in good condition, these are not generally accepted points. Knob and tube wiring was not designed for the types of electrical loads that exist in modern living styles. This is compounded by the tendency that exists to overload branch circuits by extending beyond ranges they were originally intended for. Additionally, knob and tube wiring was designed to have free air space around it (for cooling), and invariably over the years it insulation or other material is placed in contact with it. Finally, the insulation on the wire tends to dry and crack with age often exposing the conductors.

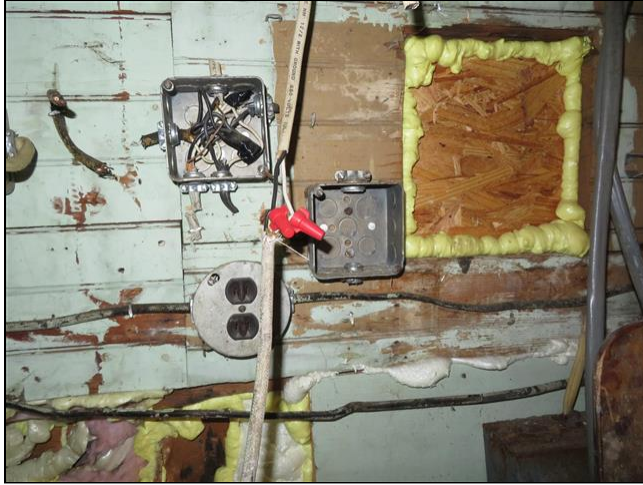
7.3 Item 1(Picture) Attached garage

(1) Improper electrical connections were observed in the attached garage. All electrical connections and splices should be in electrical boxes or done through other approved means. Improper electrical connections can present a risk of personal injury or electrical fire. It is advisable that repairs be effected.

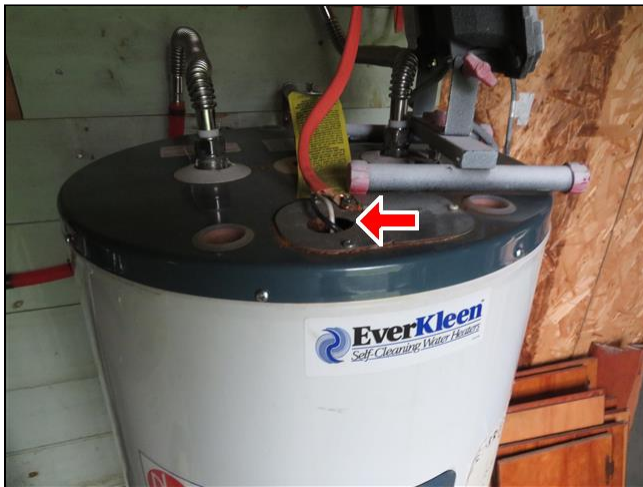
7.3 Item 2(Picture) Utility room

(2) Improper electrical connections were observed in the utility room. All electrical connections and splices should be in electrical boxes or done through other approved means. Improper electrical connections can present a risk of personal injury or electrical fire. It is advisable that repairs be effected.

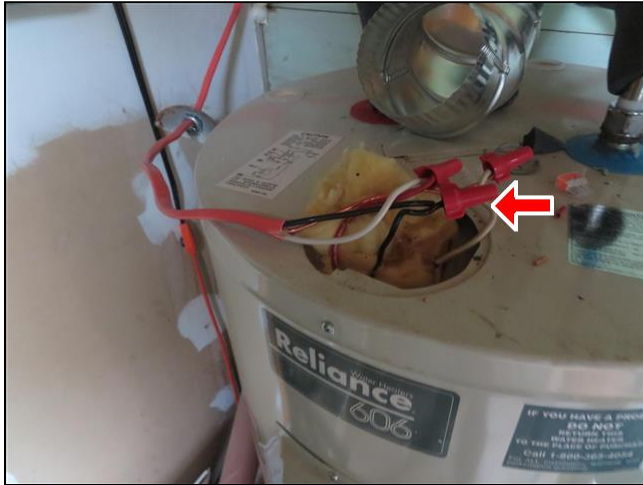
7.3 Item 3(Picture) Utility room

(3) Improper electrical connections were observed in the utility room. All electrical connections and splices should be in electrical boxes or done through other approved means. Improper electrical connections can present a risk of personal injury or electrical fire. It is advisable that repairs be effected.

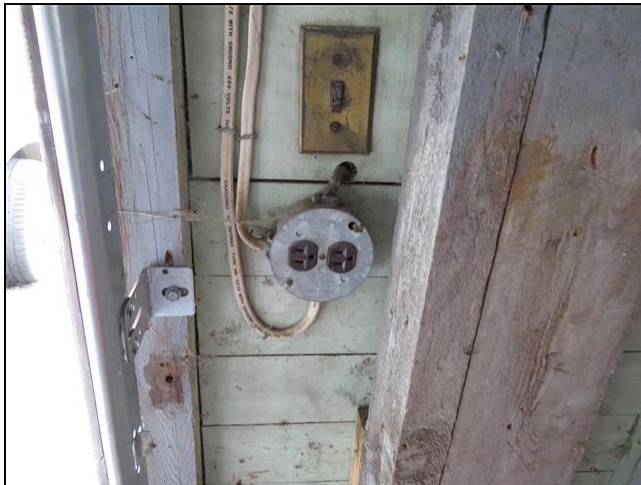
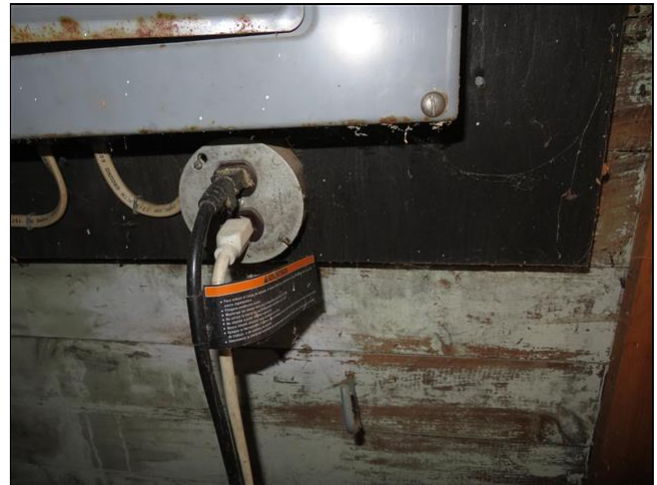
7.4 Item 1(Picture) Attached garage

(1) The receptacles noted in the garage were not GFCI (Ground Fault Circuit Interruption) protected. Receptacles in wet areas (such as kitchens, bathrooms, garages, outside, and unfinished basements) can pose shock hazards if they are not on GFCI-protected circuits. Specifically, the requirement from the standard reads: *"Garages, and also accessory buildings that have a floor located at or below grade level not intended as habitable rooms and limited to storage areas, work areas, and areas of similar use"*. It is advisable that repairs or modifications be made by installing GFCI protection to these receptacles (and all other required receptacles).

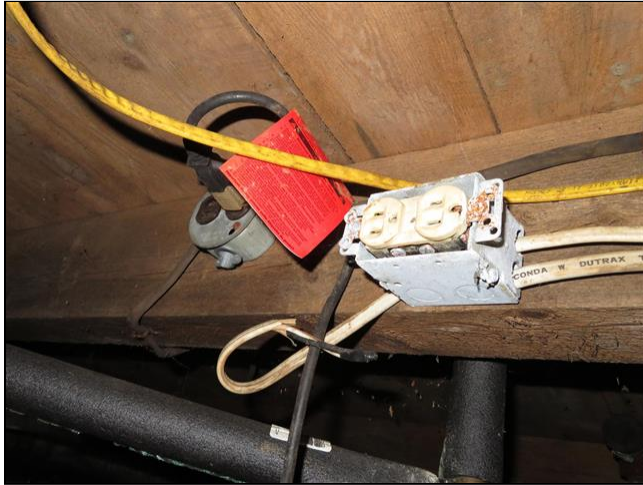
7.4 Item 3(Picture) Crawlspace

(2) The receptacles noted in the unfinished basement/crawlspace were not GFCI (Ground Fault Circuit Interruption) protected. Receptacles in wet areas (such as kitchens, bathrooms, garages, outside, and unfinished basements) can pose shock hazards if they are not on GFCI-protected circuits. Specifically, the requirement from the standard reads: *"Unfinished basements — for purposes of this section, unfinished basements are defined as portions or areas of the basement not intended as habitable rooms and limited to storage areas, work areas, and the like"*. It is advisable that repairs or modifications be made by installing GFCI protection to these receptacles.

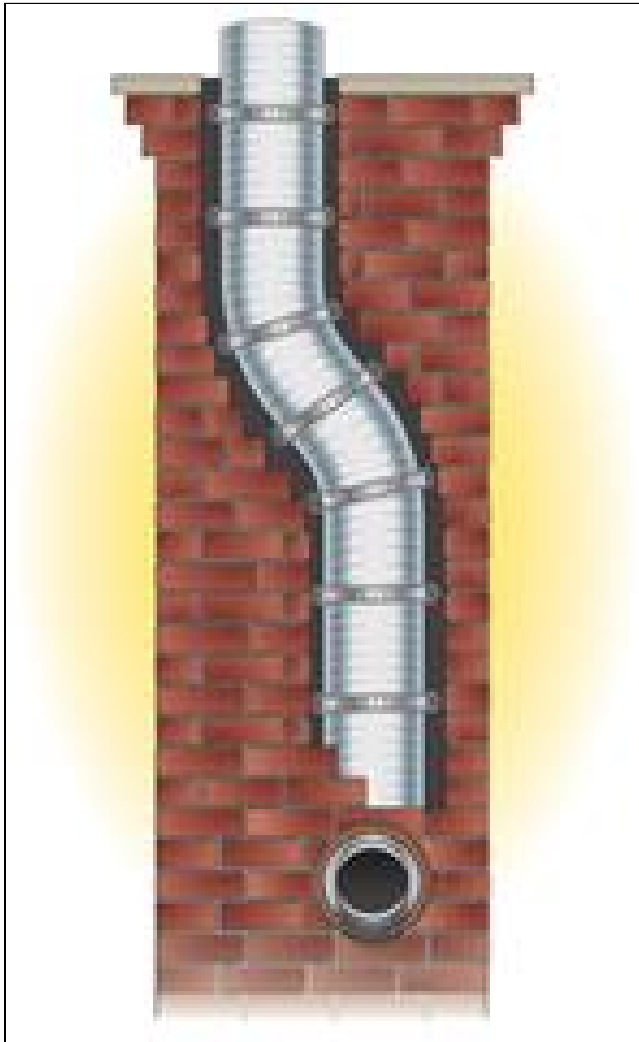
8.0 Item 4(Picture) Illustration

Another consideration is NFPA 211, which is a set of standards which the State has adopted as a rules (laws). Section 7.2.2.1 states "Masonry chimneys shall be lined."

It is recommended that the issue be further assessed and required repairs effected. Further, the authority having jurisdiction should be contacted for any additional information.

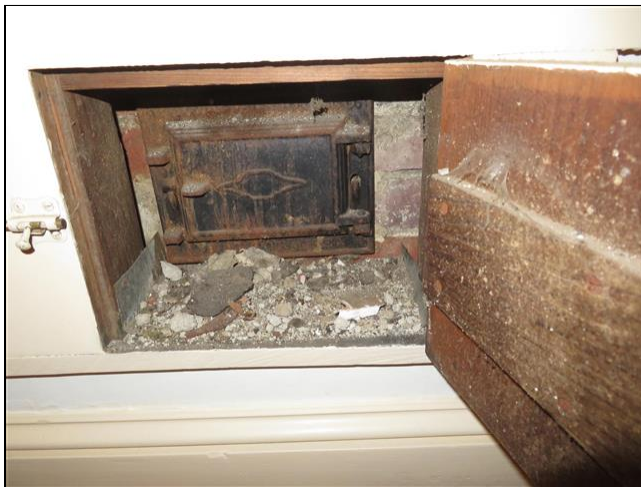
8.0 Item 7(Picture) Right side chimney

(3) The cover for the flue cleanout was not operable, and the flue was not accessible for inspection. It is recommended that repairs be effected and the flue inspected.

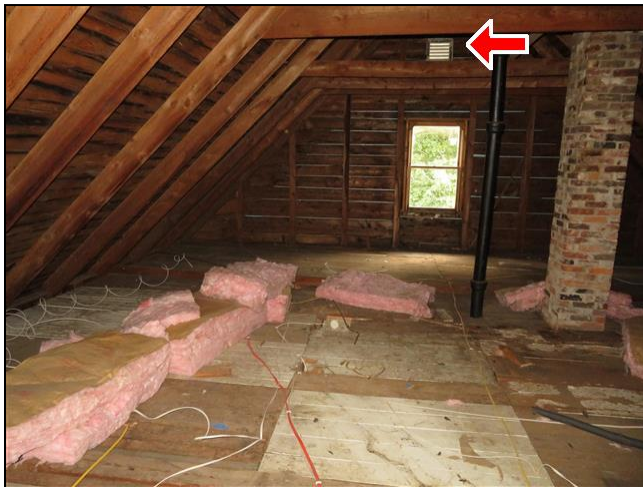
9.3 Item 1(Picture) Attic

Roof and attic ventilation is accomplished by means of a single gable vent. This approach would generally be regarded as insufficient to allow adequate air flow. It is recommended that a second gable vent be added.
