Commercial Inspection Report

Inspection Date:
03/25/2024

Report Number:
20240325

**1655 San Carlos,
San Carlos, CA**

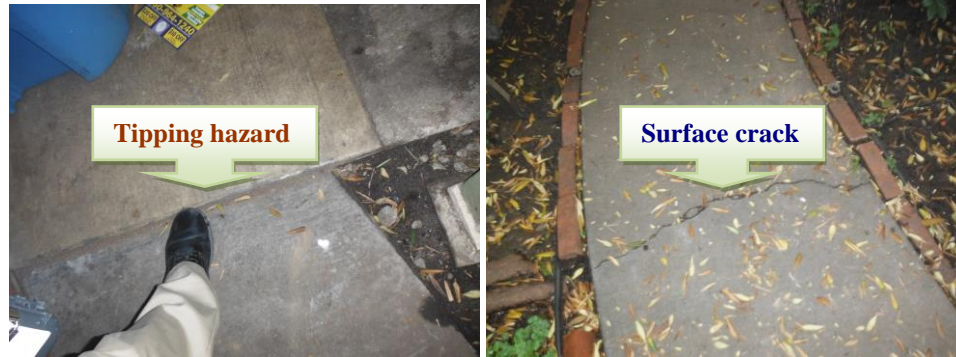
The hard surfaces, such as driveways, walkway, flatwork, etc., appear in poor to fair condition. Cracks in concrete are normally caused by the curing process, subtle movement, thermal expansion/contraction, In general, this type of cracking or unstable surface should be considered serious and a tripping hazard. Cracks, holes, settlement, heaving and/or deterioration were found in the walkway. One or more sections of the walkway in the courtyard were uneven, making them a tripping hazard.

We recommend the advice of a licensed professional, followed by corrective action as needed to improve their current condition and safety rating.

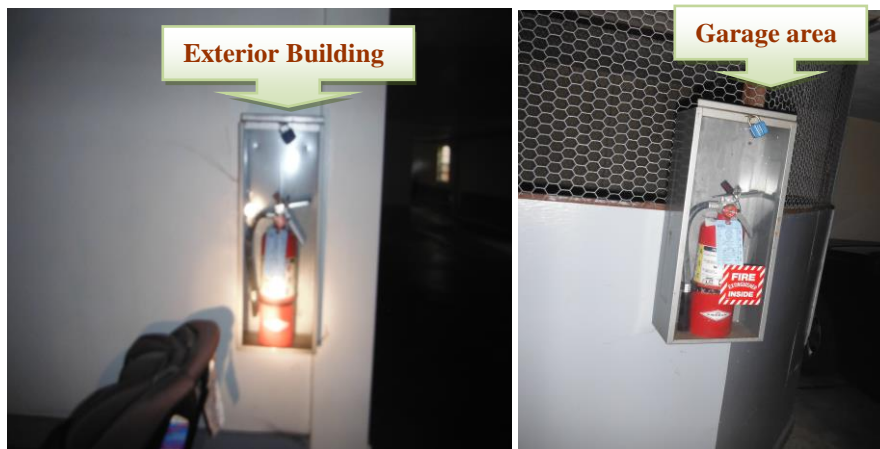
The exterior staircases for both buildings and garage were noted with fire extinguishers. These devices were not tested, as it's not within the scope of our inspection. Check the fire extinguishers date tag for the last inspection and when they were calibration is recommended. Fire extinguisher calibration certificate is required annually.

NOTE: No fire extinguisher was noted in the water heater utility room. Not having a fire extinguisher in the water heater utility room, as required by safety standards, is a concerning oversight. A fire extinguisher is an essential safety device that can help contain small fires and prevent them from spreading.

It's crucial to rectify this issue promptly to ensure compliance with safety regulations and to mitigate the risk of fire-related incidents. Installing a fire extinguisher in the water heater utility room is recommended as a corrective action to address this deficiency and enhance fire safety measures within the premises.

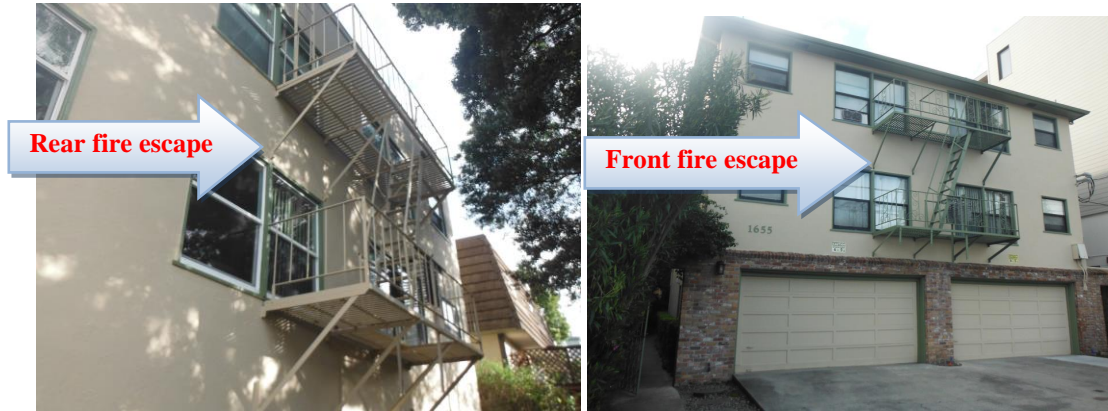
The Fire Escape Was *Not* Operated, and *Not* Inspected

No formal or "complete", inspection of the fire escape and its mechanics will be included as it not within the scope of this Home Inspection.

If further information is desired concerning the condition, function and operation of the fire escape and its mechanics, as well as maintenance tips and information, we recommend arranging for an inspection and orientation from a competent fire escape and spa maintenance company.

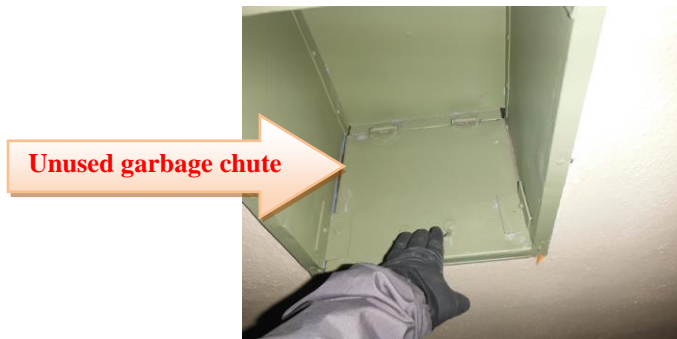
Features associated with this area were in fair to satisfactory condition, see notes above. *One section of the upper hall level appears to have hand a garbage chute, which is current permanently secure.* One or more section of the patio and walkway was installed with a French drain.

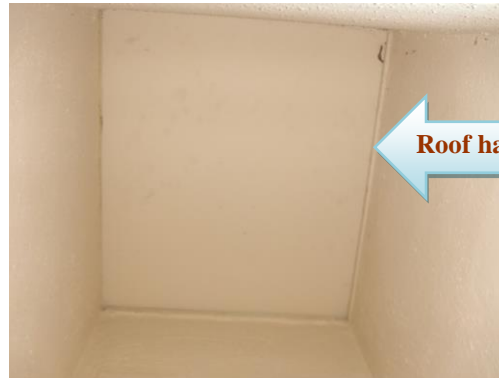
The roof hatch located on the upper level hallway. No ladder was attached to the wall; the home inspector used his own personal ladder to enter the roof.

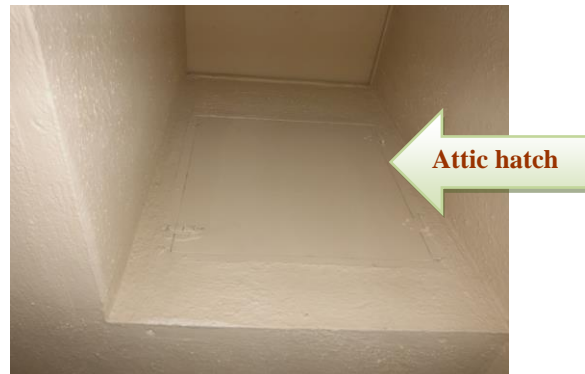
The attic hatch located on the upper level hallway; however, we were unable to open the hatch during our inspection. We assume no responsibility for any damage to adjacent areas caused by this further inspection.

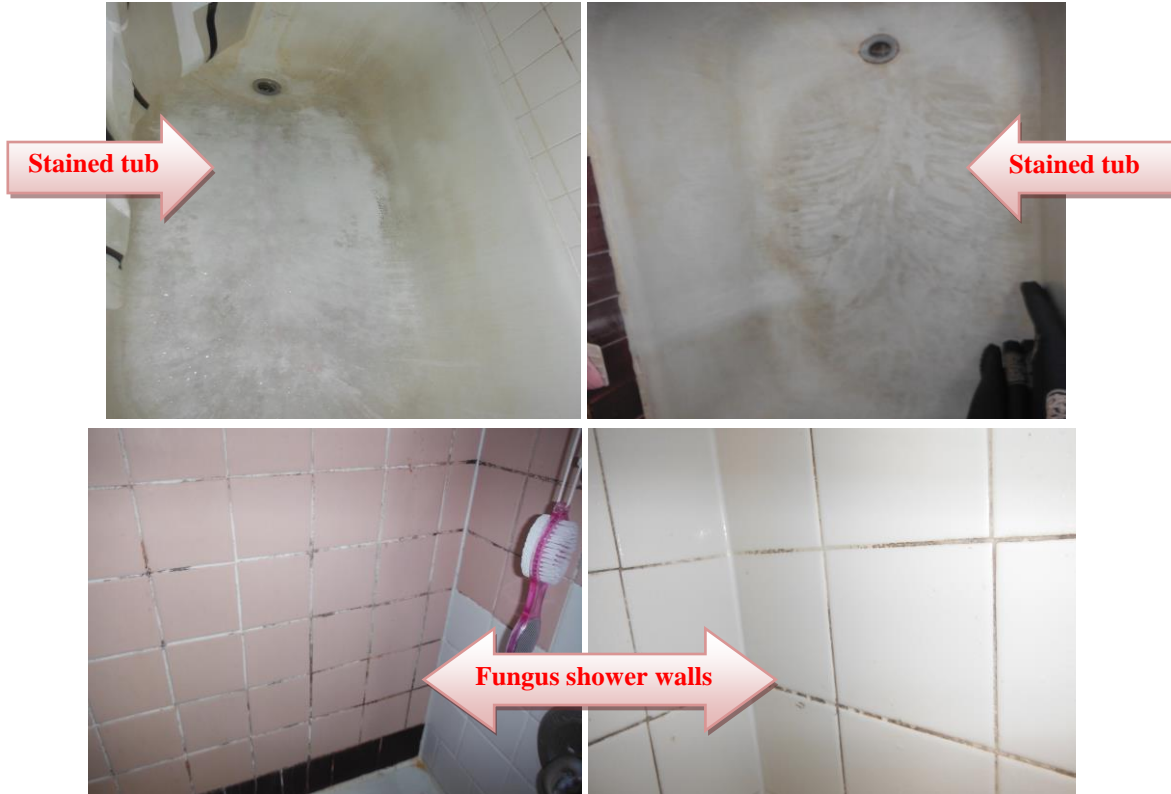
Unit 1, 6, 7 washroom tub surface was noticeably stained and noted with fungus between the tiles grout lines.

Unit 1 shower tiles were noted with crack tiles, which is a pathway for moisture intrusion.

The shower and tub surround found washrooms were in serviceable condition, with exception noted below. The area around the spigot, handles and or shower head etc. should be properly sealed to forestall moisture intrusion. The water supply lines (diverter valve) when operated, were fully functional and in serviceable condition. **Unit 1, 6, 7 washroom tub surface was noticeably stained and noted with fungus between the tiles grout lines. Unit 1 shower tiles were noted with crack tiles, which is a pathway for moisture intrusion.**

We recommend the advice of a licensed professional, followed by next corrective action as needed to improve its current condition.

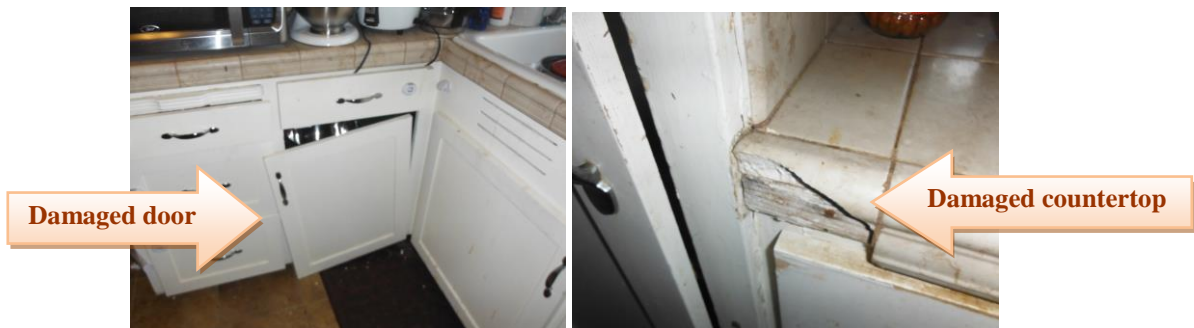
The cabinets and countertop were in acceptable condition, with exception noted. *The cabinets and countertops for unit 6 were noted crack tiles for the countertop and loose cabinet doors. Corrective action is recommended.*
