INSPECTION REPORT

For the Property at:
4090 CLEVELAND AVENUE
COLUMBUS, OH 43224

RE: Report No. 8437, v.2
4090 Cleveland Avenue
Columbus, OH
43224

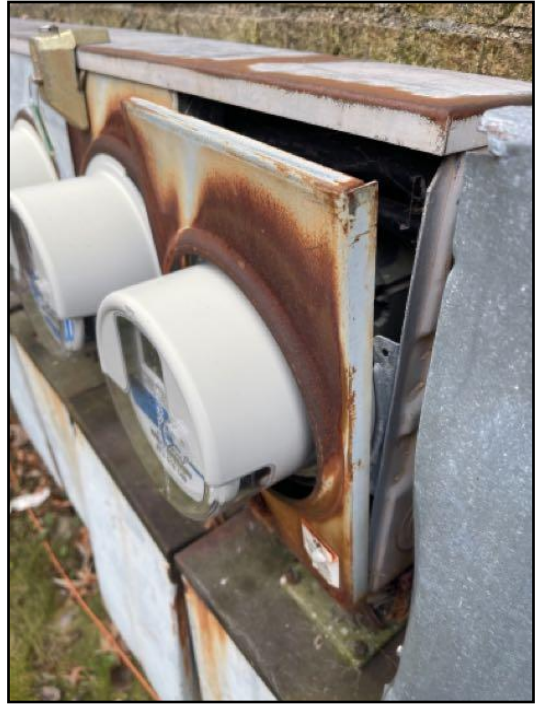
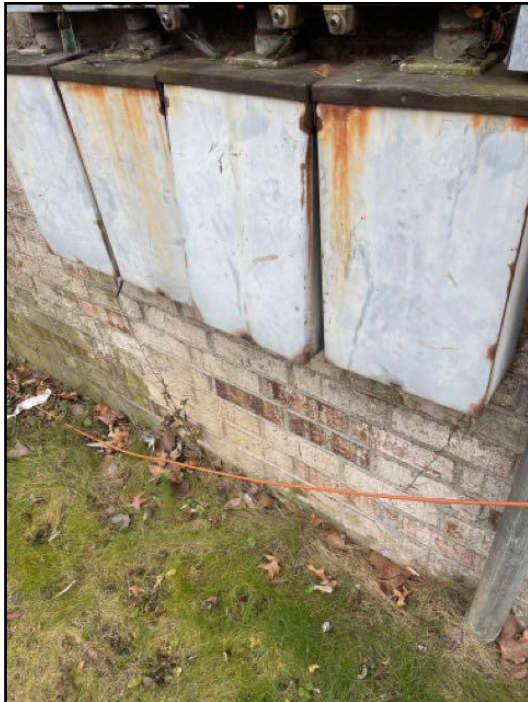
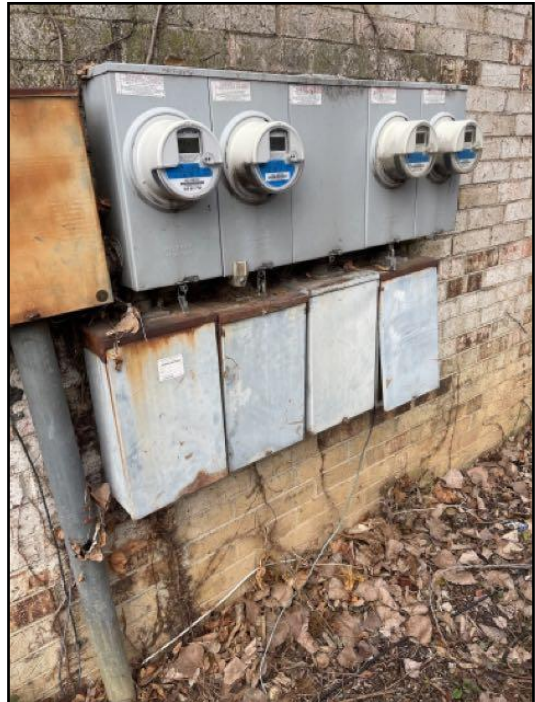
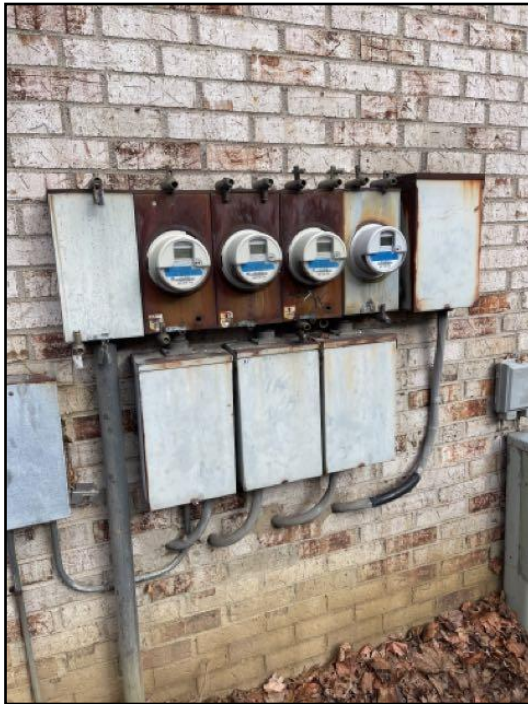
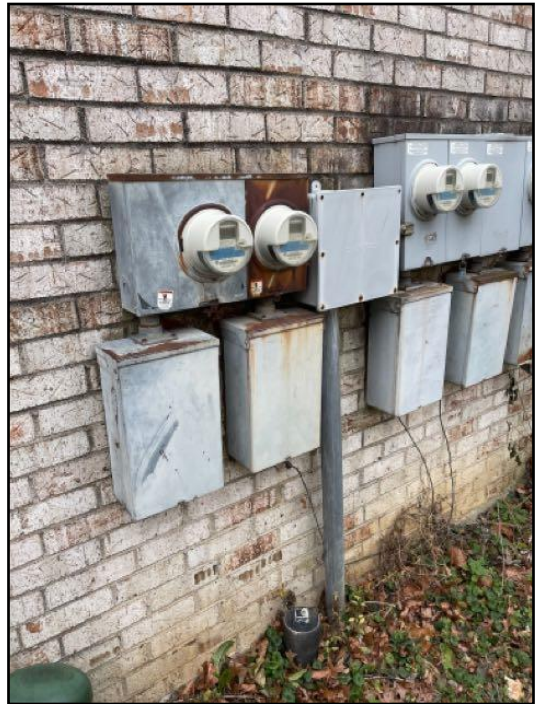
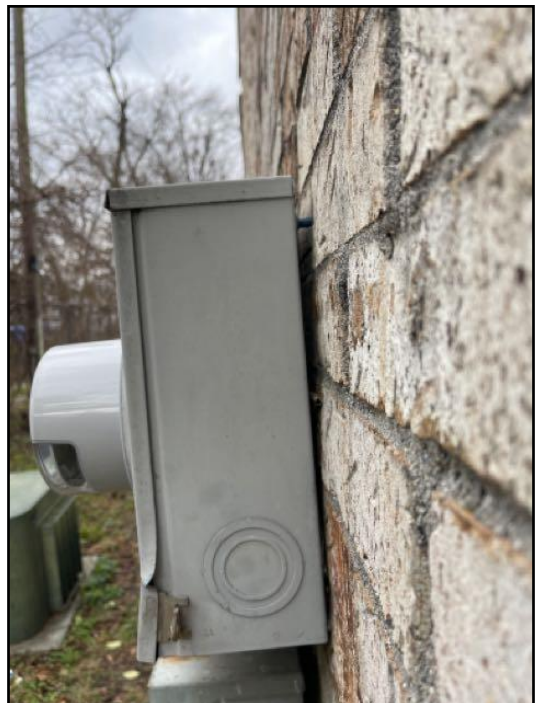
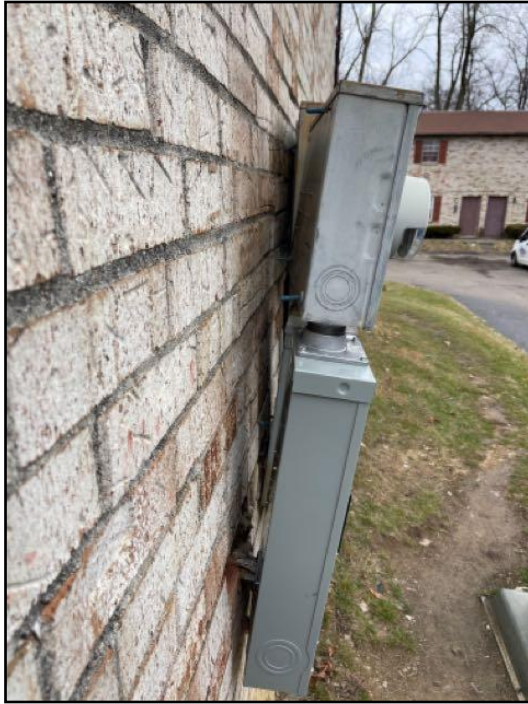
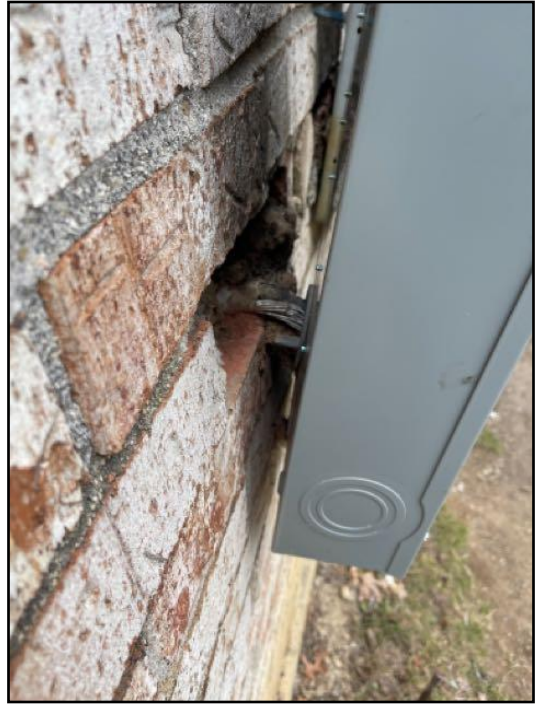
4. Condition: • Electric panels, meter boxes, junction boxes and splitter boxes with rust converting primer is expected to operate satisfactorily for 30 years in an outdoor or indoor environment while extremes of loading work to weaken the insulation systems inside the electrical equipment. This high expectation demands the best in state-of-the-art design, metal processing, and coating technologies. This issue is an indicator that a qualified technician should evaluate the equipment and make any and all repairs as necessary before you close

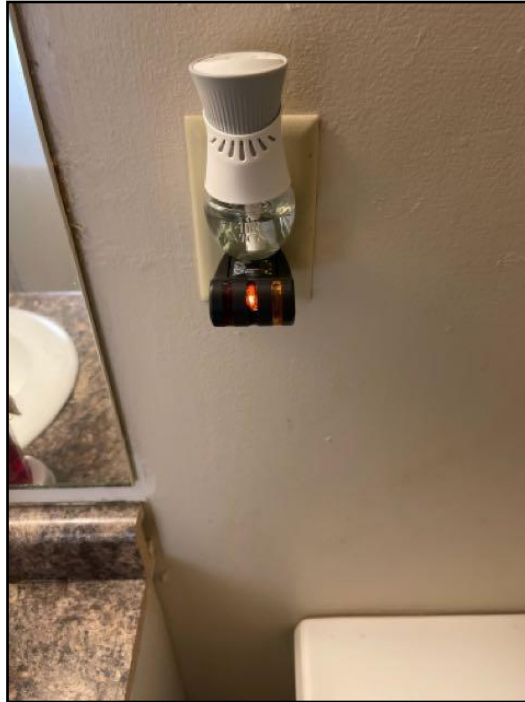
26. Ungrounded three-prong receptacles

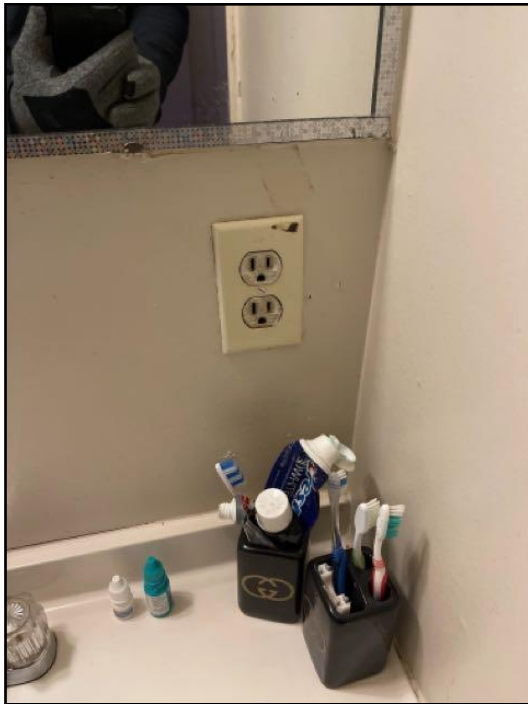
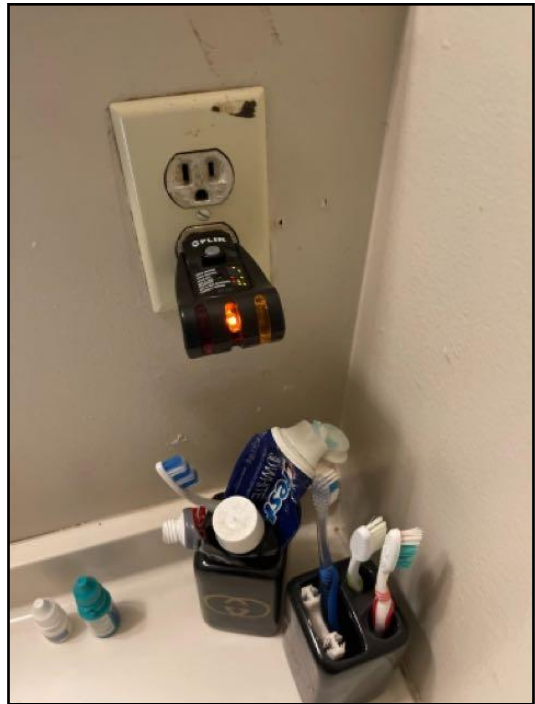
12. Condition: • The Installation of ground fault circuit interrupter (GFCI) outlets is advisable in Bathrooms, Kitchens, Exterior, Basements, Garages, Laundry Area and over counters. A (GFCI) outlet offers protection from shock or electrocution. I recommend contacting a qualified electrical contractor to improve safety

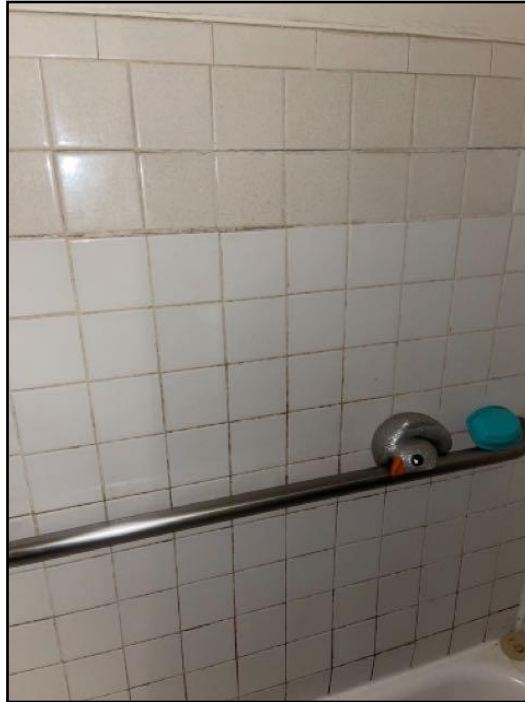
54. *Loose tile in the tub/shower enclosure*

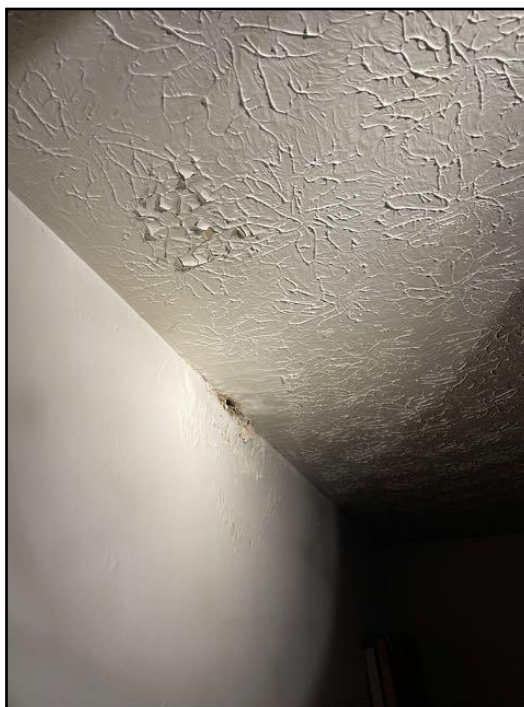
41. Condition: • Water damage was found at this location. Infrared (IGC) thermal imaging sensor/camera, was used to visually guide the inspector to the precise spot that moisture may be hiding. If left unattended could cause other components of the structure to deteriorate. I recommend a contractor investigate this problem and find a remedy.

83. *Water damage was found at this location....*

Task: Repair

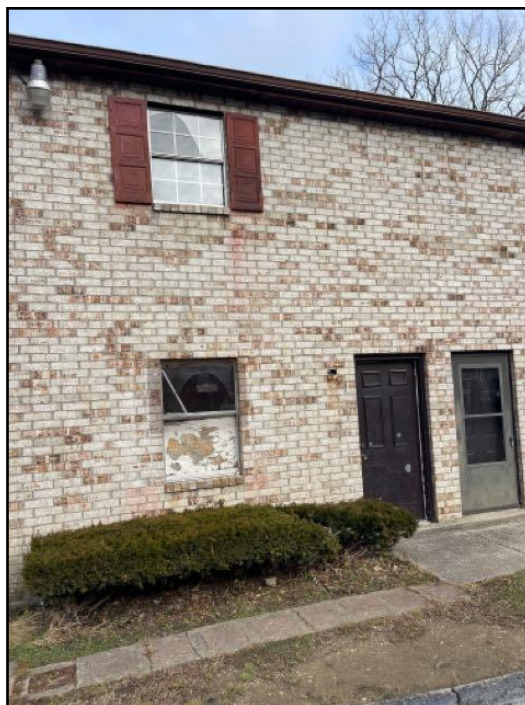
45. Condition: • Fire damage was found. Consult the owner for extent of damage and occurrence period. The proper municipal authority should supply documents in review of this occurrence with recommendation of correction if any. ASTM E 119 (ASTM International 2000) For wood members that have charred, the char layer can be easily scrapped off. Obviously, any charred portion of a fire-exposed wood member has no residual load capacity. The wood beneath the char layer has residual load capacity; but, this residual capacity will be less than the load capacity prior to the fire. Members that have only visual smoke damage or slight browning of the surface also have significant residual load capacity. I recommend further investigation be made into this incident to insure structural integrity of the building.

Implication(s): Possible Decreased Load Capacity

90. Fire damage was found. Consult the owner fo...

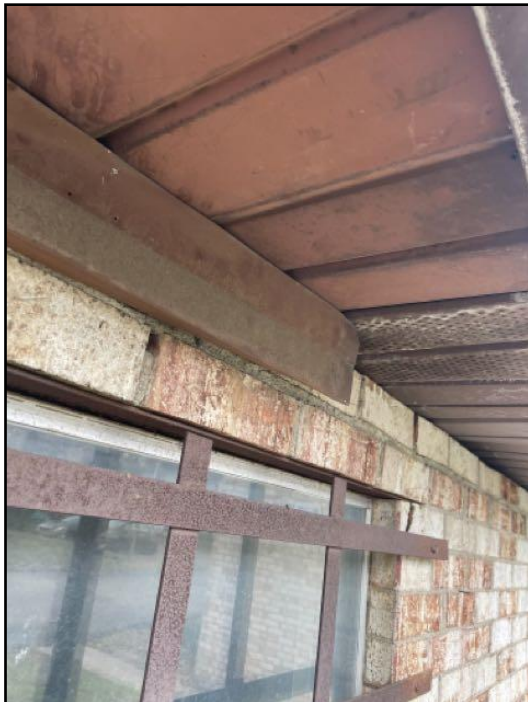
110. Siding has minor damage. Any opening should...

Task: Repair

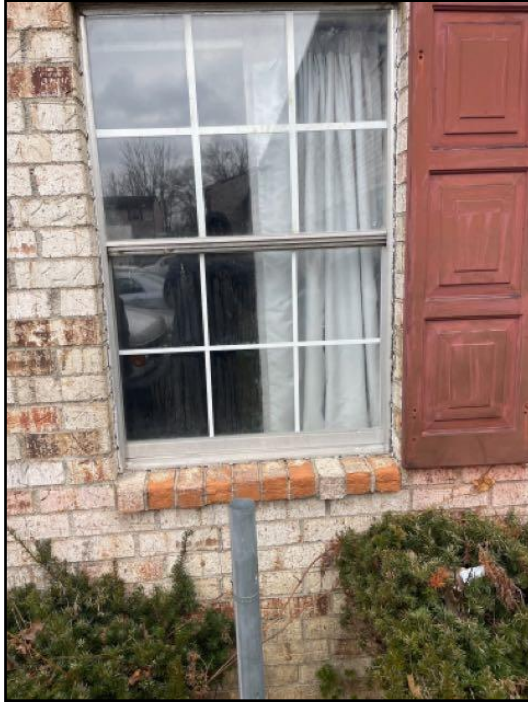
57. **Condition:** • Lost seal; formation of condensation between the glazing
Fogging or other moisture between the panes of glass which indicates a broken seal was found, repairs are

recommended. Signs of lost seals in the thermal pane windows may appear and disappear as temperature and humidity changes. Some windows with lost seals may not have been evident at time of this inspection. The windows were checked for obvious fogging. I recommended all windows be inspected by a window contractor for further lost seals.

129. Lost seal; formation of condensation between...
