Report Date: March 23, 2022
Field Assessment Date: March 11, 2022

Property Condition Report

1612 Frazier St
Conroe, Montgomery County, Texas 77301

AEI Project No. 458021
Client Reference No. NA
Client Reference Name: Frazier

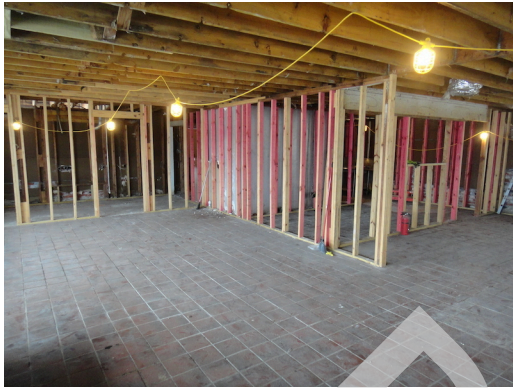
Interior overview bldg 1

Refer to Section 3.1.1, 3.2.4 and 4.1 for additional discussion and recommendations regarding the water infiltration.
