Inspection Pros

**891 Bell Street  
Lafayette CA 94549**

Client(s): Portue  
Inspection Date: 10/10/2025  
Inspector: Scott Ersamer ,

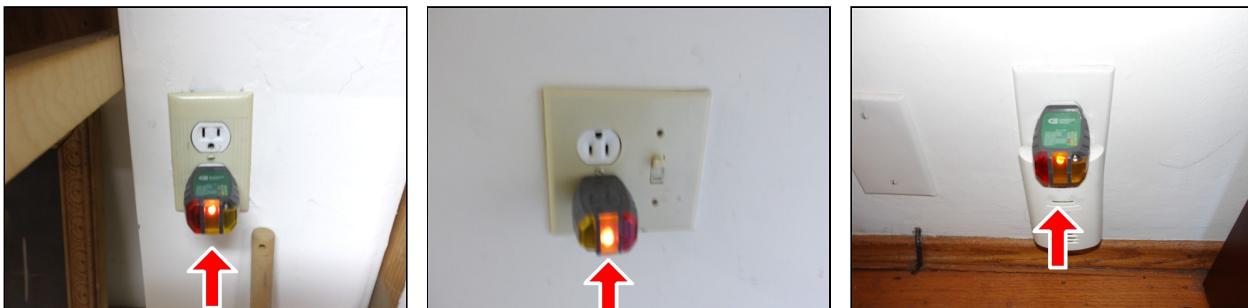
♦ Several of the three prong electrical receptacles tested were found to be ungrounded. This is a common finding in older buildings. At a minimum, we recommend that they be retrofitted back to their original two prong configuration. Ideally, we recommend that they be properly grounded by a licensed electrician to ensure proper function and maximum safety. Estimated repair cost is \$100s - \$1000s of dollars depending on the number of ungrounded electrical receptacles to be grounded and the complexity of the repair.

- 9. Several of the three prong electrical receptacles tested were found to be ungrounded. This is a common finding in older buildings. At a minimum, we recommend that they be retrofitted back to their original two prong configuration. Ideally, we recommend that they be properly grounded by a licensed electrician to ensure proper function and maximum safety. Estimated repair cost is \$100s - \$1000s of dollars depending on the number of ungrounded electrical receptacles to be grounded and the complexity of the repair.
- 10. The cover plates were missing at some of the electrical receptacles located in the garage and in the adjacent office/storage areas. We recommend that they be fitted with approved cover plates to protect the wiring from accidental contact and physical damage. Estimated replacement cost \$3 - \$5 for each cover + labor.

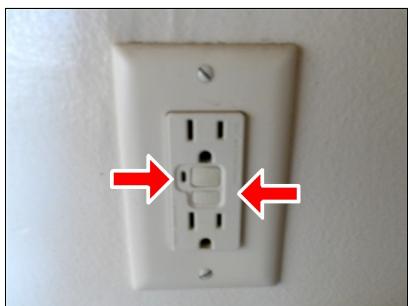
♦ Ground fault circuit interrupter (GFCI) protection devices have been installed in several locations throughout the building. GFCIs are modern wall receptacles or circuit breakers, designed to protect occupants from electric shock. Although not required at the time of construction, GFCIs are now required in the following areas, but may not be limited to, kitchen countertop receptacles, bathroom hydrotherapy tub and sink areas, garages, basements, spas, hot tubs, fountains, pools, sump pumps, crawl spaces, near laundry tubs, and exterior walls. We recommend that all such locations be provided with GFCI protection if they are not already so equipped. Additionally, GFCI devices should be tested periodically in accordance with the manufacturer's recommendations to ensure that they continue to provide the necessary protection.

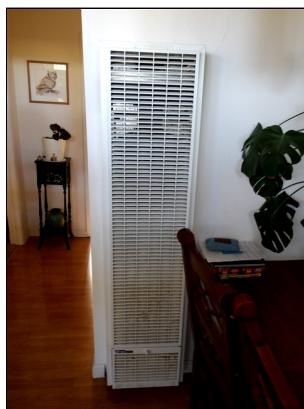
♦ #891: The wall heater pilot light was lit, however it failed to respond to the thermostat when tested. We recommend a licensed Heating, Ventilation & Air Conditioning (HVAC) contractor be retained for further evaluation and repair as deemed necessary. Estimated repair cost of \$150 - \$500.

- 11. #891: The wall heater pilot light was lit, however it failed to respond to the thermostat when tested. We recommend a licensed Heating, Ventilation & Air Conditioning (HVAC) contractor be retained for further evaluation and repair as deemed necessary. Estimated repair cost of \$150 - \$500.
- 12. #899: The pilot light for the wall heater was shut off at the time of the inspection, therefore we cannot comment on its function or condition. We recommend verification of proper operation once service has been restored. Estimated repair cost of \$150 - \$500.

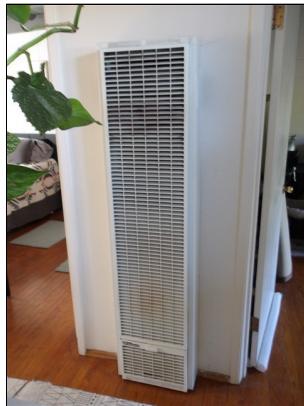
♦ #899: The pilot light for the wall heater was shut off at the time of the inspection, therefore we cannot comment on its function or condition. We recommend verification of proper operation once service has been restored. Estimated repair cost of \$150 - \$500.

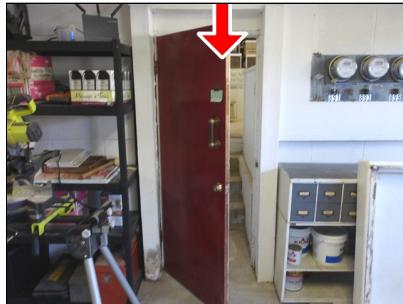
☒ ♦ The garage/interior passage door was not an approved fire door. By today's standards, any door between the garage and the living space should be an approved fire-rated door (1 3/8" solid core) with a self-closing mechanism. Upgrading should be considered for maximum safety.

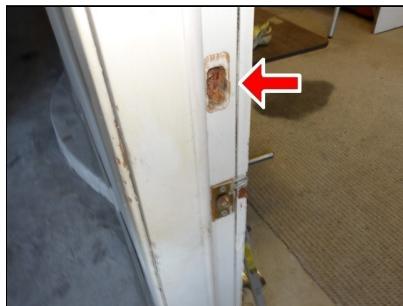
☒ ♦ The strike plate was missing from the carport/garage passage door frame. We recommend it be replaced to ensure proper function.

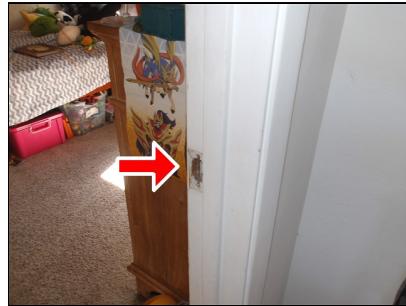
- ☒ ♦ Some of the doors lacked door stops. This can allow the handles to hit the walls. We recommend that all of the doors be equipped with appropriate door stops to help prevent potential damage to the walls.
- ☒ ♦ A few of the interior doors rubbed on the frames. Additionally, a few of the doors did not latch properly. We recommend adjustment or repair as deemed necessary to restore proper operation.
- ☒ ♦ #891: The strike plate was missing from the left rear bedroom door frame. We recommend it be replaced to ensure proper function.

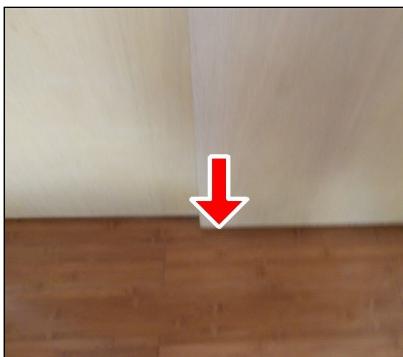
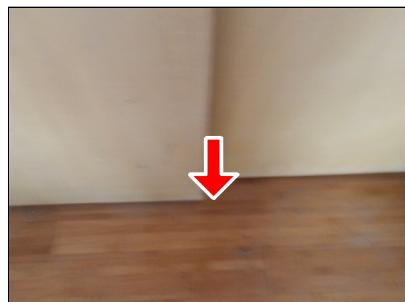
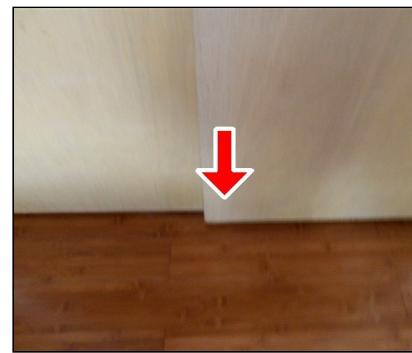
#891

- ☒ ♦ The center floor guides were missing at the base of several of the closet doors. We recommend replacement to keep the doors from swinging.

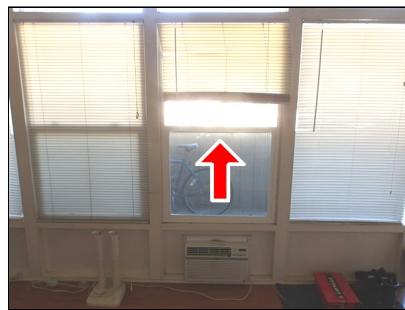
♦ #893: The lift & hold mechanism(s) in place on the window located above the air conditioner were damaged or defective. We recommend referral with a licensed window contractor for repair as deemed necessary to restore proper function. Estimated repair cost \$150 - \$500.

- 13. #893: The lift & hold mechanism(s) in place on the window located above the air conditioner were damaged or defective. We recommend referral with a licensed window contractor for repair as deemed necessary to restore proper function. Estimated repair cost \$150 - \$500.
- 14. #895: We observed what appears to be evidence of condensation between the panes of glass in the front bedroom windows. This suggests a failed seal between the glass panes. We recommend that all failed insulated glass units be replaced by a licensed window contractor to restore proper function and for a better appearance. estimated replacement cost \$500 - \$1500 each.

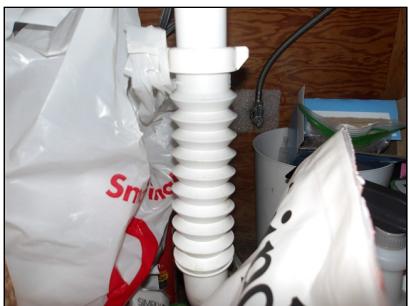
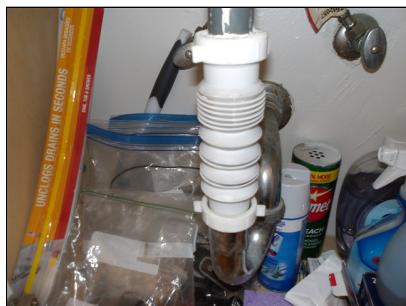
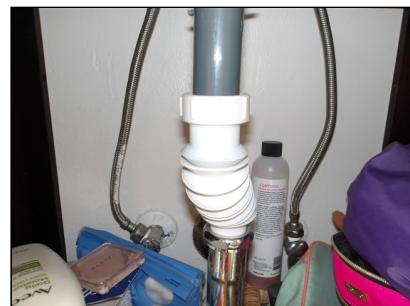
- ▣ ◆ #891, #893, #899: The flexible drain assembly arms installed under the bathroom sinks are more prone to clogging and leakage. We recommend replacement with rigid piping as a preventative measure.

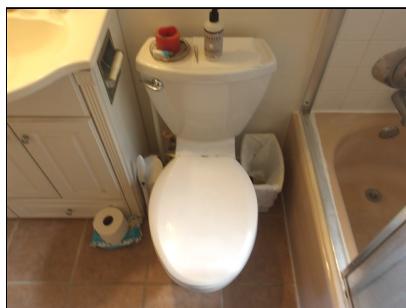
☒ ◆ #893: The bathroom toilet was found to be slightly loose at the floor. While no damage was evident, this can be conducive to water leakage and/or damage. At a minimum, we recommend that the toilet be tightened. Ideally, the toilet should be removed and reset upon a new wax ring if deemed necessary. Any damage discovered in the course of this work should be repaired at this time.

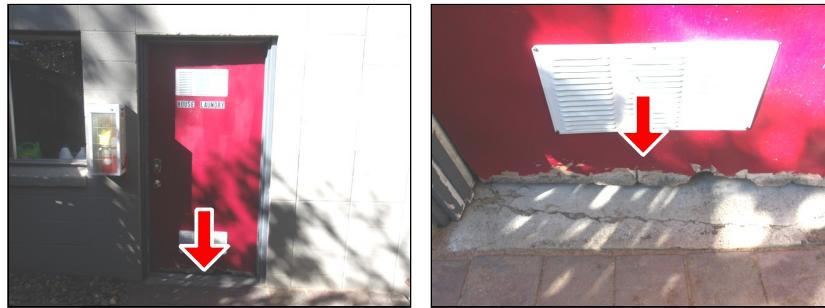
♦ Damage was observed at the bottom of the laundry room passage door at the left side. We recommend the door be repaired if possible, or replaced if deemed necessary. Estimated repair/replacement cost \$500 - \$2500.

- 15. Damage was observed at the bottom of the laundry room passage door at the left side. We recommend the door be repaired if possible, or replaced if deemed necessary. Estimated repair/replacement cost \$500 - \$2500.

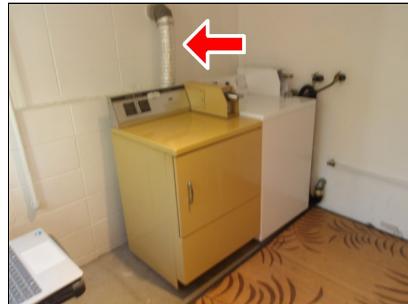
♦ The clothes dryer vent is routed vertically on the wall. This installation is more likely to cause lint clogging inside the duct. Clogged dryer lint ducts can adversely affect the operation of the dryer and can be a potential fire hazard. We recommend they be periodically cleaned to ensure safe and efficient operation of the dryer.
