PROPERTY CONDITION REPORT

Client(s): Mike Erickson
Property: 20265 Lake Chabot Rd,
Castro Valley, CA 94546
Realtor: Phillip Fair
Date: 8/9/2024
Inspector: Rick DeBoard - Certification #1051
Report #: PCA8210

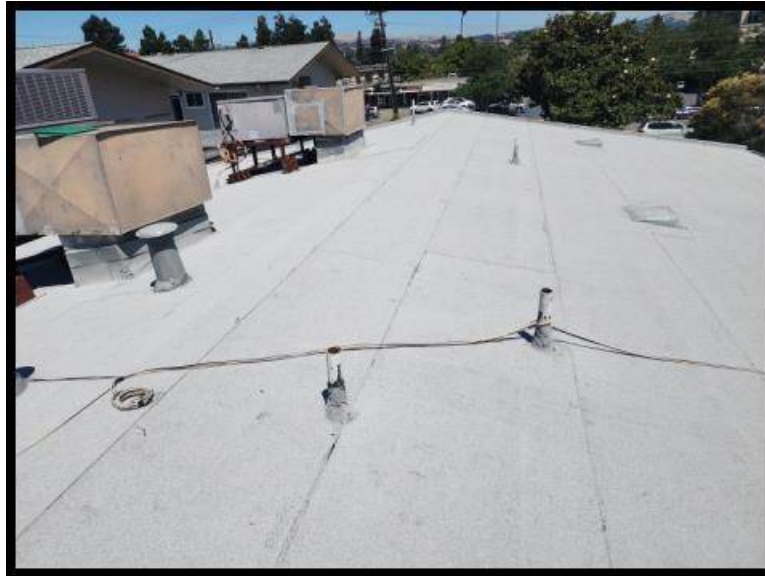
7.1 Roofing Materials

Roofing application consists of a built-up membrane with a granulated cap sheet. We are unable to determine how many plies of felt paper were applied, as it would be necessary to take a core sample of the membrane to do so. The typical industrial application would be 3, 4 or 5 plies of felt paper. Typical life expectancy of a NEW 3 ply application is 8-10 years, 4 plies is 10-15 years, and a 5 ply roof is 15-20 years. This roof appears to be in good condition. Roof sheathing is plywood, and appears to be in good condition.
