#1 (LEFT BUILDING)

835 Minnie St
Jacksonville, FL 32204

NOVEMBER 7, 2024

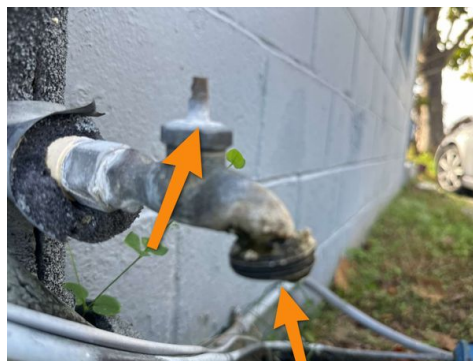
left side of home

LEAKY HOSE SPOUT - CONTINUOUS DRIP

Recommendation

Contact a qualified professional.

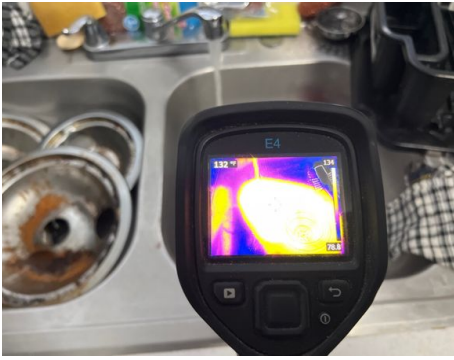
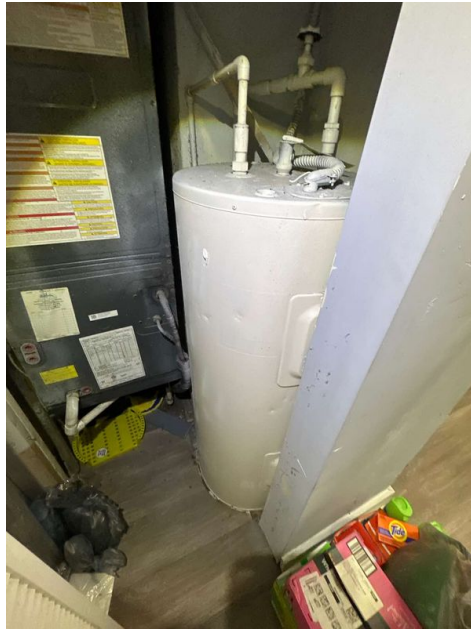
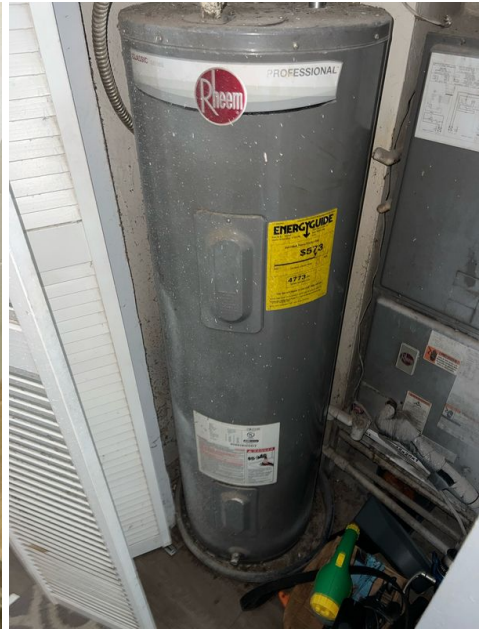
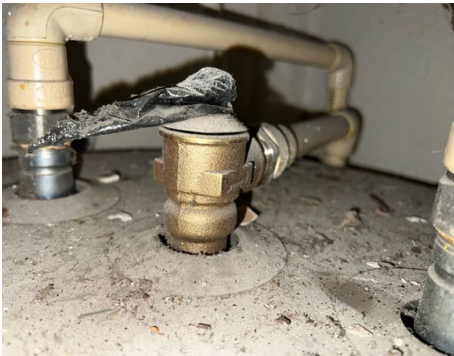
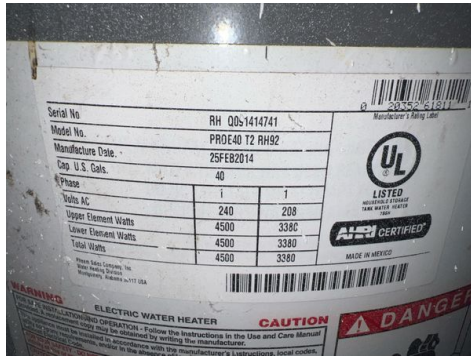
General Info: General View of Water Heater(s)

The water heater(s) appeared to be functioning properly at the time of inspection.

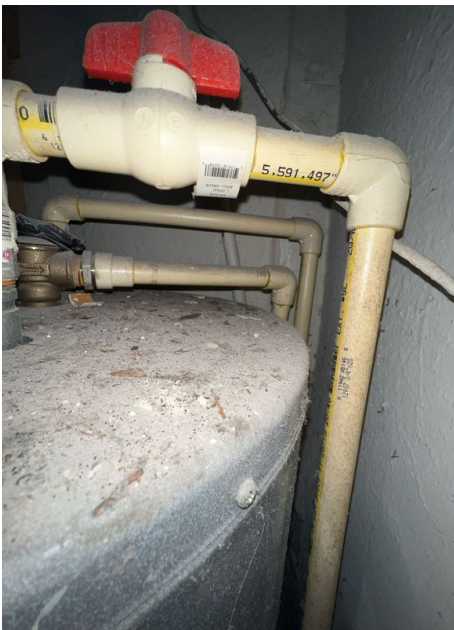
General Info: Discharge Pipe Present

A TPR valve discharge pipe was present. No deficiencies were observed unless otherwise noted in this report.

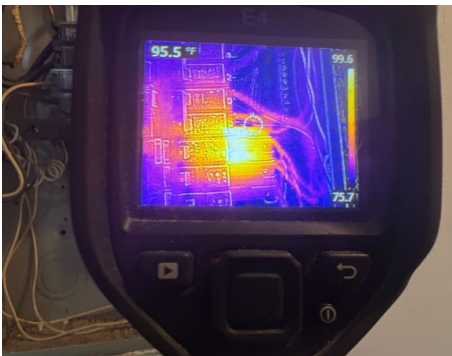
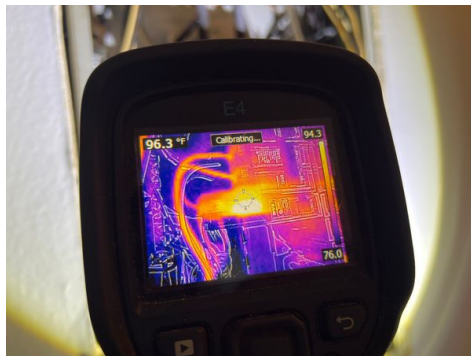
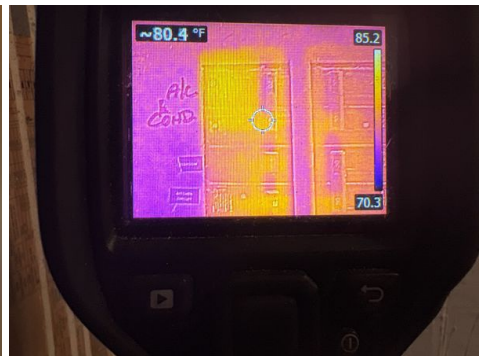
No hot spots or anomalies were observed in the electrical panel, under current loading conditions, during the inspection.

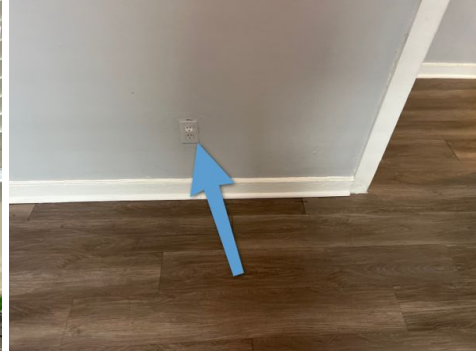
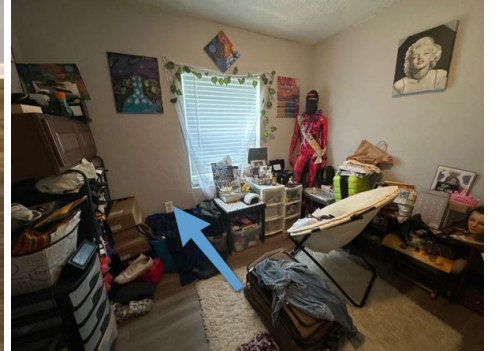
831

A few electrical outlets in the home were loose. This is typical and common wear overtime. Recommend securing the outlet to the junction box, so the outlets are secure. A DIY link is included below for informational purposes.

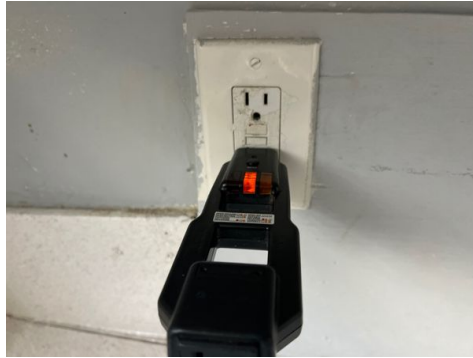
The electrical outlet pictured below showed an improper ground according to the receptacle tester. An open ground outlet can cause an electrical surge to the connected device resulting in damage or electrical shock. Recommend further evaluation and repair by a qualified electrical contractor.

Contact a qualified professional.

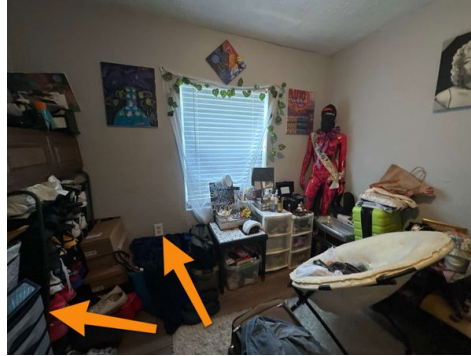
The bedroom electrical outlets in unit 835 shows reverse polarity. The hot and neutral appeared reversed according to the receptacle tester. Improper wiring can cause a potential electrical shock hazard in rare occurrences, but is typically a easy repair. Recommend further evaluation and repair by a qualified electrical contractor.

Contact a qualified electrical contractor.

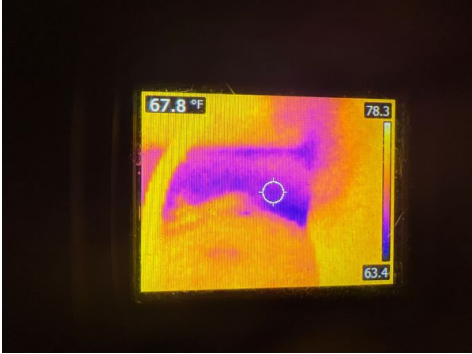
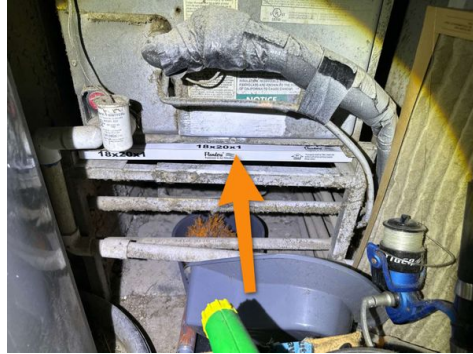
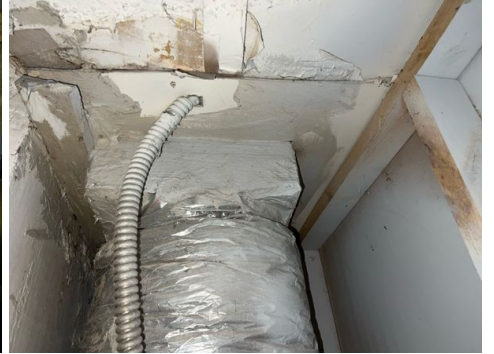
835

LEAKING AIR AT AIR HANDLER UNIT

The air handler unit is leaking conditioned air at the supply duct connections at unit 835. The foil tape has failed. Recommend re-sealing the supply ducting to reduce energy loss and potential condensation concerns. There is also no filter cover.

Contact a qualified professional.

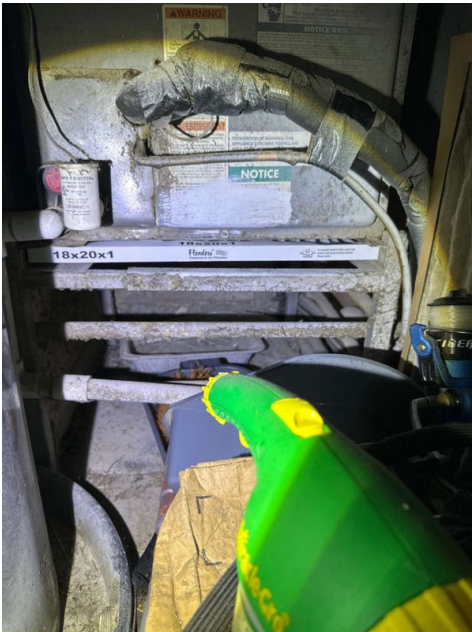
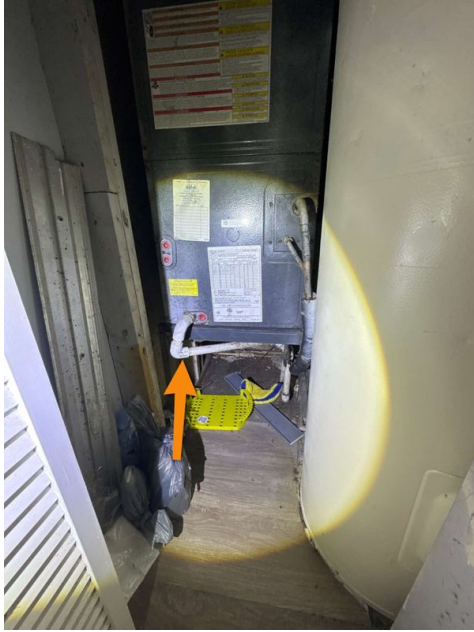
833

7.3.2 Inside Unit

Moderate

There is either no drain pan or no overflow safety float switch under the air handler in unit 833. This does not allow for any leak protection in case the unit leaks in the future. Recommend consider adding a overflow safety float switch or drain pan or at least being cautious of this and monitoring periodically. There is also no cleanout cap. There are signs of previous leaks and minor fungi growth at the drywall as well behind the unit. Recommend repair as needed.

Contact a qualified professional.

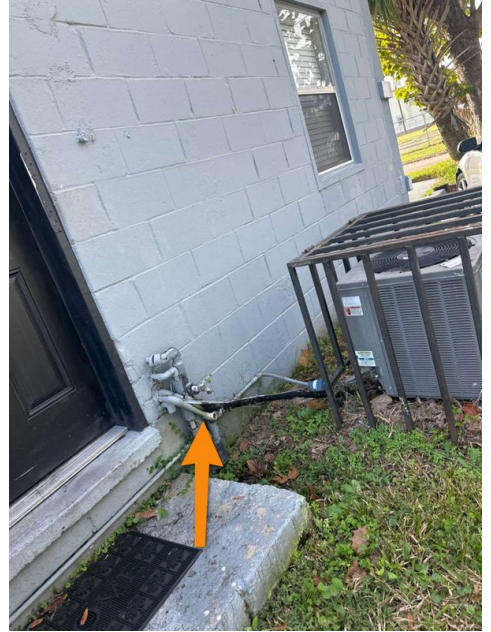
left side of home

CONDENSATE DRAIN PIPE TERMINATED NEAR FOUNDATION

The condensate drain pipe terminated at or near the foundation of the home. This can allow water to saturate the soil in this area, possibly entering back into or under the structure. Extending the drain pipe, away from the foundation, is recommended.

Contact a qualified professional.

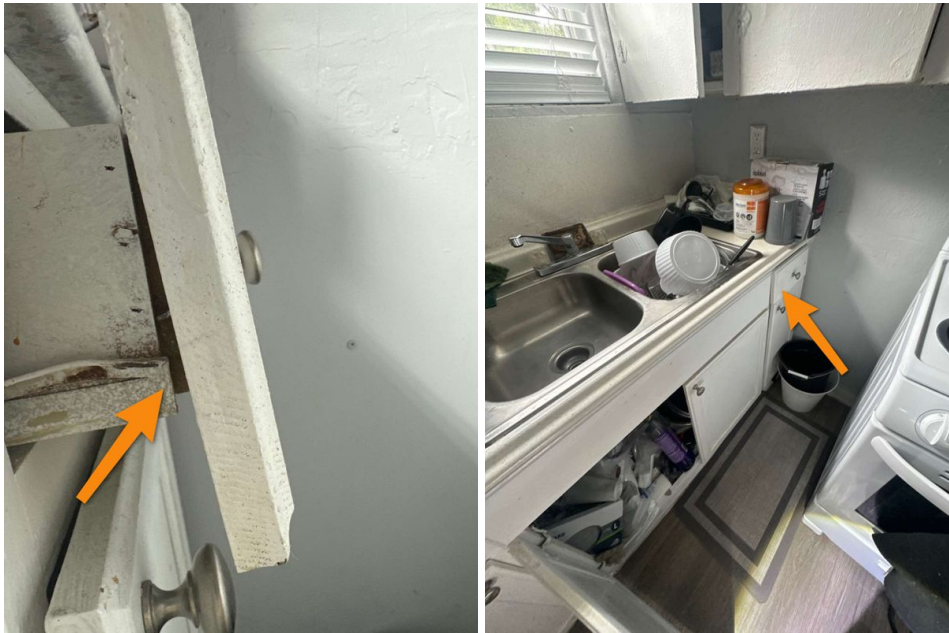
LOOSE CABINET DRAWER FACE

The cabinet drawer face in unit 835 is loose and out of position. Recommend repair as needed.

Contact a qualified cabinet contractor.

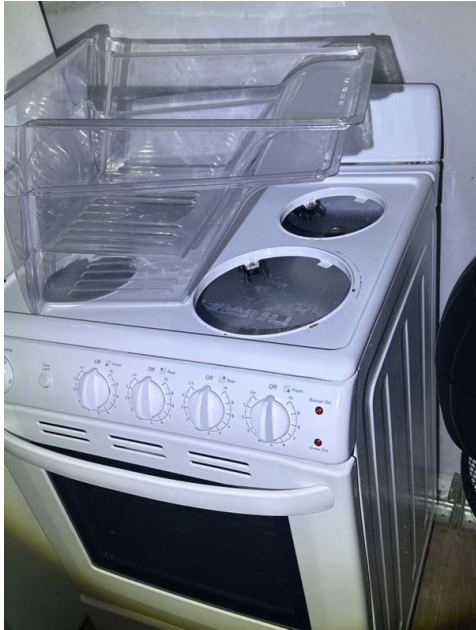
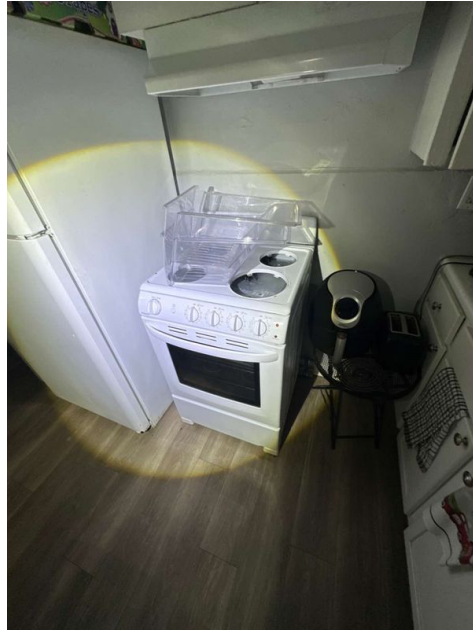
REMOVED BURNER COMPONENTS FOR STOVE

The burner components were removed at the stove for unit 833, but the tenant said she was just cleaning the stove components and that everything works fine.

Recommend monitoring.

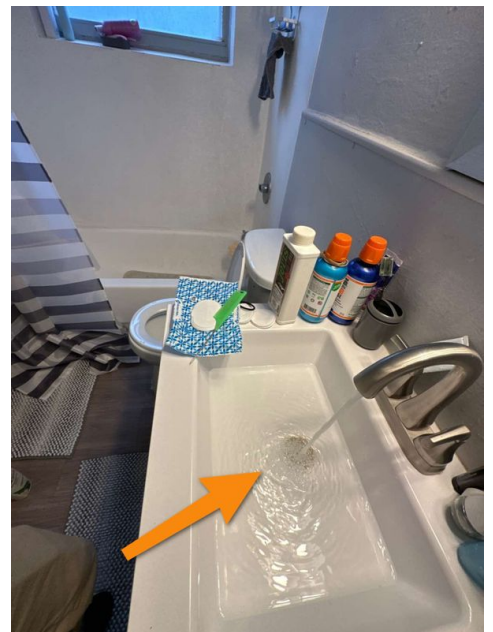
The bathroom sink in unit 833 was slow to drain during the inspection (the sink still drained, but at a slower rate). Recommend snaking or clearing the partial blockage as needed to allow for normal drainage (likely just hair or debris build-up).

Contact a qualified plumbing contractor.

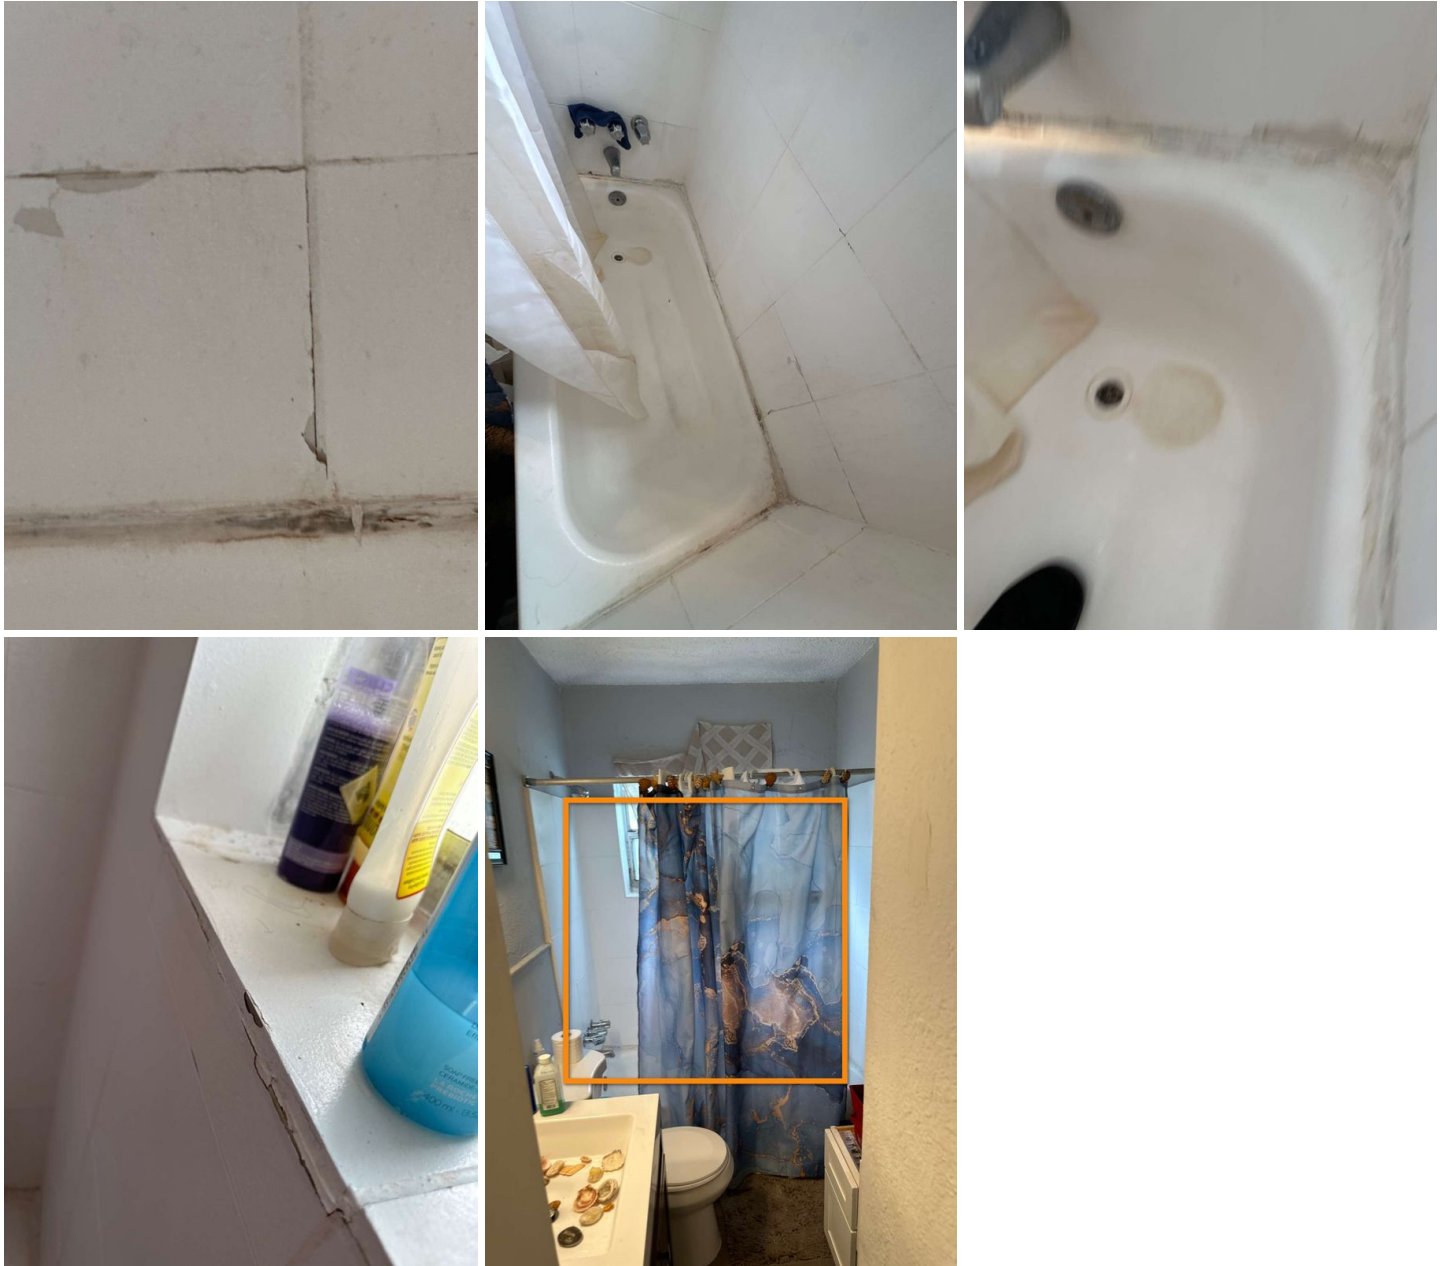
835

FAILED COATINGS AT SHOWER WALLS AND TUB

A paint type of refinish was applied to the shower walls and bathtub, which is okay, but this coating has failed in areas and is chipped and peeling. Some areas need caulking as well. Recommend repair as needed.

Contact a qualified professional.

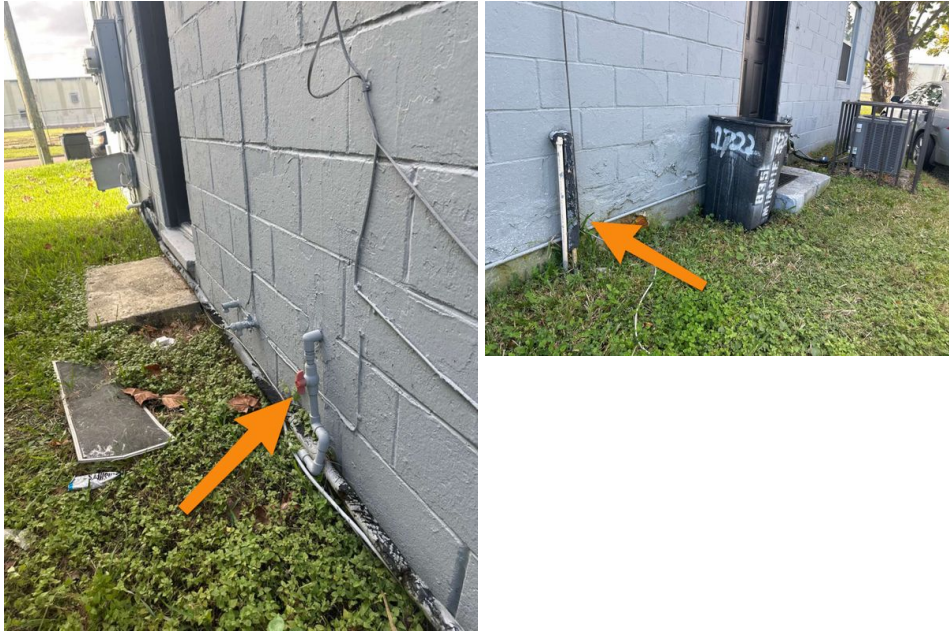
Recommend insulating the exterior supply pipes to help protect the piping from the elements.

Contact a handyman or DIY project

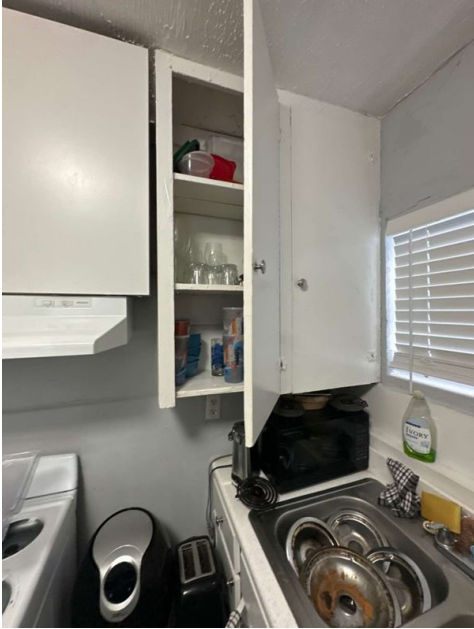
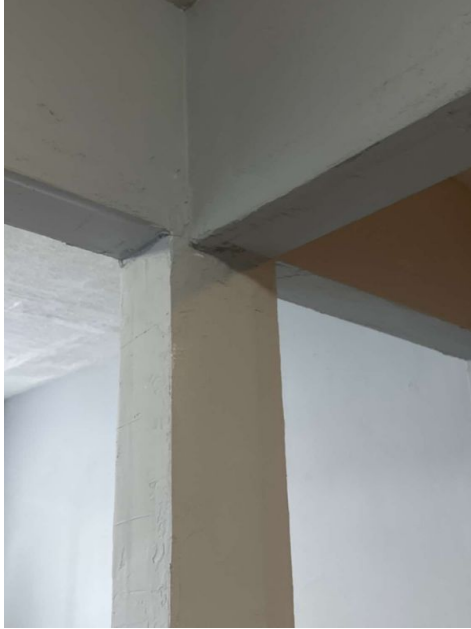
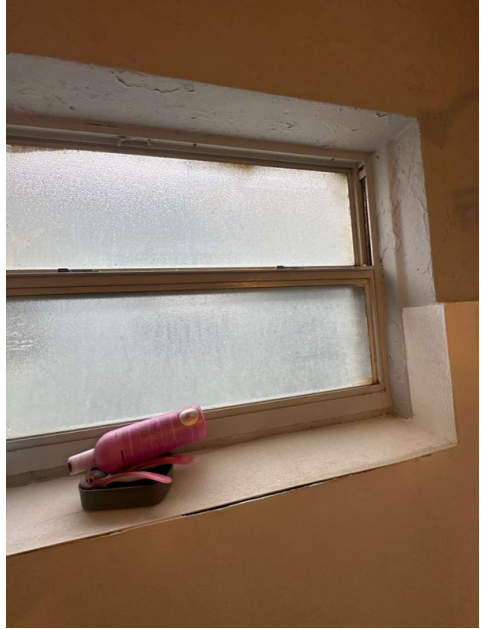
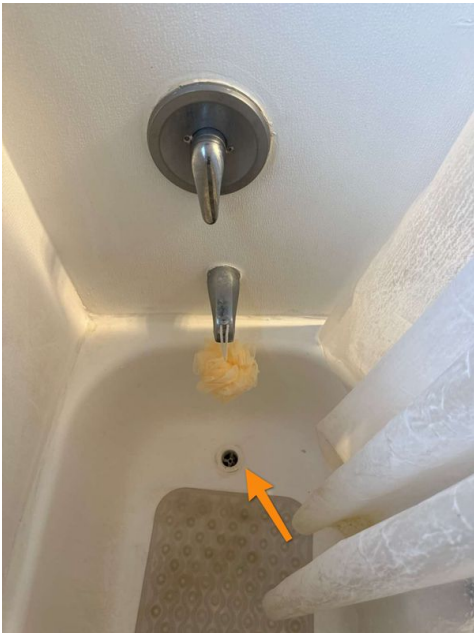
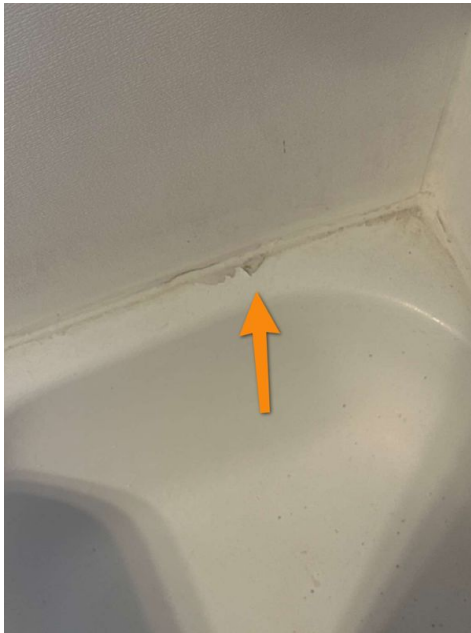
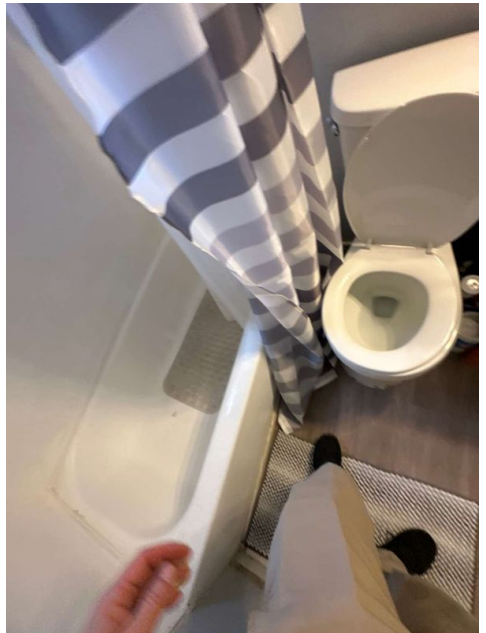
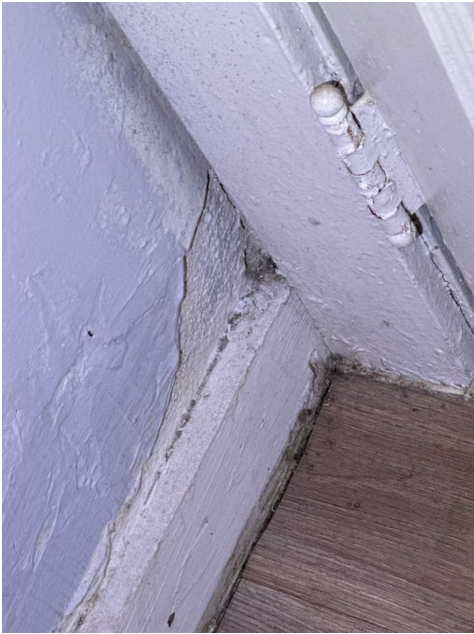
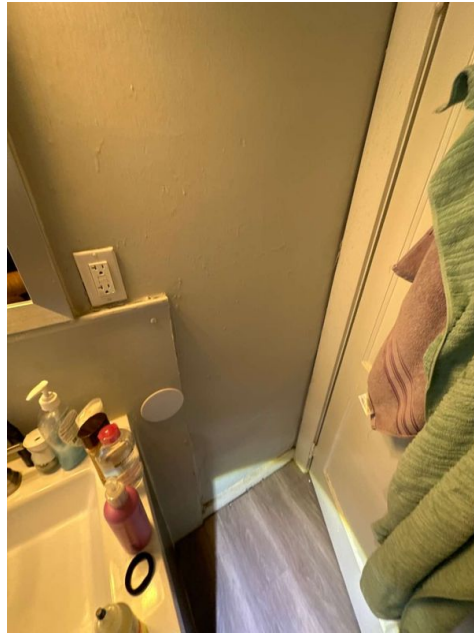
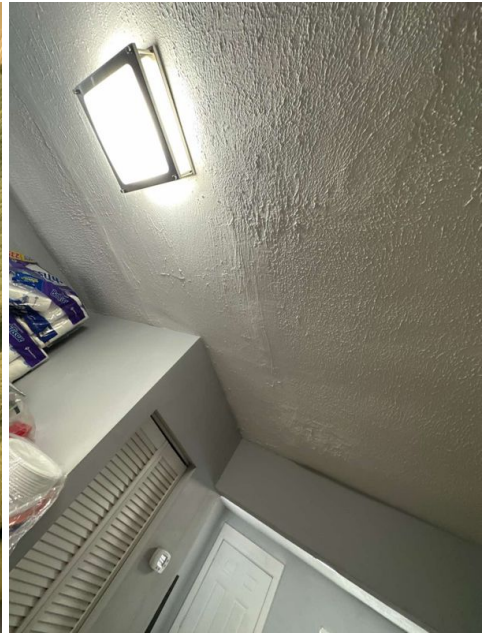
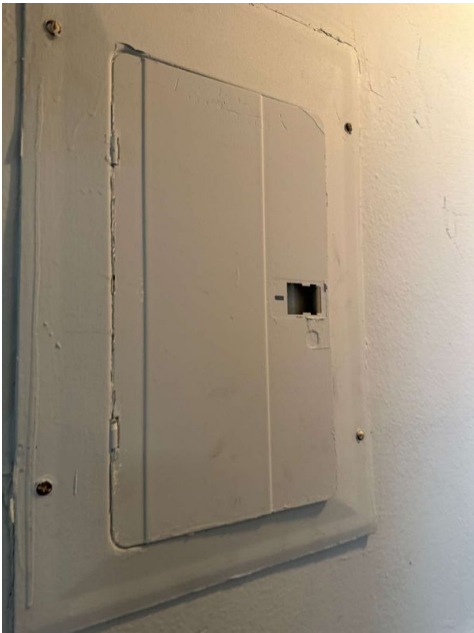
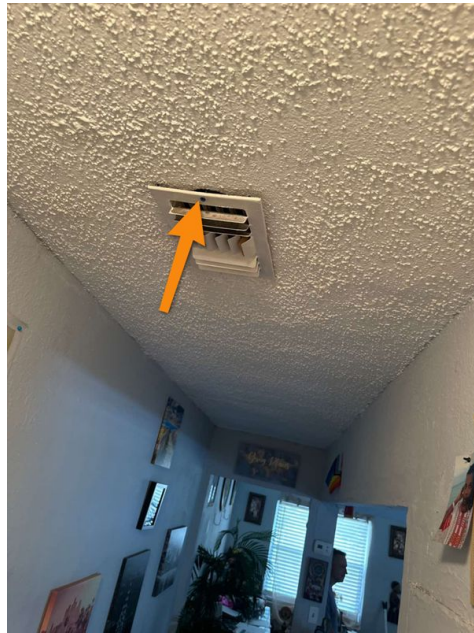
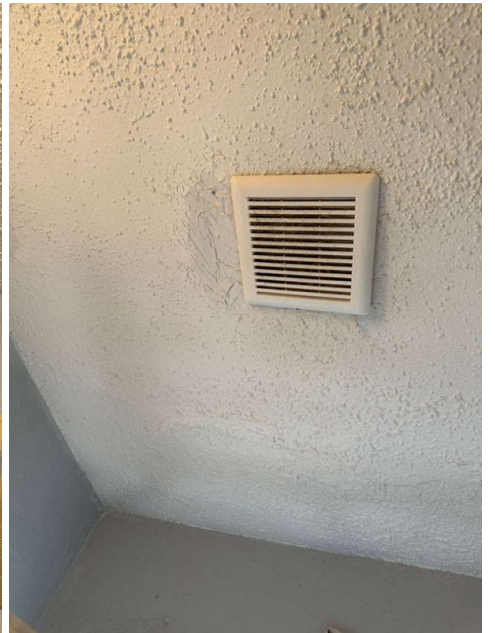
835

GENERAL WEAR AND TEAR

This is not a new home, so the home has general wear and tear that can be common for its age. You should be aware of the general condition. We inspect with realistic expectations for the age of the home, but here are some photos of some of the more noticeable wear and tear items that were noted. The drywall was also bubbled and shows very sloppy repairs. This drywall bubbling and sloppy repairs was noted for every unit, but just listed in this report.

Contact a qualified professional.

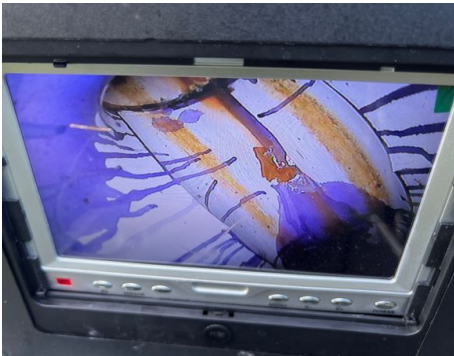
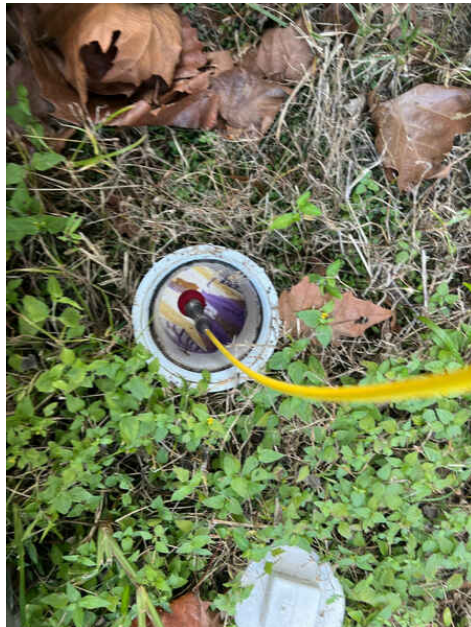
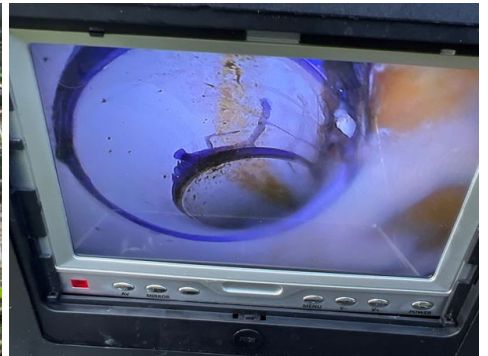
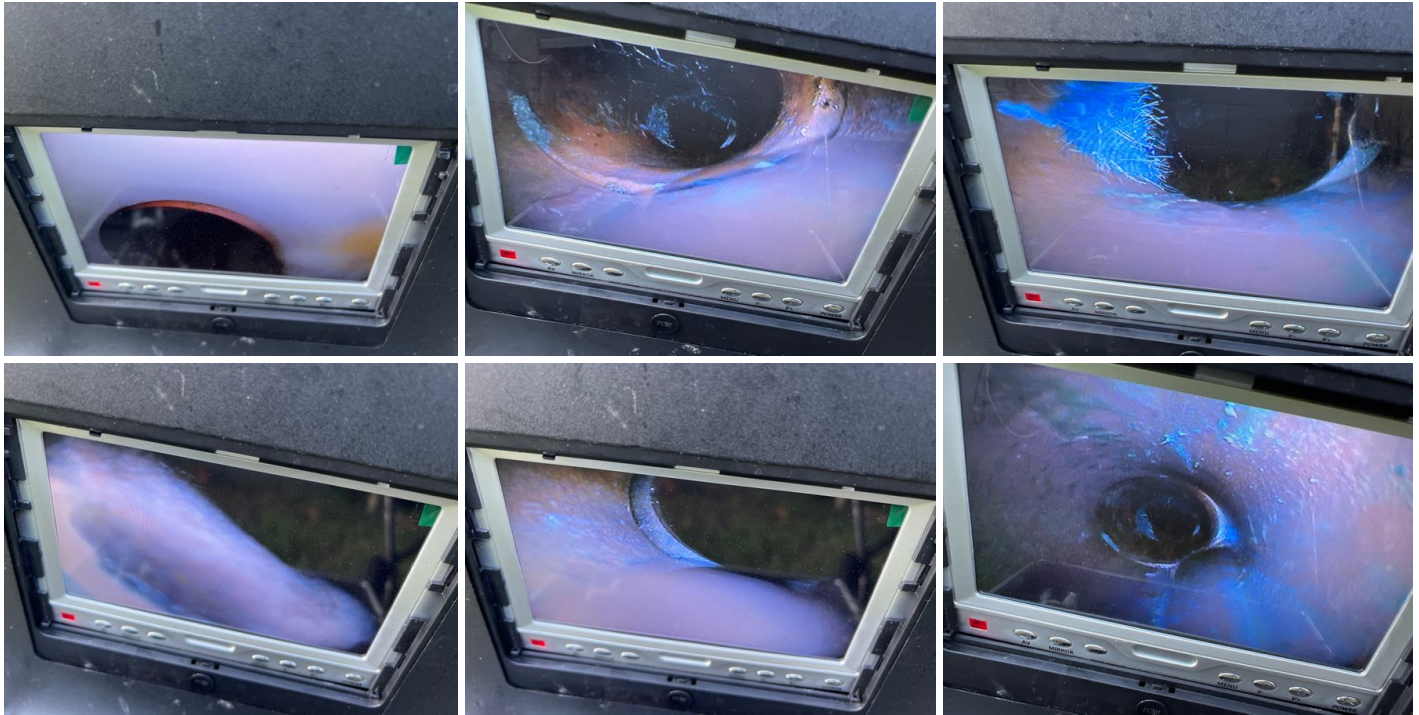
Video/Pictures: Video/Pictures

Please click link below or copy and paste to search bar to watch the sewer line video inspection:

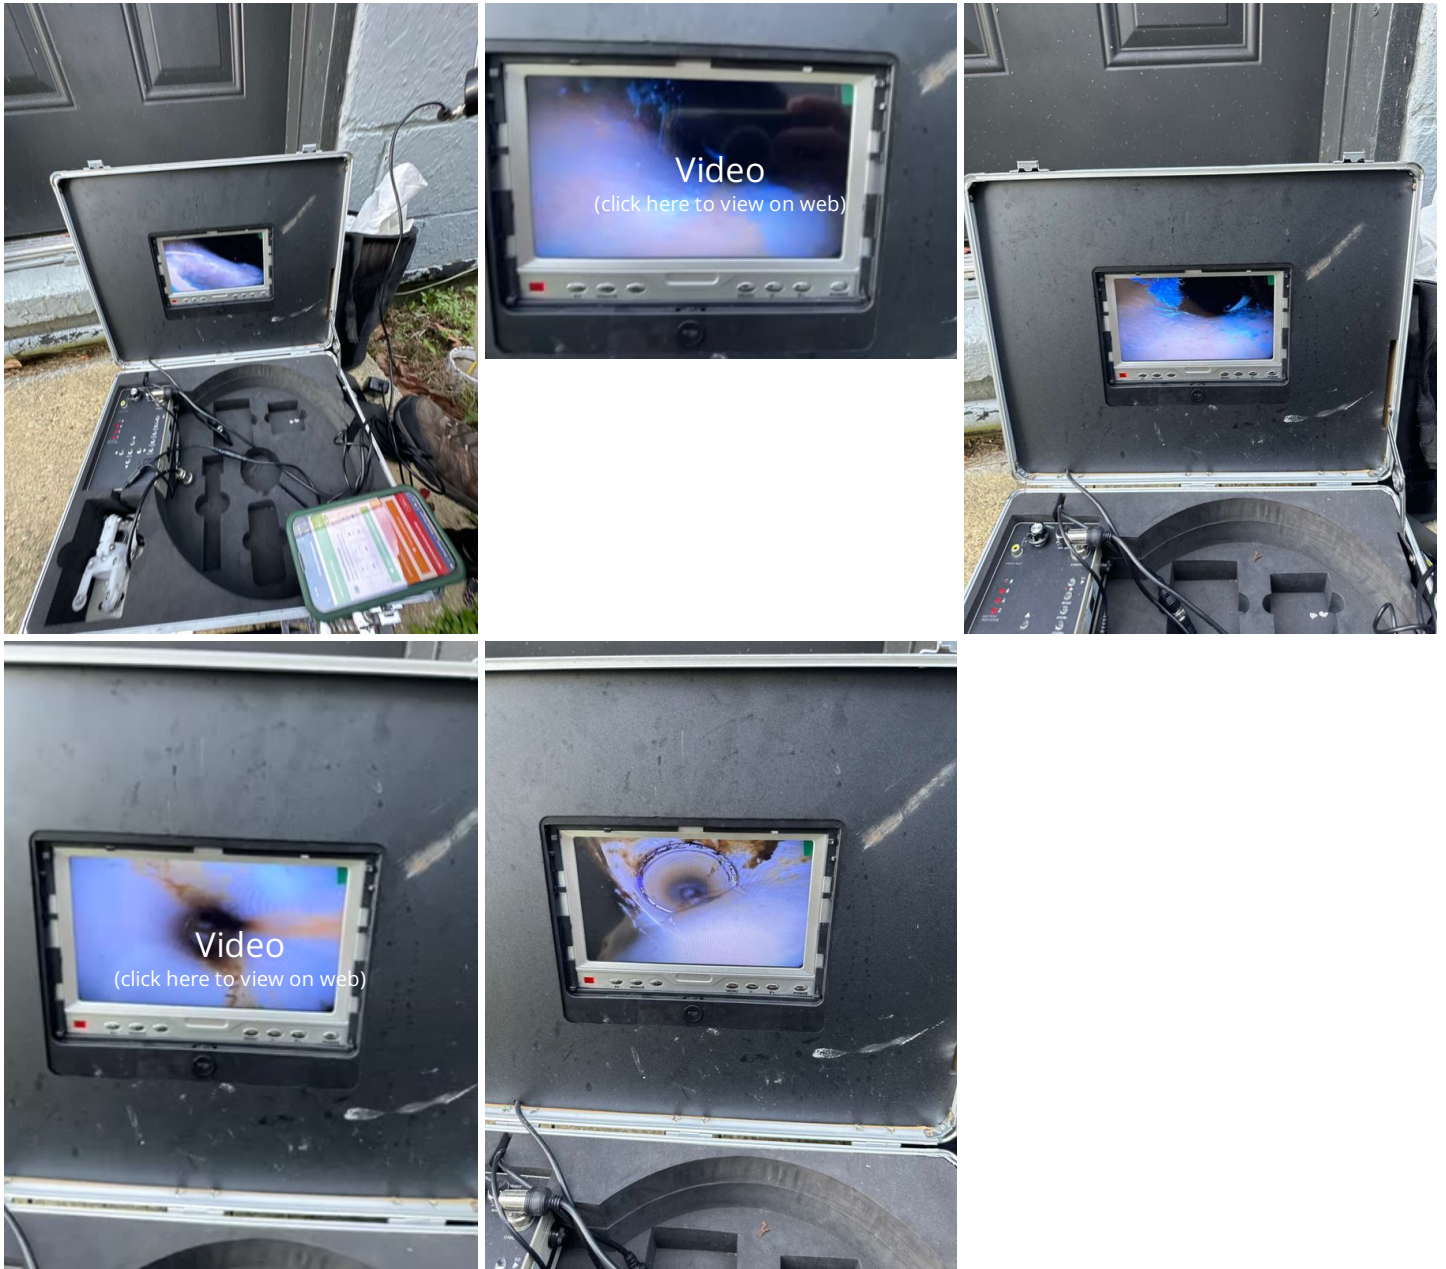
We performed a sewer scope during the inspection. We went through the main cleanout at the front of home and clay drain pipes were found (along with PVC). Clay pipes are rare, but were commonly used in the 1900s and before and are okay, but are more prone to damage. The pipes here appeared okay, but are more fragile.

Recommend monitoring.
