# DESIGN PROPOSAL

June 24, 2025  
314 E Main Street, Ottumwa, IA  
Project #05325

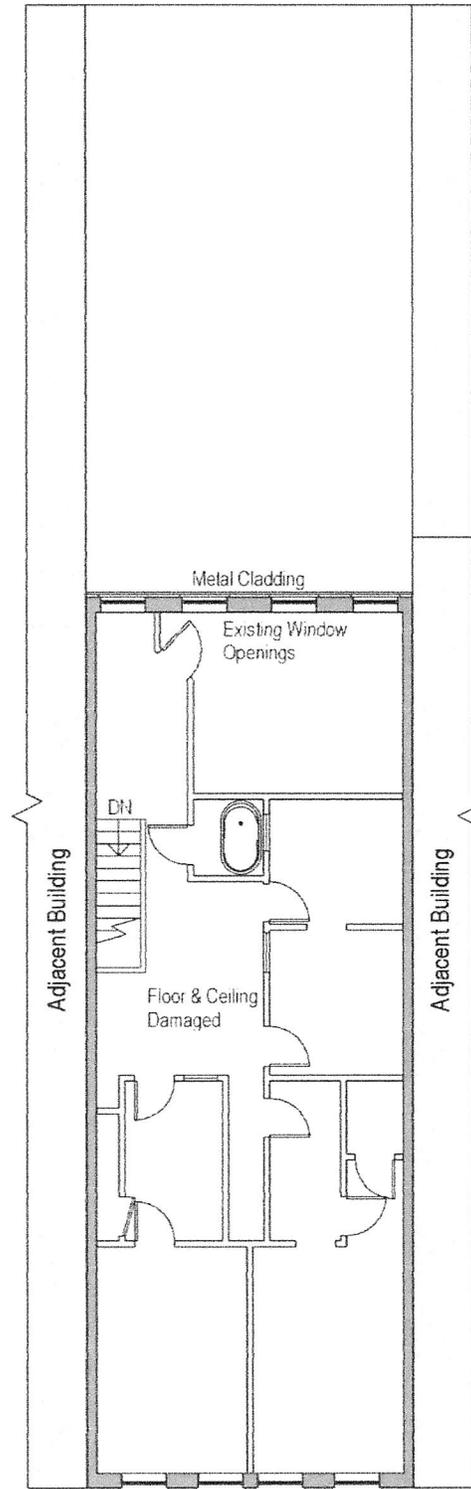
EXISTING 3RD FLOOR PLAN

- b) Third Level Flooring – there is evidence of a past roof leak which has damaged the flooring in the main circulation area on this floor.
  - c) Third Level Ceiling Framing – this is in poor condition and may need to be completely removed. The roof framing above was not fully visible. Fully inspect the roof framing to ensure joists are sound.
