Inspection Report

Property Address:
2005 9th street
Los Osos CA 93402

8/5/2024

Harper Homes: Home Inspection Services

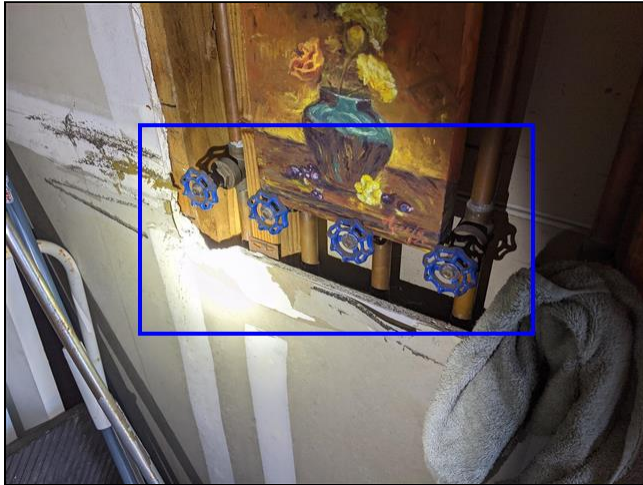
4.3 Item 1(Picture)

Water shutoffs are located in the utility room. The water can be turned off by turning the valves clockwise to the piping.
