## **Sewer Line Inspection Report**

## **Estate of Carol O'Brian**

119 S. Adams Street Glendale, CA 91205

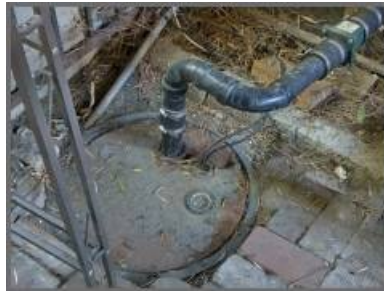
**NOTE:** The rear guest house is on a sewage ejection system.

For repairs to the sewage ejection system ABS supply line, it is recommended to contact a licensed sewage ejection system plumber.

The ejection system line repair, to be determined by a qualified ejection system plumber.
