Inspection Report

Property Address:
3735- 3741 Madison Ave.
San Diego California 92116

Date: 2/5/2025	Time: 08:45 AM	Report ID: J020525A
Property: 3735- 3741 Madison Ave. San Diego California 92116	Customer:	Real Estate Professional: Compass

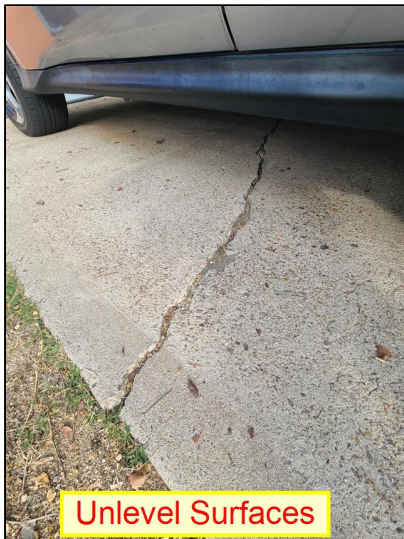
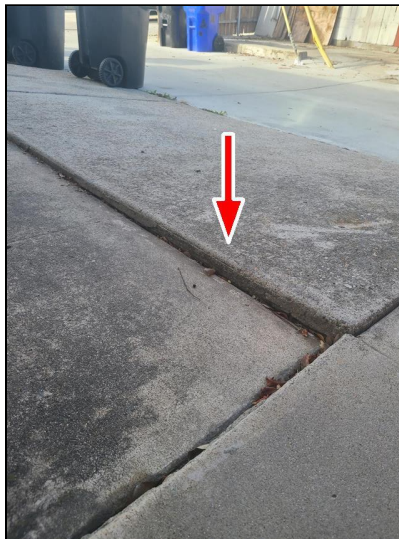
**Unlevel Surfaces- Trip Hazards.** There were areas at the driveways which had unlevel and some cracks and raised surfaces noted. **Some of these cracks were offset and may pose as trip hazards.** It is recommended that adjustments be made to create a smooth walking surface at these locations.

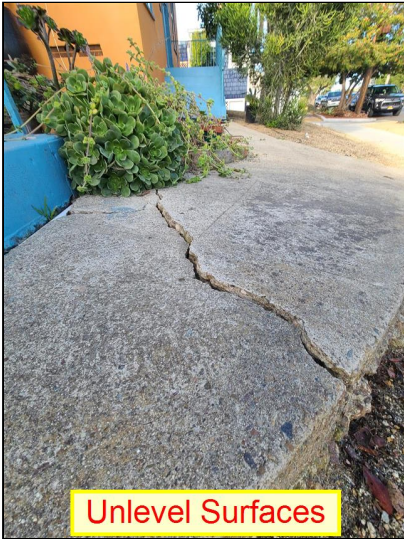
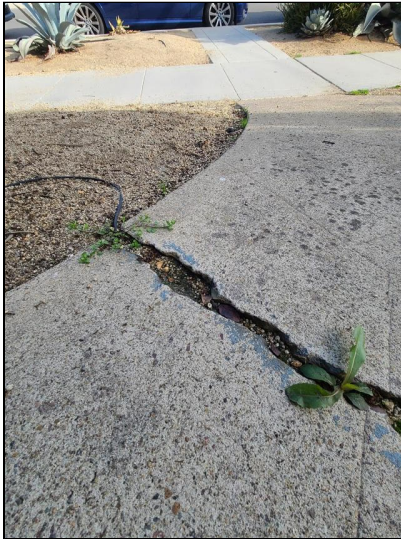
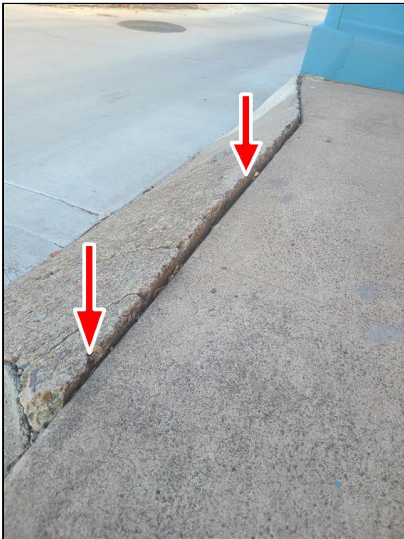
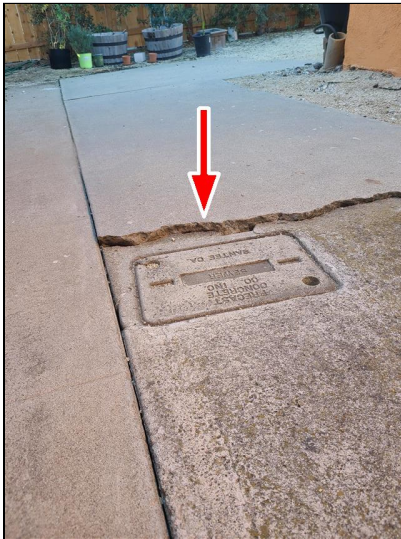
(2) **Unlevel Surfaces- Trip Hazards.** There were areas at the front entry of units #3739 and #3735 which had unlevel and raised surfaces noted . **There were unlevel surfaces at the backside of the garages as well.** These areas may pose as a trip hazard. It is recommended that adjustments be made to create a smooth walking surface at these locations.

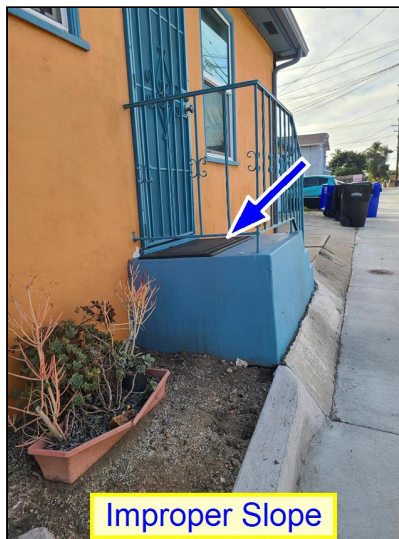
**Improper Slope.** The slope, of the right side stoop, of unit #3435 was improper. The stoop sloped towards the unit. **This will allow for water to run toward and pool against the structure.** It is recommended that this be corrected as needed.

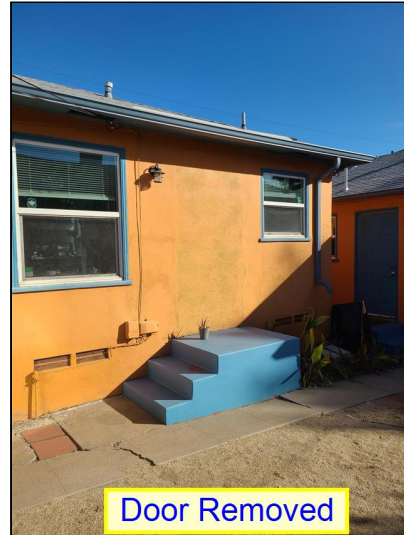
(4) **Seams Noted.** There were seams noted at the door removal at the rear of the **unit #3739** It appears that the removal of these windows may not have been properly tied into the original structure causing these cracks or seams. Improper flashings or installation/removal of windows can increase the risk of leaks. Typically these types of seams indicate that the work was done incorrectly. Due to the material coverage, this was not able to be verified. **This is noted for your information these areas should be further evaluated to ensure proper application was completed.**

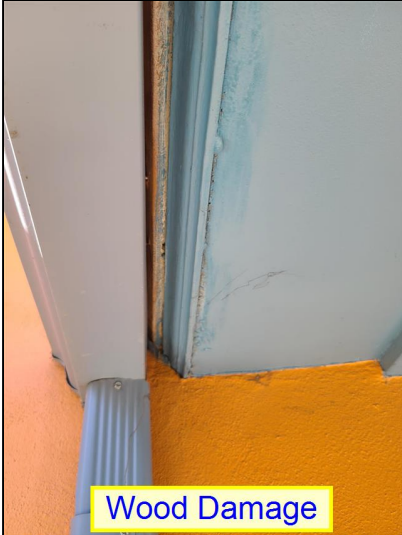
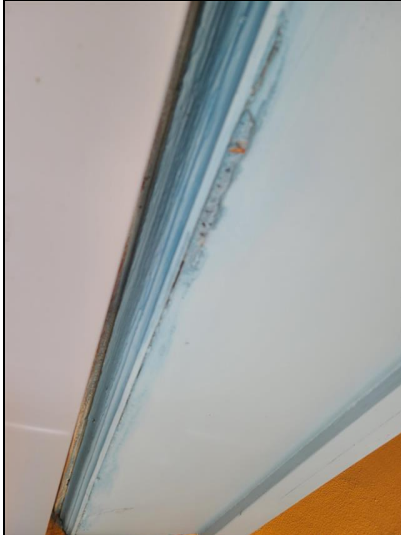
Wood Damage

(2) **Eave Damage.** There was some wood damage at some of the eaves at the rear of **unit #4548**. It is recommended that you read your termite report thoroughly and that any damaged wood be repaired or replaced by a licensed contractor if needed.

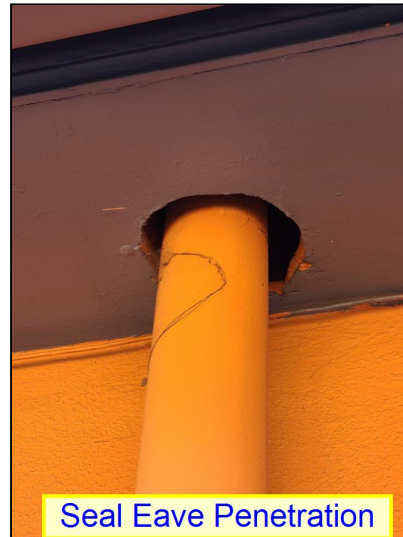
Seal Eave Penetration

(3) **Seal Eave Penetration.** There were some penetrations noted at the exterior of **unit #3741**. These penetrations have area with gaps that can allow for animals to enter. It is recommended that these areas be patched or sealed as needed by a licensed contractor.

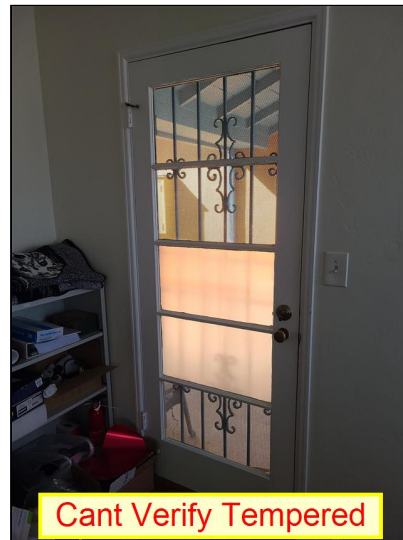
(1) **Cant Verify Tempered.** There is an exterior door at unit #4548, that contains glass that could not be verified as being safety glass . Tempered glass is a safety glazing that is required in hazardous locations, it is usually indicated as being such by labeling in corner of pane. **This is typical to find in older homes and precautions should be taken.** Recommend further analysis and replacement if necessary.

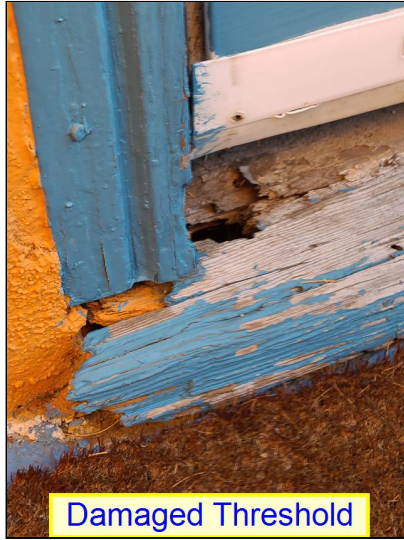
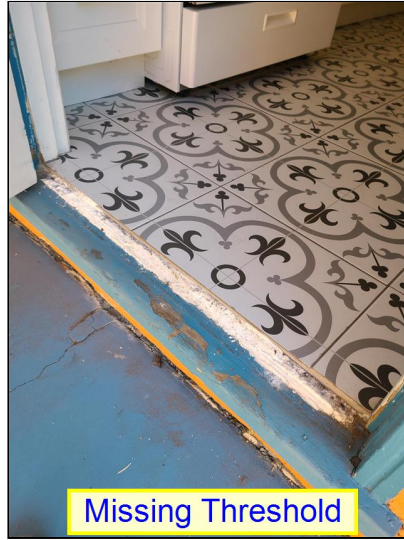
🏠 (2) **Damaged Threshold.** There was some wood damage to the threshold at the right side of the building at units #4548 and unit #3741. It was noted that at least one threshold had some wood damage. It is recommended that all damaged or unfinished wood be repaired or replaced as needed by a licensed contractor.

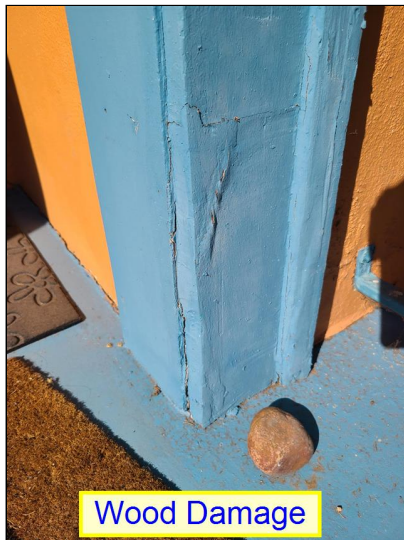
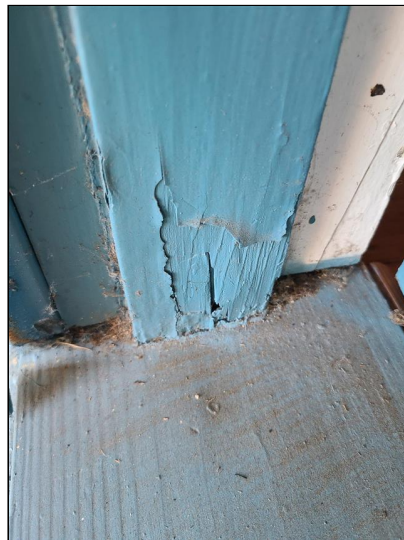
(3) **Wood Damage.** There was some wood damage noted at the exterior door frame at the front entry of unit #4548. It is recommended that all damaged wood be repaired or replaced as needed by a licensed contractor.

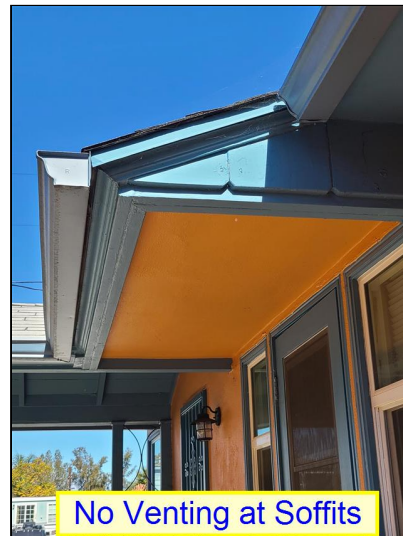
No Venting at Soffits. The soffits at the exterior patio cover were enclosed and there was no venting noted. Inadequate venting increases the risk of wood damage, should a leak or water enter these areas. Venting allows for air to circulate within these cavities. **It is recommended that the soffits at these area be equipped with vents to allow for adequate ventilation.**

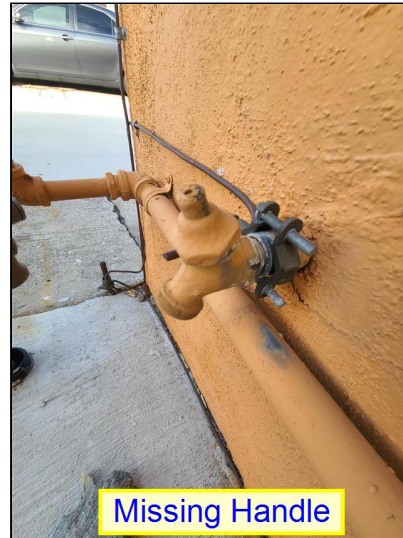
(2) **Missing Handle.** There was a missing handle for one of the hose bibs at the rear of the duplex. **This fixture was not tested for proper working order.** It is recommended that this handle be replaced to ensure proper working order.

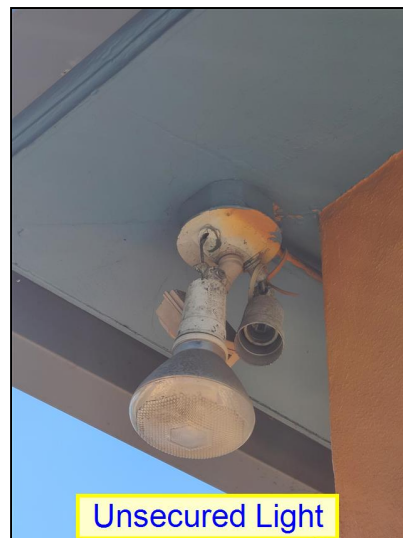
(2) **Unsecured Light.** There was a light that was not properly secured at the exterior wall. The light that did not have proper support and was pulling from the wall. This was noted at the rear of **unit #3741.** It is recommended that this be repaired as needed to allow for proper support.

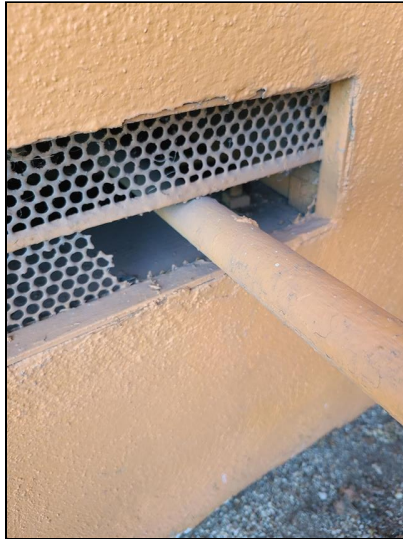
📍 (1) **Damaged Screens- Crawlspace**. There were a few vent screens that are damage or torn at the crawlspaces. The vent screens are designed to allow air into the crawlspace to help circulate the airflow in this area, yet keep out unwanted insects and pests. **It is recommended that this screen be repaired or replaced so unwanted wasps, hornets and bees rodents and animals do not enter this crawl space.**

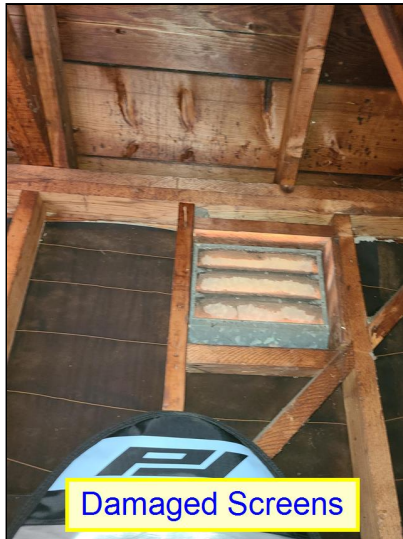
(2) **Missing/ Damaged Screen.** There was a missing or damaged screen noted at the garage. Screens help ventilate your garage and keep out unwanted bugs, cats, opossums, rodents and other creatures who may want to explore or reside within your garage. **It is recommended that all missing or damaged screen are repaired or replaced as needed.**

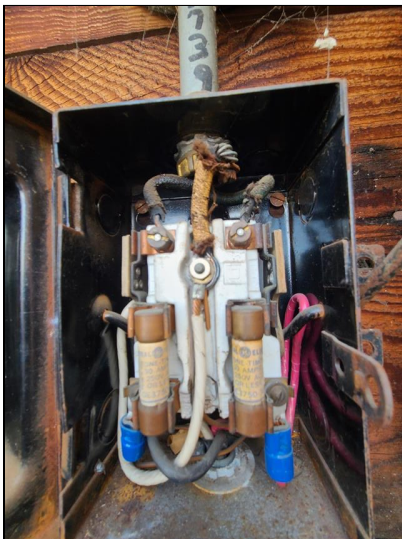
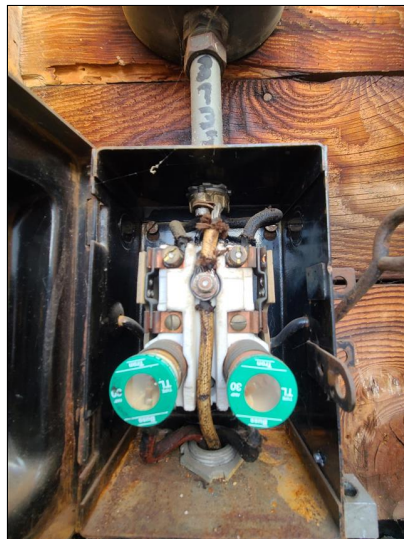
Fused System

(2) **Fused System.** The main disconnects for the **rear duplex** is on a fused system. **This is an older style of disconnecting means that is considered outdated.** You may wish to convert this to a more modern breaker type system. **It is recommended that the electrical system be further evaluated and updated as needed by a licensed electrician.**

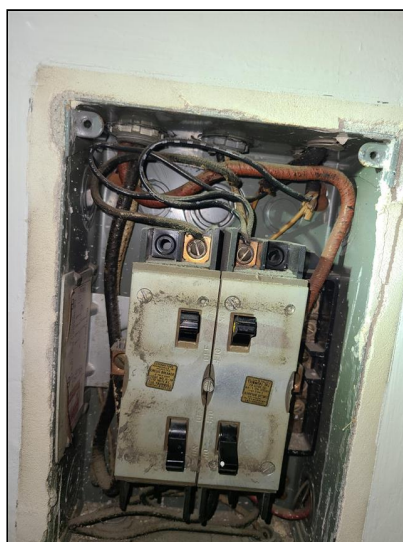
Old Electrical Panel

(3) **Old Electrical Panel.** The sub-panel within **unit #4548** was an older Trumbell panel. This is an old panel that is considered to have reached it's life expectancy. It is recommended that this panel be replaced with that of a newer model by a licensed electrician.

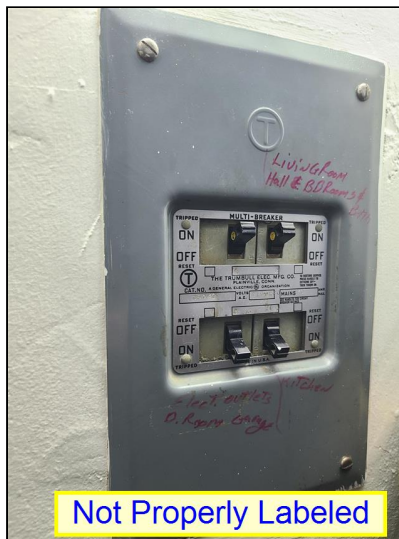
(4) **Breakers Not Properly Labeled.**

The breakers in the sub panel of **unit #4548** are not all labeled for individual use or are improperly labeled. **It is recommended that each breaker be labeled for its correct use for easy identification.** Recommend that an electrician correctly identify and label each breaker for its use.

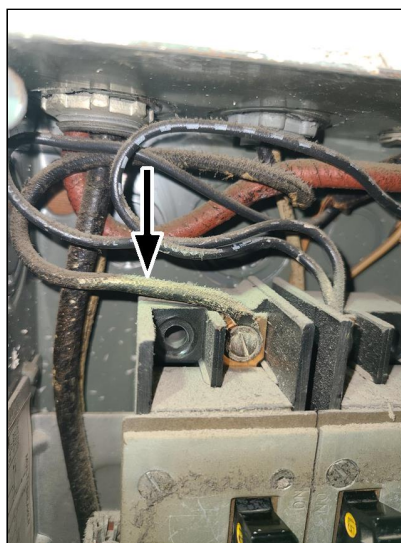
(1) **NOTE: Older Cloth Sheathed Wiring.** Due to the age of this house, some locations still have the **original UNGROUNDED** (cloth sheathed wiring). This wiring is not provided with a source of grounding. There were no visible defects found with this wiring. **Due to the age of this wiring, it is considered to have reached the end of it's useful life.** It is recommended that an electrician be called out to further evaluate the system and discuss the costs and benefits of a newer electrical system.

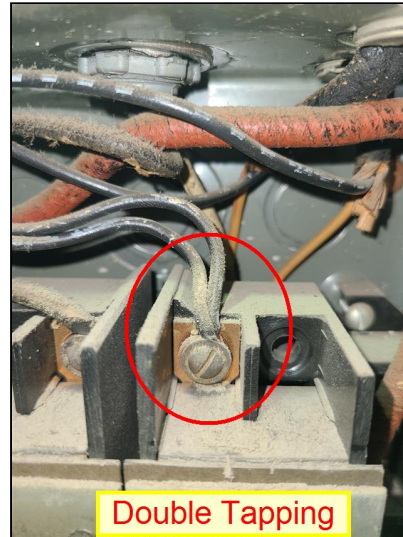
(2) Double Tapping of Breaker.

The sub panel, in **unit #4548** has a breaker that is double tapped. Double tapping is when two wires enter a single breaker. This typically occurs when the panel is too small for the current amount of breakers provided, or an additional was breaker was just not added. **Recommend further evaluation and repair by a licensed electrician.**

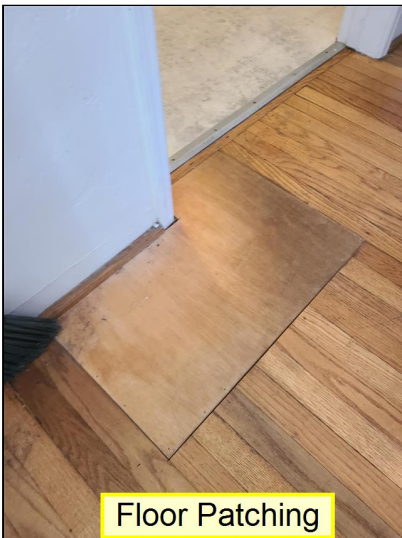
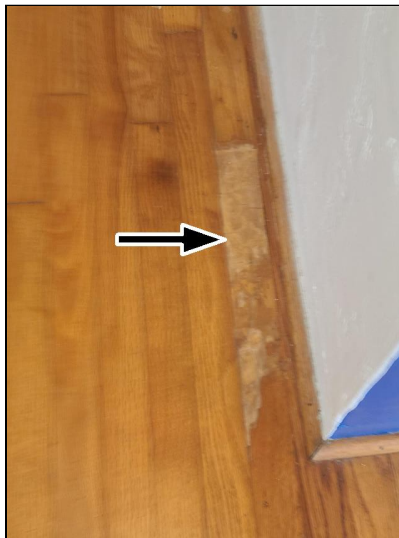
(1) **Patching Noted.** It appears that there was some patching of the wood floors in a few of these units. The floor heaters were removed and plywood has been installed. There was a color difference noted at the flooring in the family room. The cause or reason for this was not able to be determined at the time of the inspection. This is noted for your information and it is recommended that you ask the current owner about this area.

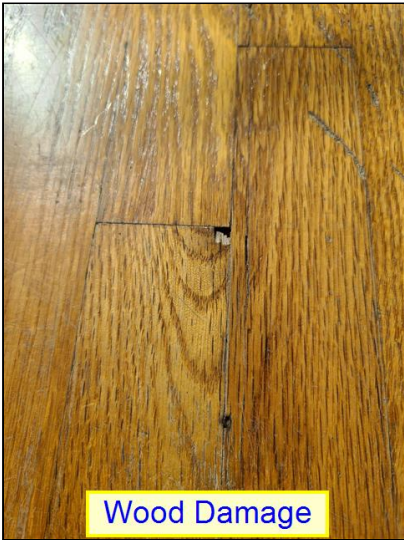
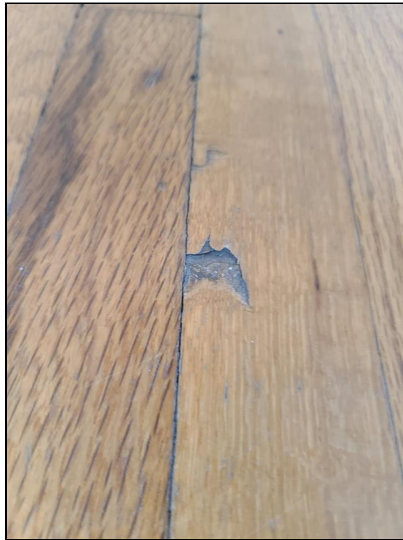
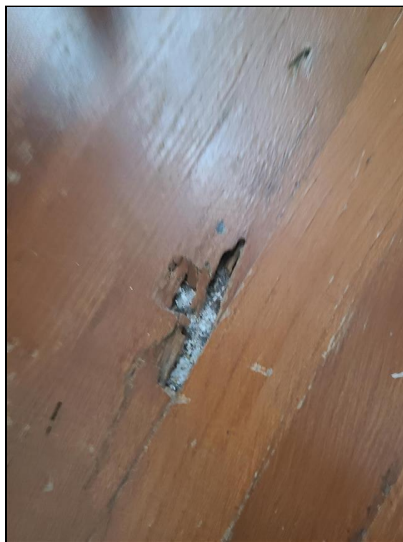
(2) **Wood Floor Damage**. There was some damage to the wood flooring noted in the bedroom of **unit #3741** as well as in the dining area of **unit #4548**. It is recommended that you read your termite report and that these areas be further evaluate and repaired as needed by a licensed contractor.

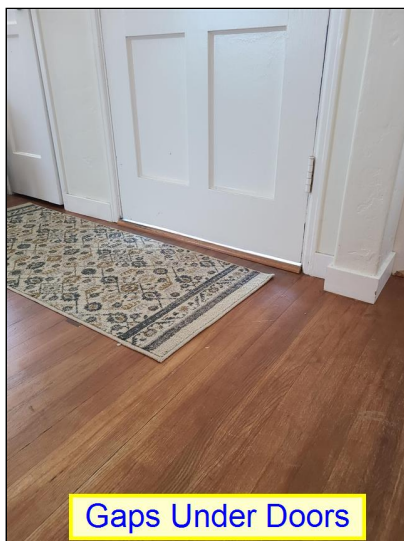
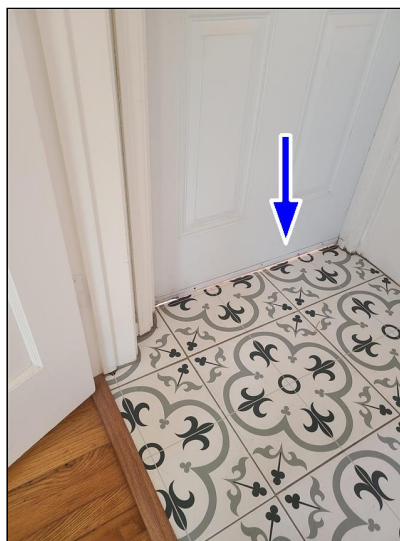
(1) **Gaps at Doors.** There was a gap at the underside of the door of the main entry of **units #3741 and #4548**. This allows the door to draft and is not energy efficient. **It is recommended that the doors be properly sealed with weather stripping to help alleviate drafting at these locations.**

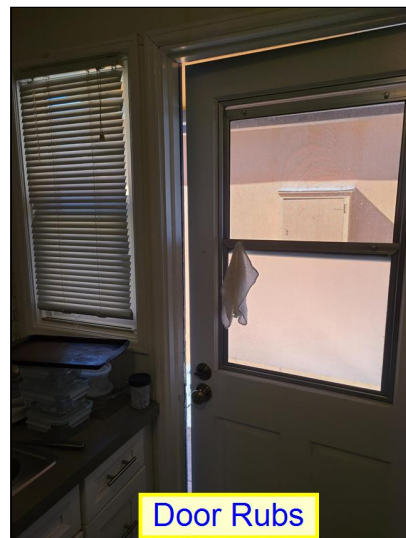
(4) **Door Rubs at Frame.** The exterior door of the kitchen, in unit #4548, rubs at the frame. This currently does not affect the function of the door. This is noted for your information and can be adjusted or repaired at your convenience if so desired.

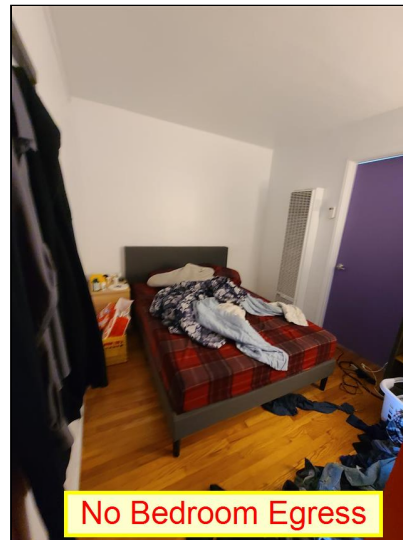
**NOTE: Not Egress Windows.** The interior room conversion, in unit #3735 was not provided with a window for emergency egress. **Today's standards require bedroom windows to have a sill height not greater than 44 inches from the floor, have a minimum opening width of 20 inches and a minimum height of 24 inches.** These measurements are set to ensure that all occupants can exit the bedrooms in case of an emergency, and that firefighters can easily enter the bedrooms from the exterior of the house. It is recommended that if these windows are replaced, that they be increased in size to accommodate today's standards.

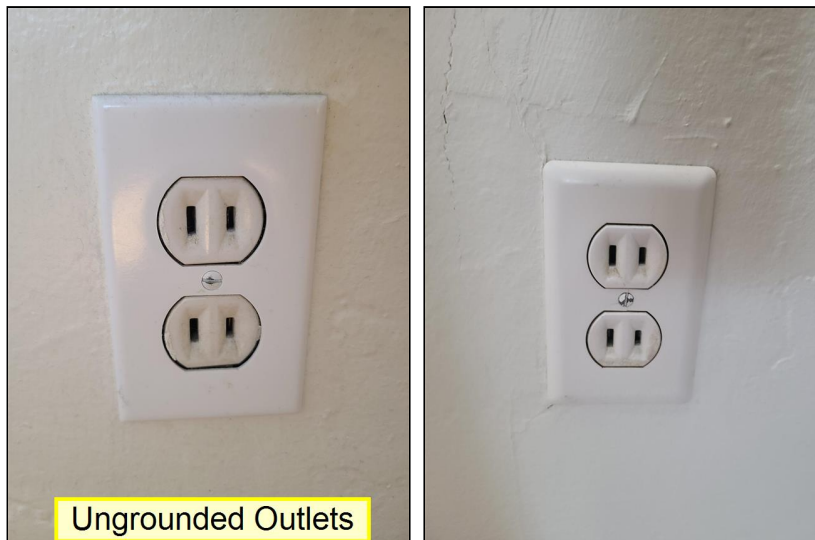
(1) **NOTE: Minimal Grounding.** Due to the year in which this unit was built; there were two pronged outlets in some of the rooms in **unit #3741 and #4548**. The original style of two pronged outlets have remained for your knowledge and reminder. These outlets can not be properly changed to the three pronged outlets unless the outlets have been properly grounded or are protected by a GFCI outlet or protected circuit, and a sticker has been added to the cover plate identifying that there is "No Equipment Ground". This is noted for your information. **It is important to know and understand that the two pronged outlets have not been upgraded and are NOT GROUNDED.**

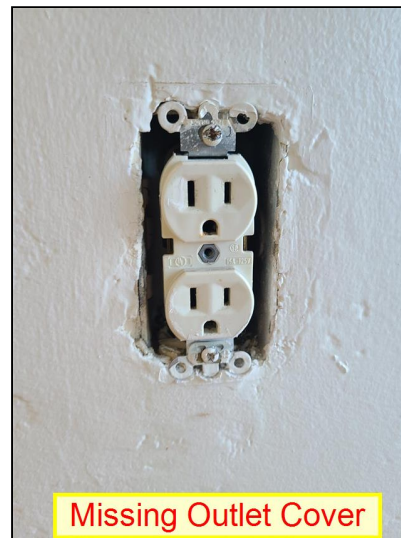
(2) **Missing Outlet Cover.** There was a missing cover in the family room of **unit #3741**. Missing faceplates expose electrical parts of receptacle outlets, and switches creating a potential shock hazard. **For safety reasons all outlets and switches should have secure covers to reduce the chance of electric shock.**

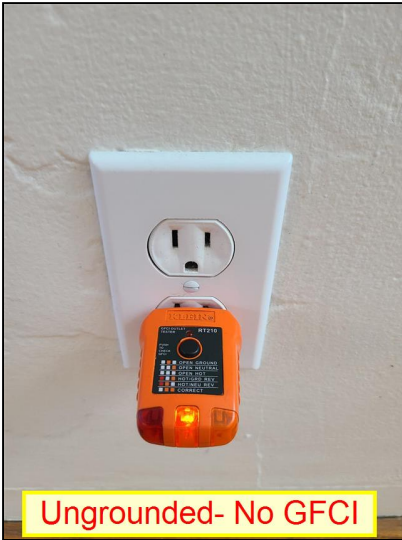
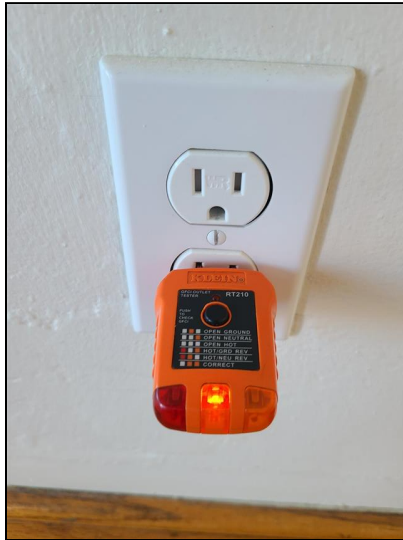
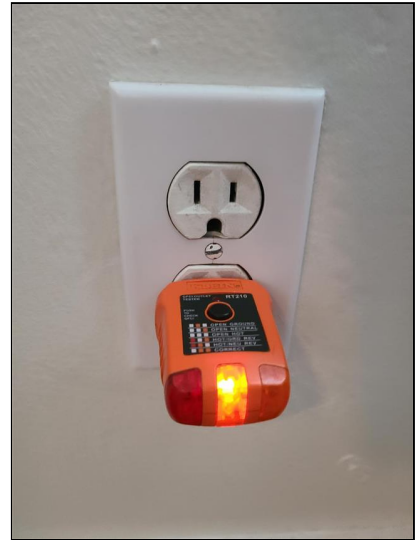
(3) **Improper Conversion- Ungrounded.** Many of the electrical outlets in the rooms of **unit #3741 and #4548** are not grounded, and were originally installed with two-pronged (ungrounded type) outlets. For convenience purposes, most of these outlets have been switched to three-pronged (grounding type outlets). **Currently this is incorrect and not permitted without protection.** . **The National Electrical Code (NEC) allows the installation of grounded type receptacles on a two-wire system ONLY if a Ground Fault Circuit Interrupter (GFCI) has been installed at the beginning of the circuit, either as a breaker or a feed-through receptacle at the first receptacle in the circuit.** All of the receptacle outlets installed downstream must have a label stating that they are GFCI-protected and that there is no equipment ground. **This is noted**

for your information and a GFCI outlet or breaker should be installed at the panel or at the beginning of each run by a licensed electrician.

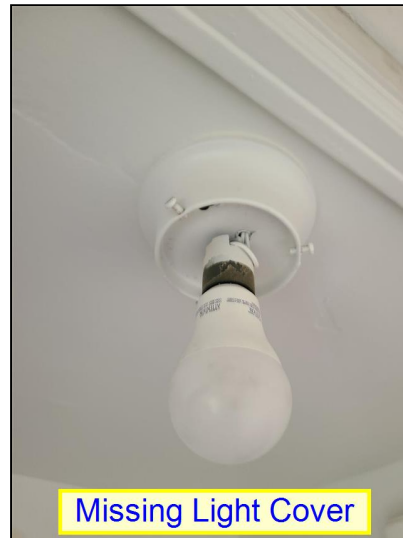
(4) **Missing Light Cover.** The light in the hallway of unit #3735 was not provided with a globe or cover. It is recommended that the fixture have a cover provided.

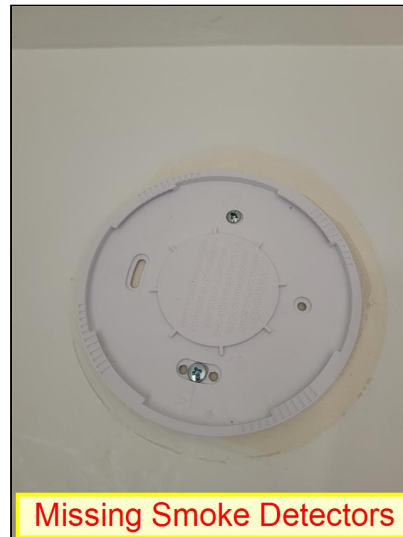
(2) Missing Smoke

Detectors. Smoke detectors should be located at each level, in each bedroom and in the room outside the bedroom (hallway). Currently there was/ were missing detector(s) in one or more of these locations, **in all but unit #4548.** It is recommended that smoke detectors are present at these locations.

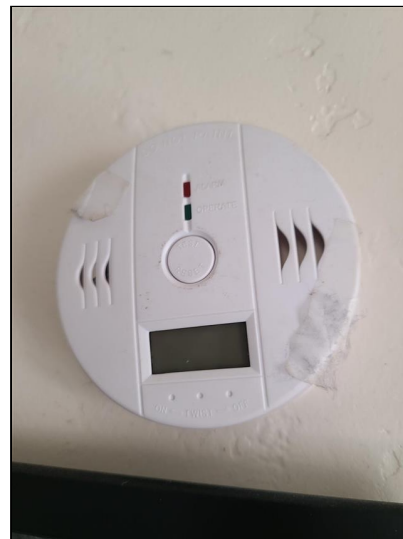
(3) Inoperative Detectors- There were one or more smoke detectors that wither had low batteries or were missing batteries, or had batteries that did not work. It is recommended that there are working smoke detectors in the required locations.

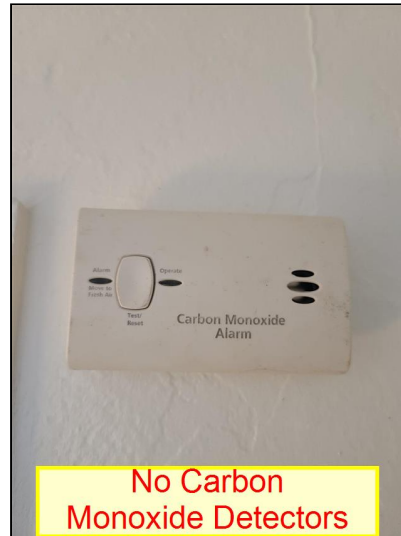
(2) No Carbon Monoxide Detectors.

As of July 01, 2011 a Carbon monoxide detector is required to be installed in all new and existing single family homes. Currently there were no carbon monoxide detectors in **units #3735, and was not working in unit #3739.** Carbon monoxide is an odorless, tasteless lethal gas which is created by combustion particles. These detectors act like a smoke alarm, and makes an audible warning to alert you if particles are detected. These need to be installed at each floor level including basements and or crawlspaces . It is a safety requirement that a working carbon monoxide detector be installed in this property.

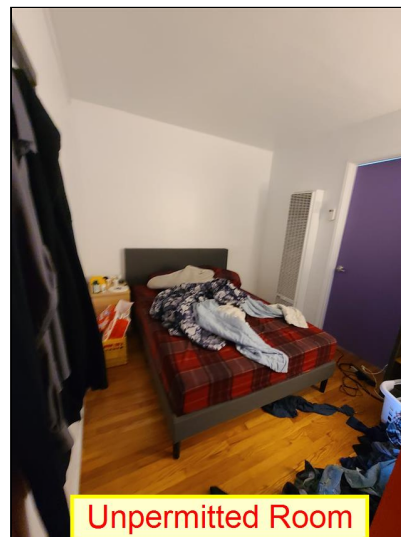
**Verify Permits.** There was an interior room in **unit #3735** which was not provided with natural ventilation, natural light or a means of egress. All habitable rooms should have a source of natural light (minimum of 1/10th of the floor area) , and natural ventilation (opening of at least 1/20 of the floor area) and a means of egress. It was noted that this room had none of the following. It is recommended that it be verified that permits were pulled and that the finals were signed for any additions made to this house.

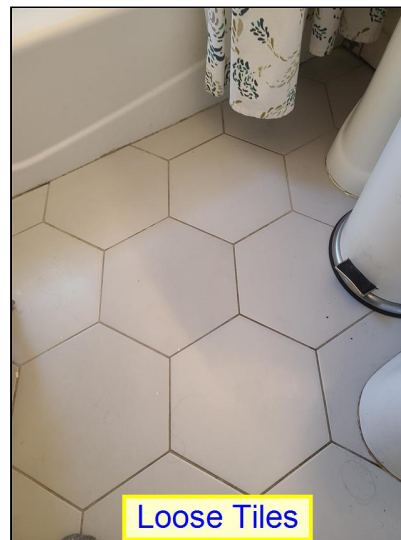
Loose Tiles/ Cracked Grout.

There were some loose tiles and cracked grout noted at the floor of unit #4548.. This is common in homes with raised foundations or second stories when a backer board is not present. It is recommended that these tiles be further evaluated and repaired as needed.

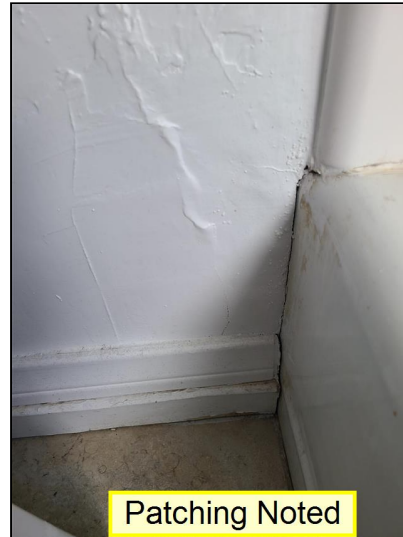
NOTE: Patching Noted. There was an area of patchwork noted at the exterior sides of the shower. This is common for this location due to the proximity of the shower and the potential of water splashing on or reaching the walls at this location. **There did not appear to be any current damage or issues at this area, however due to elevated moisture within bathrooms, further evaluation is always recommended.** This is to ensure there are no problems that can develop. We are not able to see within the wall so further evaluation is recommended.

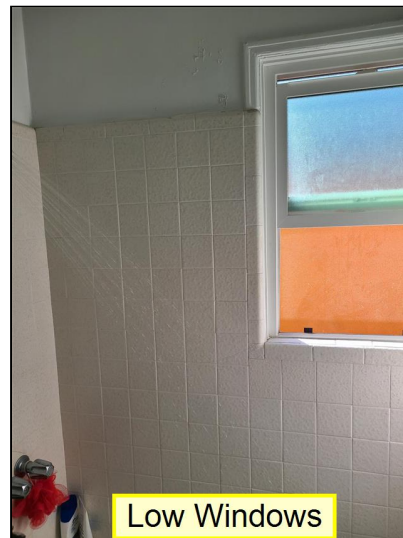
(1) **NOTE: Low Windows.** The window in the bathrooms are a low laying windows. Due of the height of the windows in comparison to the shower head, these windows are notorious for having water damage at the window sill, ledge and to framing beneath. **There was no visible evidence of any problems at the time of the inspection, however the interior of the wall was not visible and internal damage could not be determined.** Should this window be replaced it is recommended that it be framed higher to avoid water penetration. Covering this window when showering is a good idea to help keep water from entering the wall. This is noted for your information.

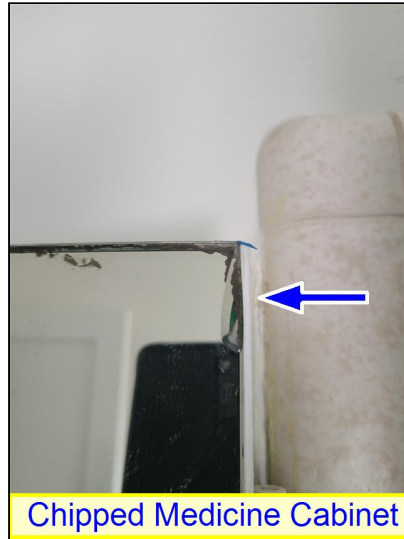
(2) **Chipped Medicine Cabinet.**
The mirror of the medicine was damaged in **unit #3735**. For safety purposes it is recommended that this be replaced by a qualified person.

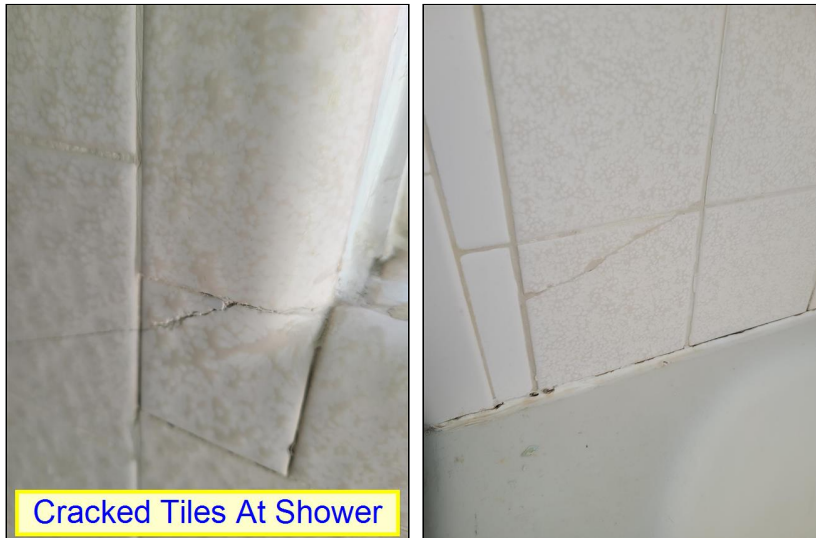
(3) **Cracked Tiles At Shower.** It was noted that there were some cracked or damaged tiles in the shower enclosure of **unit #3735.** It did not appear that water was entering these areas. **It is recommended that these areas be further evaluated and patched as needed to help ensure that water does not enter into these areas possibly causing damage.**

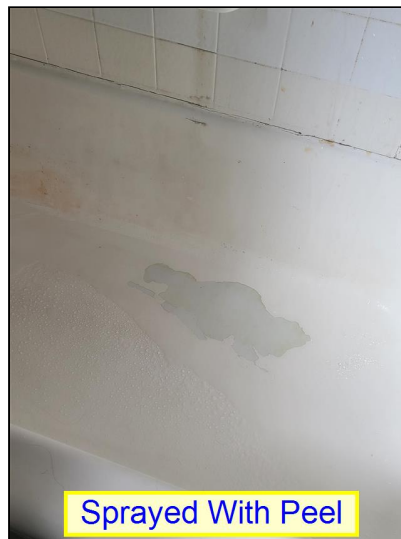
(4) **Sprayed Tub/ With Peel.** It is noted that the bathroom shower enclosure appears in **unit #3739** to have a **EP-Acrylic** liner sprayed on the surface to look new. Over time, this covering will begin to wear, and peel exposing the true condition of the enclosure. Special care should be used on these surfaces. Don't lay soap, bottles or metal objects on the finish for long periods of time, Never use abrasive cleaners, bleach, or hair dyes. When cleaning do not use: SOS pads, Comet, Ajax or Soft Scrub. Some recommended non-abrasive cleaners to use are:: Lysol Basin & Tile Cleaner, Dow Scrubbing Bubbles, Mr. Clean (liquid or eraser), Fantastic, Kaboom or any other liquid detergent tub and tile cleaner. (Always follow manufactures suggested instructions and directions). **In this application it has begun to peel at a few locations.** This is noted for your information.

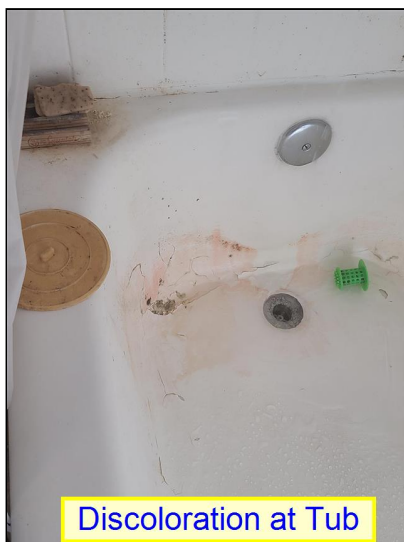
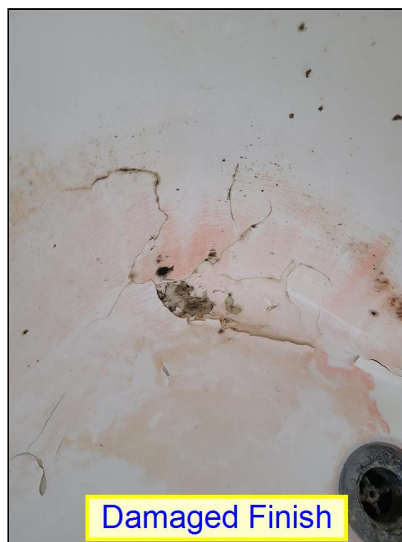
(5) **Discoloration at Tub.** There was some discoloration and damage to the surface of the tub in **unit #3739**. It could not be determined if this discoloration can be removed. **This is noted only for your information.**

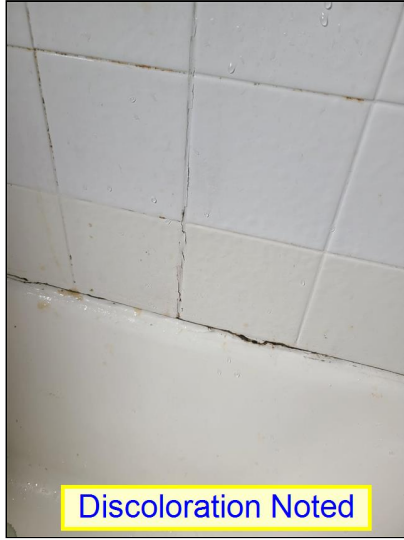
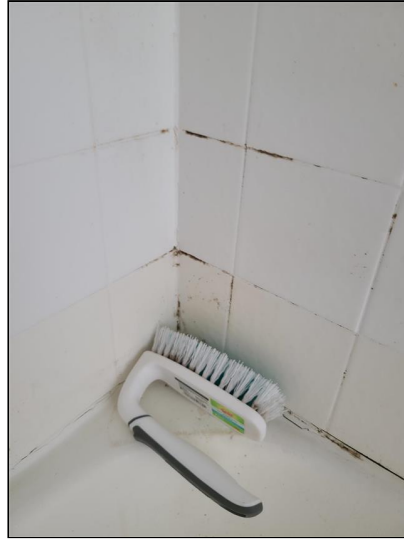
(6) **Discoloration Noted.** There is some discoloration of the caulking on the inside of the wall connection of **unit #3537**. Discoloration occurs when moisture builds up and is unable to escape

creating mildew and the discoloration of the grout/ caulking. It is recommend that this area be cleaned, bleached and re-caulked so moisture is unable to build up under the caulking.

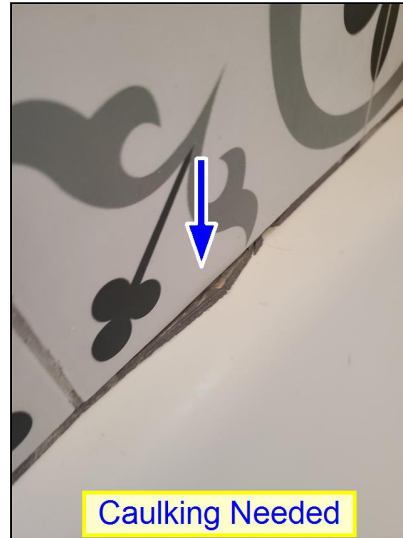
(7) **Caulking Needed.** There are areas needing grout/ caulk in the shower enclosure of **unit #4548.** Recommend that these areas receive caulking to avoid water penetration.

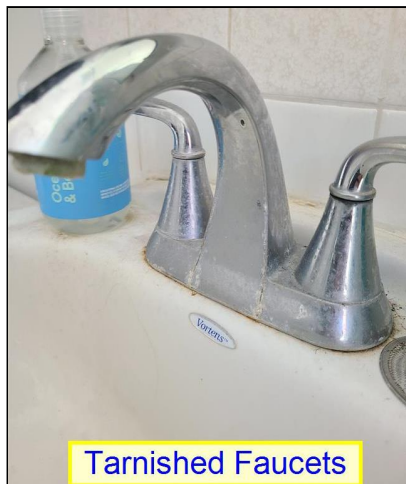
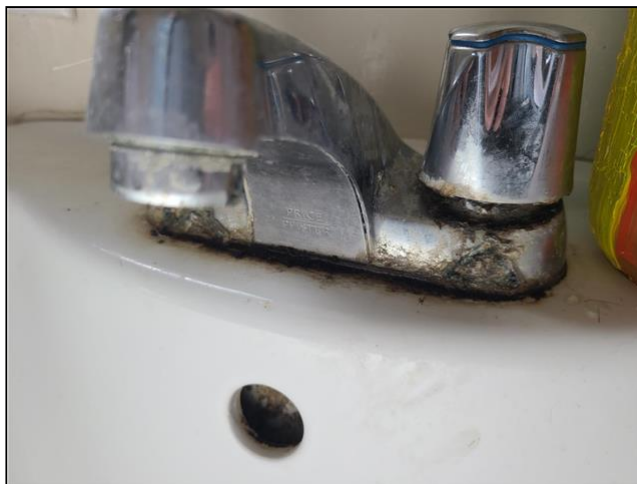
- 🏠 (1) **Tarnishing of Faucet.** There is some corrosion and tarnishing at the sink faucet in **units #3735, #3739.** This is noted for your information.

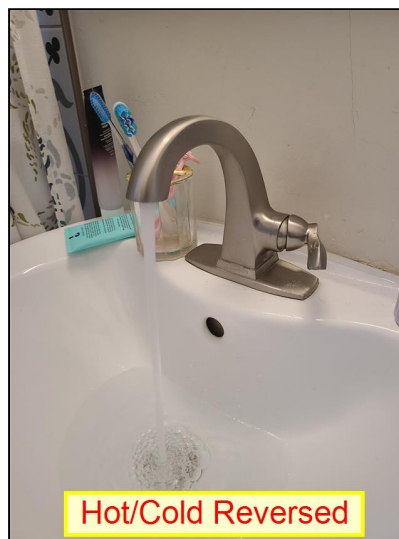
- (2) **Hot/Cold Reversed.** The hot and cold were switched at the sink of **unit #4548.** It is standard that hot water is turned on at the left and cold water is derived from the right or that the water starts cold, and turns to hot. **In this application the hot and cold are reversed.** It is recommended that this be repaired as needed by a licensed plumber.

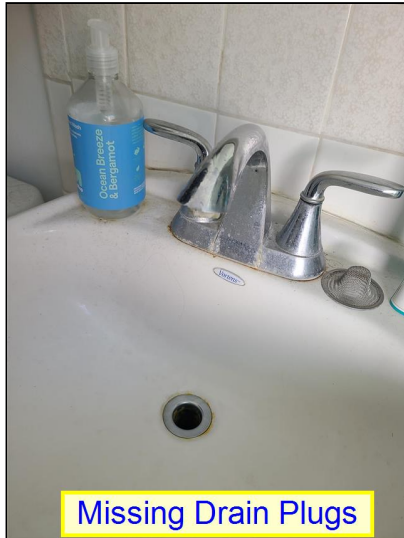
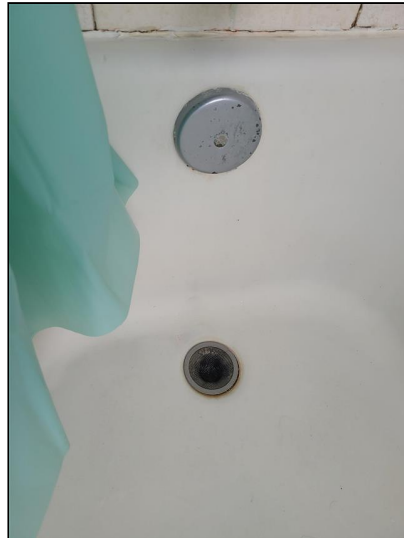
🏠 (1) **Missing Drain Plugs**. The drain plugs for both the sinks and the shower fixture were missing in several of the fixtures. **Recommend replacement for proper water retention.**

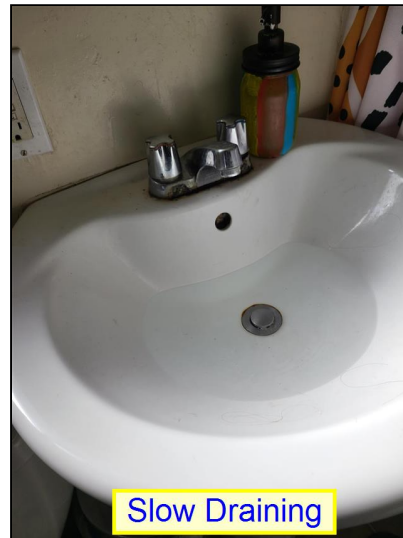
(2) **Slow Draining**. The drain line, in **unit #3739**, appears to have debris in the drain at the sink and was slow at draining. **It is recommended that these drains be cleaned out to ensure proper drainage of water.**

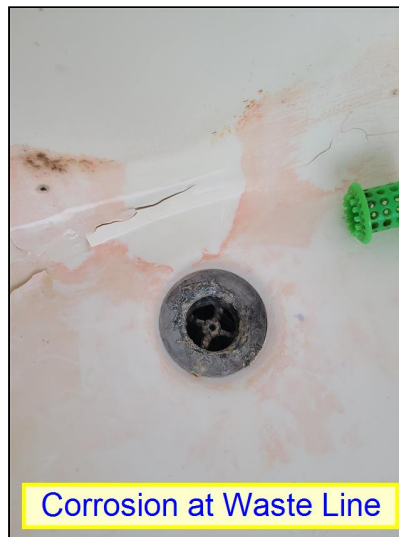
(3) **Corrosion at Waste Line.** There was some moderate corrosion at the waste line at the tub of **unit #3739**, and the drain plug did not function. It is recommended that these lines be further evaluated and replaced if need by a licensed plumber.

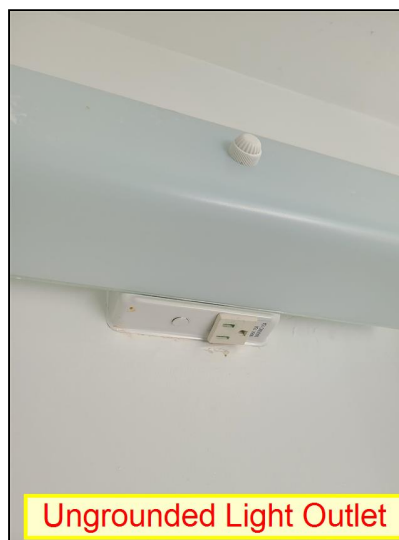
(1) **NOTE: Ungrounded Light Outlet.** There was no wall outlet provided for this bathroom. The only outlet for this bathroom is found at the underside of the light fixture. This outlet is currently ungrounded. If you change light fixtures, you will need to add a wall outlet. This is noted for your information. It is recommended that a grounded and GFCI protected outlet be provided in this bathroom.

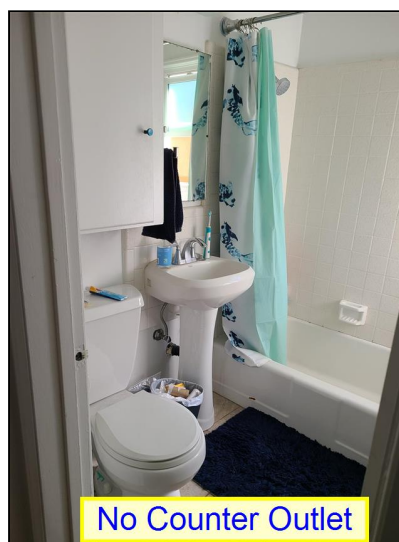
(2) **No Counter Outlet.** There are currently no electrical outlet provided for the counter in the bathroom of **unit #3735**. It is recommended that each bathroom be provided with a minimum of one GFCI protected outlet at the counter. It is recommend that a GFCI protected outlet be installed in this bathroom by a licensed electrician.

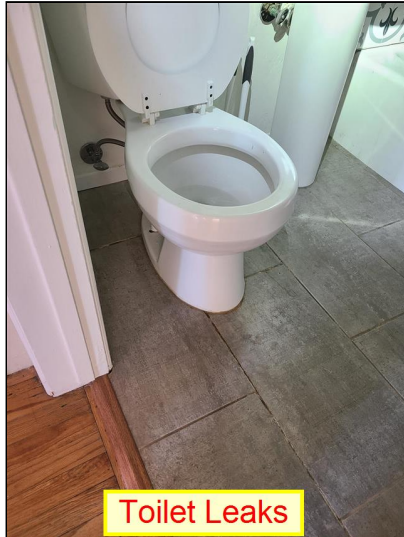
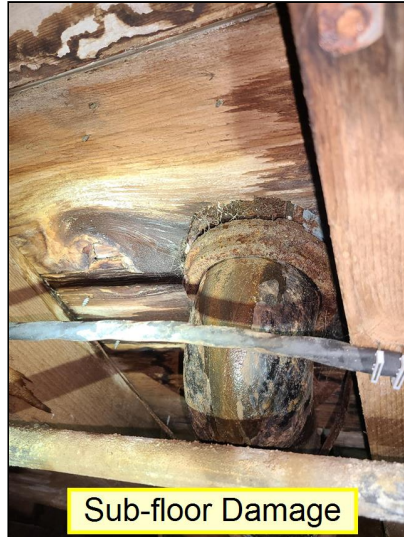
(1) **Toilets Leak.** The toilets within all of the units show evidence of active leaks at the underside of the house. **Unit #3741 had grout staining and leaks extending through the sub-floor at the underside.** Because of these leaks, there is sub-floor damage to most of these units and repairs may be needed before the wax rings can be properly set. **It is recommended that the sub-floor be further inspected and that wax rings, for all of the toilets be further evaluated and replaced as needed by a licensed plumber.**

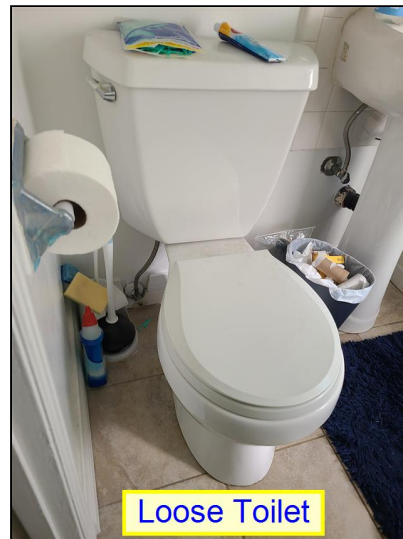
(2) **Loose Toilet.** The toilet fixture in the bathroom of **unit #3735** is loose at the floor. This could cause the wax ring to become dislodged and your toilet to leak water onto the floor. **It is recommended that this toilet have the wax ring replaced and the toilet secured to the floor (to ensure a proper seal), and caulking be applied to the base of the toilet. (WARNING) Over tightening will cause the porcelain to crack and the need for replacement of the toilet.**

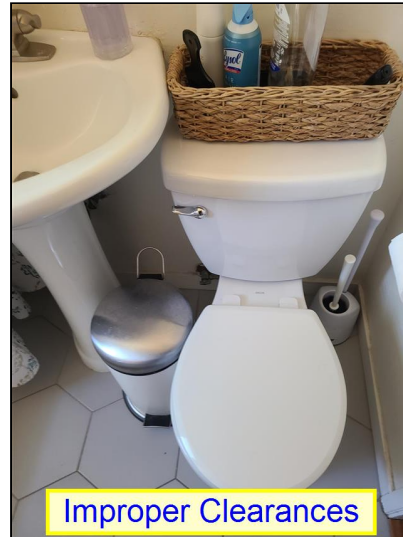
(3) **Improper Clearances.** The toilet in the bathroom, of **unit #4548**, does not meet today's clearance requirements. Toilets should have 15 inches at either side of the toilet, measuring from the center of the toilet, for a combined space of 30 inches. It should also have a front clearance of 24 inches. **Currently one or more of these clearances have not been met.** It is recommended that you verify permits for this bathroom.

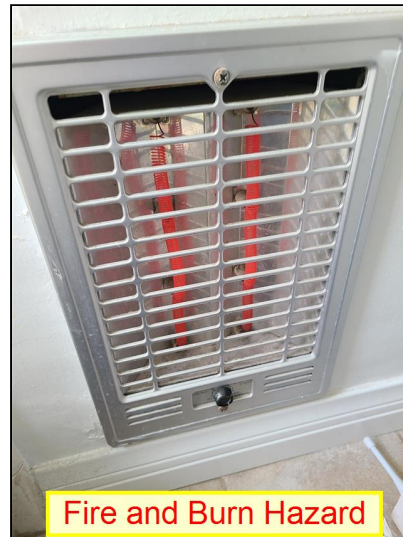
Fire and Burn Hazard. The bathroom wall heater, in **unit #3735**, reach temperatures exceeding 550 degrees. It is important that no combustible materials are placed in front of, near, or above any of these units. **No Combustible materials should come within a minimum distance of 12 inches away from any wall heater .** For safety purposes it is recommended that these heaters be disconnected.

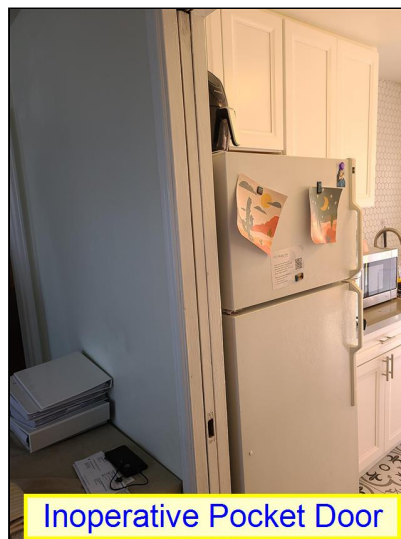
**Pocket Door Sticks.** The pocket door to the kitchen of unit #4548 catches and did not properly function. **The door was stuck in the wall and did not function.** It is recommended that this door be further evaluated and repaired as needed by a licensed contractor.

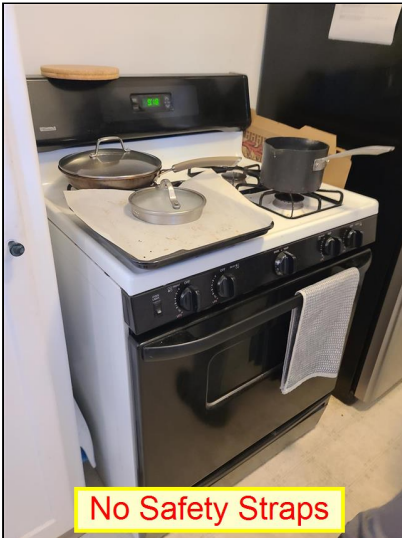
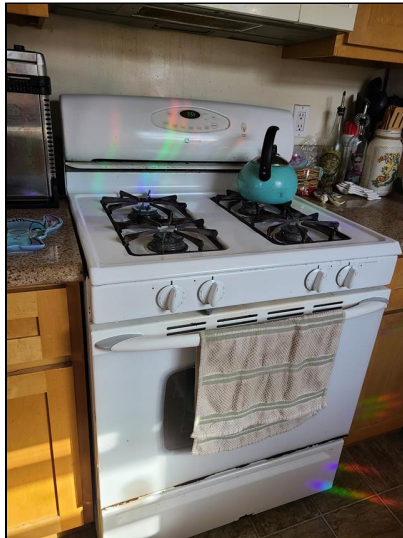
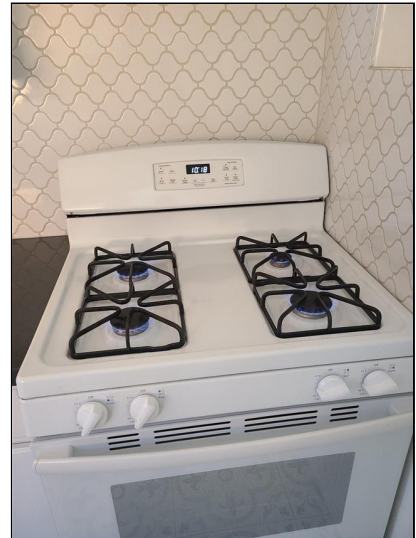
(1) **No Safety Straps on Ovens.** Ovens come with a child safety strap (Anti-tip strap) to prevent the oven from tipping and falling if children use the oven door as a step. It is recommended, especially if children are present, that this oven be equipped with a safety strap.
