Inspection Report

Property Address:
3735- 3741 Madison Ave.
San Diego California 92116

Date: 2/5/2025	Time: 08:45 AM	Report ID: J020525A
Property: 3735- 3741 Madison Ave. San Diego California 92116	Customer:	Real Estate Professional: Compass

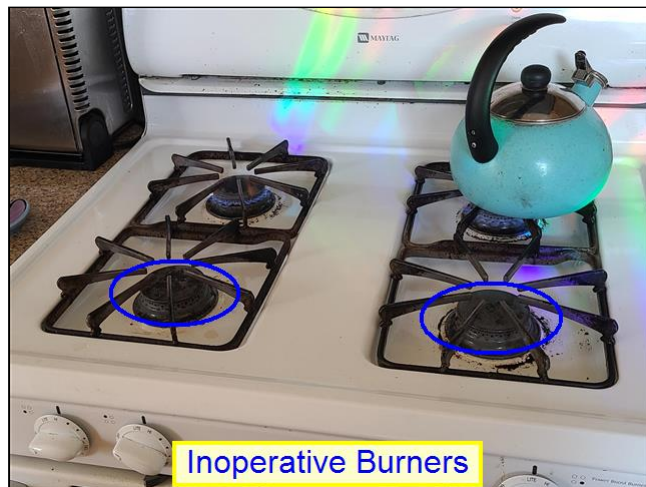
(2) **Inoperative Burners.** Two of the burners did not properly operate at time of inspection in **unit #3739**. This may be able to be repaired with a simple cleaning, or may need to have parts replaced. It is recommended that this be further inspected by a licensed repairman.

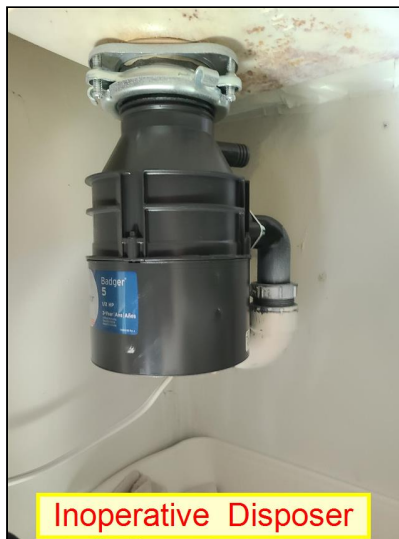
🏠 Inoperative Garbage Disposer.

The Garbage disposer in **unit #3735** did not work at time of inspection. The unit did not function or make a noise when turned "ON". It is possible that the rotors were locked, It was not determined at the time of the inspection if this unit can be corrected or will need to be replaced. It is recommended that this be repaired or replaced by a licensed professional.

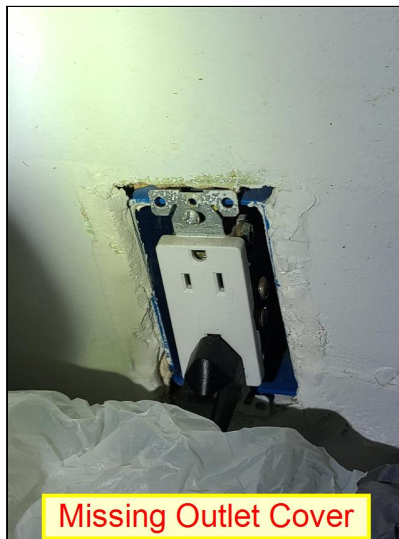
🏠 (1) Missing Outlet Cover. There was an outlet under the sink of **unit #3739** that does not have a faceplate. Missing faceplates expose electrical parts of receptacle outlets, and switches creating a potential shock hazard. For safety reasons all outlets and switches should have secure covers to reduce the chance of electric shock.

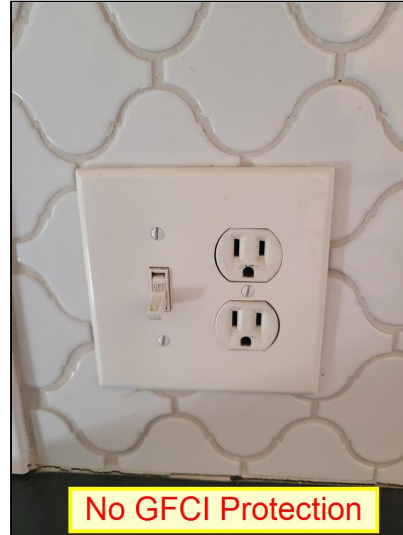
(3) **No GFCI.** There was an outlet in the kitchen of **unit #3741** that was not GFCI protected. It is recommended that all outlets within 6' (six feet) of any water source be grounded OR replaced with an GFCI protected outlet by a licensed electrician.

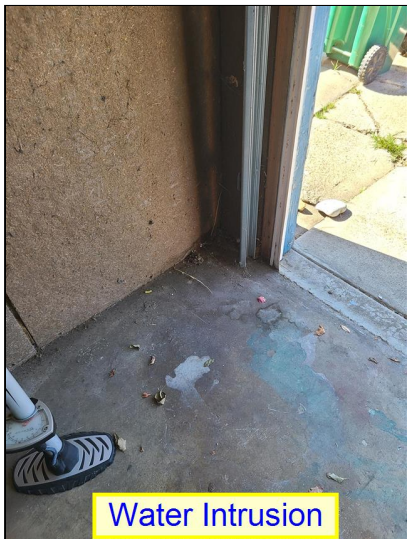
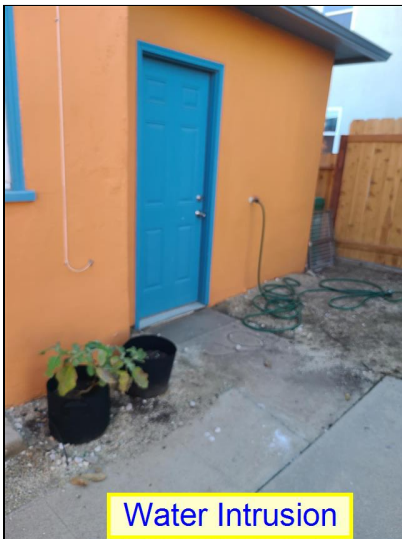
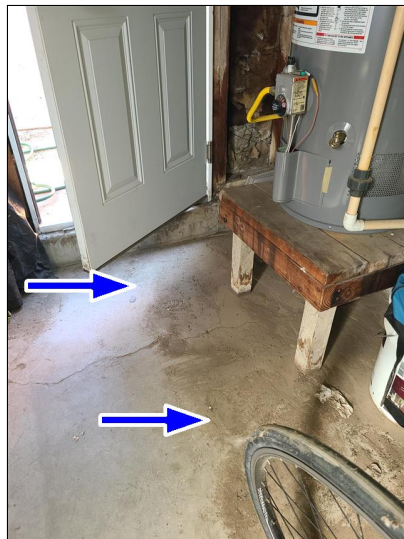
🏠 (1) **Possible Water Intrusion.** It appears that water may enter two of the garage from the underside of the garage doors. There was evidence suggesting this. **These were noted at the rear garage access door of unit #4548, and the far right garage located in the alley.** There was dirt and water staining noted at these locations. **This is noted for your information and should be corrected.**

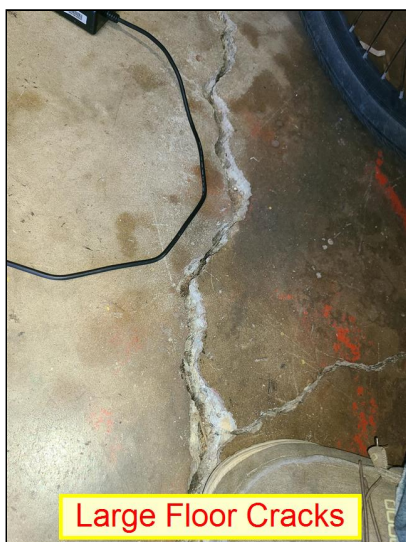
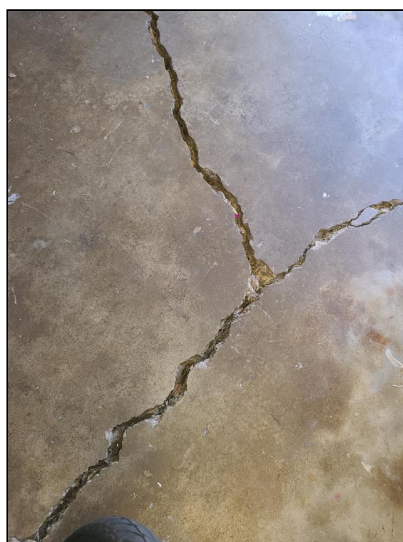
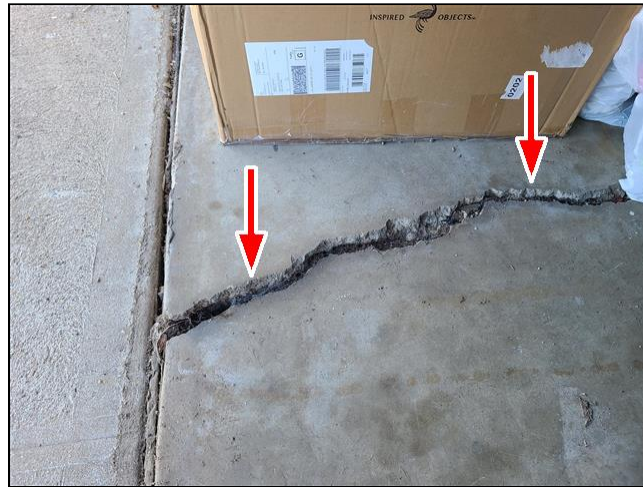
(2) **Large Floor Cracks.** There were several large cracks noted at the garage floors. **These large and off-set cracks are not typical and may indicate expansive soil or other issue.** Due to the size and extent of the cracking it is recommended that this be further evaluated and repaired as needed by a licensed contractor.

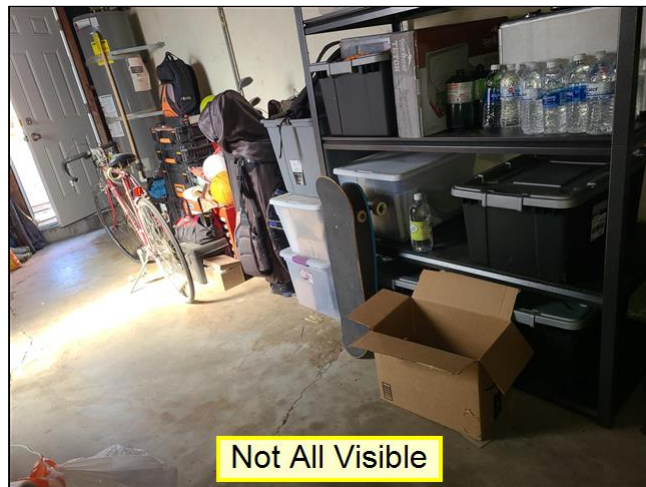
(1) **NOTE: Not All Visible.** The walls of the garage were not all visible due to personal belongings and could not be inspected. It is recommended that these walls and other areas, which views are obstructed, be further inspected once belongings have been removed and access is available.

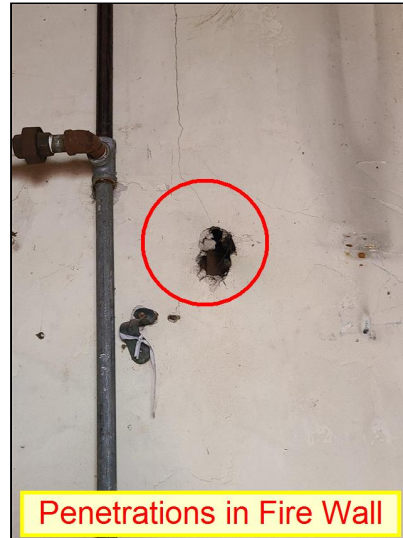
📍 (3) **Penetrations in Fire Wall.** The Garage wall of **unit #4548**, which connects to the house is a fire rated assembly. **Any penetrations to this wall must have proper protection to guard against the spread of fire and spread of carbon monoxide.**

Recommend that this wall be properly repaired by a licensed contractor.

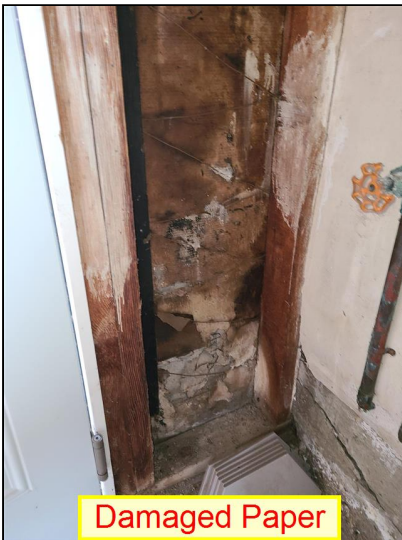
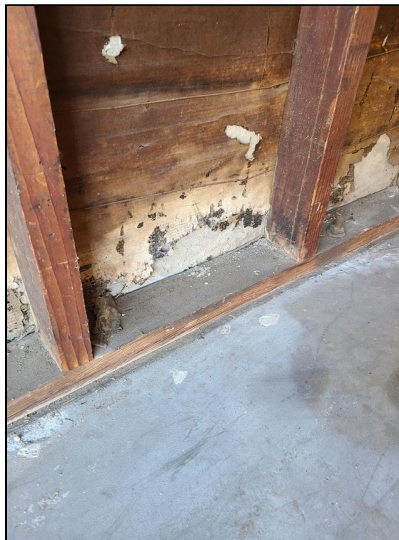
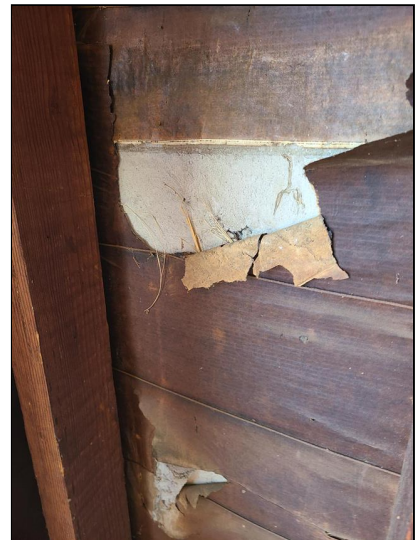
(4) **Damaged Paper.** There were several areas of the garage walls in which the paper was damaged. This paper is the water proofing membrane at the exterior wall. Having holes or damaged paper, increases the risk of water intrusion. **It was not able to be determined if this damage occurs throughout the walls of the house.** This is noted for your information and should be corrected by a licensed contractor.

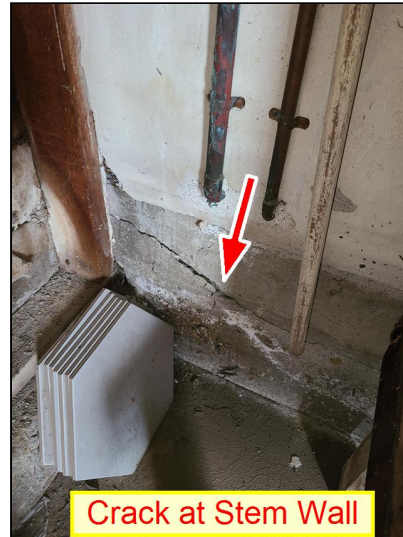
(5) Cracks In Foundation Stem Wall.

There was a crack noted at the foundation wall at the right wall at the rear garage wall of **unit #4548**. The cause of this crack was not able to be determined. **It is recommended that these areas be further evaluated by a licensed contractor and repaired as needed.**

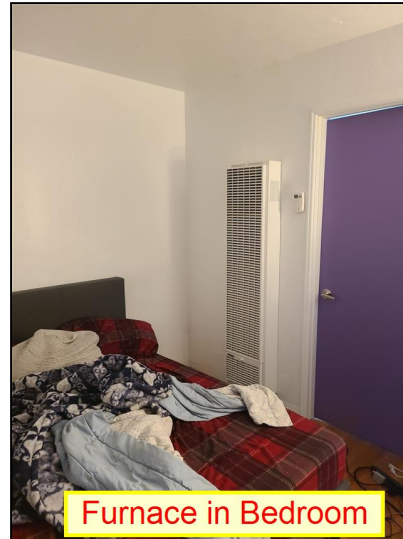
(2) **Furnace In Bedroom.** Gas fired appliances are typically not permitted in bedrooms unless they are direct vented and follow specific manufacturer instructions and local regulations. Currently an additional bedroom was added in unit #3735 and the provided furnace is now in one of the sleeping rooms. It is recommended that this heater be further evaluated by a licensed HVAC technician and that alterations be made to comply with all local codes in regards to the installation of this furnace.

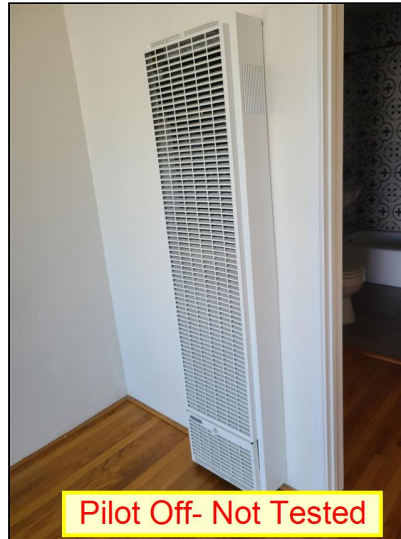
(3) **Pilot Off- Heater Not Tested.** The heater and gas line within **unit #3741** were visually inspected, but the unit not tested. The heater did not have the pilot lit, and was not able to be tested for proper working order. **Our insurance provider does not allow us to light any appliances. SDG&E will conduct a through analysis and testing of the heater for free.** Their inspections typically go beyond our capabilities. **It is recommended that you contact SDG&E or a HVAC specialist for further evaluation, and repair if needed.**

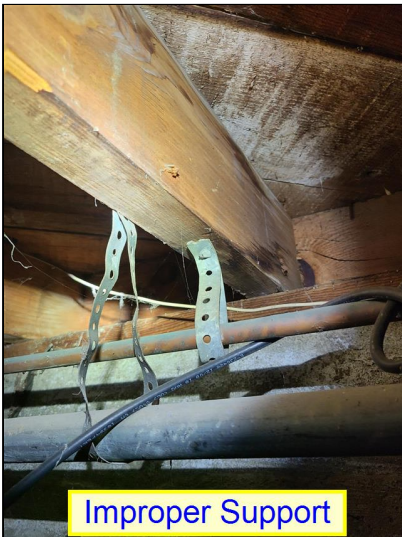
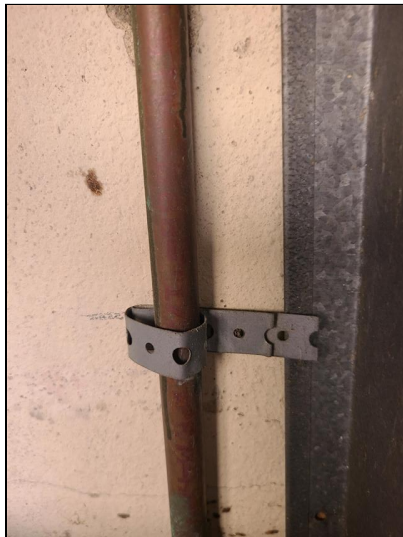
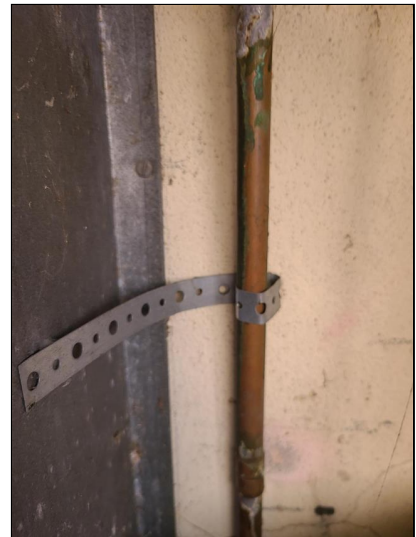
(3) **Improper Support.** The copper piping, for the water supply lines (**under the duplex**), have some areas that are being supported by galvanized metal straps. Copper piping should be supported by a non-metallic plumbing strap or other means to avoid contact with incompatible materials. **Improper support can cause electrolysis, leading to pipe deterioration and the increased risk of leaks.** It is recommended that the plumbing supply lines be properly supported and protected from damage by a licensed plumber.

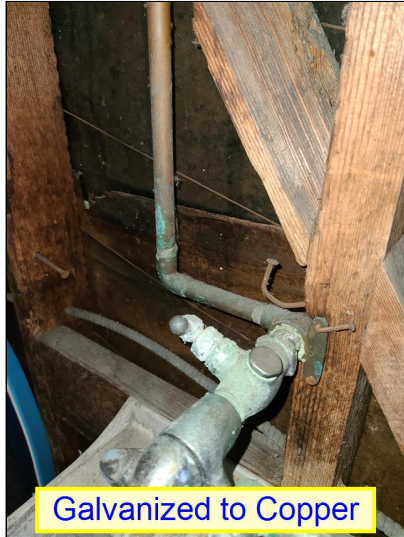
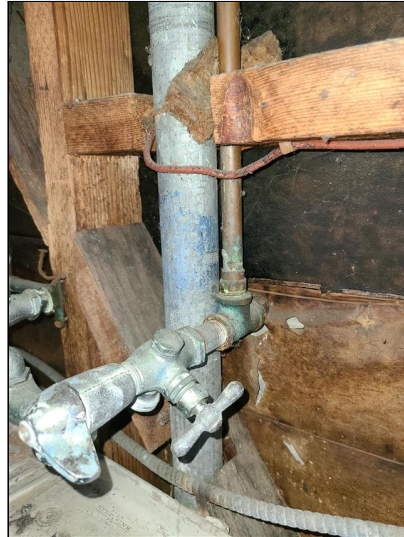
(4) **Incompatible Materials.** The copper piping, for the water supply lines, have areas that are in contact with incompatible materials. **Incompatible material contact can cause electrolysis, which can lead to pipe deterioration and increased risk of leaks.** This was noted in the garage of **unit #4548.** **It is recommended that the plumbing supply lines be further evaluated and protected from damage by a licensed plumber.**

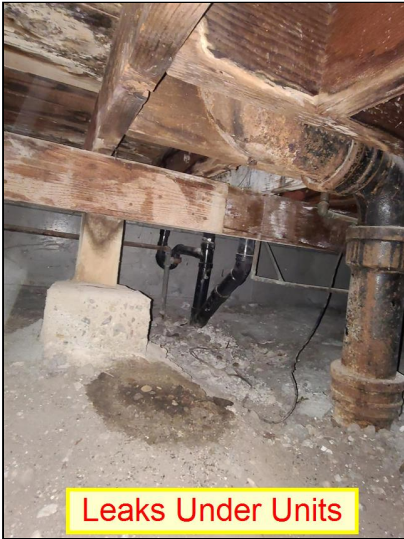
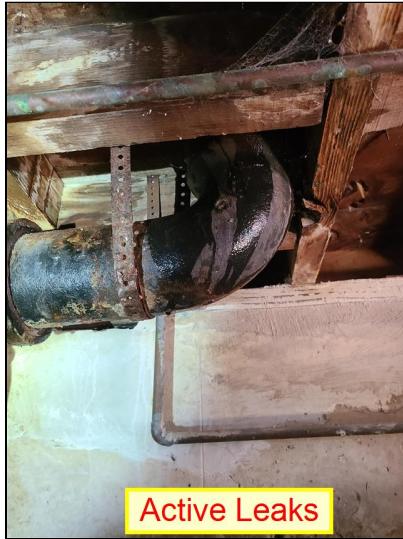
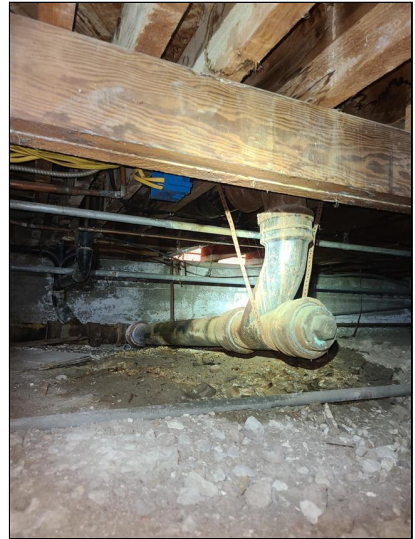
(3) **Leaks Under Units.** There are active leaks at the underside of each of the units. These leaks occur under the hall bathrooms, each being at the toilet areas. **It is recommended that these be further evaluated and corrected by a licensed plumber.**

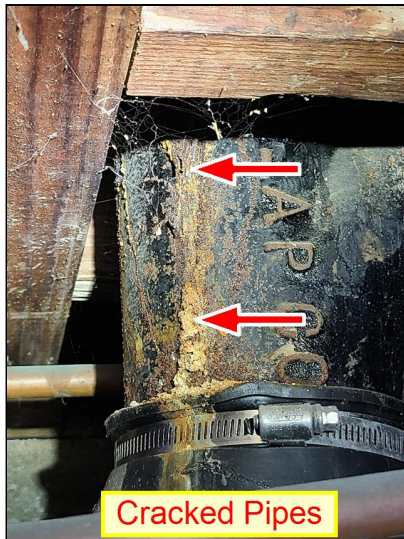
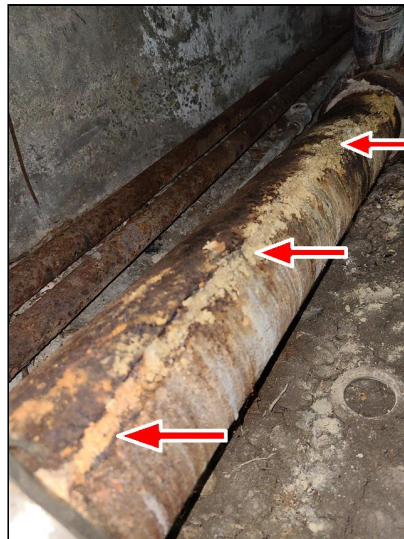
(4) **Deteriorated Pipes.** Several sections of the cast Iron pipes have deteriorated and started to flake and crack at the **underside of the duplex.** These lines have reached their expected life expectancy and **should be replaced.** **It is recommended that all deteriorated pipes be replaced by a licensed plumber.**

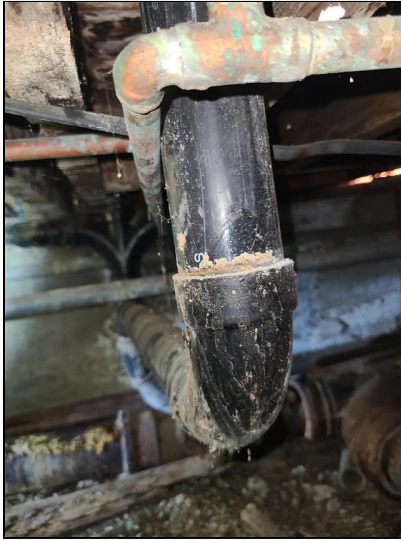
(8) **Water Staining.** There were water marks and corrosion noted on the waste lines at this location. This indicates that there have been leaks at this location in the past. **There were currently no leaks at this pipe at the time of the inspection, but it is possible this may leak if not corrected.** It is recommended that the connections be further evaluated and repaired if needed to ensure no leaks develop.

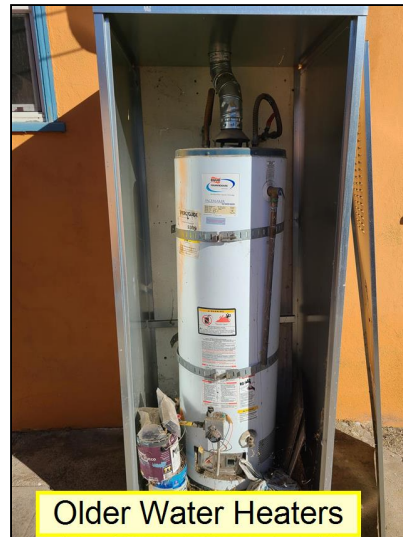
🏠 (3) **NOTE: Older Water Heaters.**

It is noted that this water heater is over 10 years old and is about at it's life expectancy. (Water heaters typically last 10 to 15 years- but have also been known to last longer). This heater may need replacement soon.

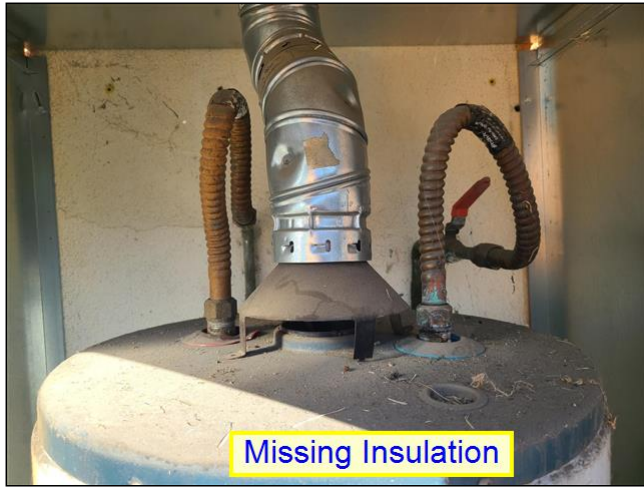
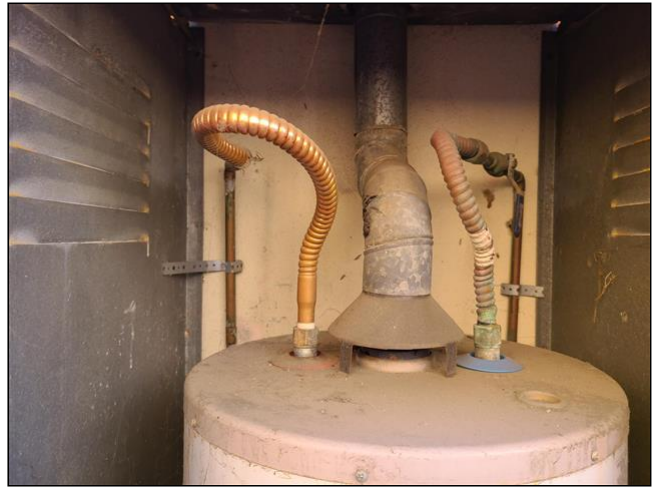
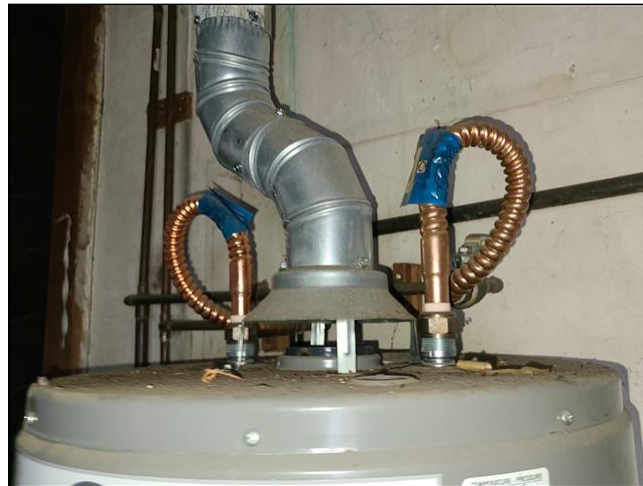
🏠 (4) **Missing Insulation.** The water supply lines at two of the units were not insulated. **The first 5 feet of hot and cold water pipes are required to be insulated if they are exposed in unconditioned space.** These were noted in units #3741 and #3739 **It is recommended that these lines be properly insulated.**

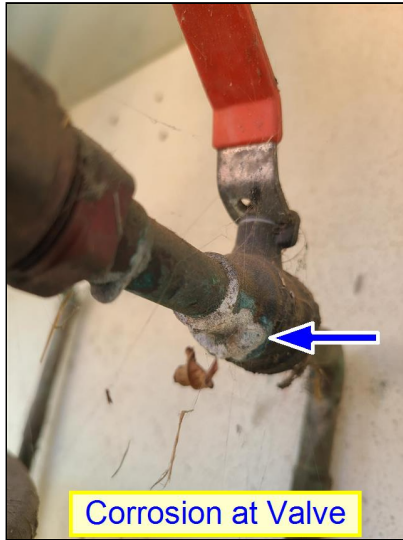
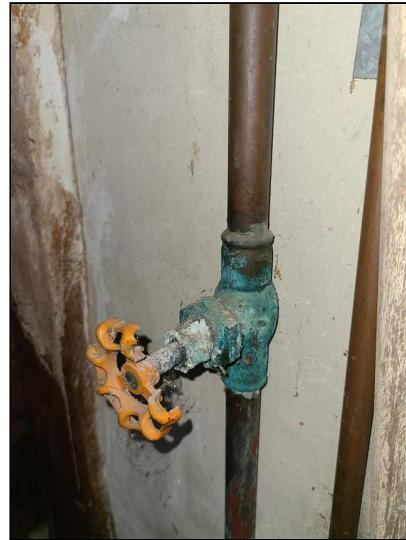
🏠 (7) **Corrosion at Valves.** The water shut off valve at the water heater of **unit #3789** has some minor corrosion and the garage water heater in **unit #4548** has severe corrosion. **We do not test these shut off**

devises. There is a chance that these shut off valves may leak or not properly function when turned. It is recommended that these valves be further evaluated and repaired as needed.

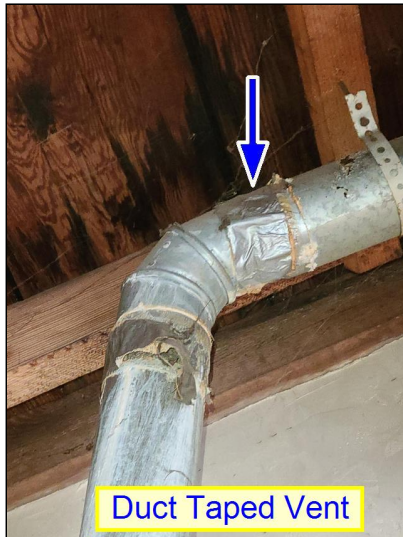
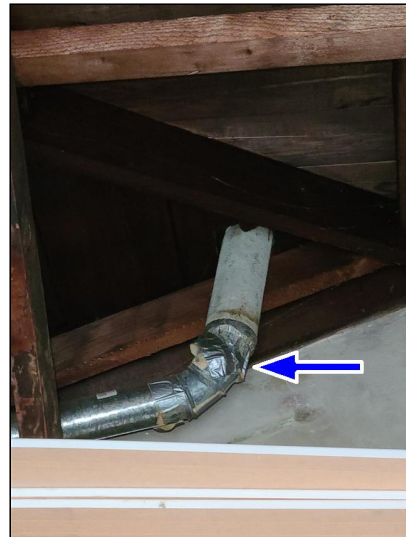
↑ (8) Duct Tape at Vent Connection. There was duct tape used at the vent connection for the water heater in the garage of unit #4548. Duct tape is not an approved material for this application. It is recommended that this be corrected as needed by a licensed HVAC technician or plumber. .

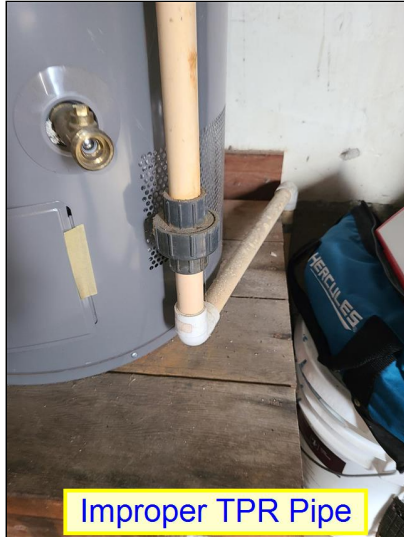
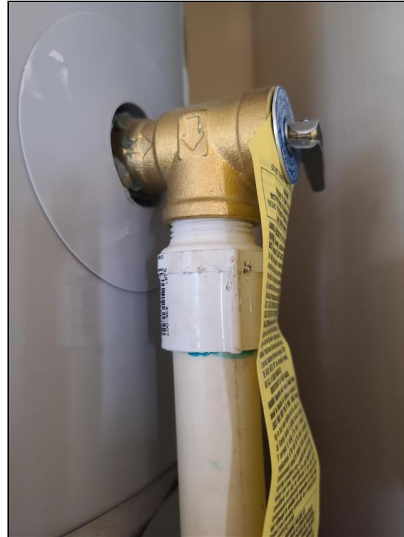
(9) **Improper TPR Valve Drain Line Material.** TPR valves are a Temperature, Pressure Relief Valve which are designed to open if the temperature exceeds 210 degrees or builds a pressure exceeding 150 PSI. These lines should be made with that material allowed for water distribution and should terminate outside within 6-24 inches from the ground. Currently the water heater of **units: #4548 and #3735** uses PVC fittings which is not permitted. CPVC, copper, galvanized or other listed material are allowed to be used. **Recommend that a licensed plumber fix this connection.**

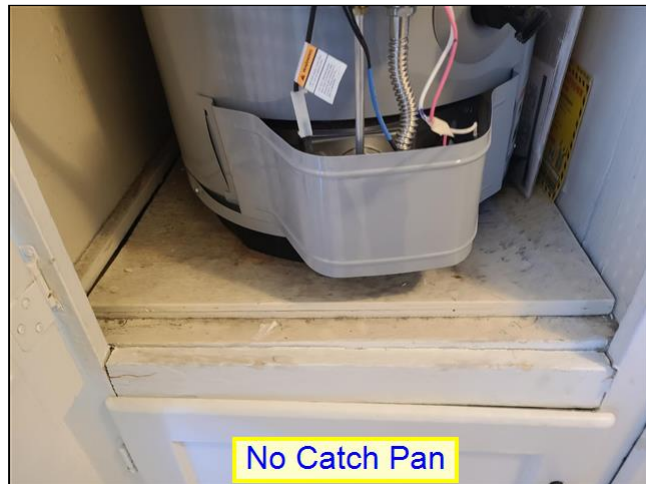
(10) **No Pan-Raised Foundation.** The water heater, **in unit #3735** is not equipped with a drain pan. All water heaters on raised foundations, should be provided with a drain pan which has a minimum depth of 1.5 inches in depth, with an attached drain line that is no smaller than 3/4 inch. **It is recommended that this unit be supplied with a proper pan by a licensed plumber or contractor.**

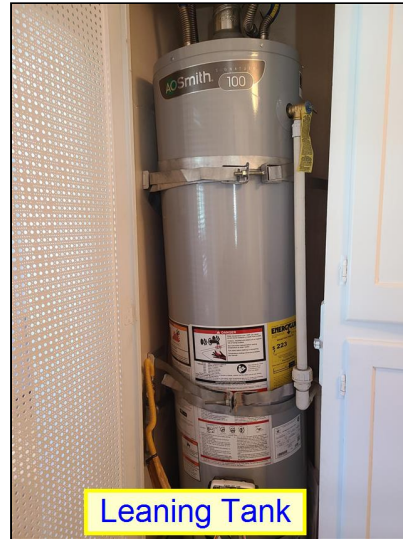
(11) **Leaning Tank.** The water heater tank in **unit #3735** was leaning. The cause of this was not known. It is recommended that this be further evaluated to ensure there is not a structural issue with the stand or support causing it to lean.

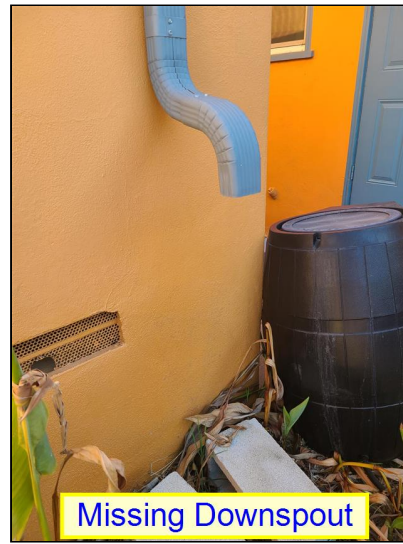
**Missing Downspout.** There was currently a missing downspout. Downspouts carry the water from the roof gutters to the ground and should direct the water away from the house and foundation. It is recommended that downspouts be provided at the provided gutters.

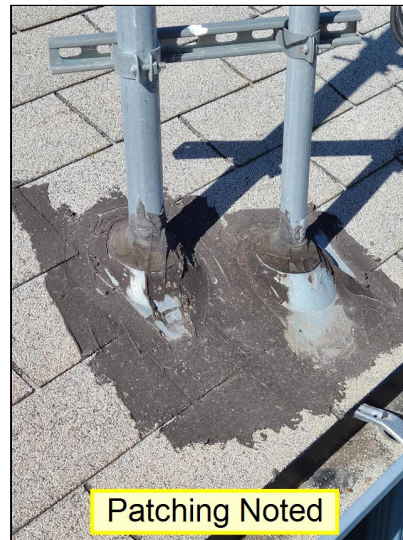
(2) NOTE: Patching Noted. There were some areas of the roof that have been patched. This is noted for your information. We are not able to determine at the time of the inspection if the roof leaks at these areas. This is noted for your information, and as a disclaimer. It is always recommended that a licensed roofing contractor be called out for further evaluation if the repairs cannot be verified as being done by a licensed roofing contractor.

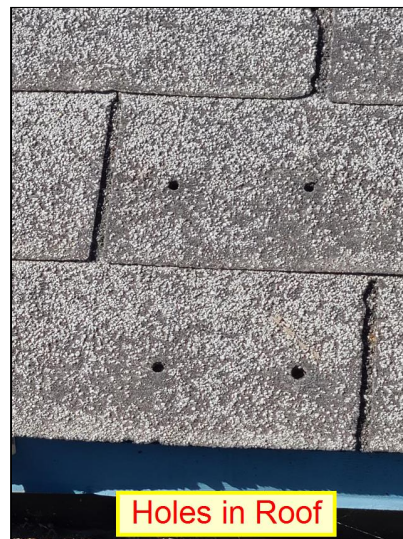
(3) Holes in Roof. It appears that there was a satellite or something similar that was bolted through the roof of **unit #3735** that has been removed. **This has left holes in the roofing material at the left side of the building at this location.** This can cause water to damage the sheathing at this location. **It is recommended that this be corrected as needed by a licensed roofing contractor.**

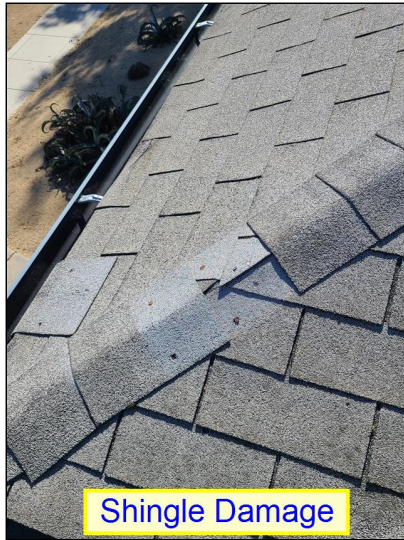
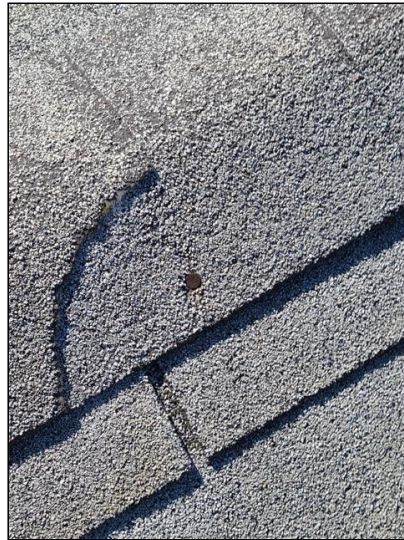
(4) **Shingle Damage**. There were some damaged or missing shingles noted at the roof. It appears that the wind has blown back or damaged the roofing material at this location. It is recommended that these materials be repaired as needed by a licensed roofing contractor.

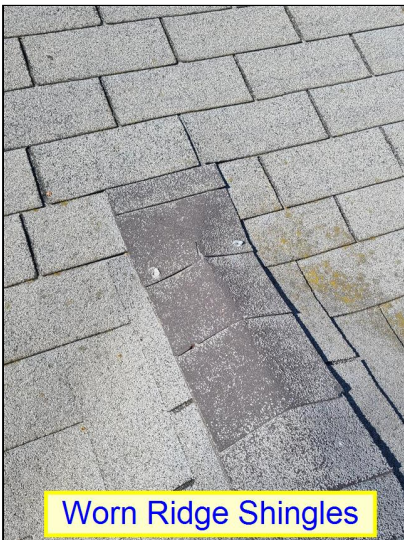
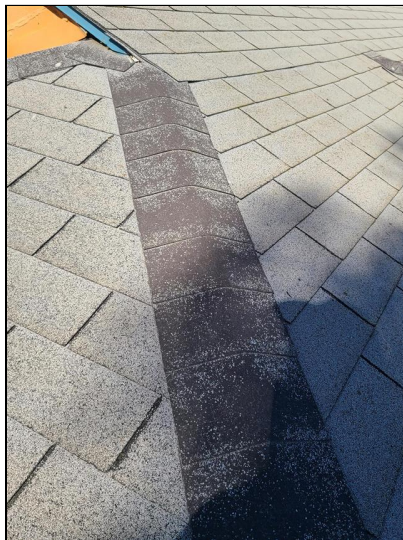
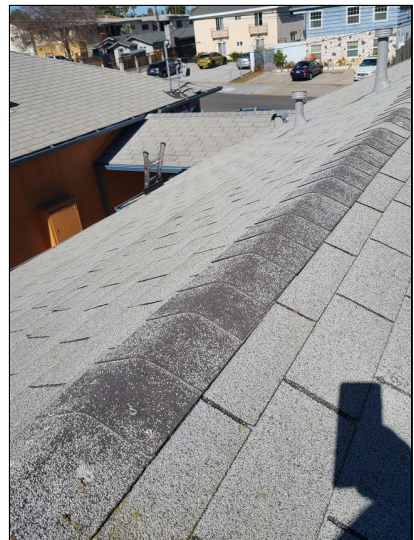
(5) **Worn Ridge Shingles**. The ridge shingles at the front house (4548) have areas that are worn and damaged. The life of these shingles have about expired. These shingles should be replaced as soon as possible. It is recommended that these shingles are replaced by a licensed roofing contractor.

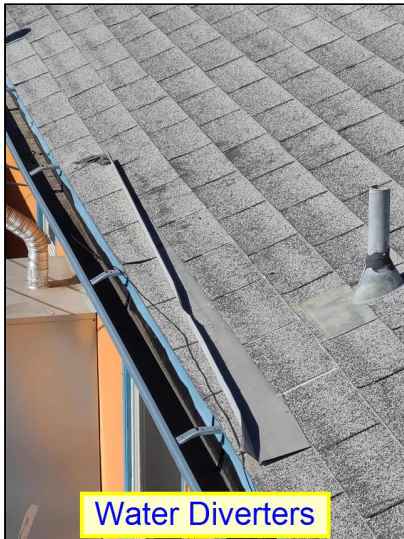
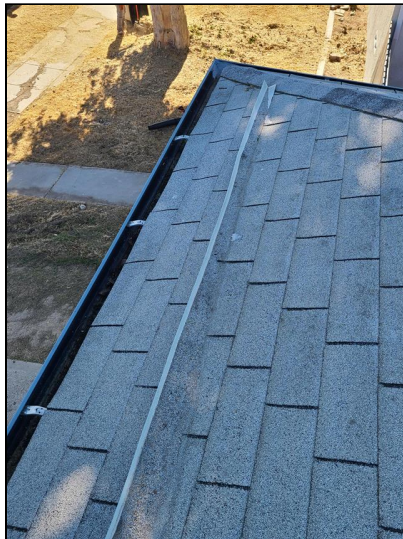
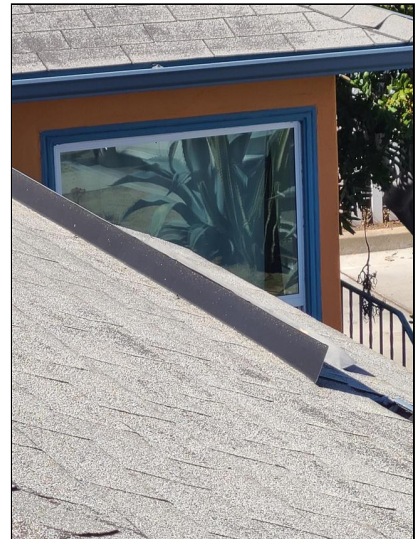
(7) **Water Diverters.** The roofs of these buildings have sections that contain water diverters. These diverter flashings have been installed at several locations. **These diverters can allow for water to accumulate and tuck under the shingle increasing the risk of roof leaks.** **It is recommended that this diverter be removed and a proper gutter provided.**

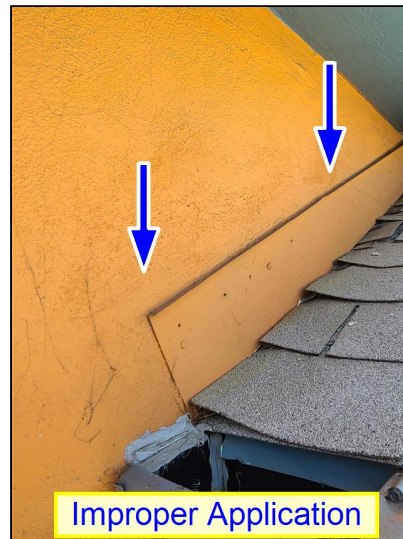
**Improper Flashing Application.** It appears that the counter flashing at the roof/ wall connection was improperly installed. This flashing should be embedded into the wall at this location. Currently the flashing is caulked or sealed to the exterior. **This increases the risk of water intrusion as the caulking breaks down, or begins to pull away from the chimney.** **It is recommended that the flashing at this location be further evaluated and repaired as needed.**

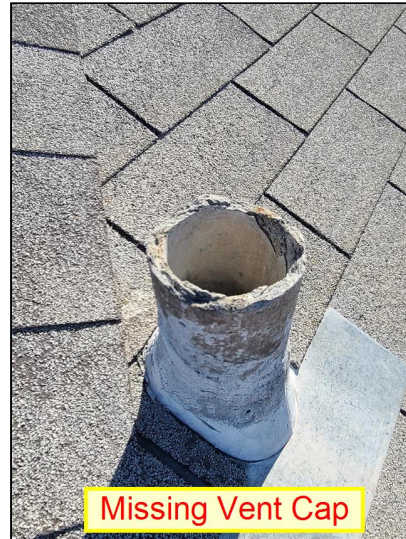
(1) **Missing Vent Cap.** There was a vent termination at the roof that did not have a vent cap. This was noted on a transite pipe extending from the roof of **unit #3741**. Vent caps are metal fittings which extend over the vents of gas fired appliances. This inhibits water from entering the vent stack which could cause damage to the equipment in which it serves. This vent goes to an unknown or abandoned appliance. It is recommended that this vent either be properly capped, or be removed by a licensed contractor or roofer.

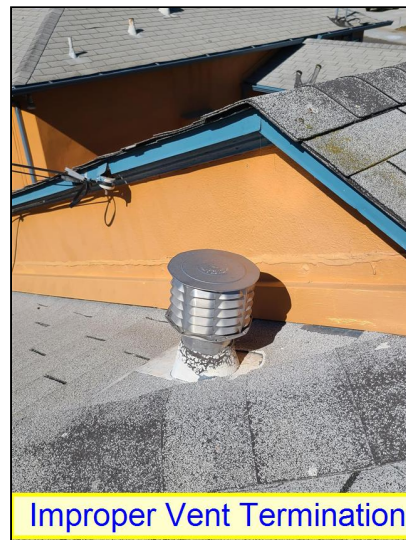
(2) **Improper Vent Termination Point.** This HVAC vent currently terminates less than eight feet from a house wall. This vent must terminate two feet (2') above the roof's edge to a point of no less than 10 feet from the roof. It is recommended that a licensed plumber or HVAC specialist be called out to properly extend and support the vent stack.

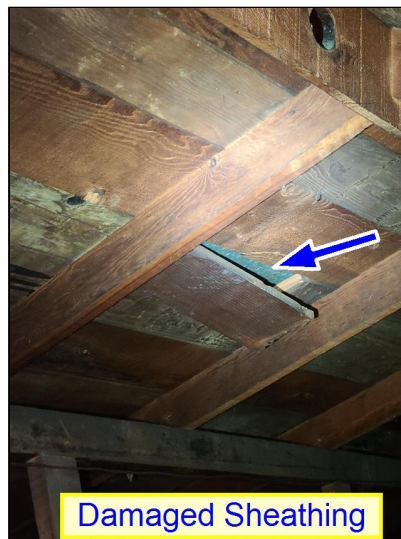
(2) **Damaged Sheathing.** There were a few locations of damaged sheathing noted in two of the units (**#3741 and #4548**). This did not affect the structure of the roof. **It is recommended that this be repaired when the roof is replaced.**

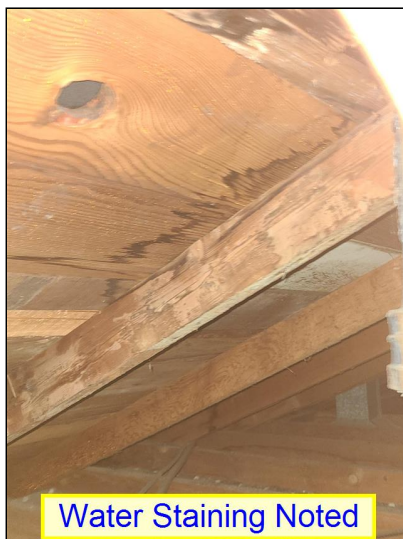
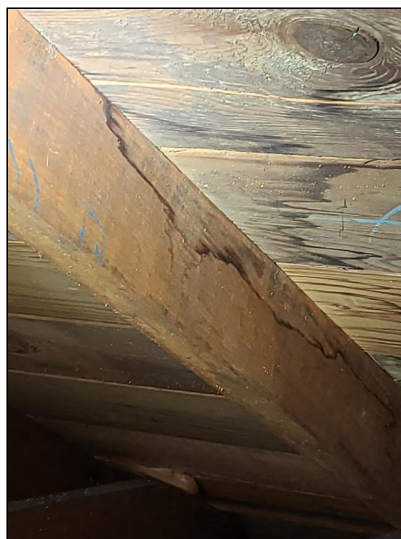
(3) **Water Staining Noted.** There was some minor water staining at some of the sheathing or rafters in the attics at each of the units. **It could not be determined at time of inspection if these were active leaks.** There was no visible evidence of roof or material damage at these locations. **This is noted for your information and can be further evaluated if so desired.**

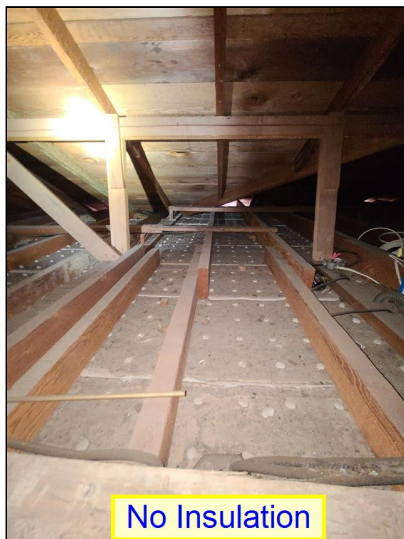
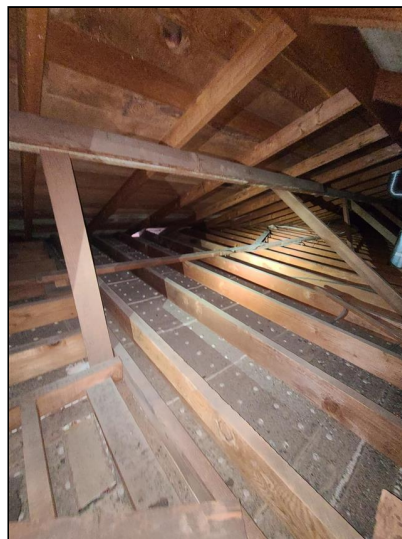
No Insulation. There was currently no insulation in the attic. Insulation is used to help retain the heat in the winter and help cool your house in the summer. Areas missing insulation or with inadequate insulation, will not only cause your home to not efficiently heat and cool; but it can also decrease the life expectancy of your roof. **Recommend replacement of missing or insufficient insulation.**

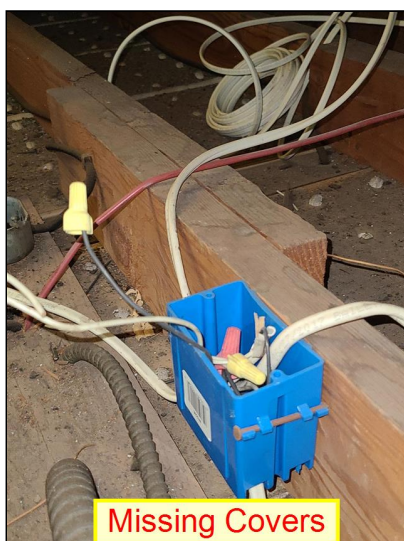
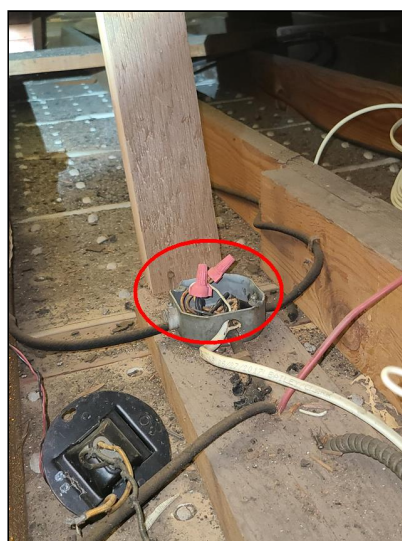
Missing Covers on Junction Boxes. There are at least 2 missing covers at the junction boxes in the attic of unit #4548. Junction boxes are used to conceal wire connections, protecting them from damage and decreasing the risk of fire and shock. **Recommend installation of cover plates on all outlet boxes.**

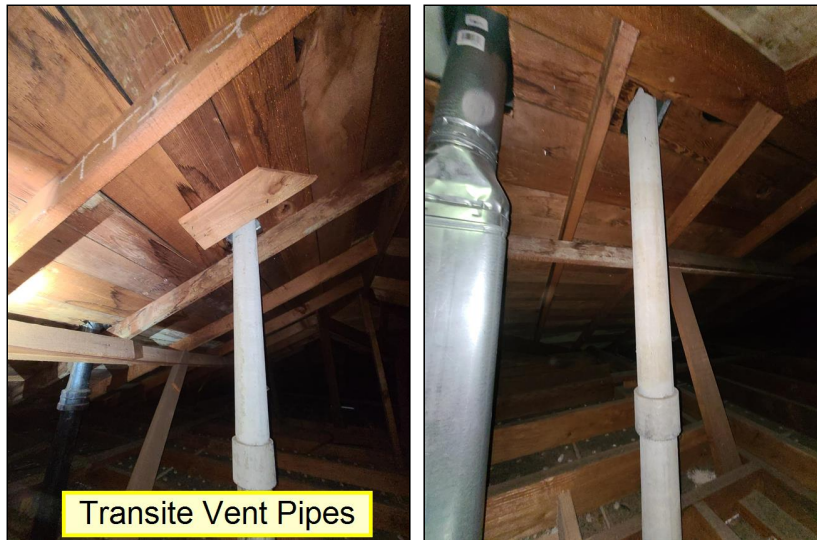
NOTE: Transite Vent Pipes. It was noted that there were Transite vent pipes in the attic. Transite has a high probability of containing asbestos, a material that if damaged or disturbed can cause serious health risks. For more information about this material please read the provided links found in **Section 2.13.** of this report.

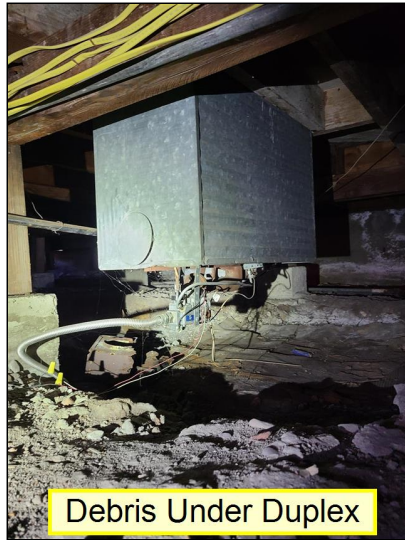
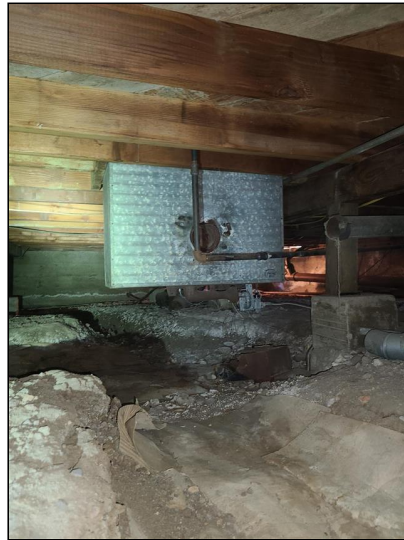
(4) **NOTE: Debris Under Duplex** There was debris at the underside of the duplex. Currently there were abandoned floor furnaces. It is recommended that these abandoned objects be removed from the underside of the house.

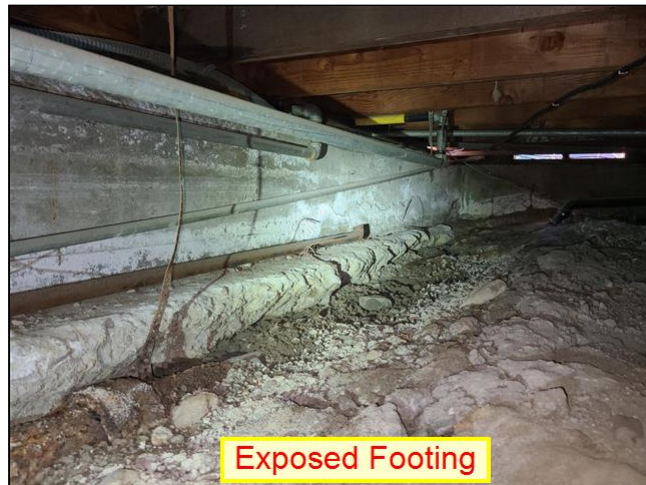
(5) **Exposed Footing.** The rear foundation footing was exposed at the rear wall of the duplex. This was mainly noted at the underside of unit #3735. It appears that the soil has heaved causing the footings to become exposed at this location. It is recommended that this be further evaluated by a foundation specialist to determine what actions should be taken to correct this issue.

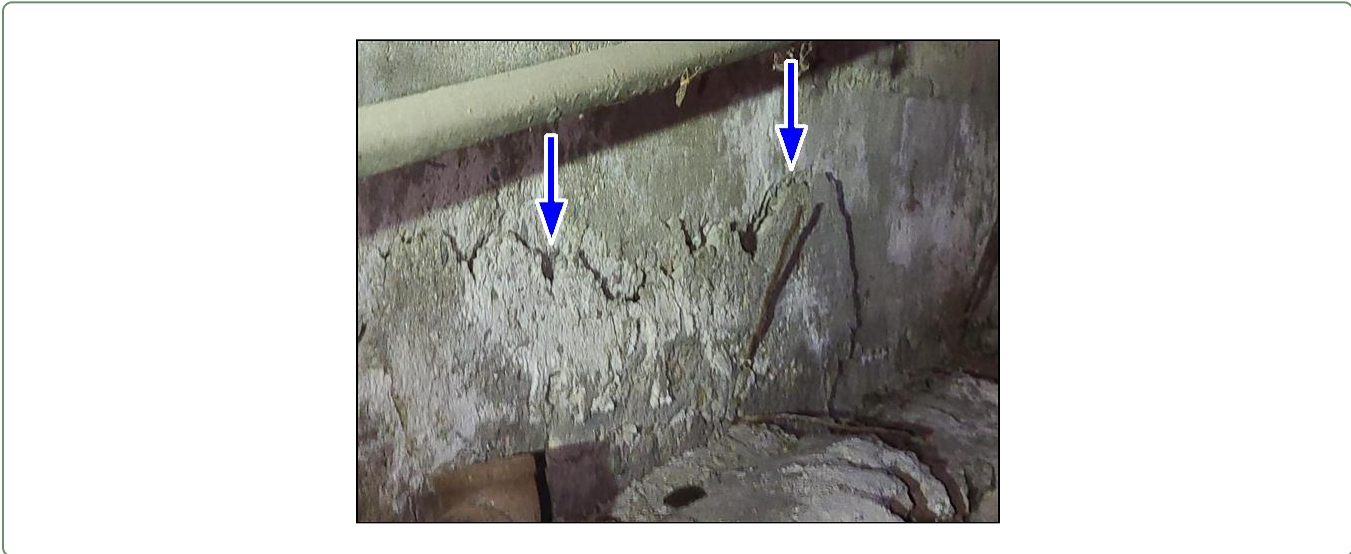
(8) **Minor Spalling.** There were a few areas in which there was minor spalling noted at the underside of **unit #3741 and moderate spalling under unit #3739 duplex** . Spalling is when the surface concrete begins to delaminate or flake away from the wall. Eventually this can lead to deterioration and weakening of the foundation. **It is recommended that the spalling of the foundation be checked periodically, and if these areas dramatically worsen over time, that a licensed concrete specialist be called out for further analysis and repair.**

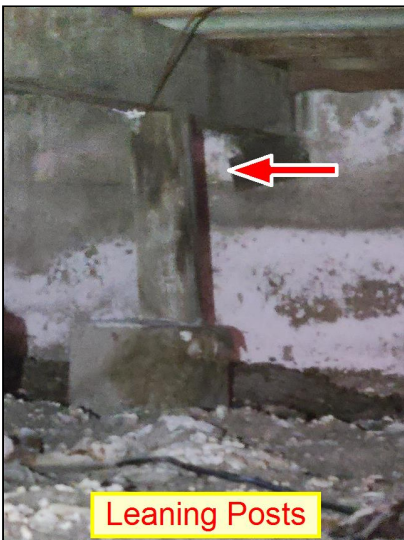
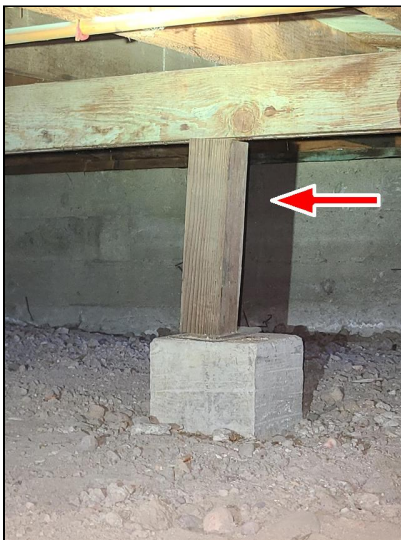
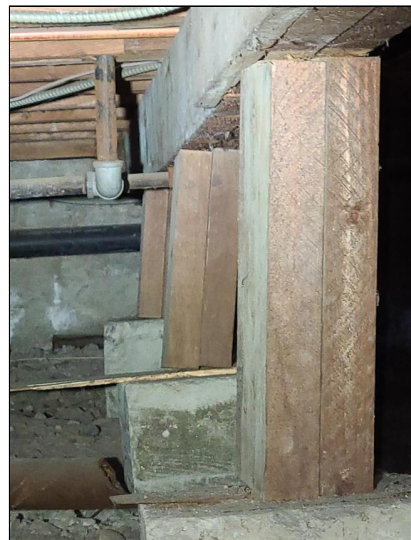
(2) **Leaning Posts.** There are a few posts, mostly at the underside of the duplex that were not level and leaning to the side. **There were at least six noted at this location as well as a few at the underside of the front house (#4548).** It is recommend ed that these posts be corrected to an upright position by a licensed contractor.

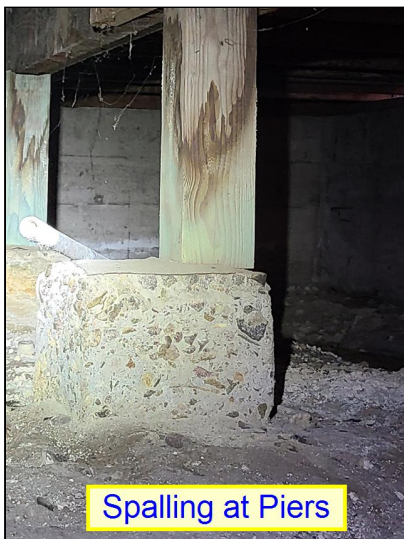
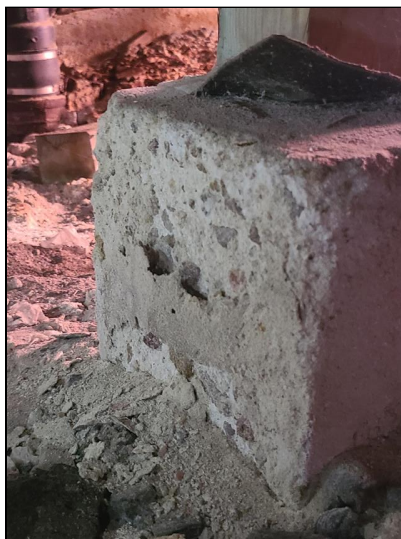
(4) **Deterioration of Piers**. There are a few piers at the underside of **unit #3741** have some moderate deterioration. It is recommended that a licensed foundation contractor be called out for further evaluation and repair.

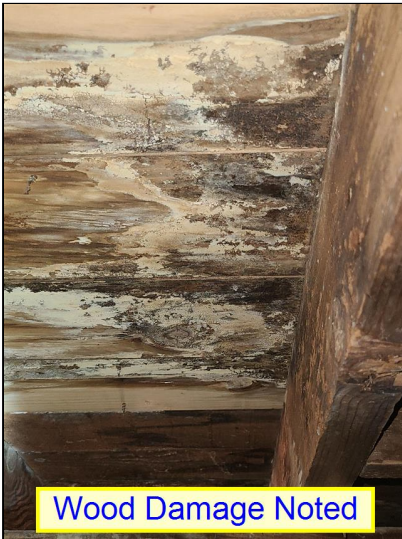
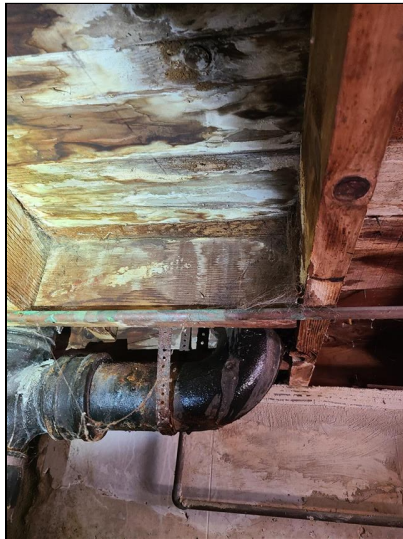
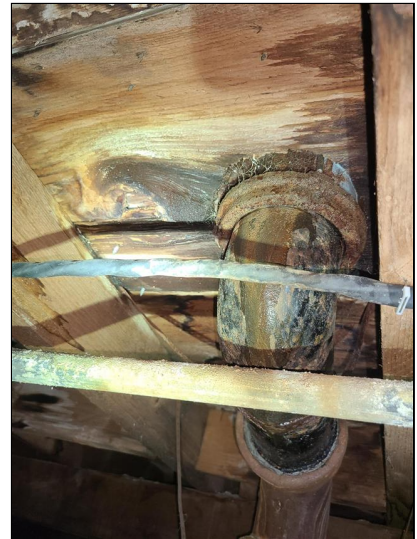
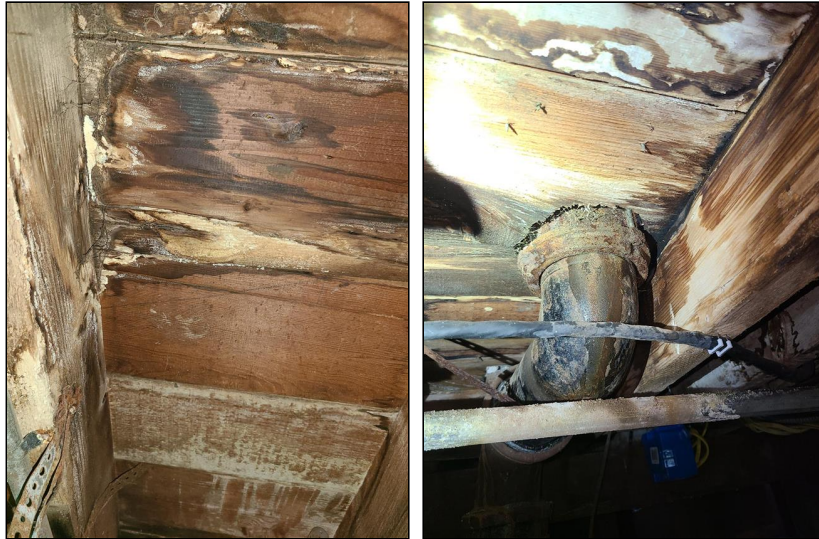
**Wood Damage Noted**. There was some wood damage to the flooring members noted at the underside of the units. **Most of this unit occurs at the underside of the bathrooms at each of the units.** There were currently leaks at each of the bathrooms at each of the buildings. It is recommended that a termite specialist be called out for further analysis and that all damaged wood be repaired or replaced by a licensed contractor.
