Inspection Report

Property Address:
3735- 3741 Madison Ave.
San Diego California 92116

Date: 2/5/2025	Time: 08:45 AM	Report ID: J020525A
Property: 3735- 3741 Madison Ave. San Diego California 92116	Customer:	Real Estate Professional: Compass

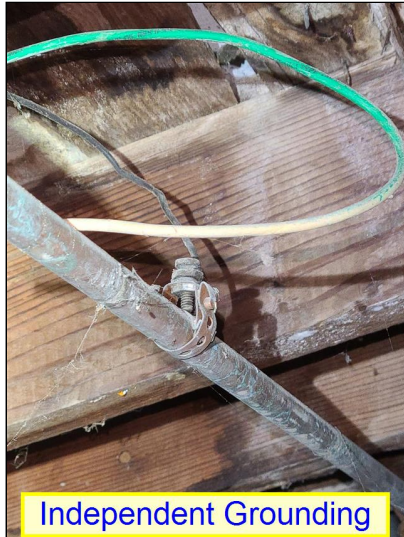
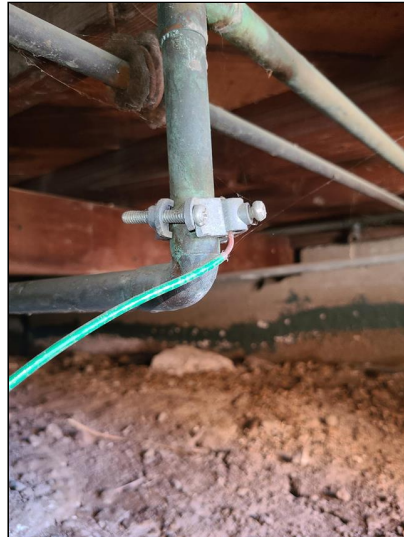
(2) **Independent Grounding.** There was some independent grounding of the outlets to the cold water line. This is no longer an approved method of grounding. **It is recommended that this be further evaluated and repaired as needed by a licensed electrician.**

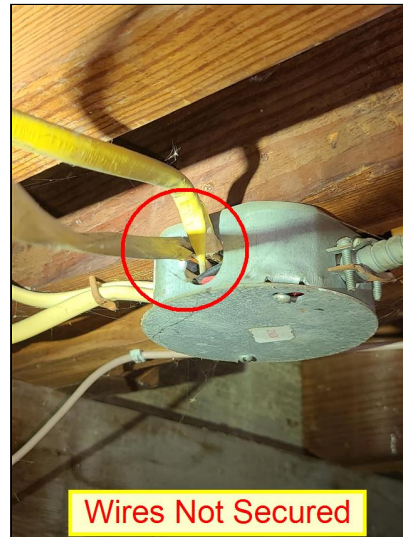
(3) **Wires Not Secured to Boxes.**

There are junction boxes in which the wires are not secured to the boxes at the underside of **unit #4548**. All junction boxes should have the wires secured to the box via bushings or wire clamps. Not having secured wires can cause the wires to become loose or damaged causing increased risk of damage or injury. **It is recommended that a licensed electrician be called out to repair these boxes.**
