# **Property Condition Report**

**12 Suite Apartment Building**  
**17105 Madison Ave.**  
**Lakewood, Ohio 44107**

**October 28, 2024**

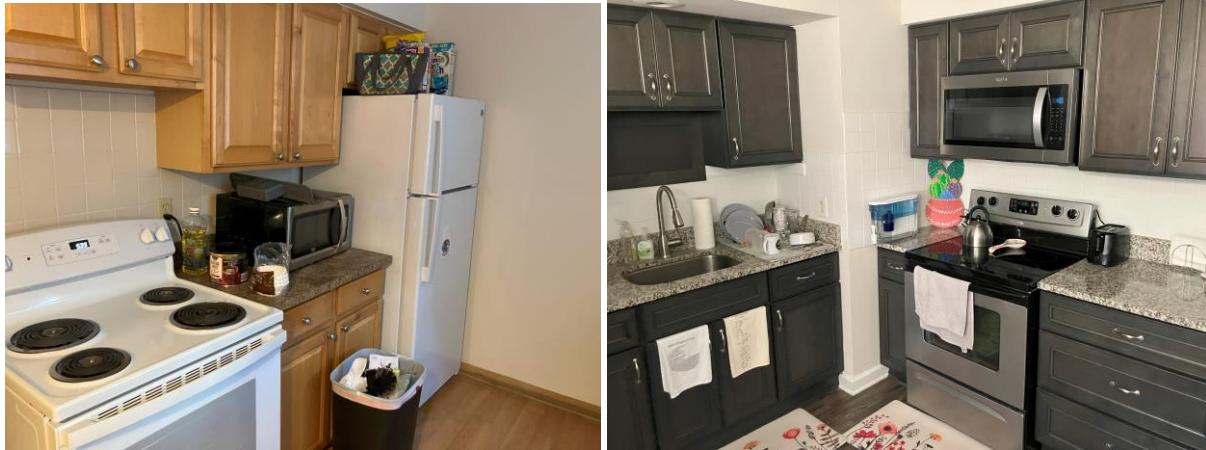
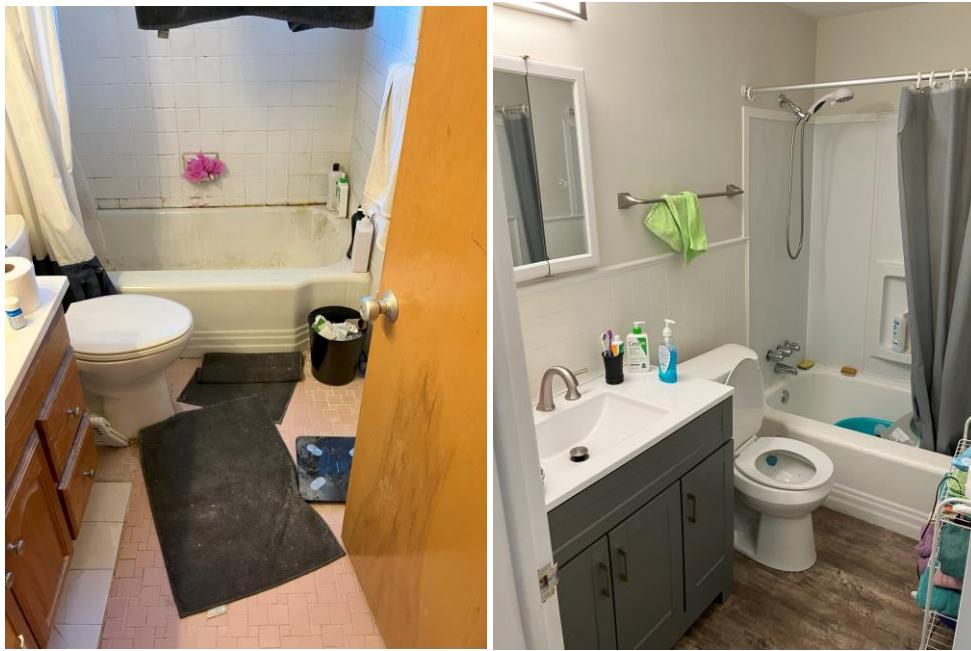
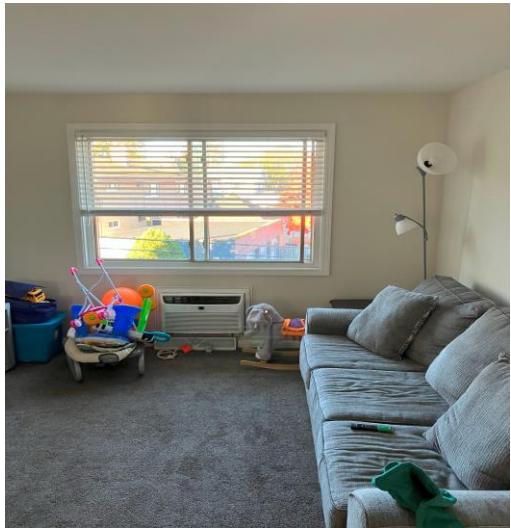
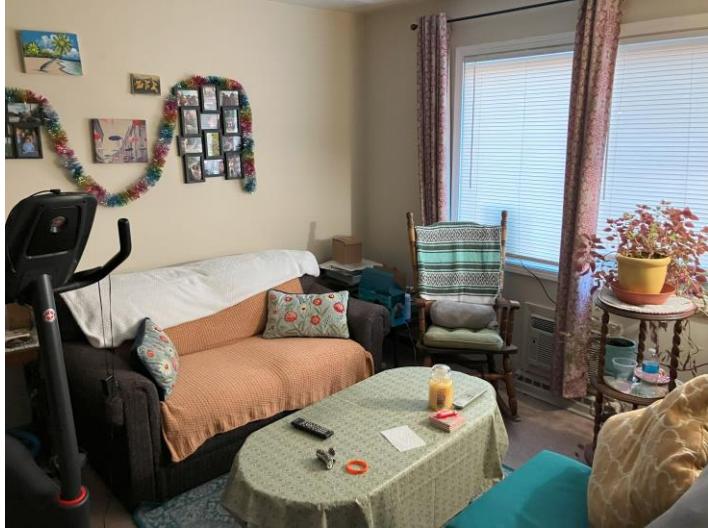
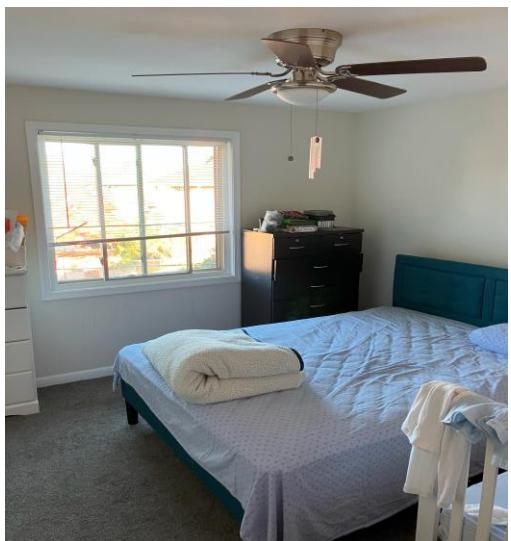
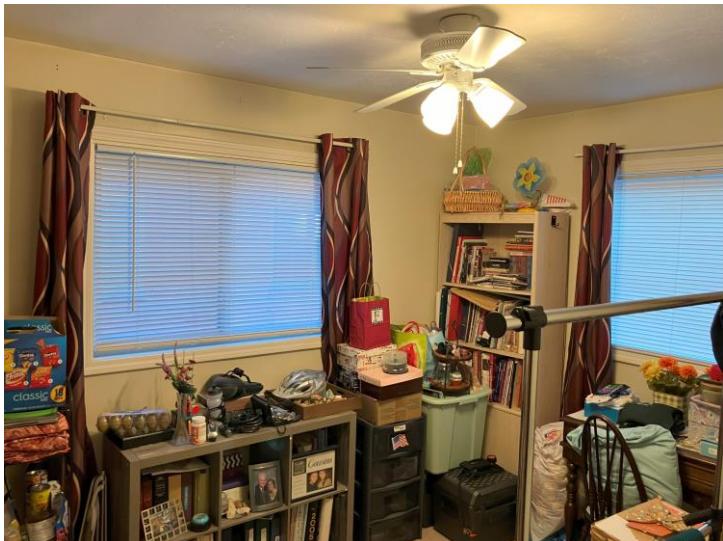
The interiors of all units inspected were in generally good condition and livable/rentable except apartment 7, which has bathroom ceiling damage, although it is occupied. Cabinets were in good repair, as were sinks and countertops. Appliances were of mixed age and condition, but in working order.

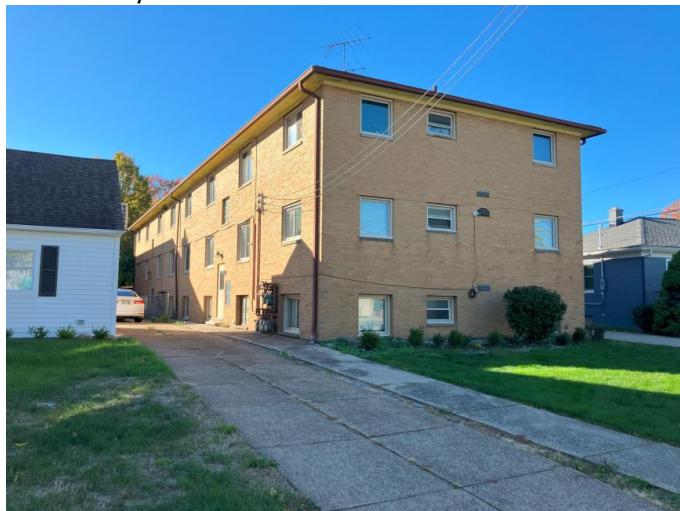
Present day

The discoloration appears to be on the surface and is indicative of tree sap and other detritus being deposited there. Researching old Google street views, there are clearly large trees to the east of the building and overhanging the building. There is also evidence on site of them overgrowing the fence and of them having been removed from that area.

Therefore it does not appear that there has been any permanent damage that would affect the roof integrity.
