SafeHome Inspections, LLC

Commercial Inspection

44/46 Main St

Inspected on Mon, Nov 30 2020 at 9:30 AM

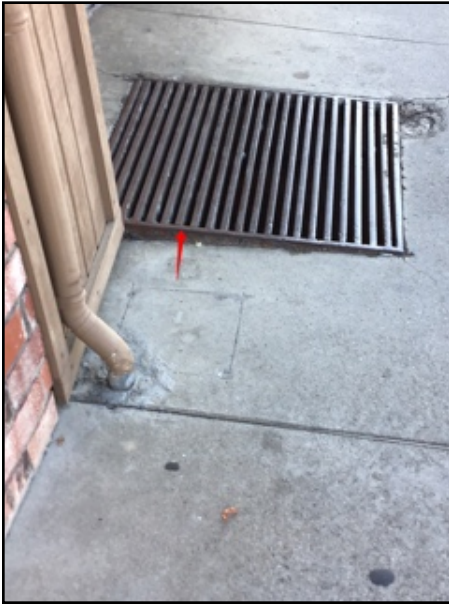
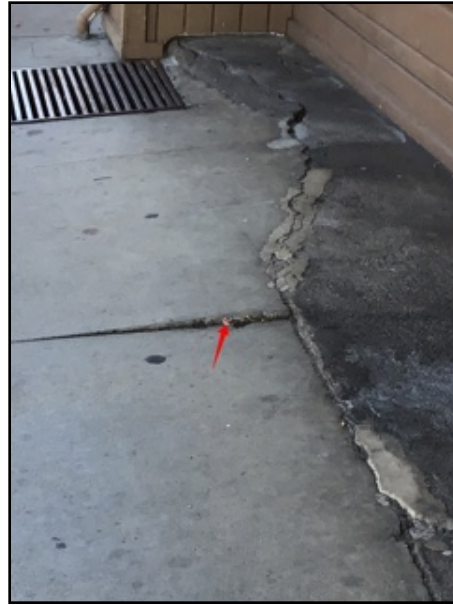
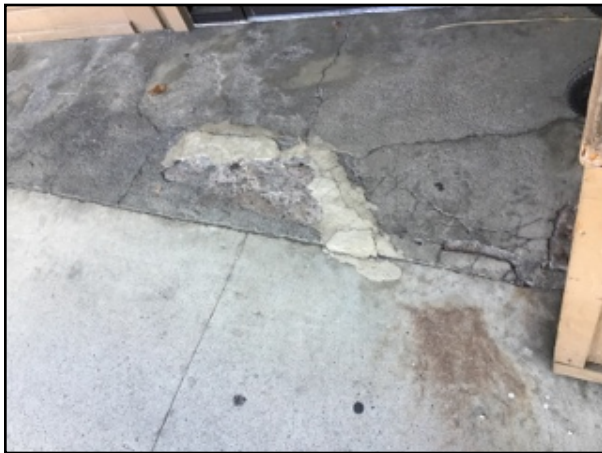
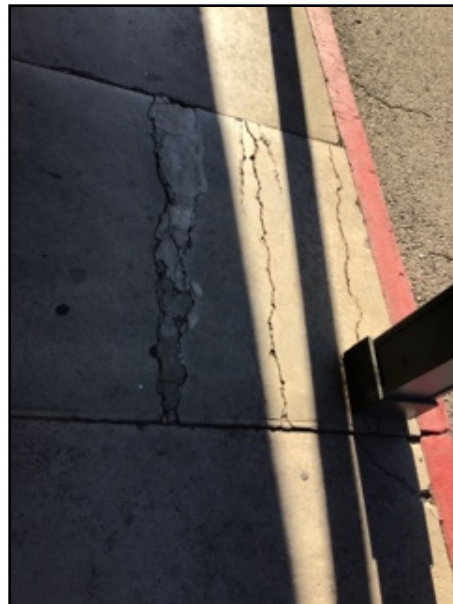
Trip hazards around the structure. This has the potential to cause personal harm due to uneven concrete/walking surfaces. Recommend seeking a handyman for further evaluation.

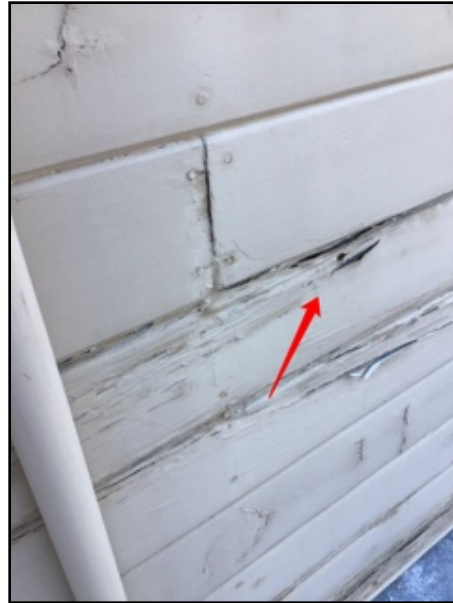
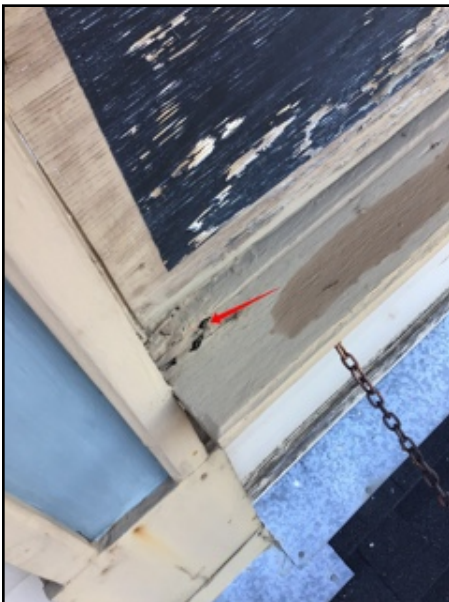
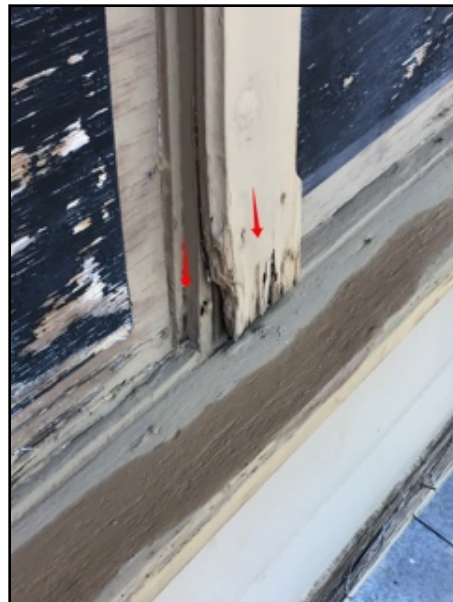
Water damaged siding at the front of the structure. Recommend removing and replacing water damaged areas to prevent further damage. Recommend seeking the pest inspection report for further evaluation.

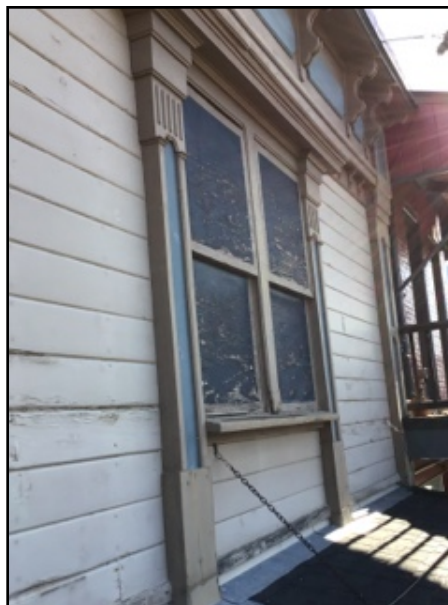
Figure 5-2

Single hung windows at the front of the structure have been boarded up. Recommend seeking a window specialist for further evaluation.

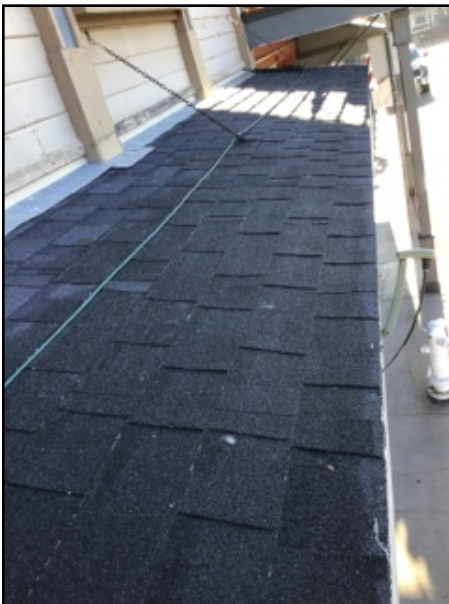
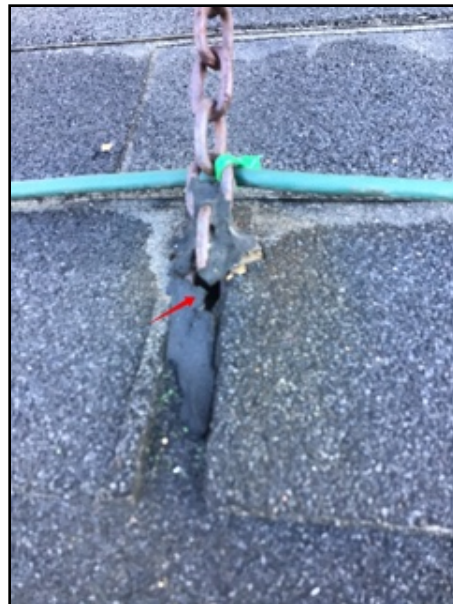
Worn/damaged composition shingle roofing at the front of the structure. Recommend seeking a roof inspection company for further evaluation.

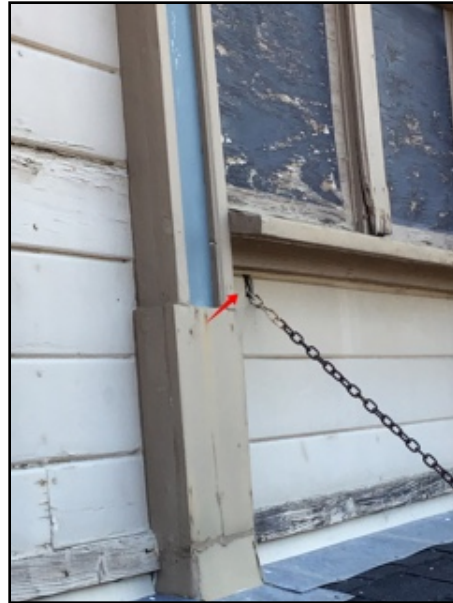
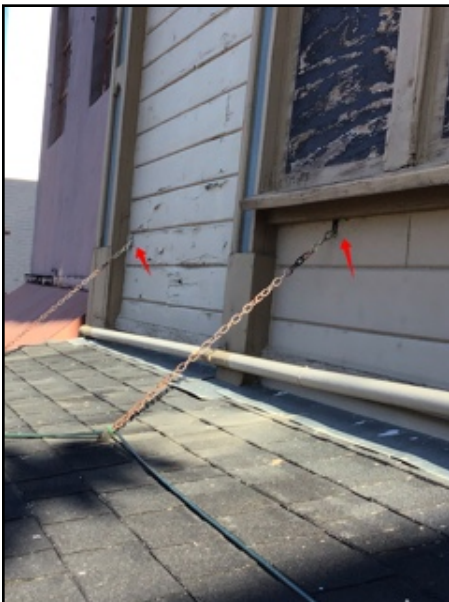
Open penetrations into the siding at the front of the structure. Recommend sealing open penetrations to prevent water damage/intrusion. Recommend seeking the appropriate tradesmen for further evaluation.

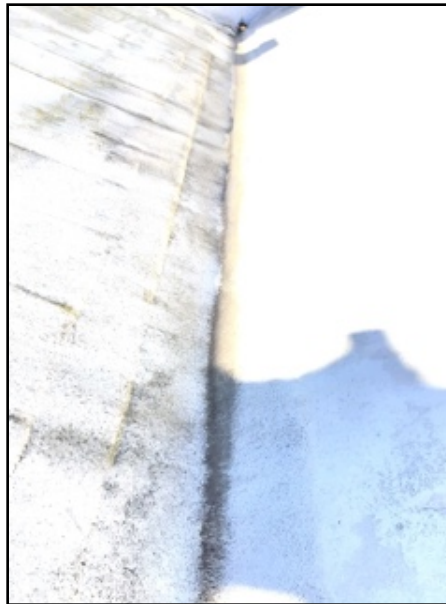
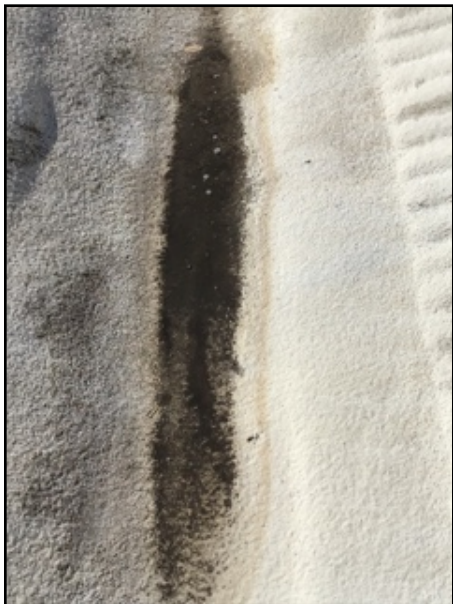
**Comment 9:**
Pooling/ponding water noted on roof. Recommend seeking a licensed roof inspection company for further evaluation.

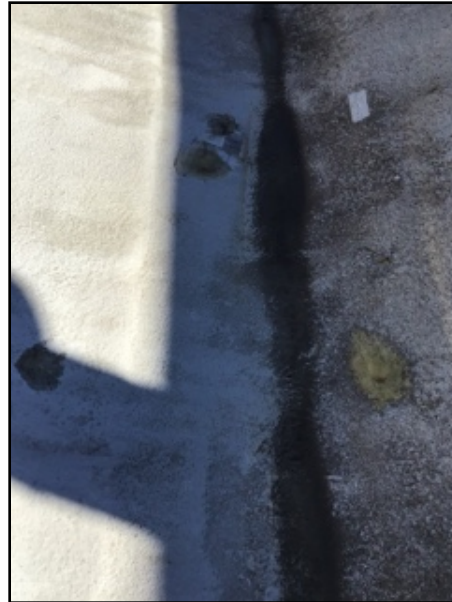
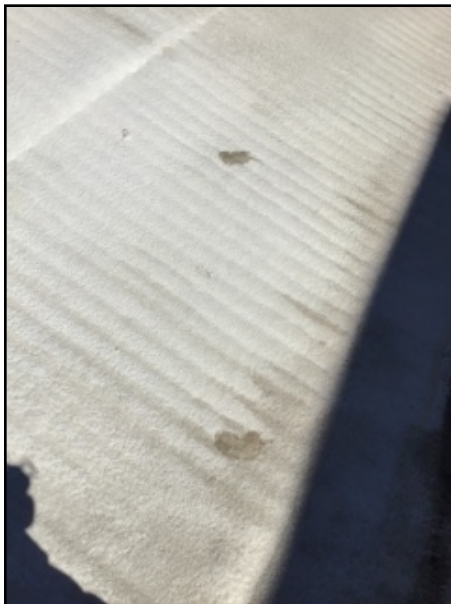
Past repairs noted on the roof. Recommend seeking a licensed roofing company for further evaluation.

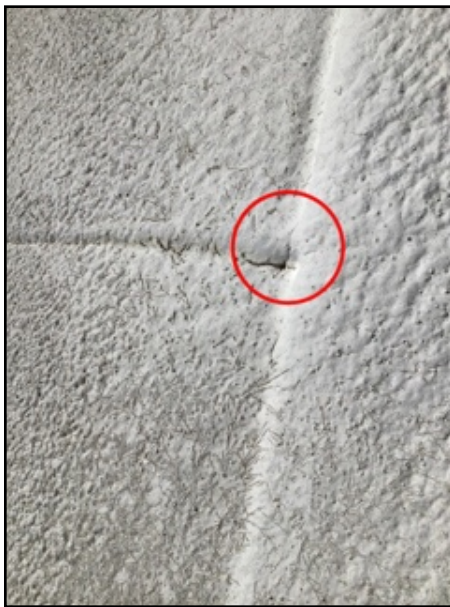
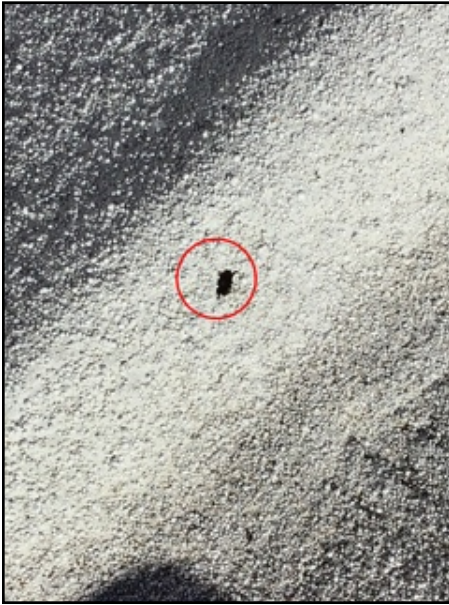
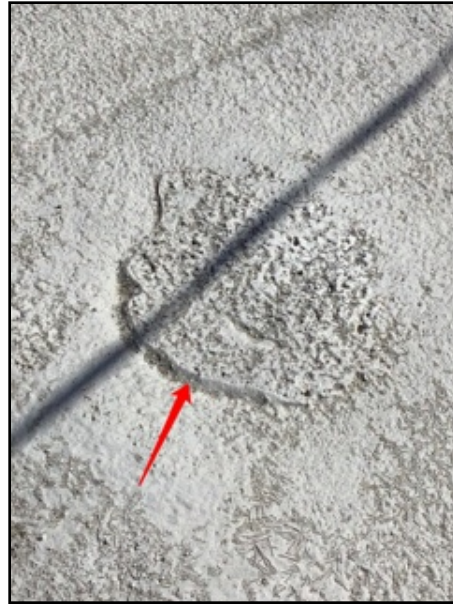
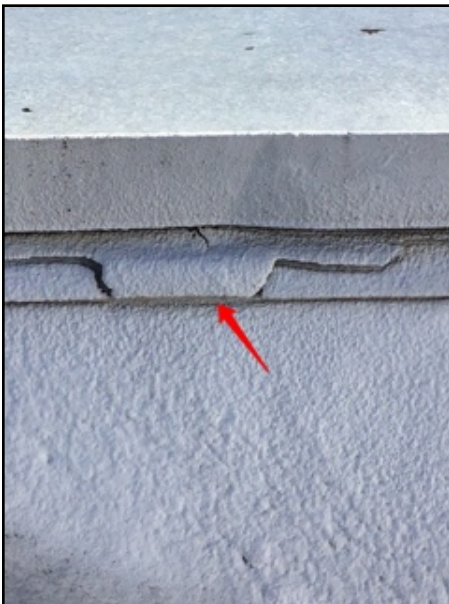
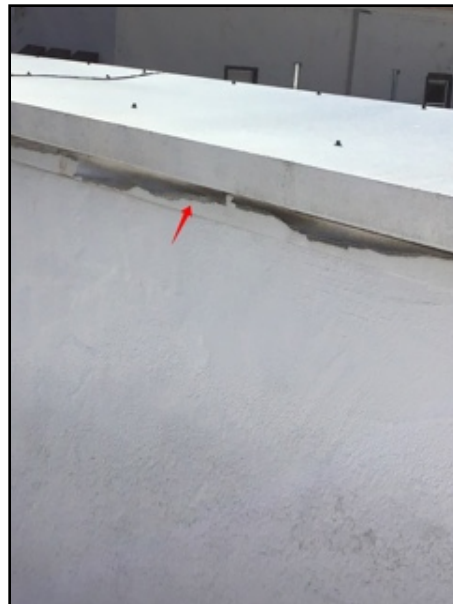
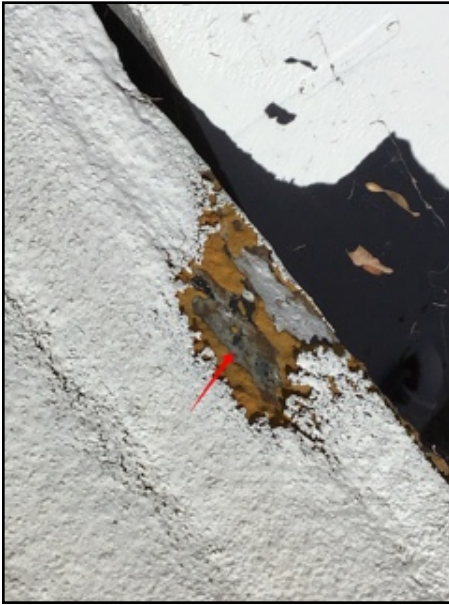
Worn/damaged spray foam roofing at the front and rear of the structure.
Recommend seeking a licensed roof inspection company for further evaluation.

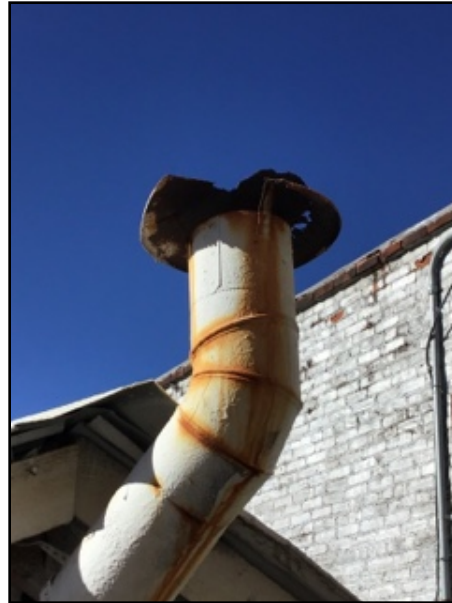
Figure 12-2

Damaged cap for flue at the rear of the roof. Recommend installing new cap to prevent intrusion/damage. Recommend seeking the appropriate tradesmen for further evaluation.

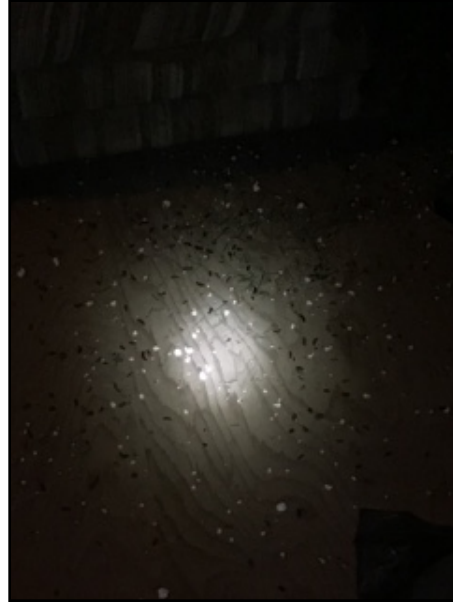
Figure 16-2

Evidence of rodents in attic. Recommend seeking the appropriate tradesmen for further evaluation.

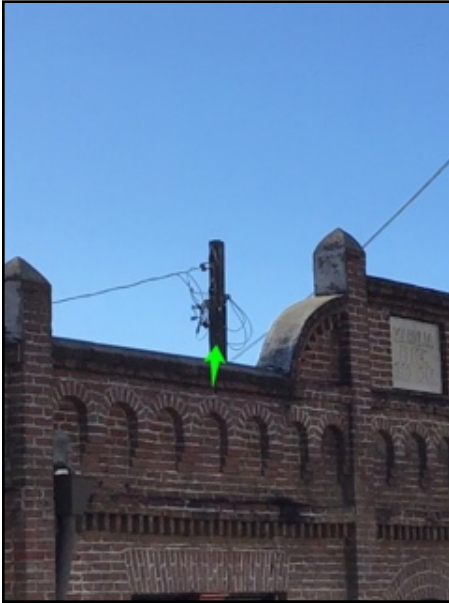
Figure 24-1

Comment 24:
Three phase 120/240.

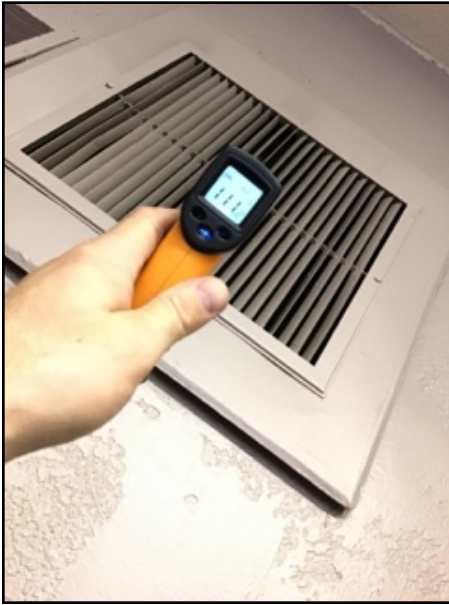
Figure 32-1

At the time of the inspection the heater functioned properly with a normal temperature rise.

Furnaces over 10 years old should be checked, cleaned and serviced yearly by a licensed contractor.

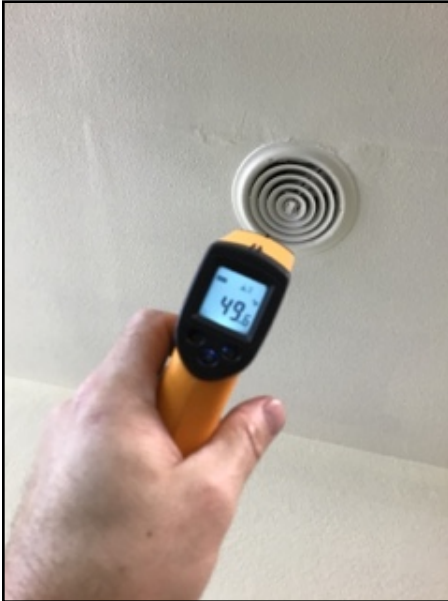
Figure 38-1

Normal drop in temperature during the time of the inspection.

Air conditioners over 10 years old and heat pumps over 5 years old should be checked, cleaned and serviced yearly by a licensed contractor.

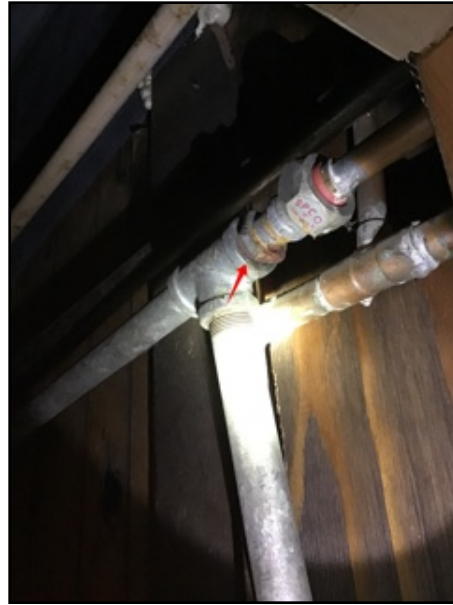
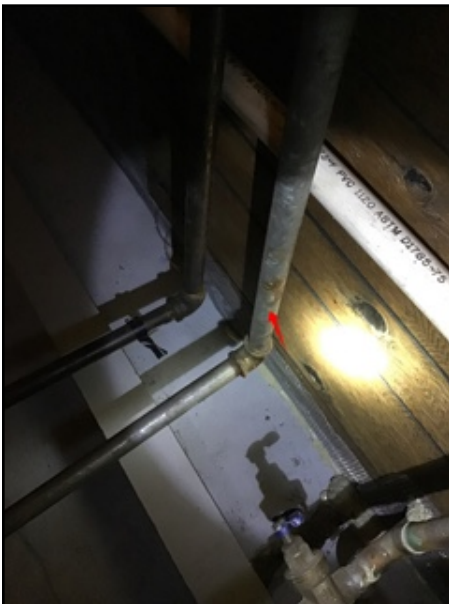
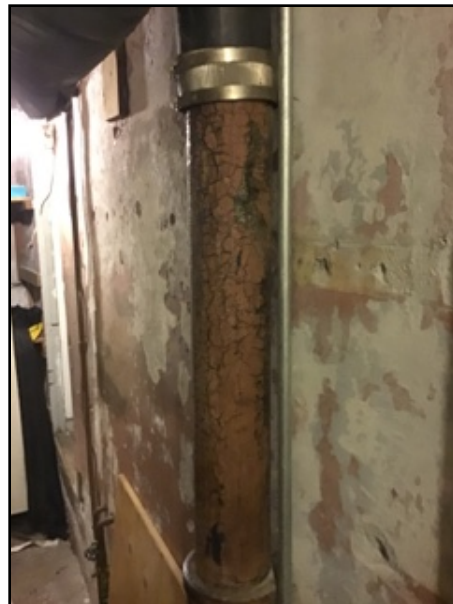
Outdated/rusted Cast-iron and galvanized plumbing around the structure. Service life of galvanized/cast iron plumbing is anywhere from 50 to 100 years. Recommend having plumbing inspected to determine life expectancy. Recommend seeking a licensed plumber for further evaluation.

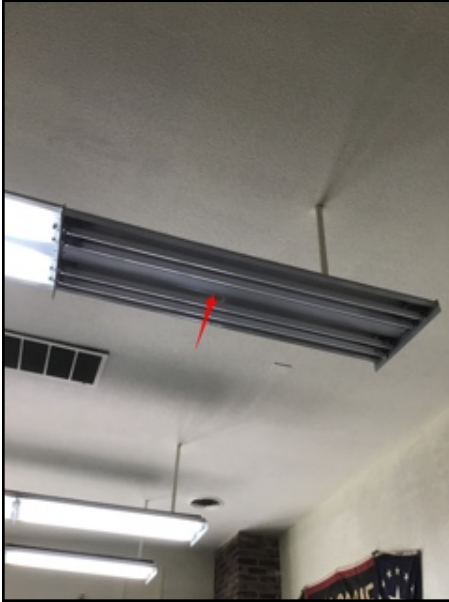
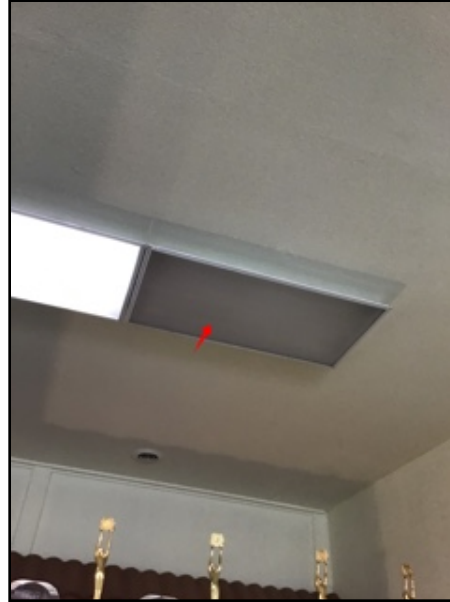
Inoperable lights at front of the structure. Please seek the appropriate tradesmen for further evaluation.

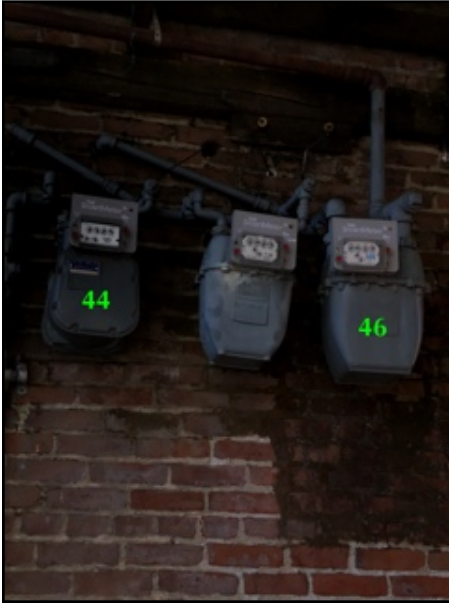
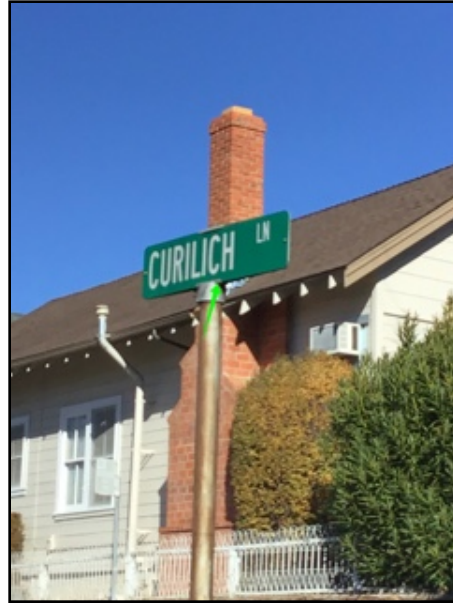
Comment 65:
Emergency gas shut off's at the rear of the structure at Curilich Lane.

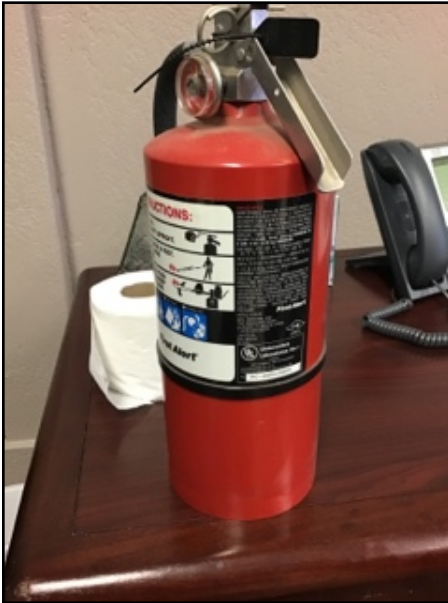
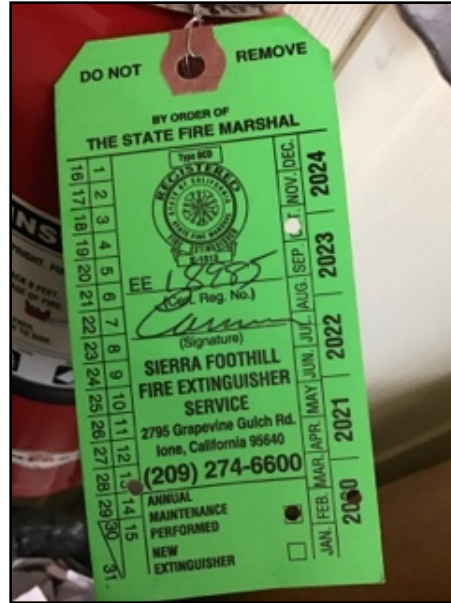
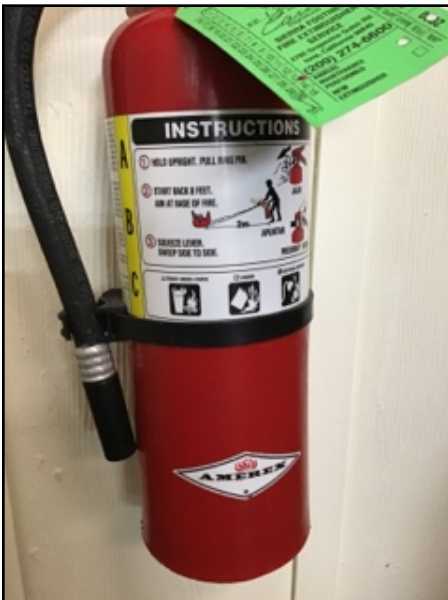
Fire extinguishers noted in both units with inspection tag from fire marshal October 13 2020. For further evaluation Recommend seeking your local fire marshal. Contact info on green tag and picture below.
