Property Inspection Report

Inspection Address
1148 53rd Street
Oakland, CA 94608

September 25, 2025

Tarkington Home Inspections
Cell (510) 566-2195
www.THInow.com

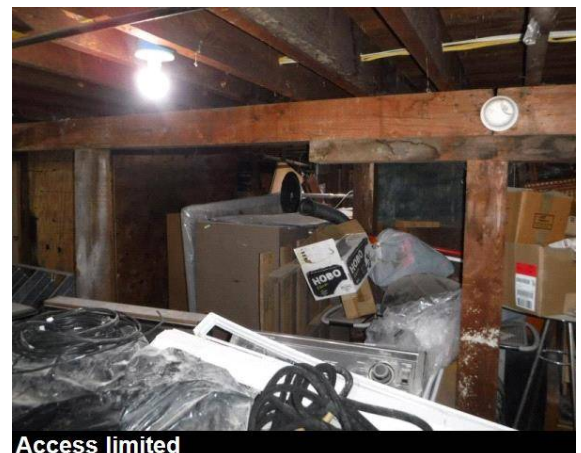
Foundation

We inspected the subfloor areas by walking beneath the accessible portions of the building floors. Our ability to fully examine the foundation and substructure framing was limited by pipes, wall surfaces, storage, and other obstructions to our view. Approximately 80% of the foundation was visually accessible during our inspection.

Access is often obstructed by insufficient clearance beneath the floor framing, by ducting, pipes, stored items, finished wall surfaces, or other obstructions to visual examination. Wherever possible, access should be provided to these areas so that an inspection can be made. With access and opportunity for inspection, defects may be found in the inaccessible areas.
