Home Systems Data, Inc
7305 E Peakview Ave
Centennial, CO 80111
303-773-6102
J. Vince Busnardo
ASHI CHI #247100

Phillippe, Thomas
1650 Pennsylvania St
Denver, CO 80203

Inspected 2/17/26 9:00 AM, Buyer and Agent, Vacant, Built 1896, Sunny 45+-, Faces West,
420inspection+170radon=\$590.00 This Report Is Non Transferable

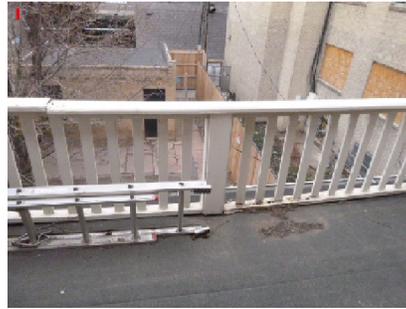
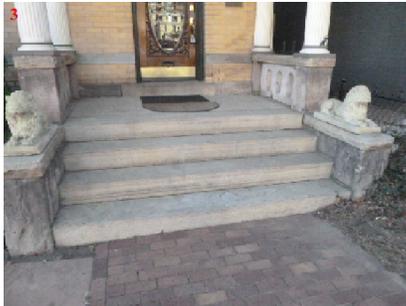
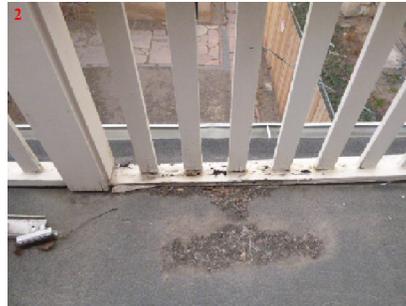
Hand Rail

The railing at the east balcony is rotted and loose, replacement needed.

A handrail is needed for the front entry steps.

Front balcony railings are low by current standards, use caution and/or upgrade.

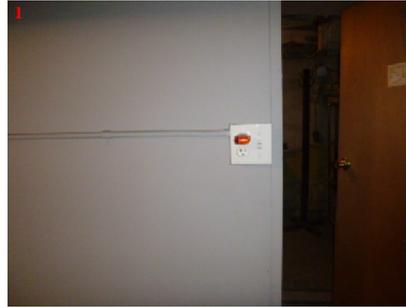
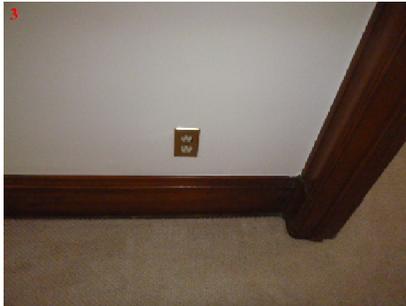
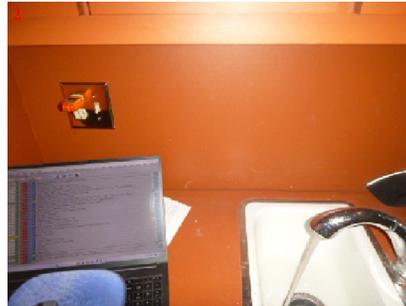
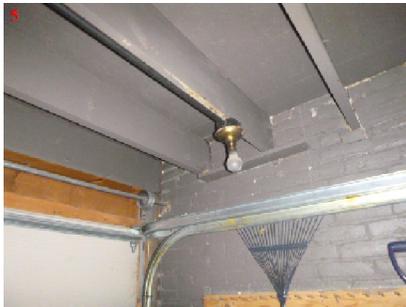
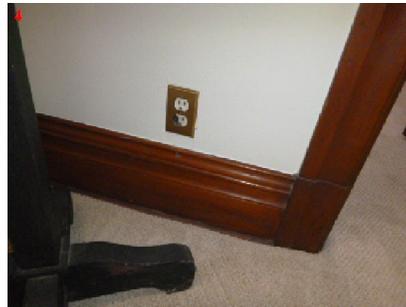
Electrical Defaults

No GFCI protection at bsmt mechanical room, break room, garage

Two prong receptacles in a few locations.

A few broken receptacles.

The overhead service cable has come loose from house mount, drip loop is now missing and wires stretched due to not being properly supported.

Lights at garage did not work.

Main panel has a white wire used as a hot lead and is not marked as such.

Recommend further evaluation/correction of the electrical system by a licensed electrical contractor to include but not be limited to the following conditions.

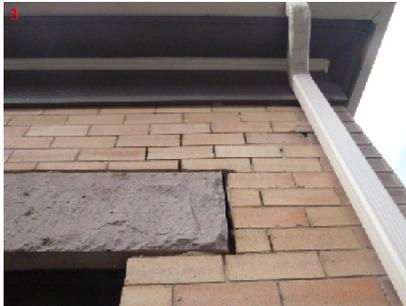
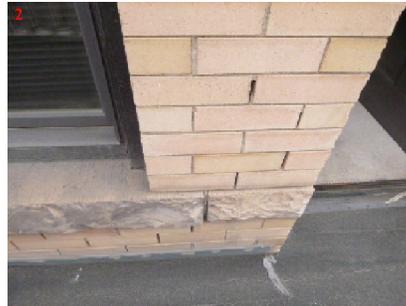
Mortar deterioration in several locations.

A few brick cracks and damage.

Precast stone at front porch is damaged.

Recommend all masonry be serviced by a certified masonry contractor familiar with historic masonry due to but not limited to the following.

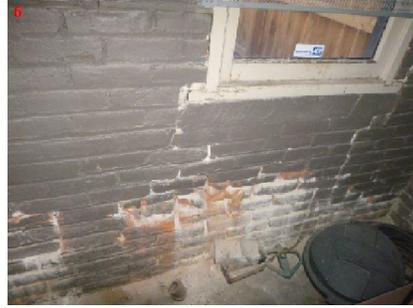
Garage Windows

Garage south window has glass missing and is boarded over.

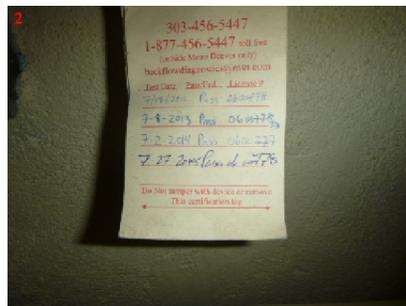
Back flow preventer certification is expired.

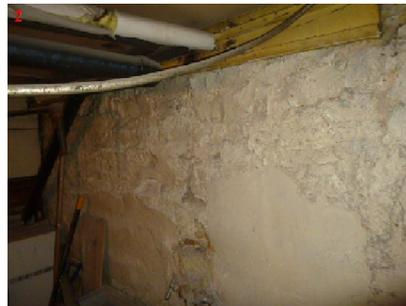
Basement Foundation Walls

Evidence of water intrusion, recommend improving exterior drainage.

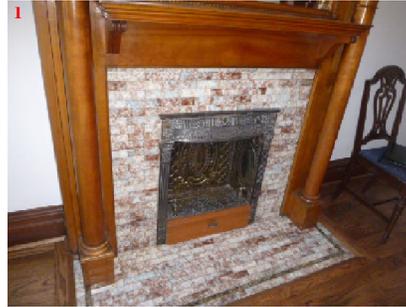
Interior Fire Place 2

Recommend a level 2 inspection (as defined by NFPA or CSIA standards) for all solid fuel burning devices at the time of sale by a certified contractor.
Parlor fireplace is original coal burner. Do not burn wood.
Flue is stuffed with insulation.

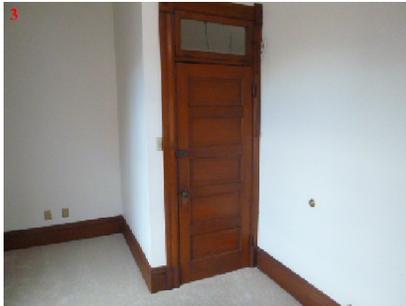
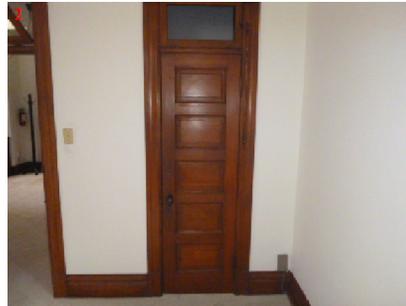
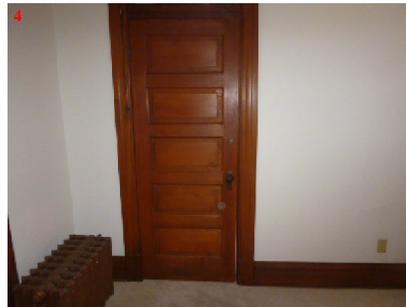
Doors throughout are racked, drag on jambs, do not latch, etc.
Indication of historic movement.
Recommend corrections as needed.

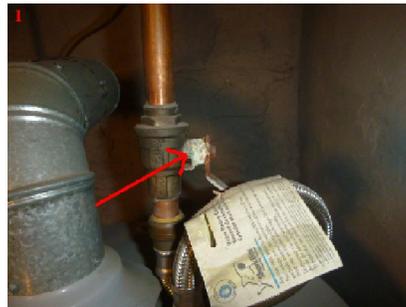
Water Heater Cold Water Valve

Corrosion noted on water heater shut off valve, recommend monitoring and correcting as needed.

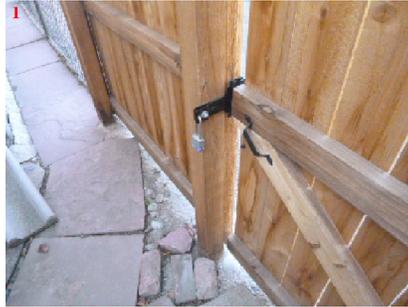
Fence will need periodic maintenance.

Some gates are locked and provided keys did not work.

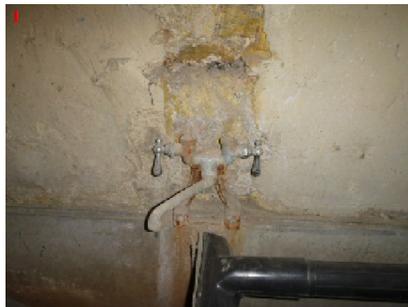
Laundry Sink Faucets

No water pipes connected to laundry sink, not tested.

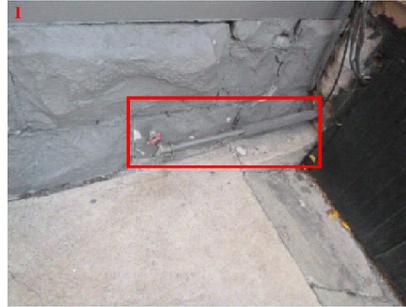
Type of Outside Spigots

Unprotected hose connections should be shut off and drained before first freeze each year.
Unit is not properly secured at exterior.

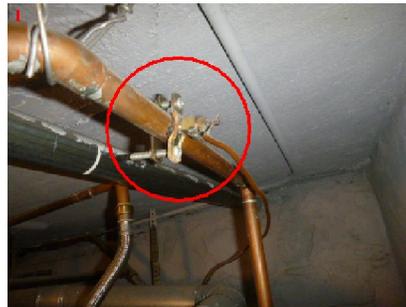
Shut Off Valves

Saddle valves are unreliable; they can become stiff making them difficult to shut off, they are prone to leaking, they are prone to breakage of the valve shaft. Recommend they be replaced with inline 1/4 ball valves.

Shut off valves are not operated as they could fail during operation and per ASHI standards.

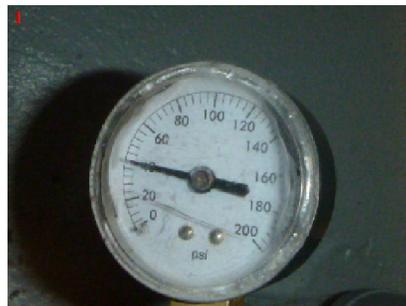
Water Pressure

Water pressure was tested at 40 psi, this is the minimum acceptable level.
Recommend further evaluation to determine if pressure can be raised.

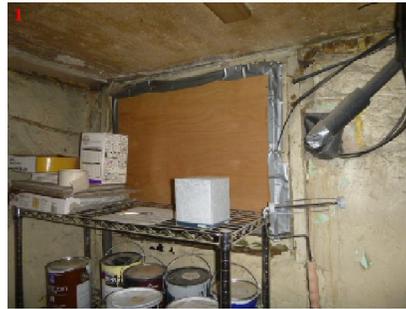
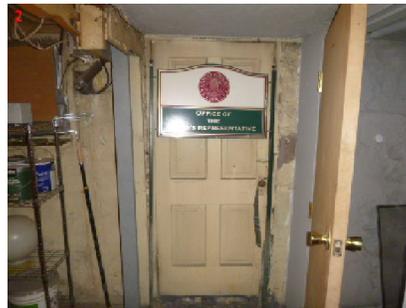
BASEMENT

Bsmt laundry has an abandoned window and exterior door. If these remain unused it is suggested they be removed and blocked or bricked over.

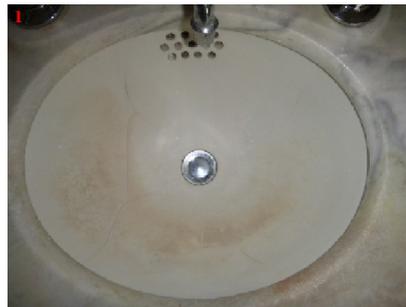
Half Bath Sink Basin

Half bathroom sink is cracked, recommend replacement before leaks occur.

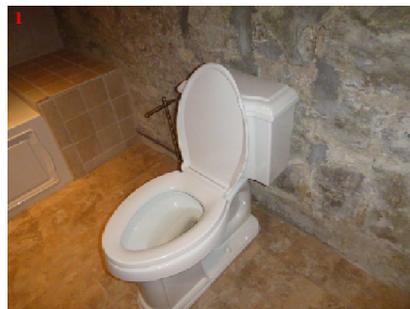
Toilet Operation

Bsmt toilet is slow to refill.

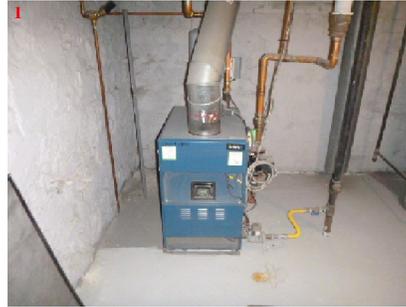
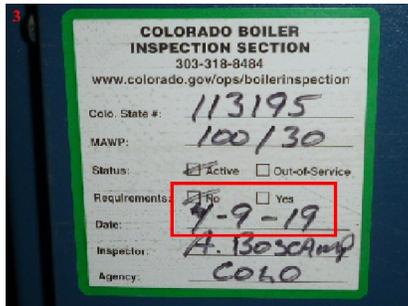
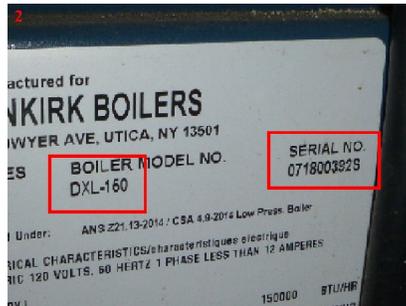
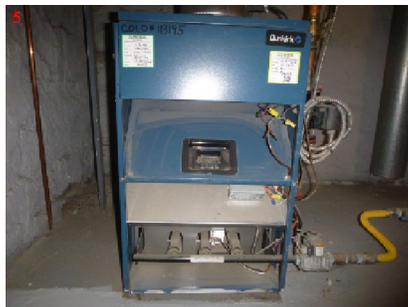
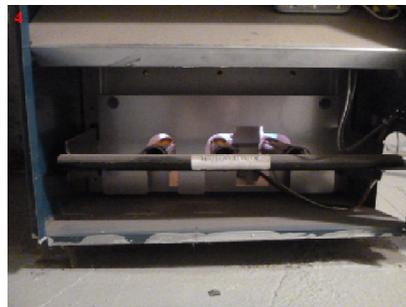
BOILER

Photo shows model/serial #'s.
Circa 2018, 150,000 BTU, Hot Water
City certificate posted is expired.

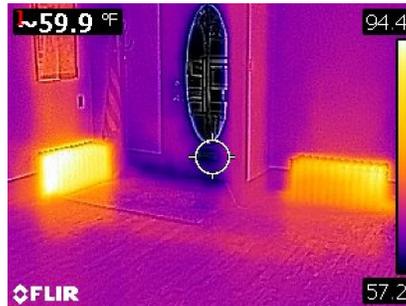
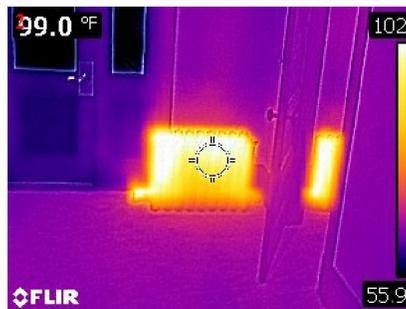
Boiler System Thermostat

One main zone and thermostat
Radiator temperatures can be controlled with valves on their inlet piping. Valves were not operated.
All radiators got warm, thermal images are of sample units.

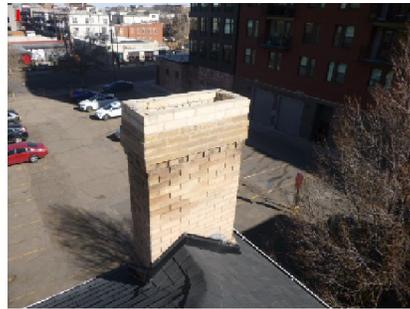
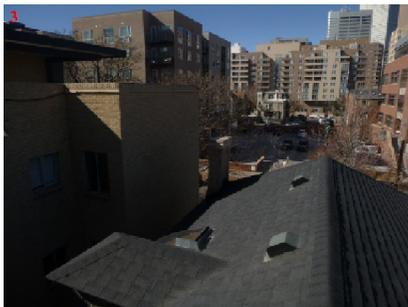
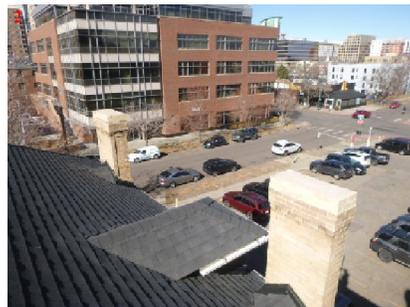
Chimney Inspected From

Five chimneys present. Four are abandoned, one at the southeast corner vents the boiler and water heater through a metal flue.

Three of the abandoned chimneys are capped.
Recommend the northeast chimney be capped.

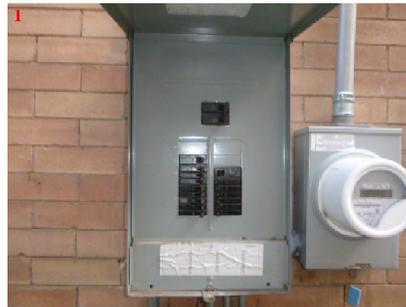
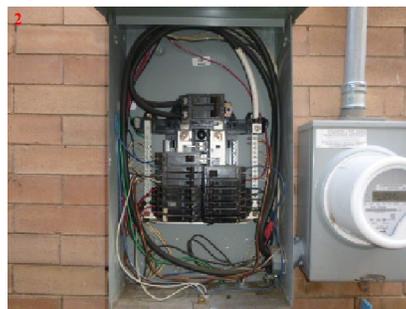
Main Panel

Photo shows the main panel with the dead front off for inspection.

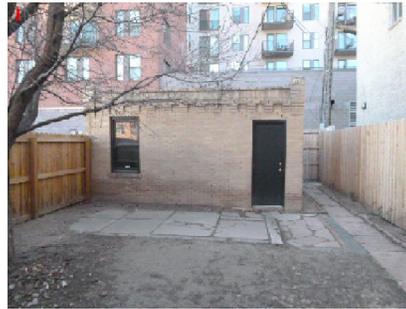
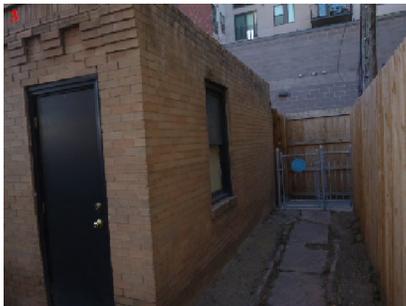
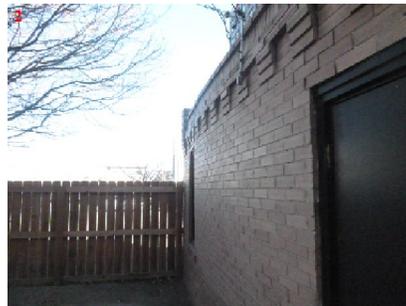
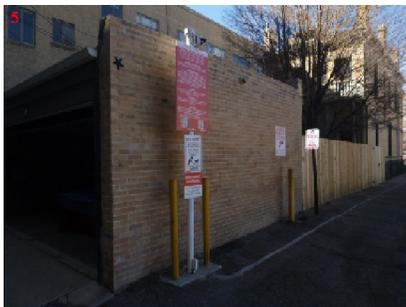
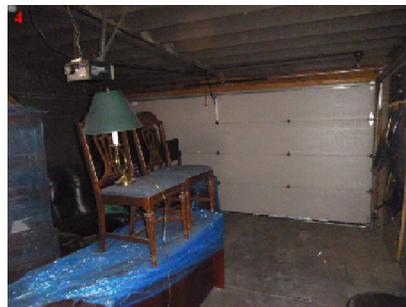
GARAGE

Documenting photos.
Inspection of garage limited by stored items.

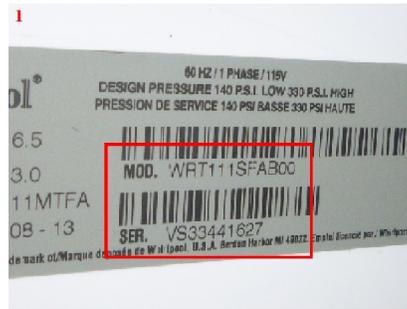
Refrigerator

Coils must be regularly cleaned.
Photo shows model/serial #'s.
Unit is not plugged in.

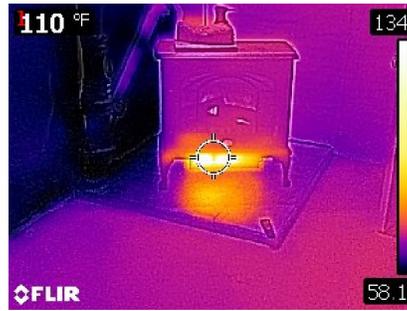
Interior Fire Place 1

Bsmt is heated by an electric fireplace in the main room. It also gets indirect heat from boiler pipes that run along ceilings. Fireplace operated as expected, turn timer on wall first then use remote to turn on fireplace.

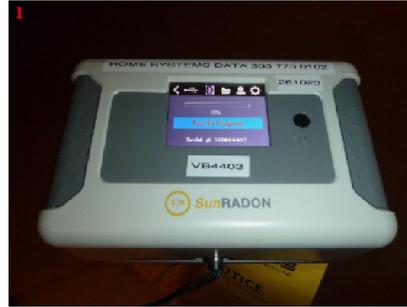
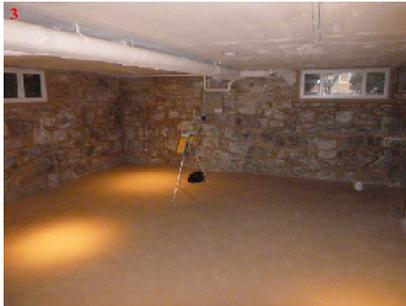
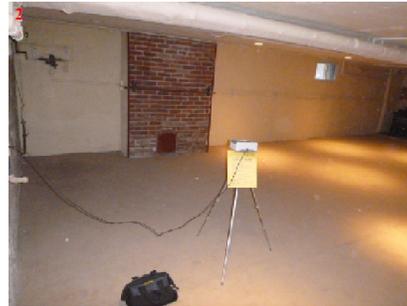
RADON

Radon test performed, see letter under separate cover for results.
Radon monitor #VB4403 set in bsmt main room.
