# **TUTOR PROFESSIONAL INSPECTIONS**

## **Confidential Inspection Report**

**806 W 11th St**

# PROPERTY INSPECTION REPORT FORM

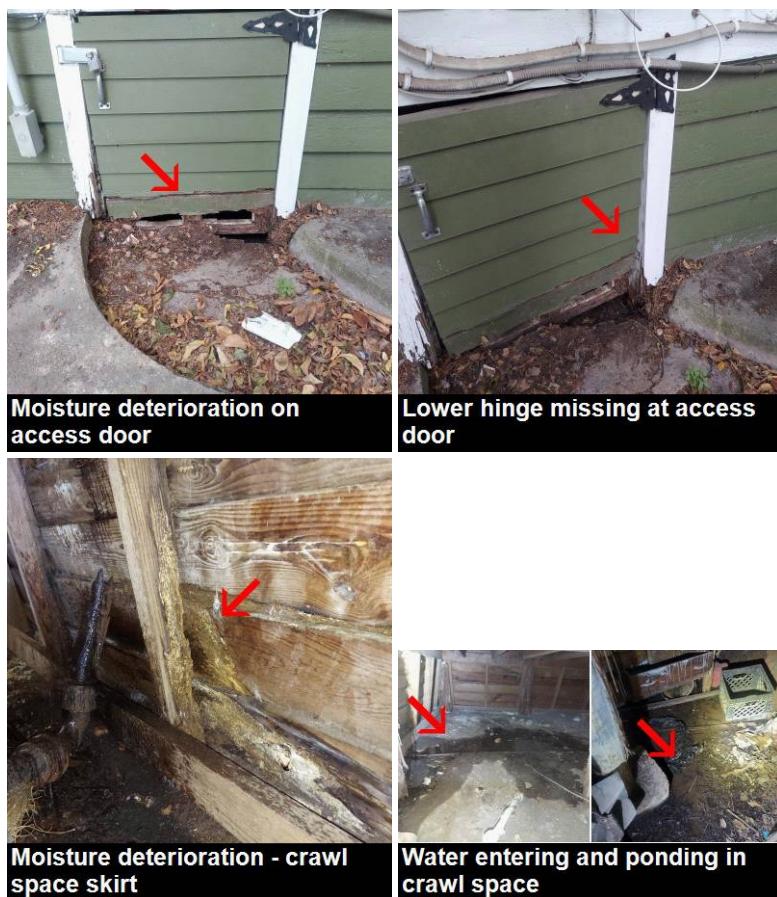
**Crawl Space Deficiencies-** There is moisture related deterioration on the skirting walls and beams where visible plumbing leaks were observed. There are indications of poor drainage and/or ponding in areas of the crawl space which could impact integrity of the piers. There was water standing in areas of the crawl space as a result of plumbing leaks and irrigation system draining into this area which is below the exterior grade. There is moisture deterioration observed on the skirting where plumbing leaks have been present for some time. One of the hinges is missing from the crawl space access door. There is significant moisture deterioration on the crawl space access door. There is damage to the block wall at the south end of the crawl space. There is a possible fallen pier observed along the south wall of the crawl space.

Indications of foundation movement were noted that included: significant deflection of floors in multiple areas of the interior building; doors that run when opening and closing; settling fractures observed around doors, windows, walls and ceiling around the home.

Moisture deterioration on east skirting

Damage to block wall in south crawl space

We recommend that you consult with a structural engineer and/or qualified foundation expert to determine if repairs may be needed.

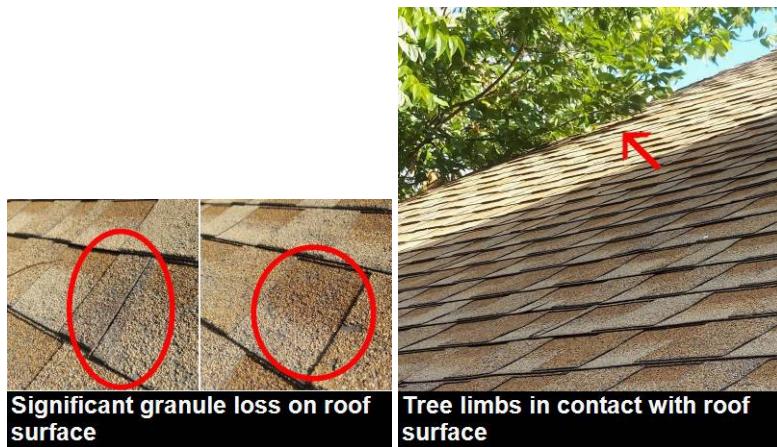
**ROOF COVERING OBSERVATIONS-** **The roof covering appears to be nearing the end of its useful service life.** A qualified professional roofing contractor should be consulted to make further evaluation and/or repair or replacement recommendations for current conditions. Tree limb(s) observed in contact and rubbing surface of roof. Trim tree limbs off roof 4-5 feet to reduce wear/damage to roofing materials. There is moisture deterioration observed on the shingle mold trim on the upper west side of the home.

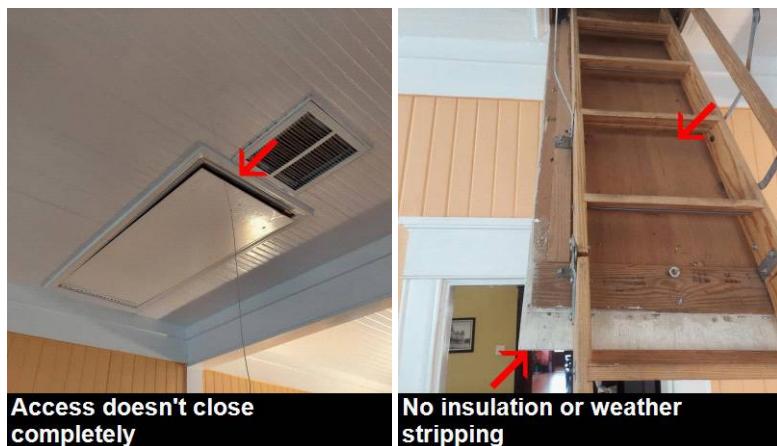
Attic access ladder in the rear reception area is not hung in accordance with the manufacturer's specifications that preclude the use of screws that could shear and cause serious injury. Current standards require 16-d nails or lag screws. There is evidence of rodent activity in the attic area. The attic access cover does not close completely which may allow air leakage between the attic and conditioned areas of the building.

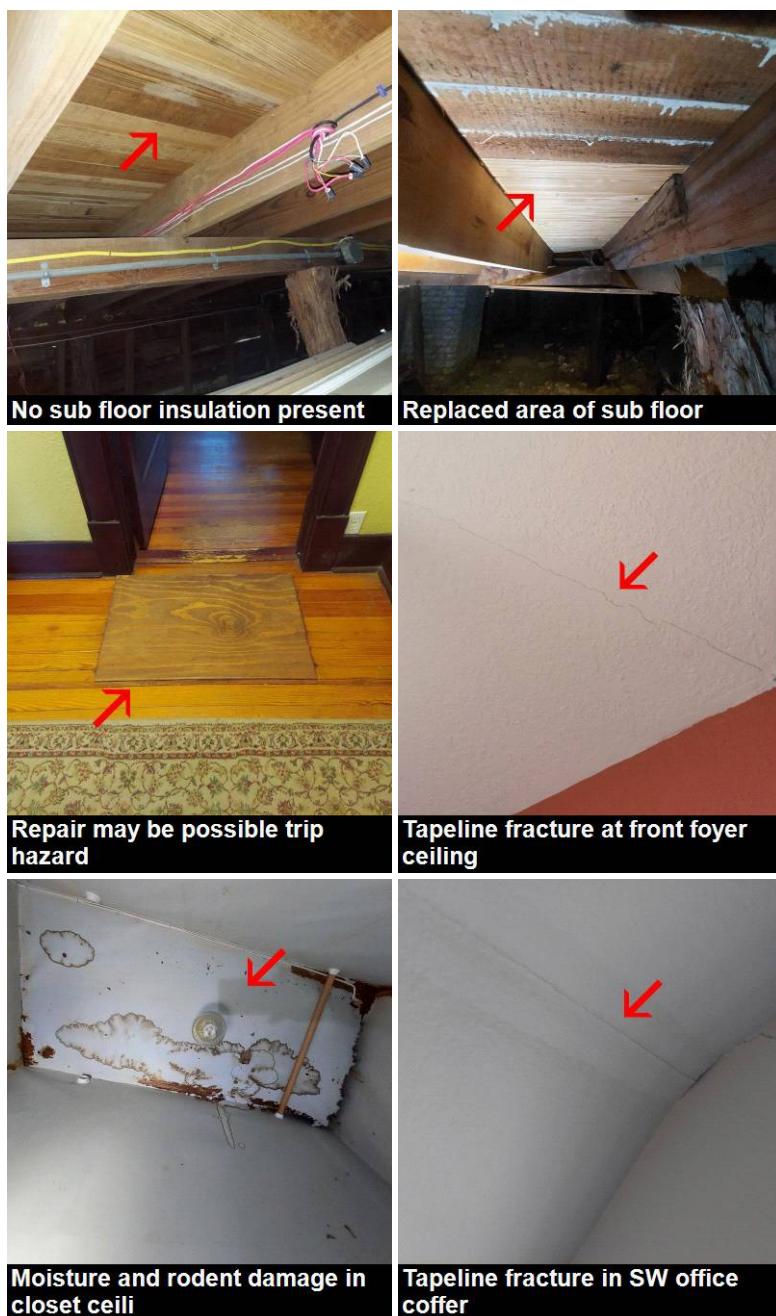
around the home where deviations in the level of the flooring are observed. This is likely the result of foundation settling. Client may wish to have a qualified foundation repair company conduct a further evaluation of the structure to determine if leveling is required at this time. There are some areas visible from the crawl space where the flooring or sub floor have been replaced. There is a patch repair on the floor in the area between downstairs offices which could be a trip hazard. There is noticeable deviation observed in the floors in some areas of the upper level. There are some areas of damage observed on the hardwood flooring.

Possible moisture deterioration in ceiling

Damaged areas of hardwood flooring

Fracture in west office ceiling

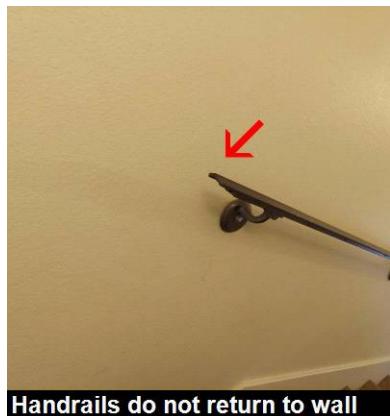
INTERIOR STAIRS: Handrail did not return to wall as required by current standards.

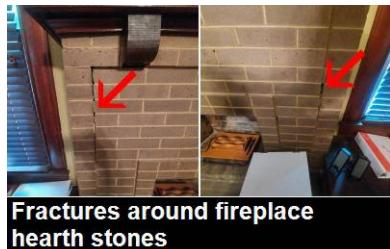
FIRE PLACE LOCATION- First Floor, southwest office. FIREPLACE TYPE- Masonry FIRE PLACE OBSERVATIONS- There are fractures in the hearth stones around the fireplace opening. Based on age, we recommend you have the unit cleaned and inspected by a fireplace professional before attempting to use the system.

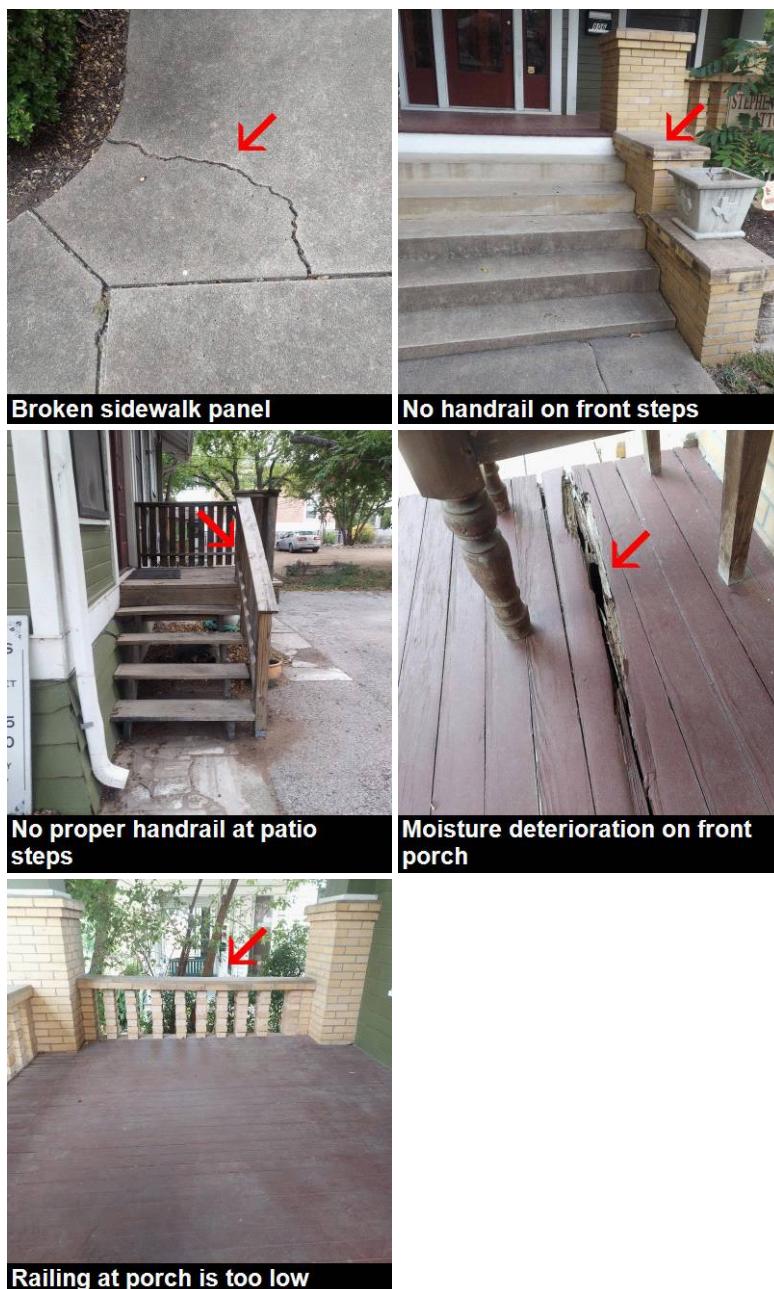
PORCH OBSERVATIONS- There are no handrails to the front porch which is required by current standards when there are four or more steps. Circular handrails shall have a diameter of  $1\frac{1}{4}$ " - 2". Non-circular handrails shall have a maximum cross section of  $2\frac{1}{4}$ " There is a broken panel corner at the front walk way. There is moisture deterioration on an area of the front porch deck that should be repaired to reduce injury risk. The railings around the perimeter of the deck are too low per current standards (railings must be 36" in height).

PATIO OBSERVATIONS: There are no handrails to the covered patio which is required by current standards when there are four or more steps. Circular handrails shall have a diameter of  $1\frac{1}{4}$ " - 2". Non-circular handrails shall have a maximum cross section of  $2\frac{1}{4}$ "

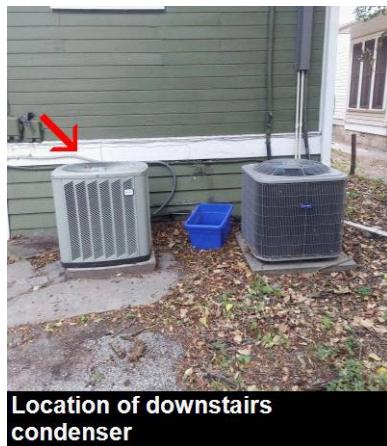
Electric. The condensing unit is a 2.5 ton unit with a max breaker of 25 amps. **The breaker is not properly sized in the panel as the unit requires a 25 amp breaker and a 40 amp breaker is found in the panel, creating an over-fused condition of 15 amps.** Recommend you have an HVAC professional or licensed electrician replace this with a properly sized breaker. Manufactured in 2020. Refrigerant type is R-410a.

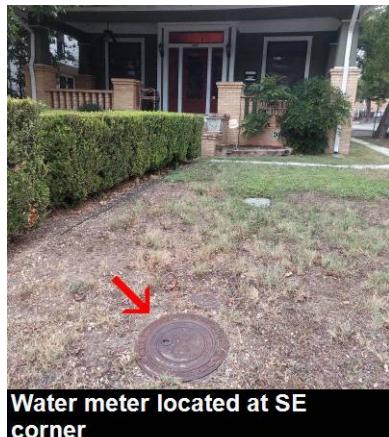
Municipal service is primary water source. SUPPLY PIPING TYPE- Copper POTABLE WATER LINE OBSERVATIONS- Appears serviceable EXTERIOR PLUMBING- No **vacuum breaker / anti-siphon protection observed on exterior hose bibs/faucets.** This is a basic safety attachment to the end of faucets that will protect from a cross connection or back-flow of water into the house. **Exposed copper pipe in the crawl space may allow freezing and other issues if not properly covered.**

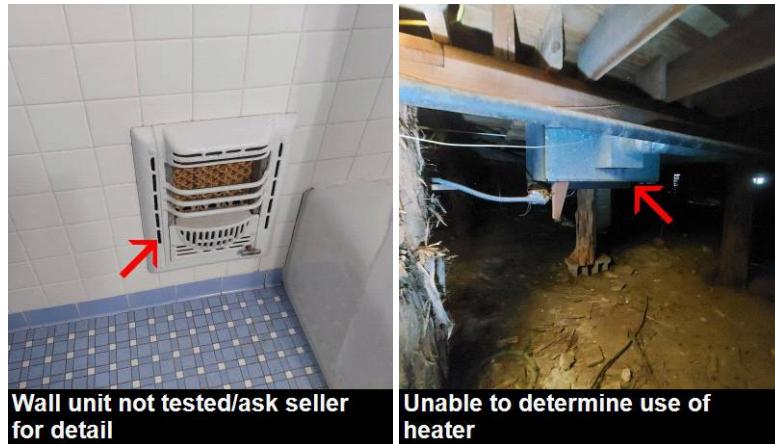
There is a heating unit located in the crawl space whose exact function cannot be determine. The wall heater in the downstairs bathroom was not tested/inspected at the time of this inspection.
