#3 (RIGHT MIDDLE BUILDING)

835 Minnie St
Jacksonville, FL 32204

NOVEMBER 7, 2024

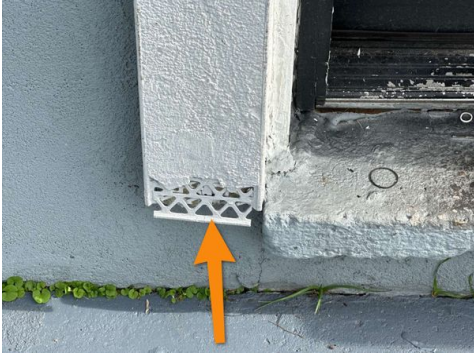
DAMAGE AT SIDING/TRIM

Damage was present to the siding and/or trim in the areas pictured below. Recommend repairing the siding to ensure proper drainage and to allow for normal wear and tear.

Contact a qualified professional.

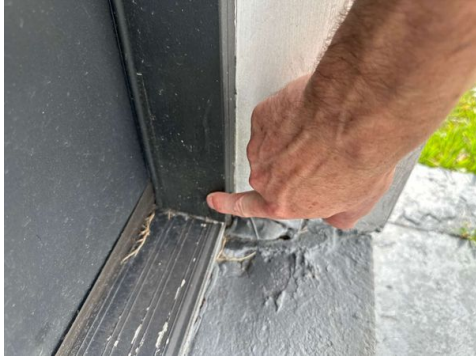
WOOD DECAY - LOWER DOOR TRIM

Wood decay noted at unit 825 exterior door's lower door jamb. Recommend repair to allow for normal wear and tear.

Wood decay is common for exterior doors with only a small roof overhang above it or where wind driven rain can enter. This can allow water to run down the seams during wind driven rain. This is a exterior rated door, so this is okay, but wood decay is commonly found at these doors after enough time. Adding storm doors or extending the roof overhang can help reduce this.

Contact a qualified professional.

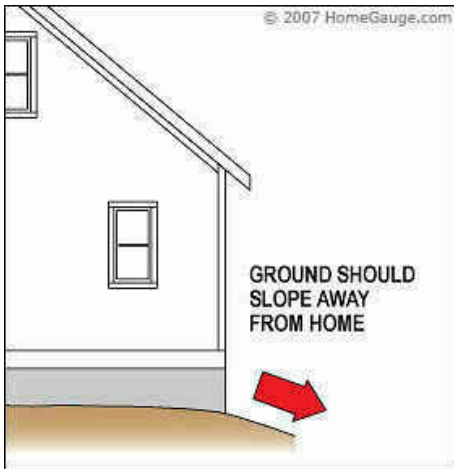
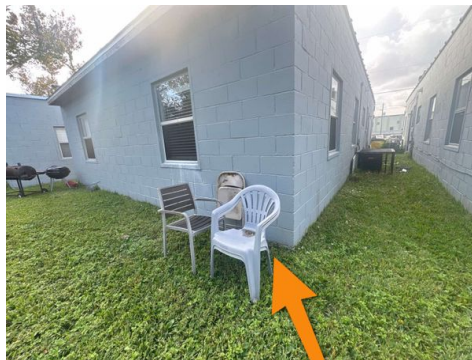
There are a few negative slopes that does not appear to drain water away from the home. Recommend correcting the grading or drainage so water is diverted away from the structure. Typically dirt needs to be added, compacted and sloped away from the home to allow for better drainage or underground drains can be added.

Contact a qualified handyman.

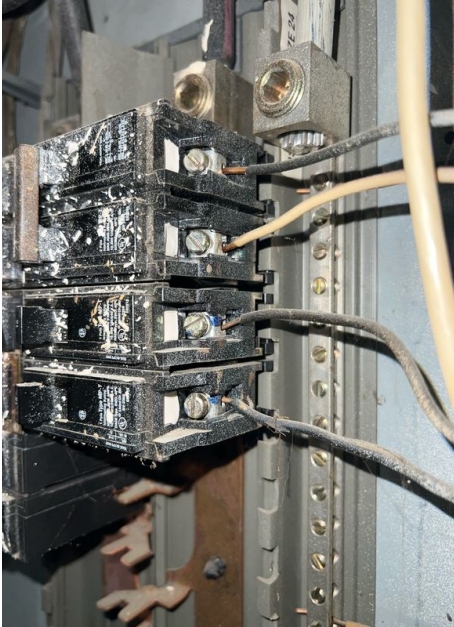
General Info: No Hot Spots Observed with IR Camera

No hot spots or anomalies were observed in the electrical panel, under current loading conditions, during the inspection.

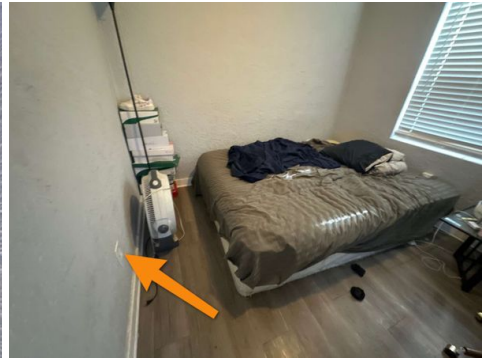
825

The electrical outlets pictured below showed an improper ground according to the receptacle tester. An open ground outlet can cause an electrical surge to the connected device resulting in damage or electrical shock. Recommend further evaluation and repair by a qualified electrical contractor.

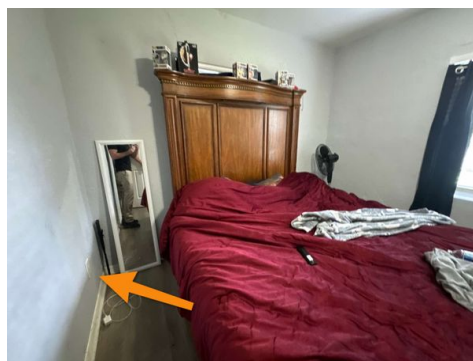
827

Unit 827s bedroom has a 2 prong receptacle. This type of outlets do not have a ground, which can be common for older homes (lack of grounds in the wiring). Recommend upgrading for safety.

Contact a qualified electrical contractor.

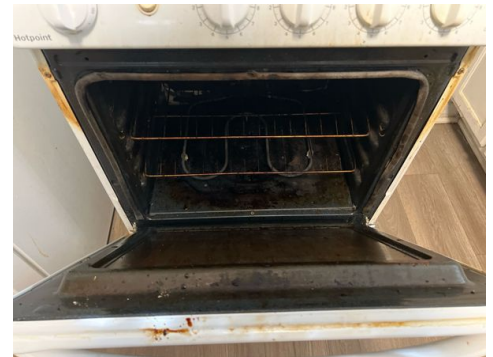
The oven light was inoperable during the inspection. Recommend replacing the light bulb or repair if necessary.

Recommendation

Contact a handyman or DIY project

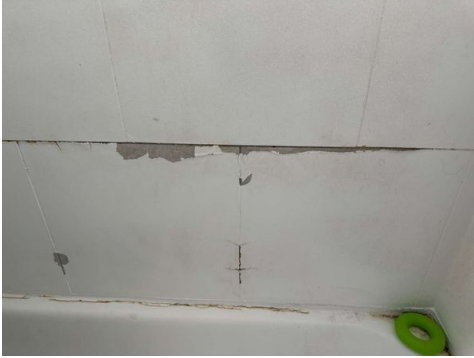
A paint type of refinish was applied to the shower walls and bathtub in unit 827, which is okay, but this coating has failed in areas and is chipped and peeling. Some areas need caulking as well. There is also wear at unit 825s bathtub, as well as standing water in both units bathrooms from an inadequate drainage pitch. Recommend repair as needed.

Recommendation

Contact a qualified professional.

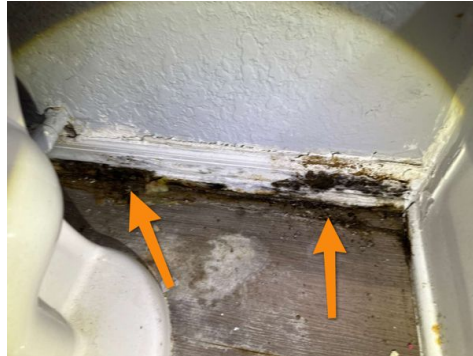
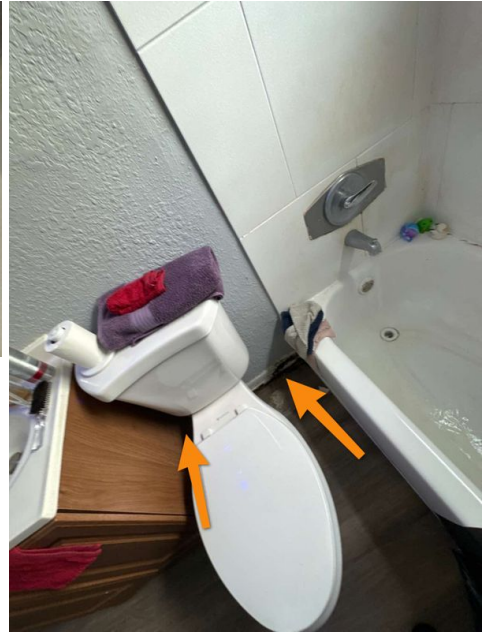
827

Unit 827s bathroom toilet is loose from the floor connection. Repairs may involve re-setting the toilet on a new wax seal. There is also fungi growth and a lot of water stains at the baseboard behind the toilet, so the toilet could be leaking from time to time if moved too far or there is excessive water overspray during showers, but needs further evaluation and repair by a plumber.

Recommendation

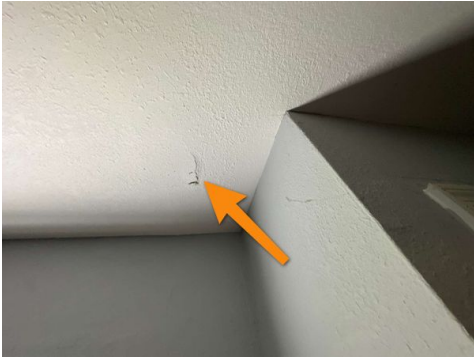
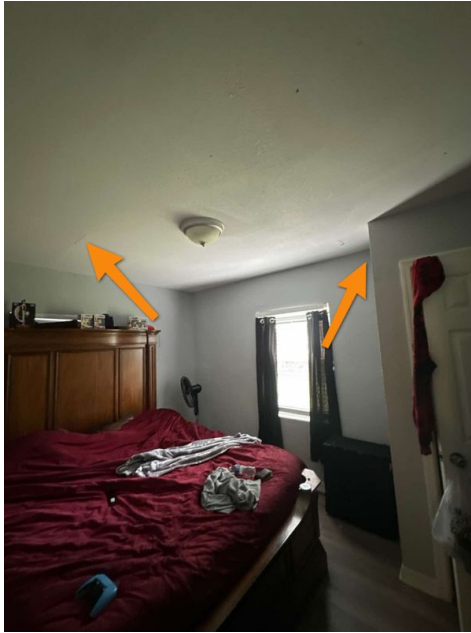
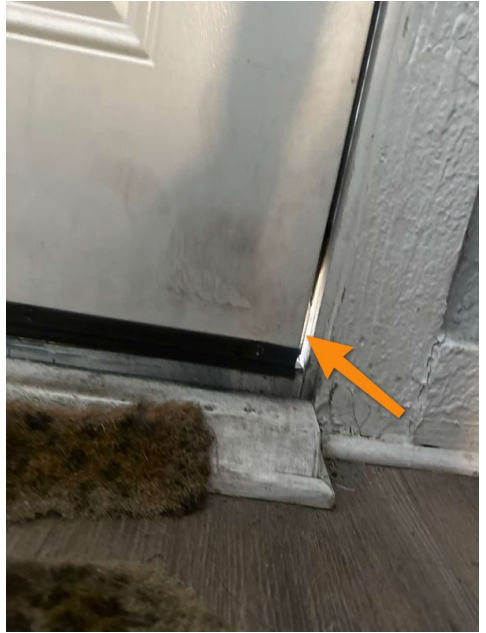
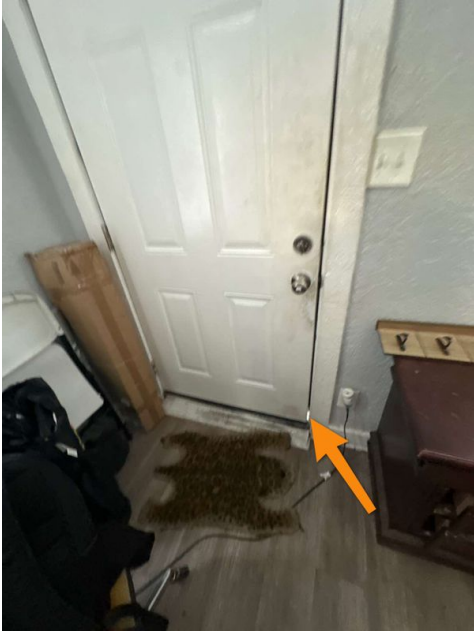
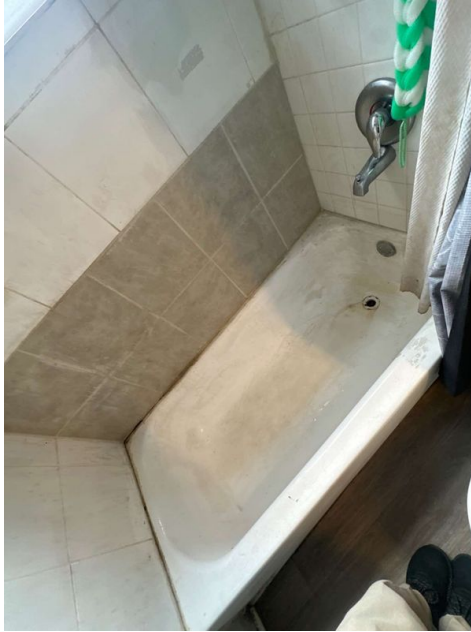
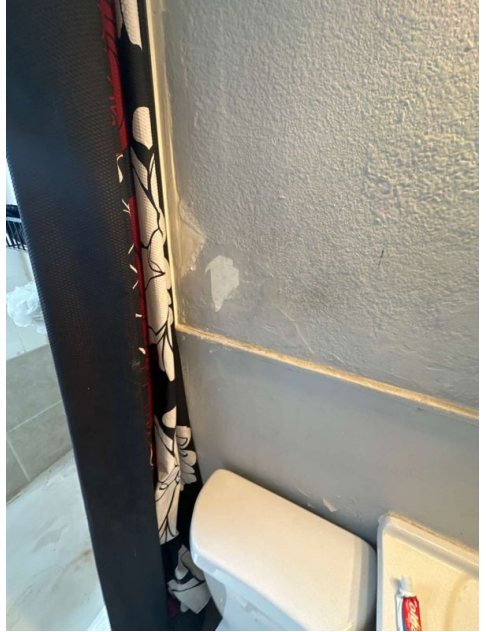
825

This is not a new home, so the home has general wear and tear that can be common for its age. You should be aware of the general condition. We inspect with realistic expectations for the age of the home, but here are some photos of some of the more noticeable wear and tear items that were noted.

Contact a qualified professional.
