# **REAL ESTATE INSPECTION REPORT**

**Estate of Carol O'Brian**

119 S Adams St Glendale CA, 91205

DATE OF INSPECTION: 09/01/2026

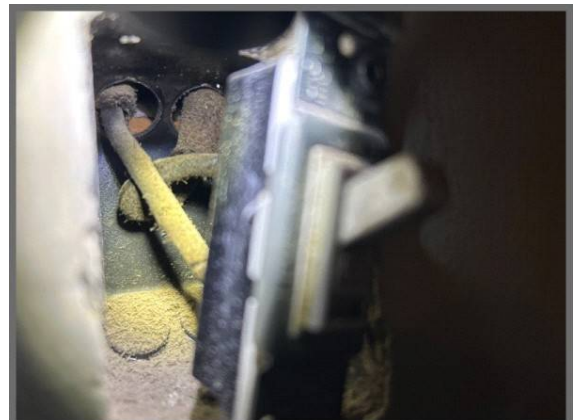
Cloth Wiring

The wiring is a combination of older, original cloth insulated copper wires and plastic insulated wires. Some of the older wiring consists of knob and tube wiring. This is an older wiring that is not in a conduit. It is generally considered to be outdated and in need of upgrades. Further evaluation is recommended.

The cloth covering will continue to wear out and poses a significant increased risk of failure. This wire is considered to be past its expected working life. It is recommended that this wiring be fully evaluated by a qualified electrician to determine if it is time for replacement at this time or in the near future.

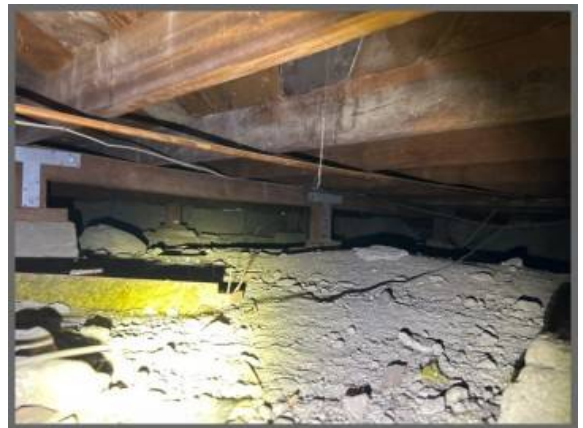
**NEEDS ATTENTION.** The crawl space has debris in it, it is advisable to have this removed and the area cleaned up. Wood especially should be removed to help prevent future infestations.

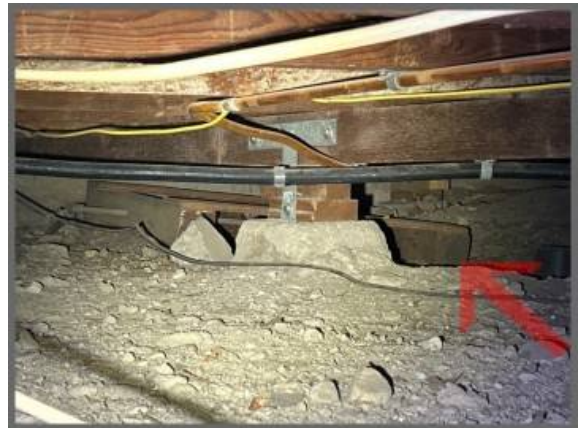
**NOT ACCEPTABLE.** There is a crawl space access at the back of the building, The under house crawl space access is difficult and smaller than current standards that require an opening of 24 x 18 inches minimum. As a result the crawl space could only be viewed from the basement in a limited capacity.

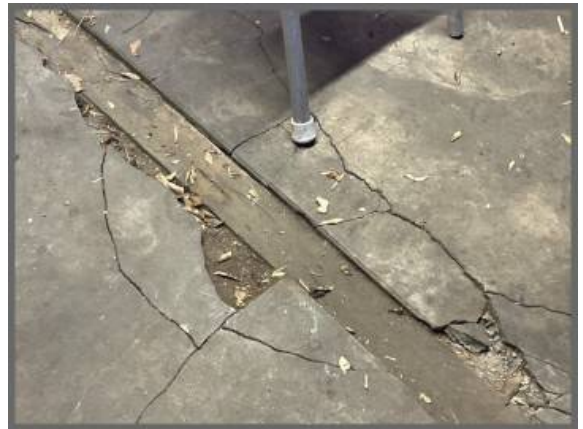
**NOT ACCEPTABLE.** There are significant cracks in the garage floor slab and the structure has shifted and settled.

It is advised to consult with the qualified specialist for more information and further evaluation of this system.

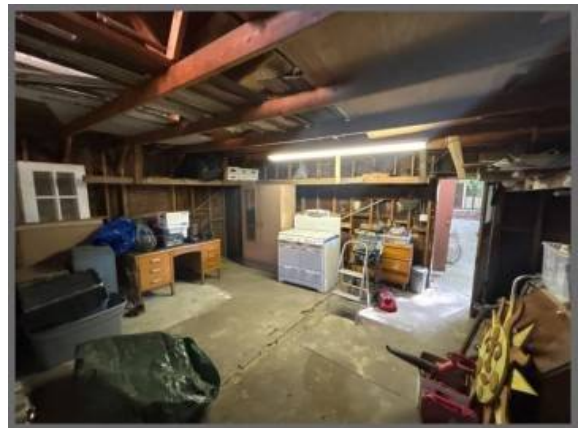
**NEEDS ATTENTION.** The garage framing has areas of deterioration such as to the framing and siding

It is advised to consult with a qualified specialist for more information and further evaluation.

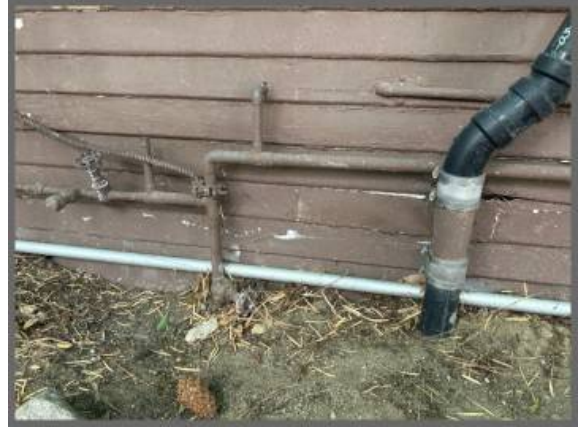
**NEEDS ATTENTION.** The current main water line may be smaller than standards would require. While this may operate it may not supply the volume of water that may be demanded at all times.

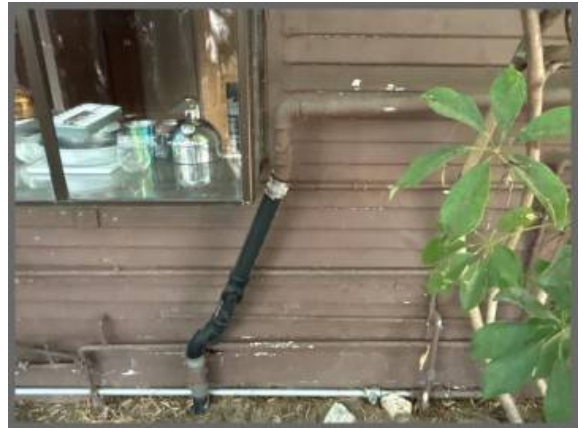
**NOT ACCEPTABLE.** There are areas of open exterior waste lines. This should be capped in order to prevent rodent intrusion into the waste line system.

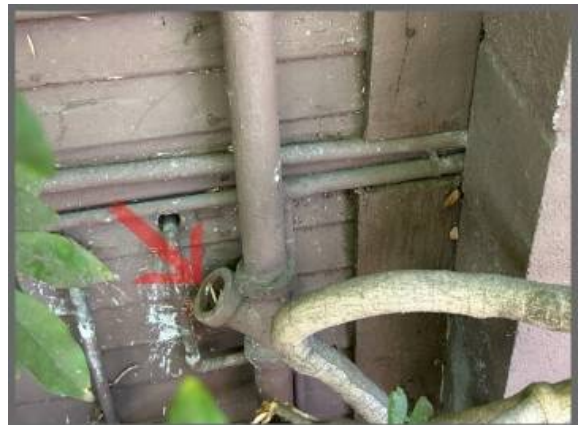
There are areas of exposed plastic abs waste lines at the right side of the building. These sections of waste lines can become more easily damaged, and should be comprised of cast iron.

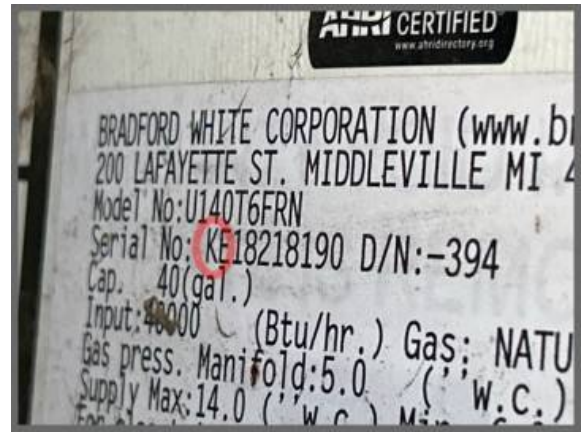
The water heater is about 13 years old. Water heaters have an average life of 8 - 12 years.

The letter "K" represents the year 2013 for Bradford White water heaters.

**NEEDS ATTENTION.** Although currently working, the water heater is very old and has exceeded its expected life span. It is beyond this inspection to determine how much long it will last. It will likely need replacement.

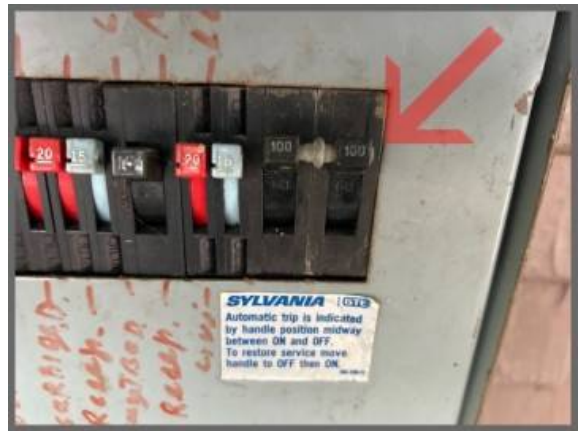
**SAFETY ALERT.** This is a Zinsco brand system. This brand of breakers has been known to have to have significant flaws that increases the risk of failure. They can tend to trip prematurely and the breakers can tend to malfunction at the panels creating arcing which can overheat or burn the buss bar and breakers.

This system should be fully evaluated by a qualified specialist, who will likely recommending upgrading the system.

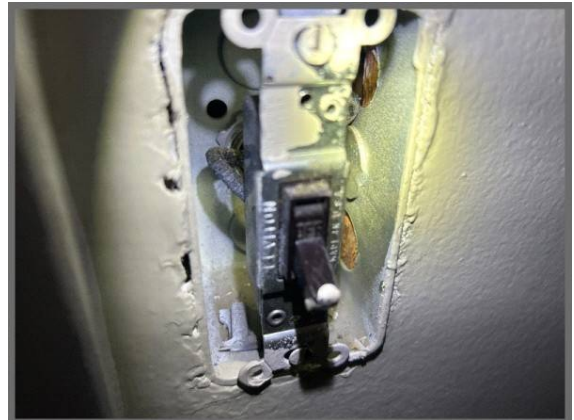
Cloth Wiring

The wiring is a combination of older, original cloth insulated copper wires and plastic insulated wires.

The cloth covering will continue to wear out and poses a significant increased risk of failure. This wire is considered to be past its expected working life. It is recommended that this wiring be fully evaluated by a qualified electrician to determine if it is time for replacement at this time or in the near future.

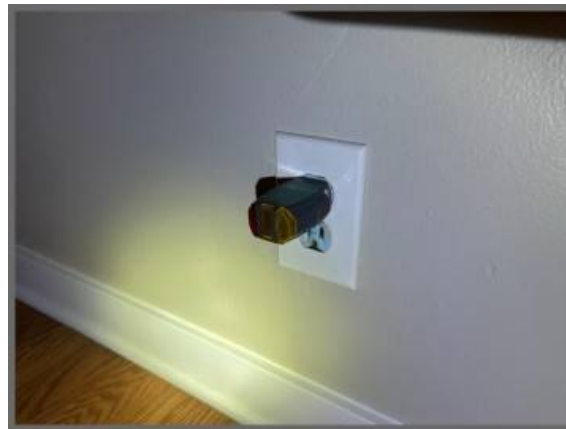
**NEEDS ATTENTION.** There are outlets that test as dead and not working such as in the dining room.

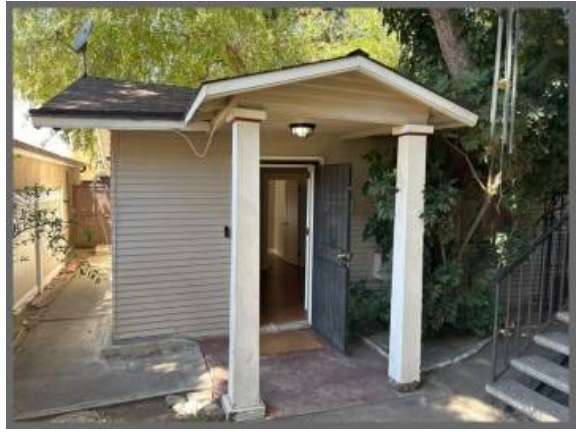
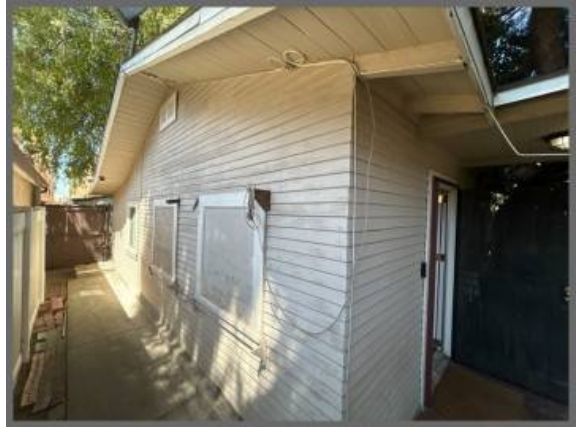
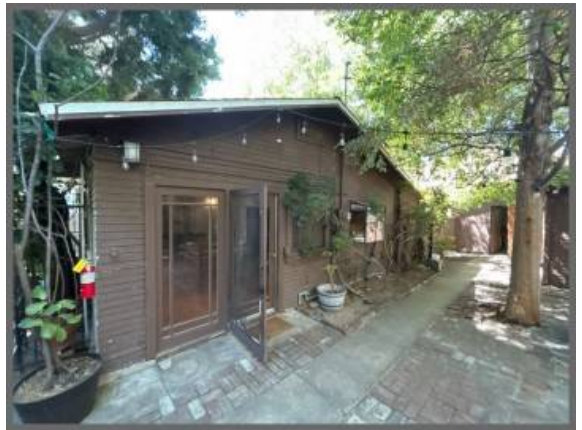
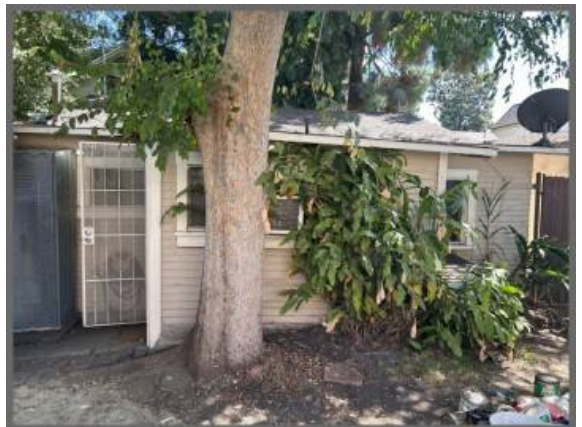
**NEEDS ATTENTION.** There are areas of gaps in the siding where rodents can enter.

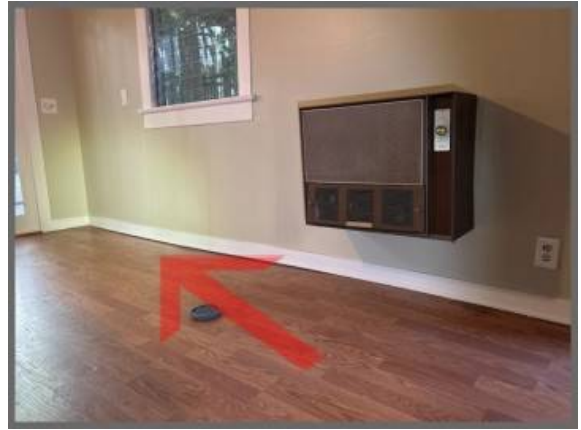
**NEEDS ATTENTION.** The floor is heavily sloping due to foundation settlement.

It is advised to consult with the qualified specialist for more information and further evaluation of this condition.

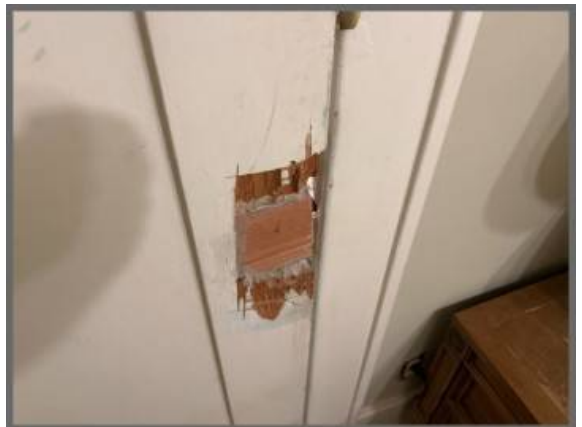
**NEEDS ATTENTION.** There are damaged doors, such as for the front bedroom.

Some windows are stuck or painted shut.

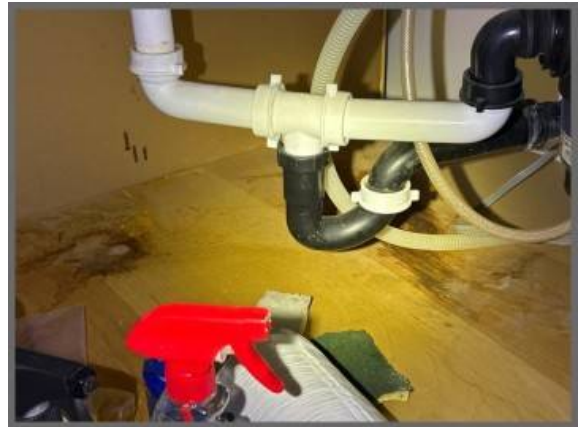
CABINETS: **NEEDS ATTENTION.** The shelf below the sink has moisture deterioration.

It is advised to consult with the qualified specialist for more information and further evaluation of this condition.

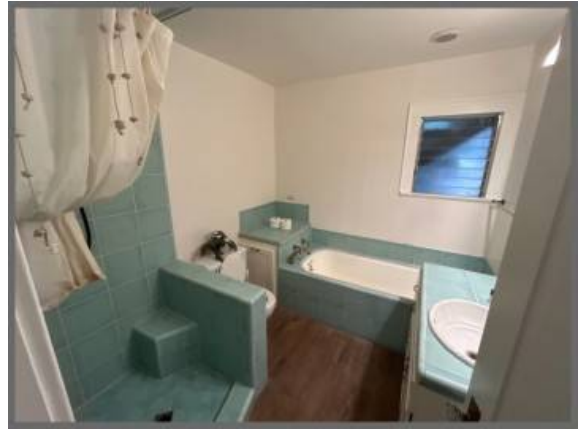
HEATER: **NEEDS ATTENTION.** The electric ceiling fan is inoperative.

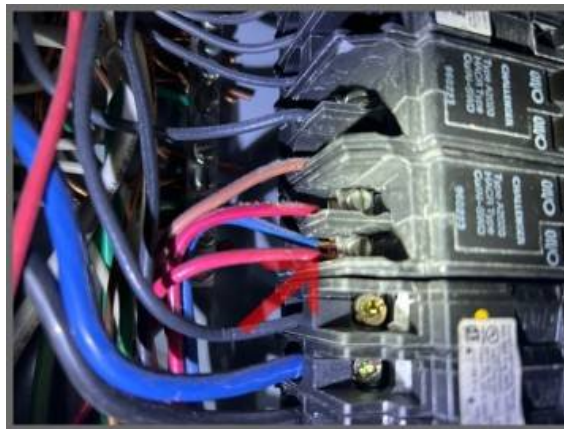
**SAFETY ALERT.** There are two wires connected to one breaker inside the electrical panel, this is an incorrect installation and may lead to arcing and other electrical issues.

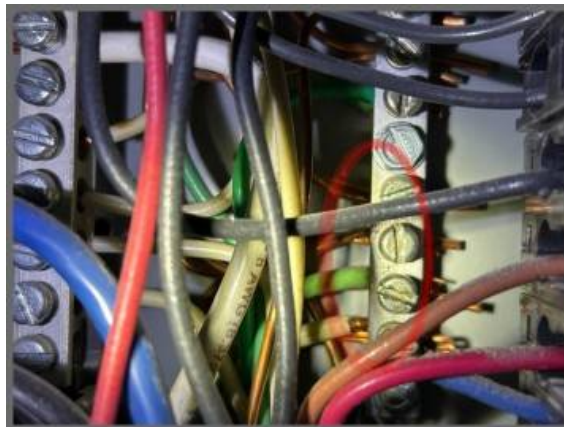
**SAFETY ALERT.** There are improper connections between the ground and neutral wires as they connect to the same terminal. Generally neutral wires and ground wires should have separate connections to prevent the ground wire from becoming charged.

It is advised to consult with the qualified specialist for more information and further evaluation of this condition.

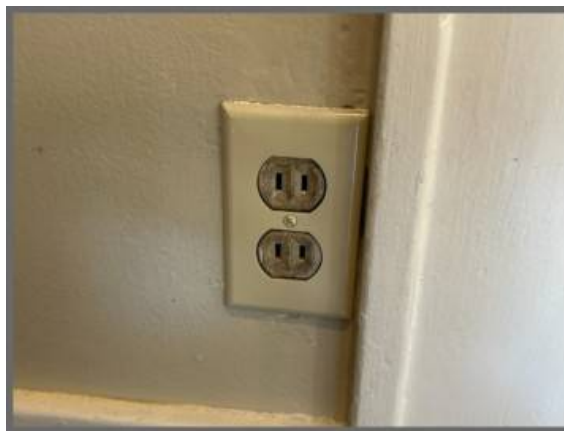
OUTLETS: **NEEDS ATTENTION.** The outlets are the two prong type, these are the older and ungrounded such as in the living room.

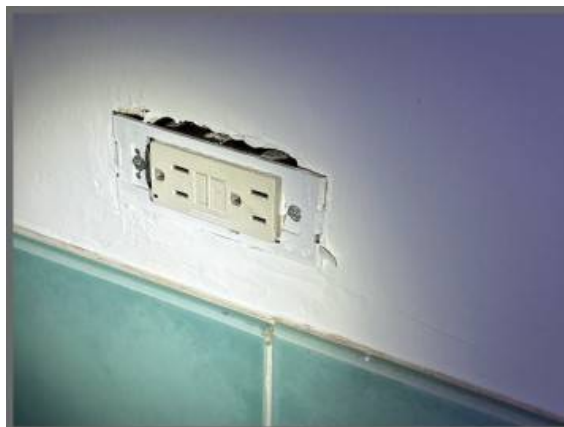
OUTLETS: **NOT ACCEPTABLE.** The GFCI safety outlet in the hallway bathroom did not operate correctly when tested, and will need replacement.

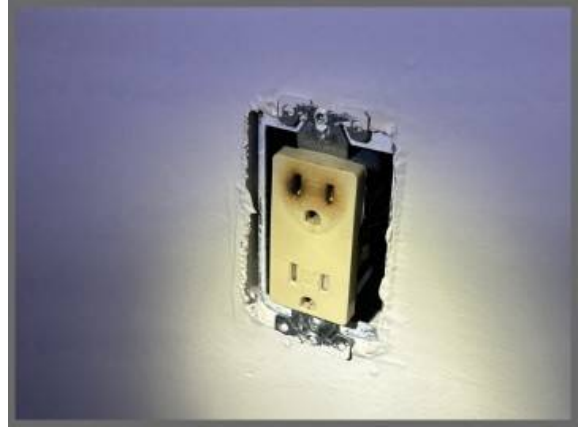
**SAFETY ALERT.** There are indications that the outlet in the dining room shorted out at one point in time as there are scorching marks present.

It is advised to consult with the qualified specialist for more information and further evaluation of this condition.

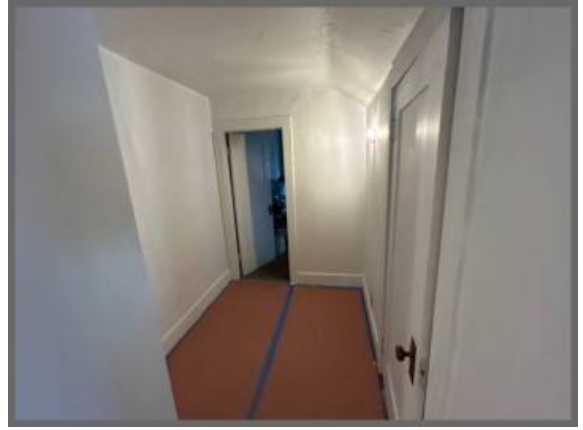
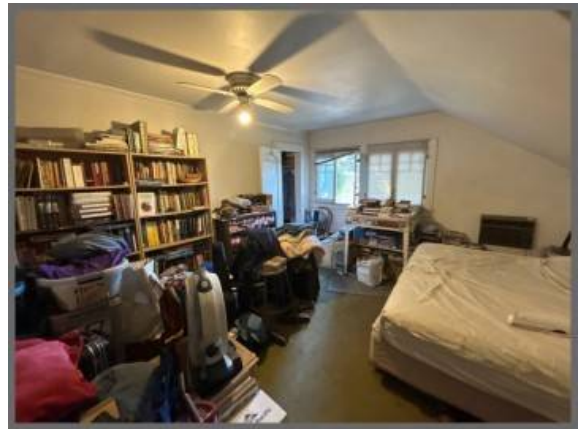
WALLS: **NEEDS ATTENTION.** There are stress cracks in some walls.

FLOORING: **NEEDS ATTENTION.** The carpet has areas of wear.

**NEEDS ATTENTION.** This unit is showing excessive wear and is in need of maintenance and repairs.

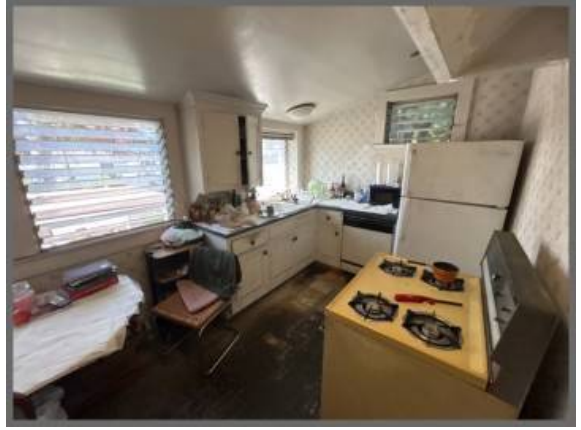
FLOORING: **NEEDS ATTENTION.** The flooring has areas of deterioration and damage.

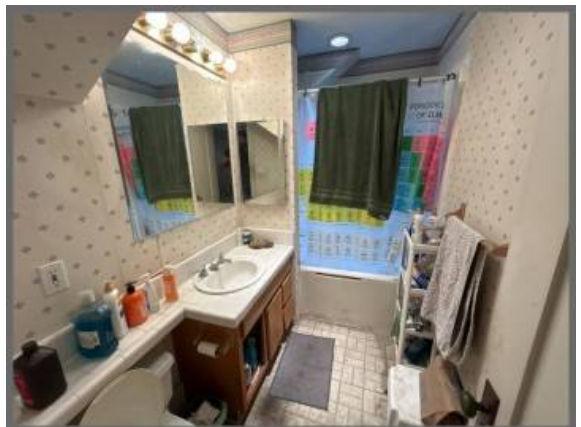
WALLS/CEILING: **NEEDS ATTENTION**. There are areas of wall damage at the sides of the tub.

It is advised to consult with the qualified specialist for more information and further evaluation of this condition.

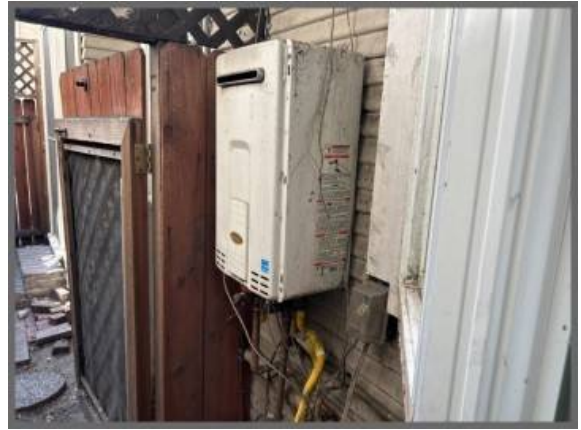
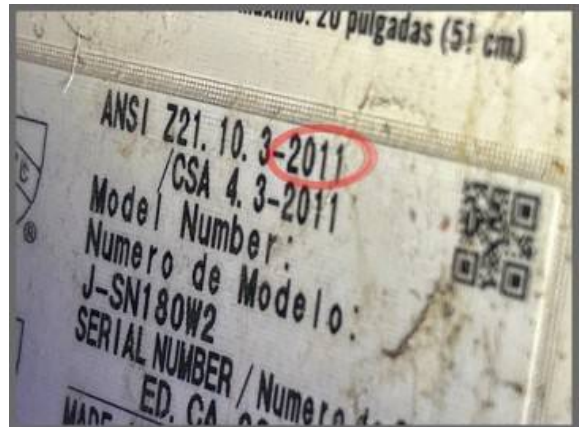
The water heater is located outside. It is a gas fired unit. This unit not only services the upstairs unit, but also the downstairs unit.

The unit is 15 years old.

**NEEDS ATTENTION.** Although functioning, the tankless water heater is older and nearing the end of its standard lifespan.

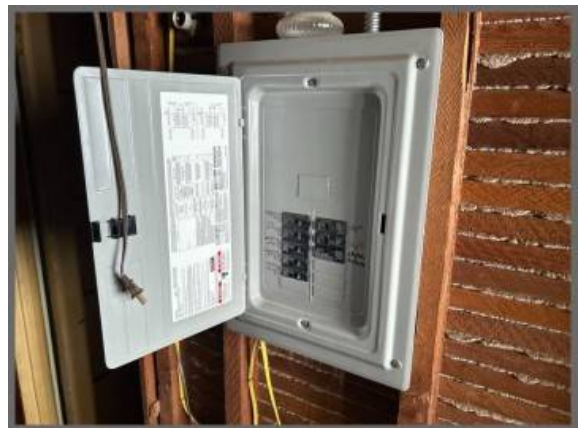
SUB PANEL: The sub panel is located in the attic.

**PRESENT.** Individual breakers are not tested for load capabilities and they are not tripped as part of this inspection.

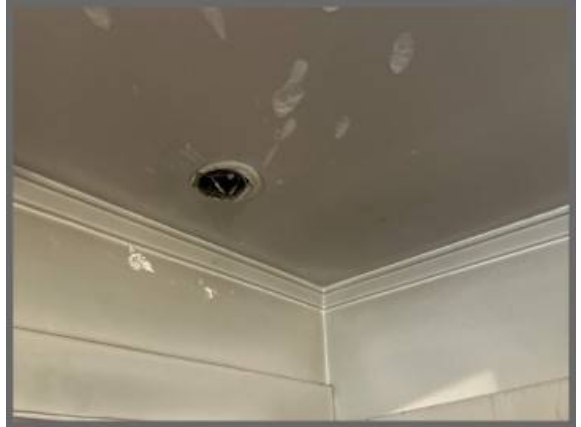
SMOKE ALARMS: **SAFETY ALERT.** There are missing smoke detectors with wires exposed.

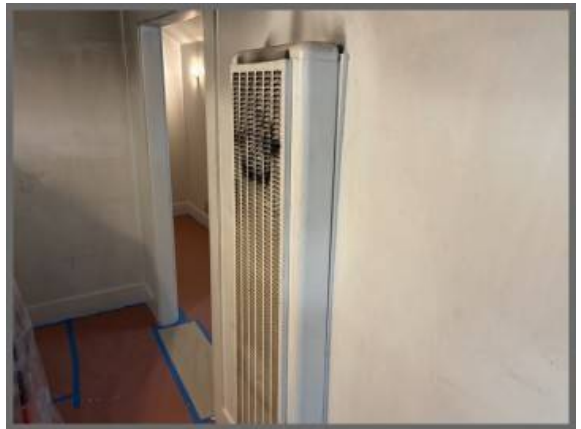
The heating system is a gas wall furnace. The furnace is located in the wall in the living room.

**NEEDS ATTENTION.** Although operable, furnace is very old, and appears to be very dirty as the front cover is discolored with ash.
