# *Inspection Reveal, LLC*

## Property Inspection Report

115 Tanglewood , Huntsville , Texas 77320

Date of Inspection: 5/21/2024 Time: 9:30am

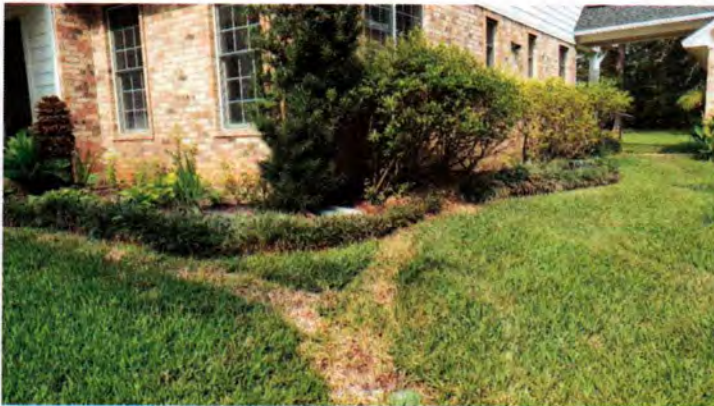
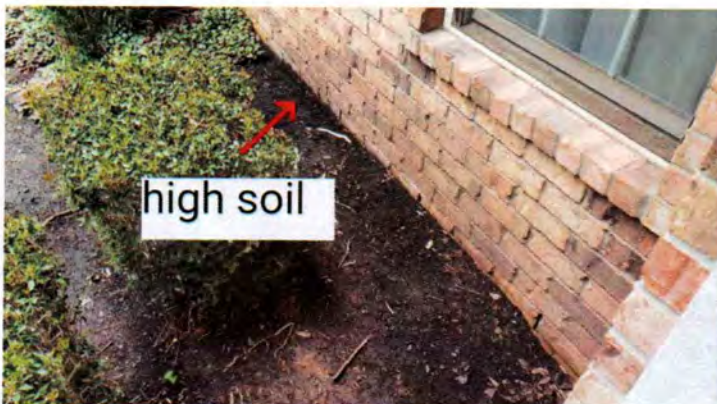
- Grading appeared to be performing as intended at the time of the inspection.
- A varmint hole was observed on the north side of the structure. Consideration should be given to having the varmint removed and backfilling the hole.
- High soil was observed around the structure in one or more locations. It is recommended that {4"} of foundation be visible below the bottom course of bricks. Grading improvements should be considered.

Varmint has been removed & hole has been filled

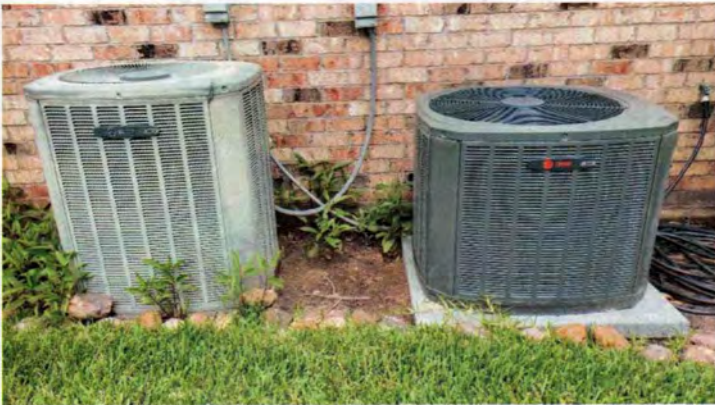
- The units appear to be functioning as intended at the time of the inspection and consistent with accepted industry standards.
- Insulation improvements are recommended on refrigerant lines near condensing unit.
- A safety / float switch was noted in primary drain pan for unit in upper attic space.
- Primary drain termination not determined at the time of the inspection.
- Insulation is recommended on the condensate drain line in lower attic space to prevent condensation drip.
- Some corrosion was observed on unit enclosure on evaporator unit in lower level of attic space.

Insulation has been  
added to the  
drain line

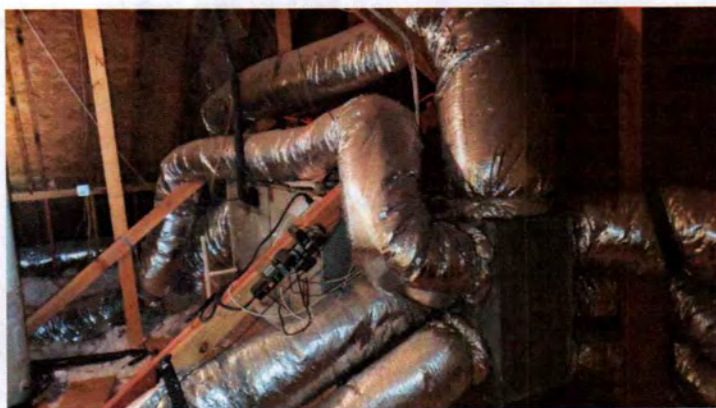
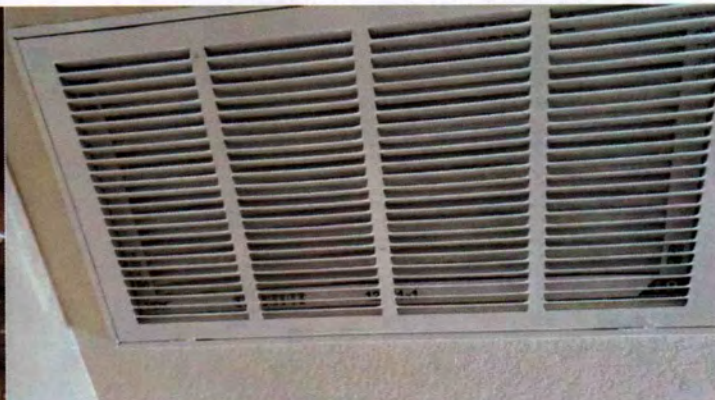
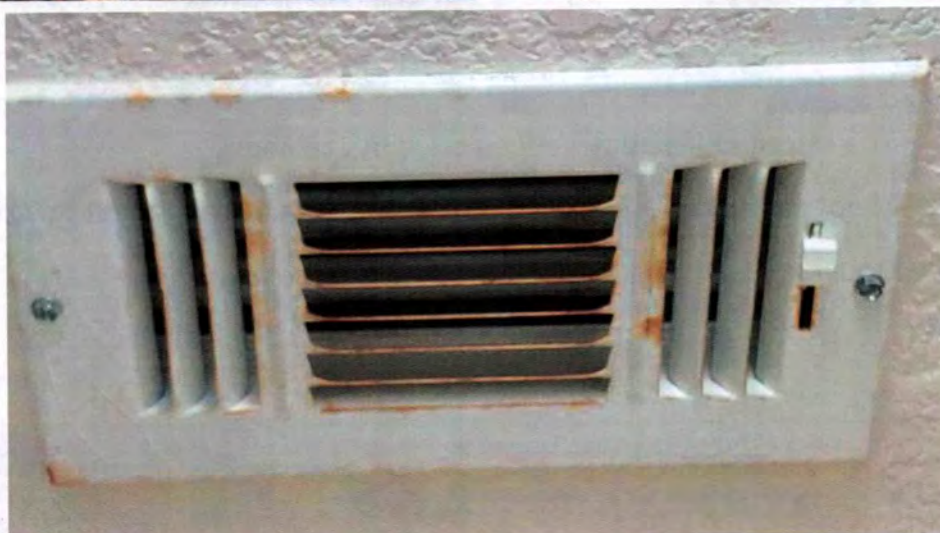
- The return air/filters were located in the ceilings.
- Flexible type ductwork noted.
- Minor corrosion/rust was observed on upstairs bathroom register. Consideration may be given to painting.
- Could not fully inspect ductwork due to accessibility.

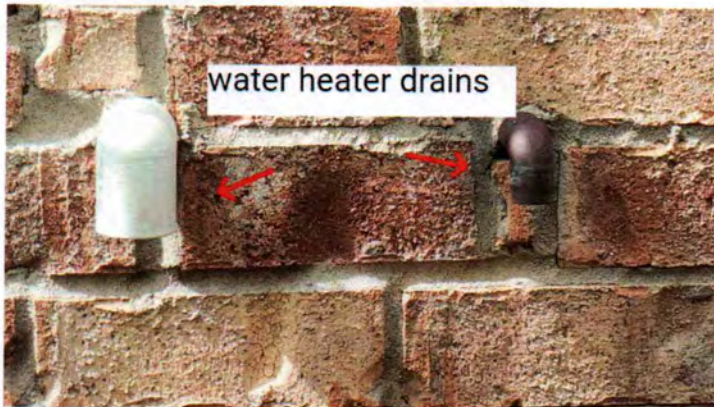
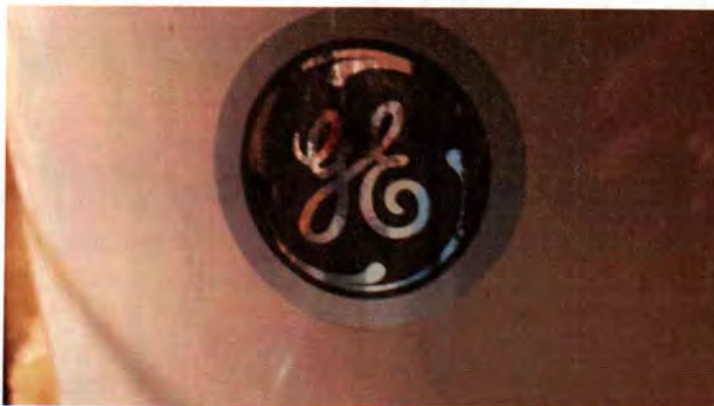
- The water heaters were performing as intended at the time of the inspection.
- The {220V} electrical connection is not properly installed. Recommend having a qualified contractor further evaluate and correct as needed.

Repaired

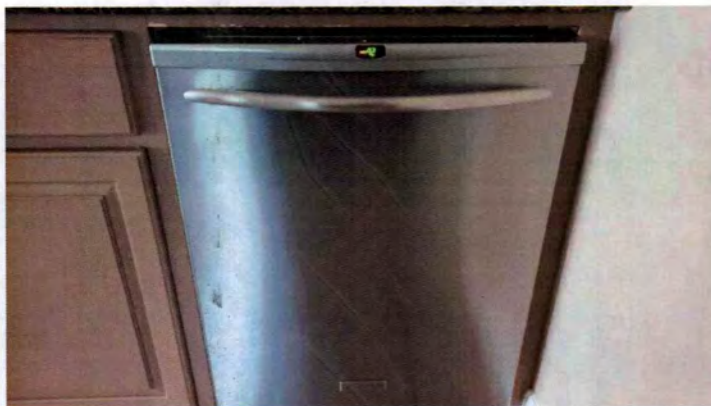
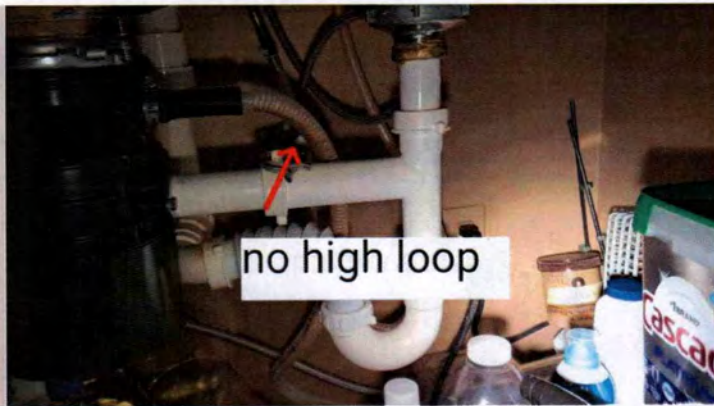
- Dishwasher was functional at the time of the inspection.
- Lack of a proper air gap noted at dishwasher drain line. In the event of a sewer backup this device prevents sewer matter from entering into dishwasher. Recommend having a qualified plumber install an air gap to prevent possible contamination.
- The soap dispenser door was observed to be loose. Consideration may be given to having a qualified technician further evaluate and correct as needed.

Repaired

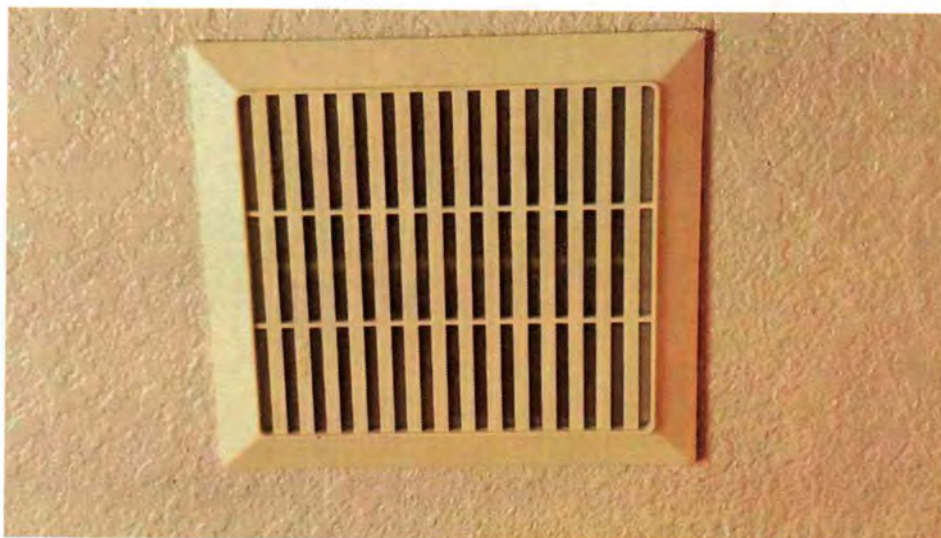
- The bath fans were functional at the time of the inspection.
- Termination of the exhaust fans were not determined at the time of the inspection.

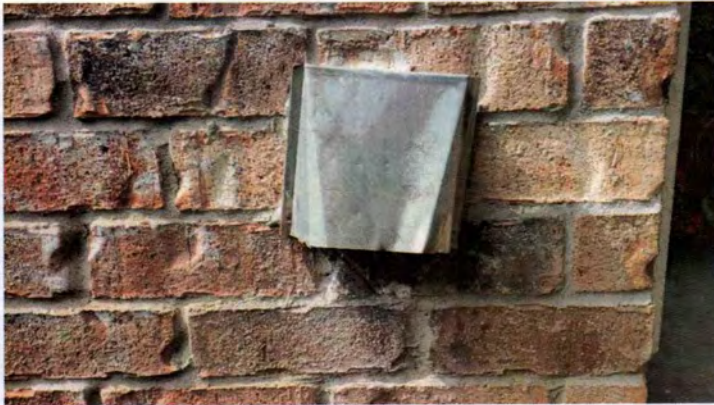
- Dryer vent appeared to be installed properly.
- Lint buildup was observed in the dryer vent and cleaning is recommended.

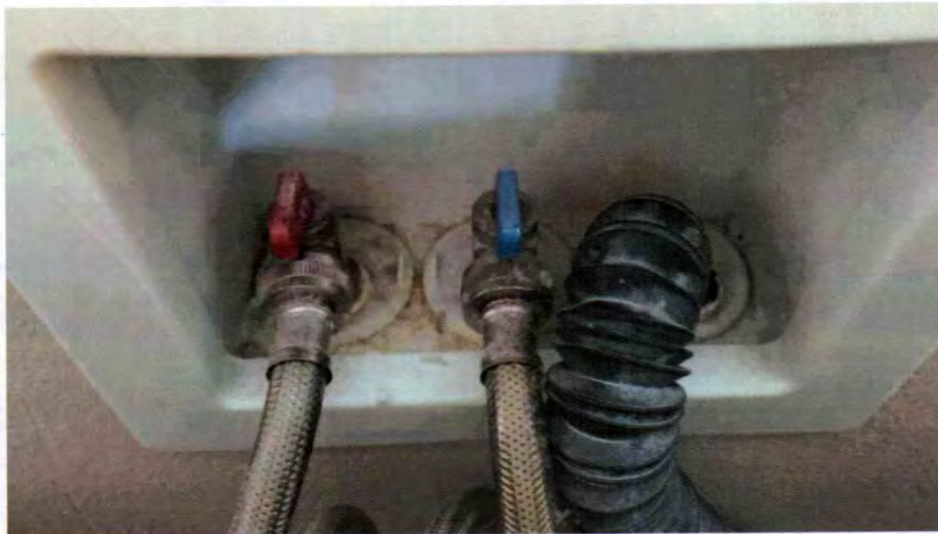
- Washing machine connections appeared to be installed properly.
- Limited view due to appliances.

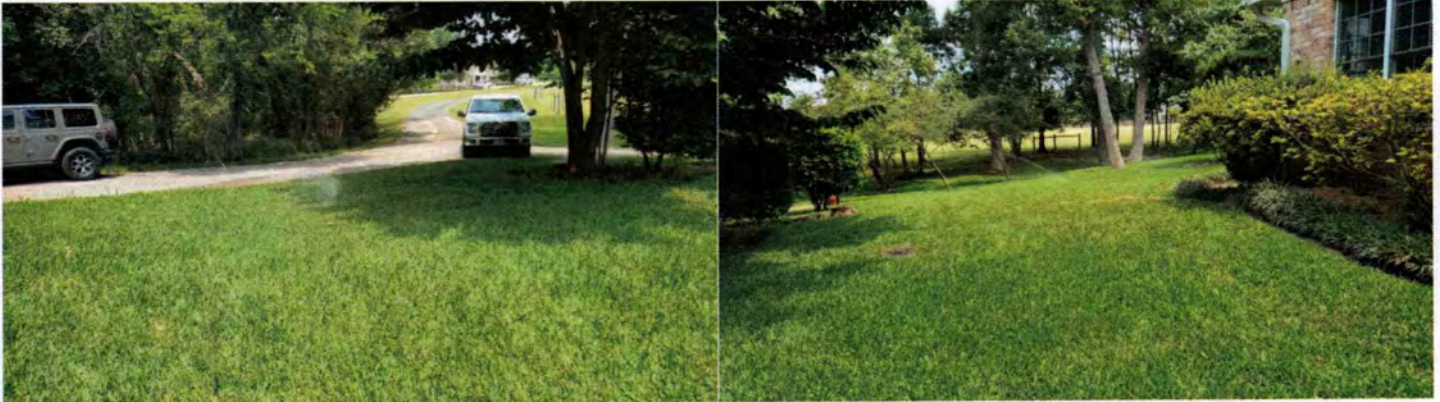
- Sprinkler system appeared to be performing as intended at the time of the inspection.
- Only one valve box was observed at the time of the inspection. Consideration may be given to having other valves located. It is recommended to keep valve boxes clean.
- A rain sensor was not observed at the time of the inspection and may be required. Consideration may be given to having a qualified irrigation contractor further evaluate.

Page 38 Item: A	Landscape Irrigation (Sprinkler) Systems	<ul style="list-style-type: none"><li>• A rain sensor was not observed at the time of the inspection and may be required. Consideration may be given to having a qualified irrigation contractor further evaluate.</li></ul>
Page 40 Item: E	Private Sewage Disposal Systems	<ul style="list-style-type: none"><li>• No high water float was observed. Recommend having a qualified contractor further evaluate and correct as needed.</li></ul>

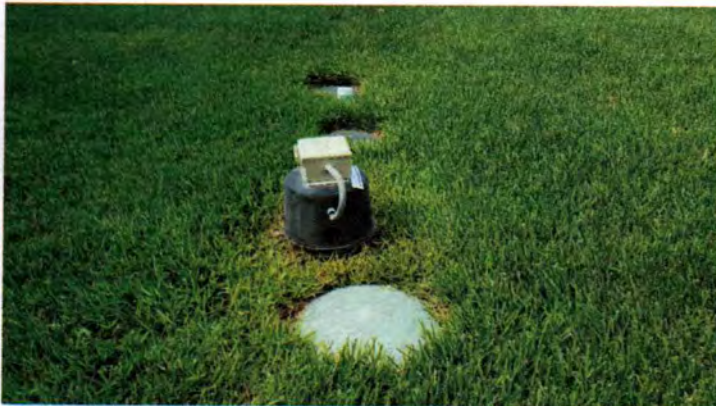
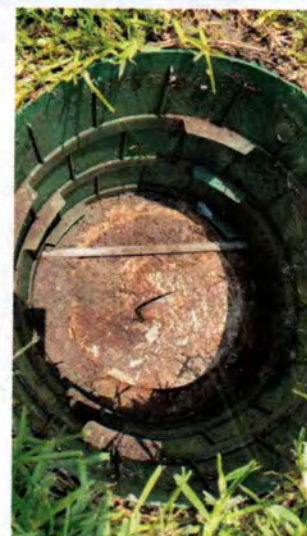
- The aerobic system appeared to be performing as intended at the time of the inspection.
- The chlorinator tube was noted as empty and may require chlorine tablets.
- **No high water float was observed. Recommend having a qualified contractor further evaluate and correct as needed.**

High water float is in place &amp; operational
