INSPECTION REPORT  
NON-INO

**PROPERTY ADDRESS:**  
84 School Street, Waldoboro, ME 04572

<b>Date:</b> 8/19/2024	<b>Time:</b> 09:00 AM	<b>Report ID:</b> 2024081902
<b>Property:</b> 84 School Street Waldoboro ME 04572	<b>Customer:</b> Alex Rowe	<b>Real Estate Professional:</b> Meriwether Gill Better Homes & Gardens Real Estate/The Masiello Group

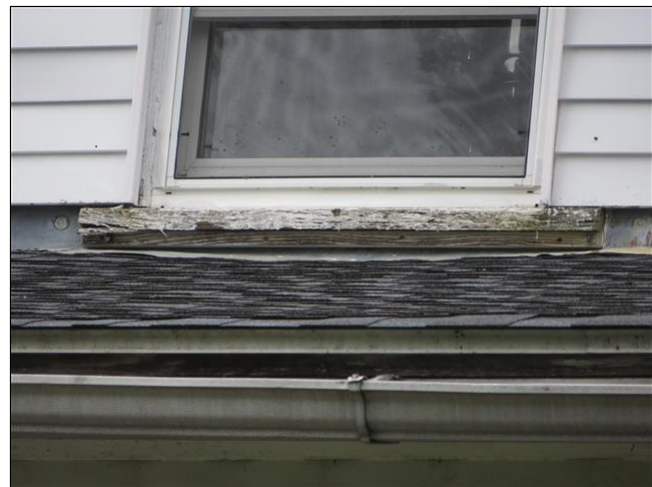
1.3 Item 2(Picture) Front

(2) A degree of decay and rot was noted with the front exterior window trim. While the issue did not appear significant at the time of the inspection, continued decay may lead to issues of water intrusion and damage to adjacent components. It is recommended that repairs be effected and that these components be monitored from time to time for further such issues in the future. (Note: The photos are not an exhaustive list of the affected areas, but a representation.)

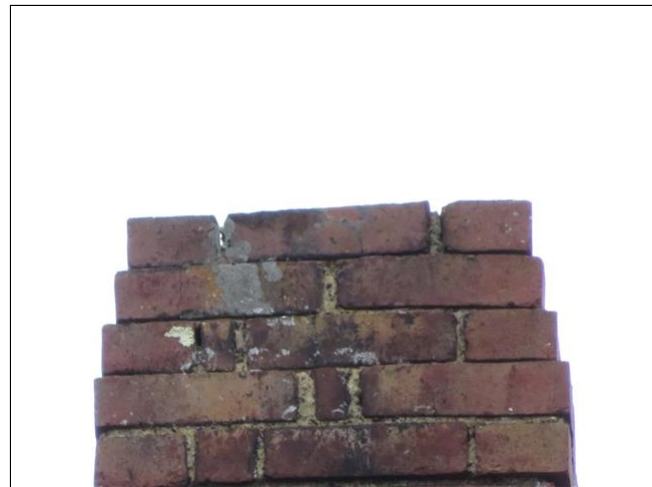
2.3 Item 11(Picture) Right side chimney

(3) It appeared that the chimney cap may be decayed or otherwise deficient. The chimney cap is an important component that helps prevent water (and snow/ice) from accumulating on top of the chimney. Moisture that accumulates on top of the chimney in the winter time can freeze and further damage the chimney materials. In the warmer months, the moisture can seep into the mortar and brick and degrade the structure. It is recommended that repairs be considered.

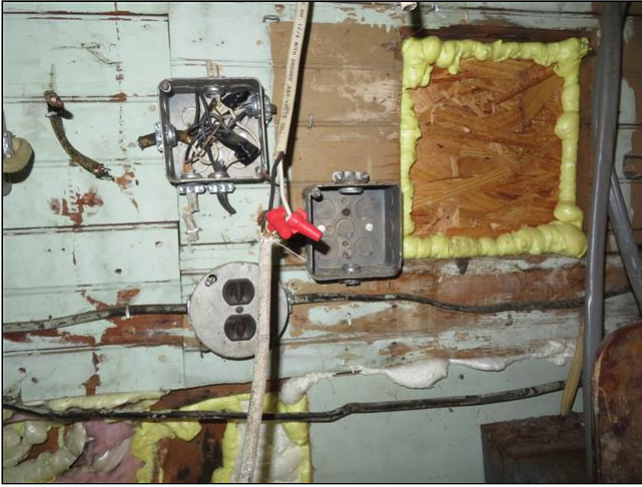
7.3 Item 1(Picture) Attached garage

(1) Improper electrical connections were observed in the attached garage. All electrical connections and splices should be in electrical boxes or done through other approved means. Improper electrical connections can present a risk of personal injury or electrical fire. It is advisable that repairs be effected.

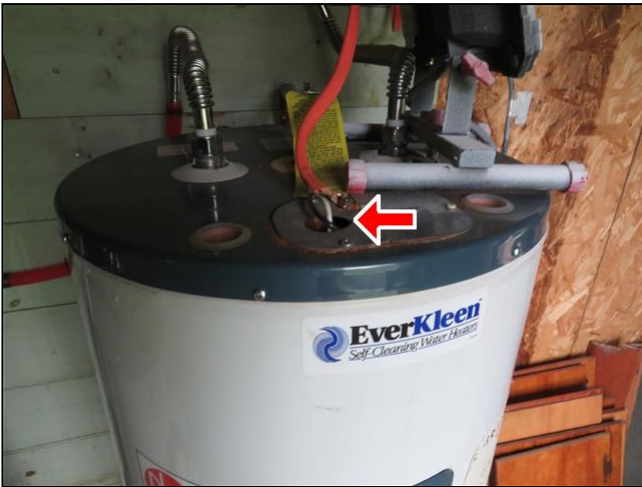
7.3 Item 2(Picture) Utility room

(2) Improper electrical connections were observed in the utility room. All electrical connections and splices should be in electrical boxes or done through other approved means. Improper electrical connections can present a risk of personal injury or electrical fire. It is advisable that repairs be effected.

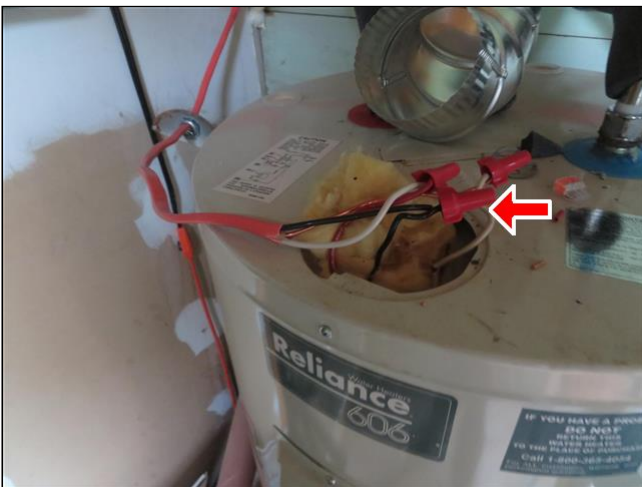
7.3 Item 3(Picture) Utility room

(3) Improper electrical connections were observed in the utility room. All electrical connections and splices should be in electrical boxes or done through other approved means. Improper electrical connections can present a risk of personal injury or electrical fire. It is advisable that repairs be effected.

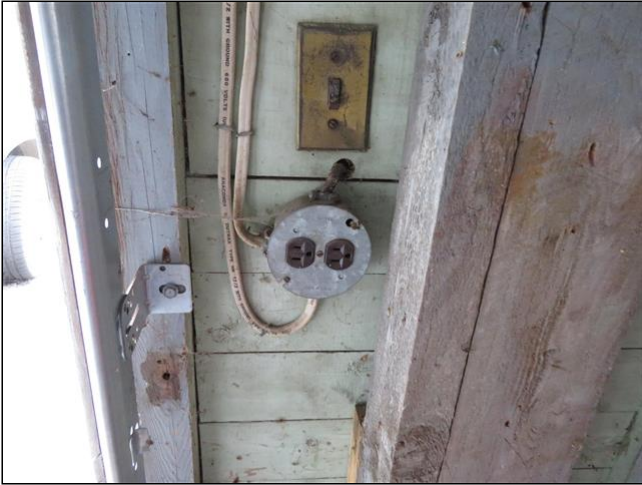
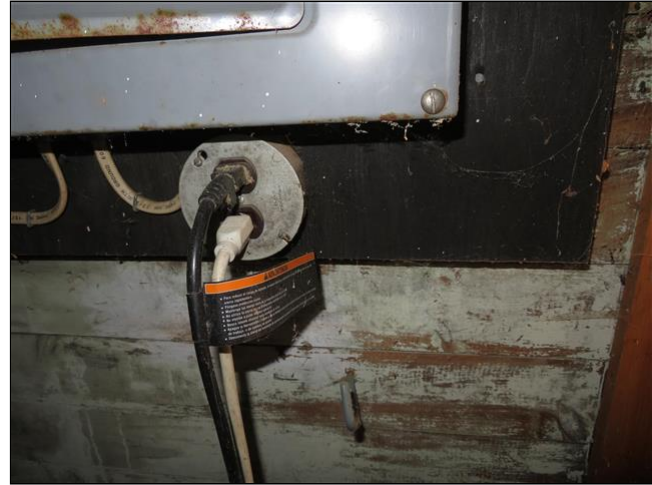
(1) The receptacles noted in the garage were not GFCI (Ground Fault Circuit Interruption) protected. Receptacles in wet areas (such as kitchens, bathrooms, garages, outside, and unfinished basements) can pose shock hazards if they are not on GFCI-protected circuits. Specifically, the requirement from the standard reads: *"Garages, and also accessory buildings that have a floor located at or below grade level not intended as habitable rooms and limited to storage areas, work areas, and areas of similar use"*. It is advisable that repairs or modifications be made by installing GFCI protection to these receptacles (and all other required receptacles).

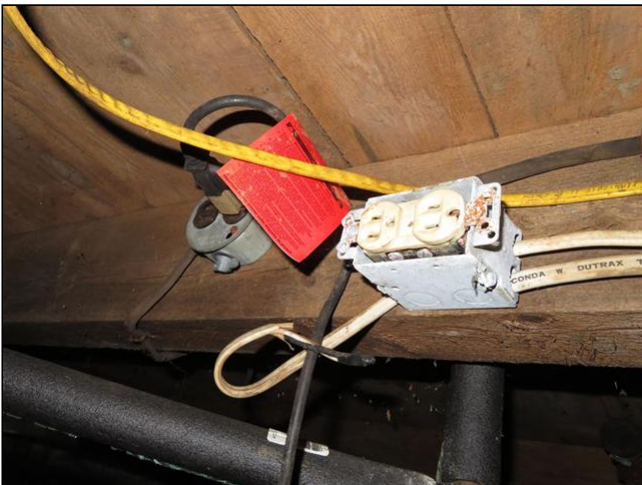
7.4 Item 3(Picture) Crawlspace

(2) The receptacles noted in the unfinished basement/crawlspace were not GFCI (Ground Fault Circuit Interruption) protected. Receptacles in wet areas (such as kitchens, bathrooms, garages, outside, and unfinished basements) can pose shock hazards if they are not on GFCI-protected circuits. Specifically, the requirement from the standard reads: *"Unfinished basements — for purposes of this section, unfinished basements are defined as portions or areas of the basement not intended as habitable rooms and limited to storage areas, work areas, and the like"*. It is advisable that repairs or modifications be made by installing GFCI protection to these receptacles.

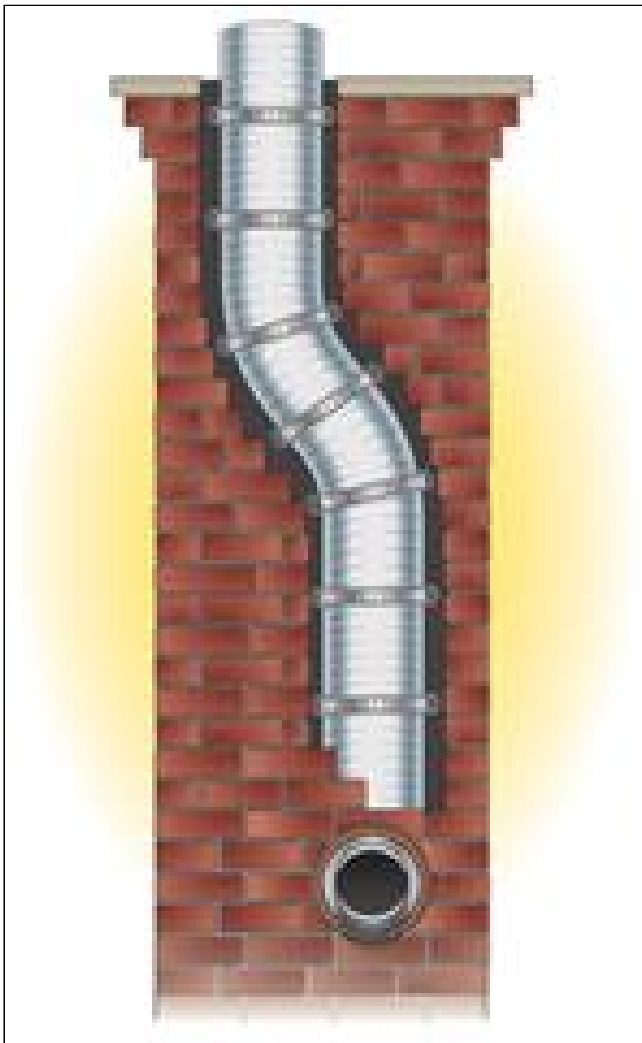
8.0 Item 1(Picture) Illustration

1. The flue gasses from combustion can be acidic and can prematurely decay the exposed brick surface.
2. The hot flue gasses can condense when they come in contact with a part of the chimney that is cold (attic or outside) and condense cause acidic liquid to run down the inside of the chimney.
3. It is possible that over time (due to age) and due to the exposure to corrosive gases and liquids that chimney will develop small cracks and defects and allow flue gasses to enter the home, becoming a health hazard.

Another consideration is NFPA 211, which is a set of standards which the State has adopted as a rules (laws). Section 7.2.2.1 states "Masonry chimneys shall be lined."

It is recommended that the issue be further assessed and required repairs effected. Further, the authority having jurisdiction should be contacted for any additional information.

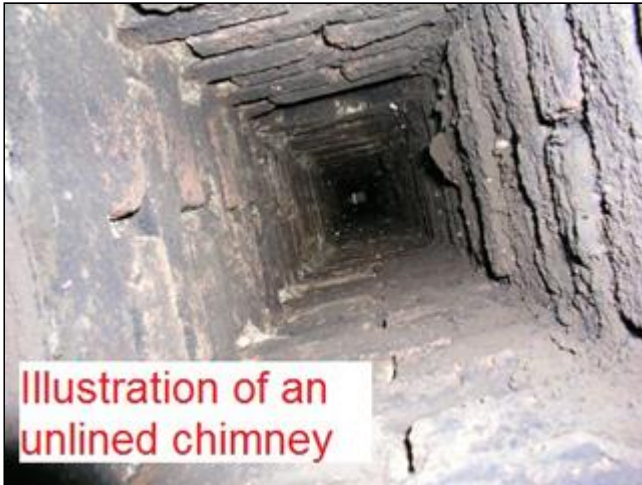
#### 8.0 Item 3(Picture) Illustration

Illustration of an unlined chimney

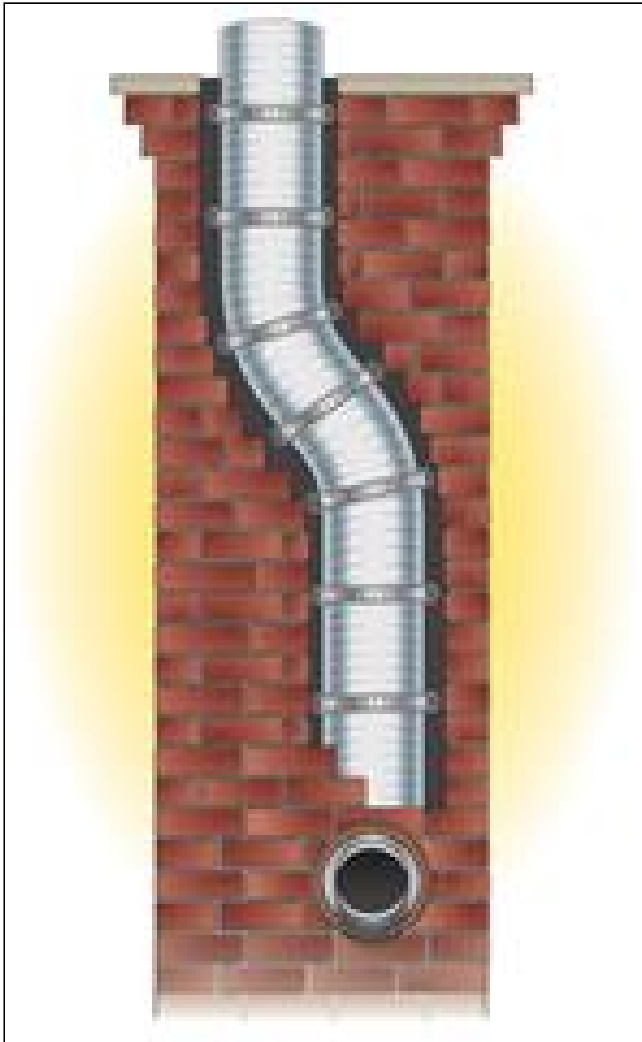
8.0 Item 4(Picture) Illustration

1. The flue gasses from combustion can be acidic and can prematurely decay the exposed brick surface.
2. The hot flue gasses can condense when they come in contact with a part of the chimney that is cold (attic or outside) and condense cause acidic liquid to run down the inside of the chimney.
3. It is possible that over time (due to age) and due to the exposure to corrosive gases and liquids that chimney will develop small cracks and defects and allow flue gasses to enter the home, becoming a health hazard.

Another consideration is NFPA 211, which is a set of standards which the State has adopted as a rules (laws). Section 7.2.2.1 states "Masonry chimneys shall be lined."

It is recommended that the issue be further assessed and required repairs effected. Further, the authority having jurisdiction should be contacted for any additional information.

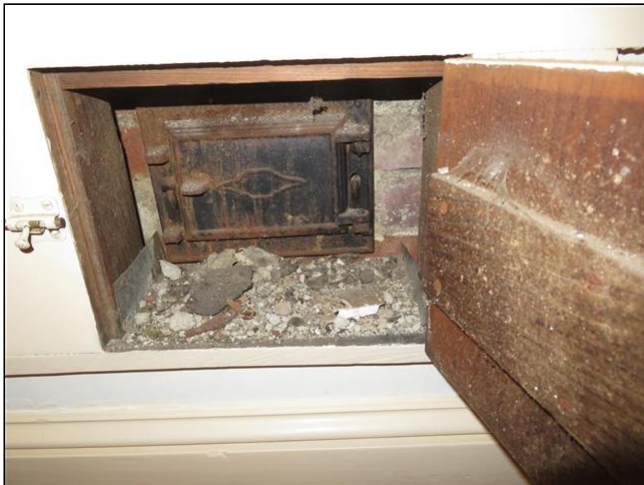
8.0 Item 7(Picture) Right side chimney

(3) The cover for the flue cleanout was not operable, and the flue was not accessible for inspection. It is recommended that repairs be effected and the flue inspected.

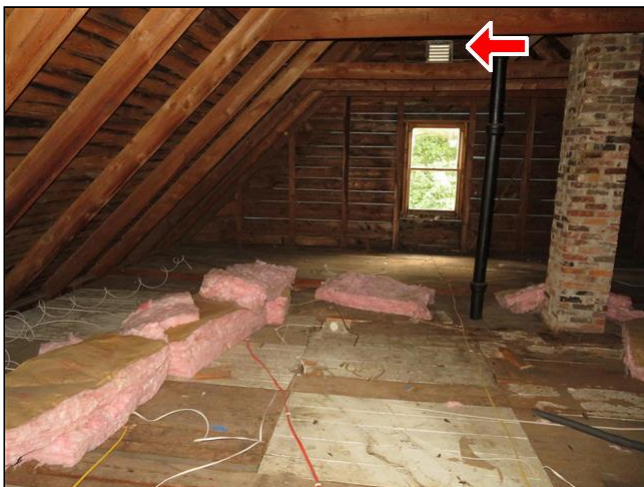
9.3 Item 1(Picture) Attic

Roof and attic ventilation is accomplished by means of a single gable vent. This approach would generally be regarded as insufficient to allow adequate air flow. It is recommended that a second gable vent be added.
