PHASE I
ENVIRONMENTAL
SITE ASSESSMENT

64 Union Way
Vacaville
California

May 21, 2019
19-ENV5425

Subject: Phase I Environmental Site Assessment Report
64 Union Way
Vacaville, California 95687

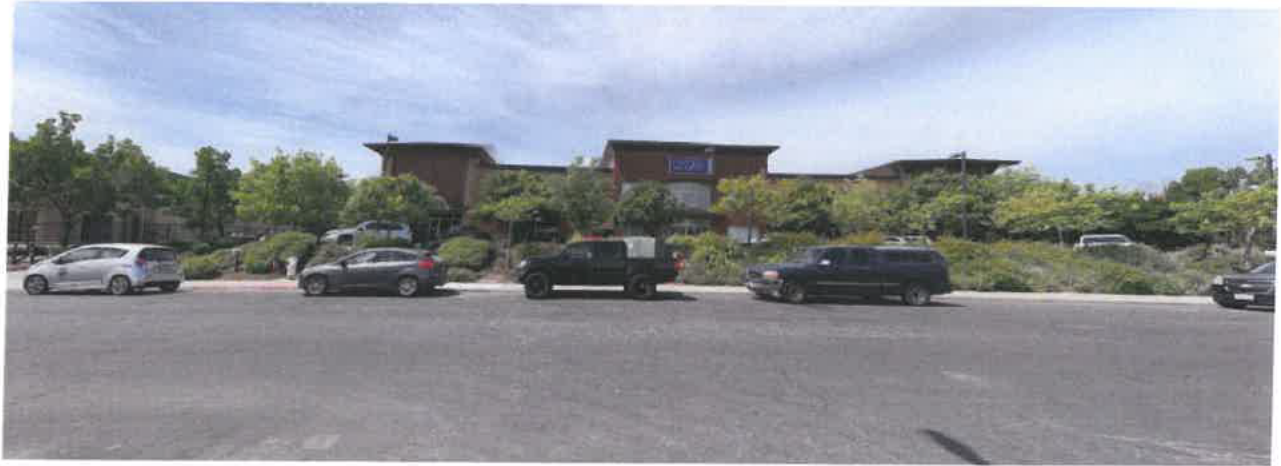
Two-Story Light Industrial Building (circa 2010) - The two-story light industrial building is located within the center of the subject site (See Photos 1 – 4). The main entrance is located along the northeast side of the building. Several roll-up doors provide access to the warehouse area from the southwest side of the building. Discussions with Mr. Kurt Bringolf, co-owner of the subject site and employee of Oxford Instruments, indicated that Eclipse Medical Imaging was the original tenant of the subject site and they were joined with Platinum Medical Imaging before being bought by Oxford Instruments around 2011. All three businesses conducted the same activities on the subject site- refurbishment of CT equipment.

Photo 1: Subject Site (Facing Southwest)
Two-Story Light Industrial Building and Associated Paved Areas
Along the Southwest Side of Union Way

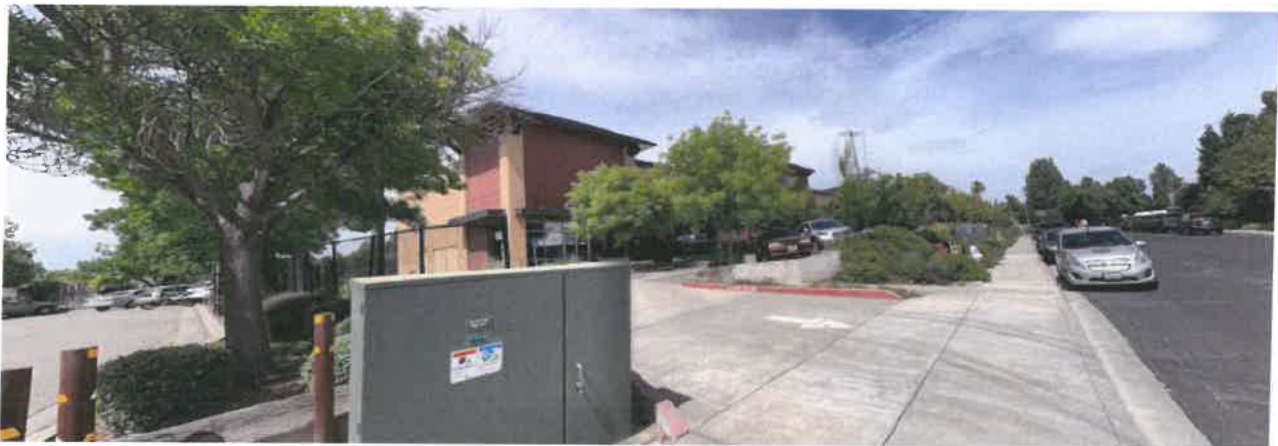
Photo 2: Subject Site (Facing West)
Two-Story Light Industrial Building and Associated Paved Areas
Along the Southwest Side of Union Way

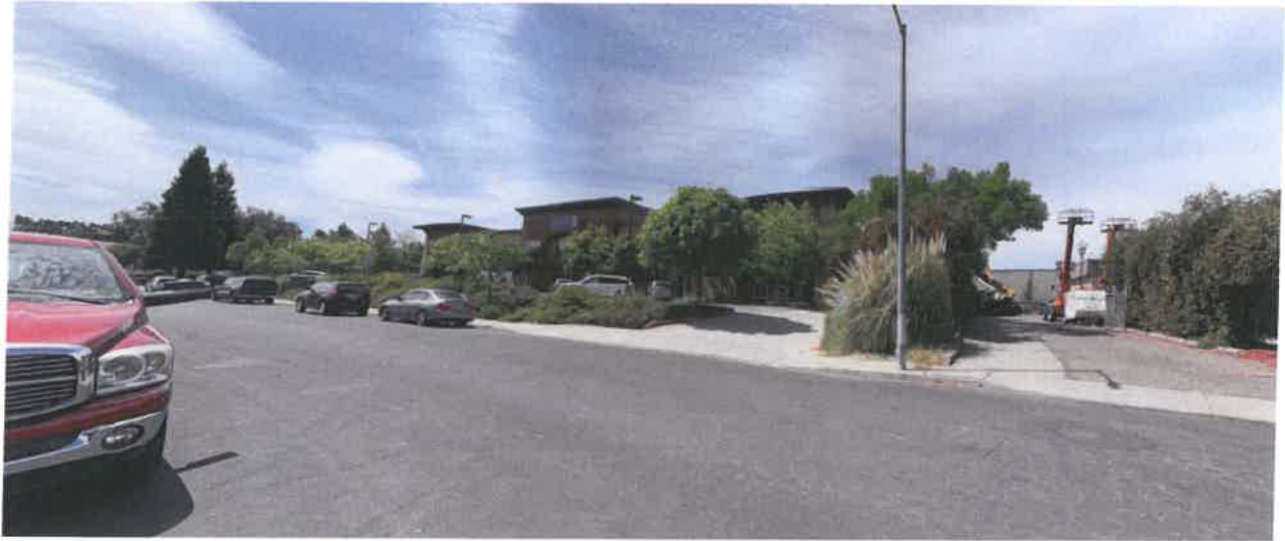
Photo 3: Subject Site (Facing South)
Two-Story Light Industrial Building and Associated Paved Areas
Along the Southwest Side of Union Way

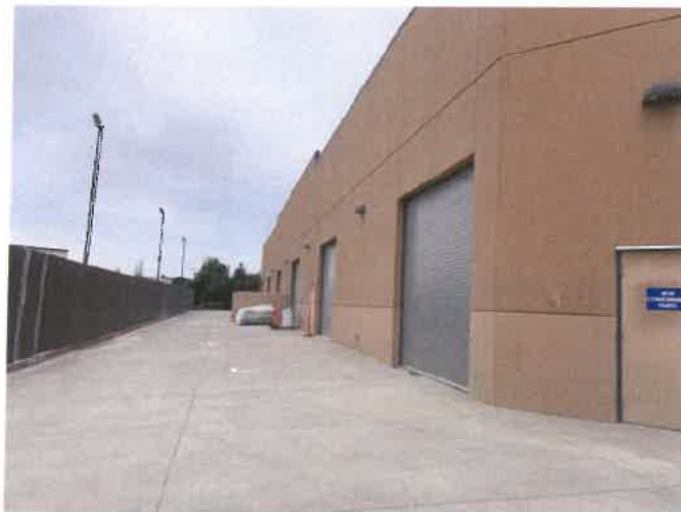
Photo 4: Subject Site (Facing Northwest)
Two-Story Light Industrial Building and Associated Paved Areas
Along the Southwest Side of Union Way

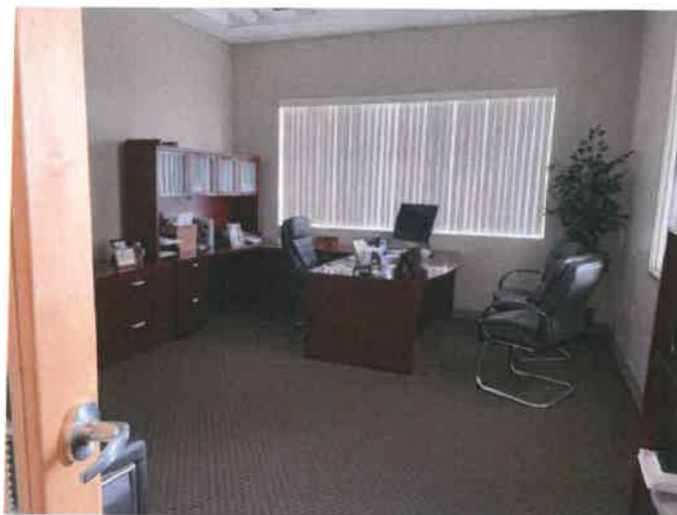
Photo 6: Subject Site (Facing Northeast)
First Floor/Second Floor
Representative Office

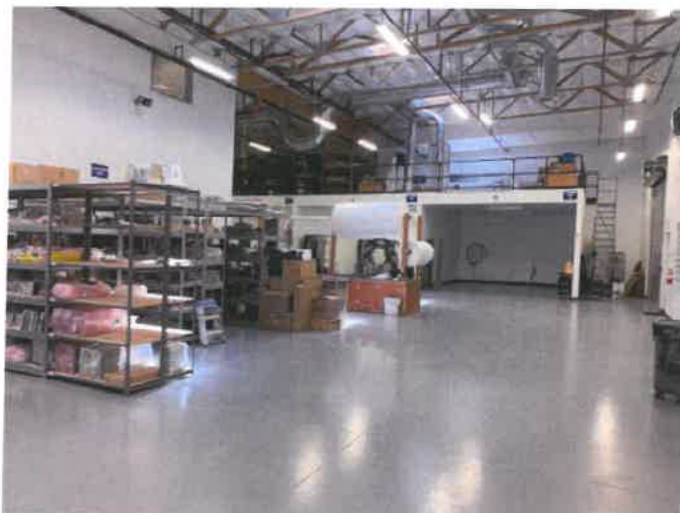
Photo 8: Subject Site (Facing Southeast)
First Floor
Warehouse Area

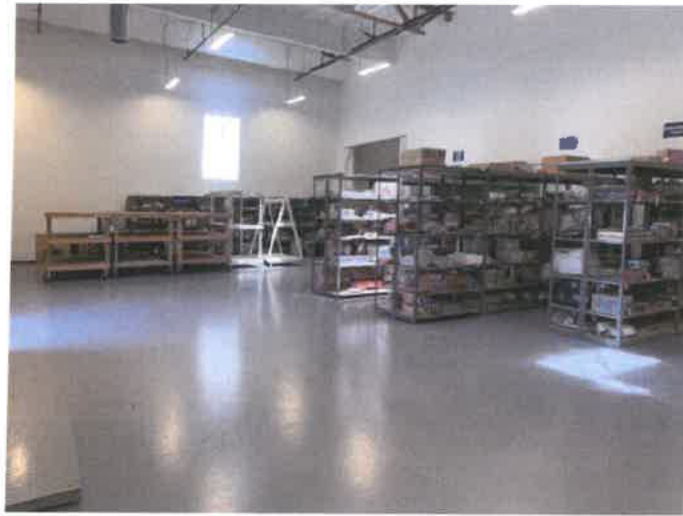
Photo 9: Subject Site (Facing Northwest)
First Floor
Warehouse Area

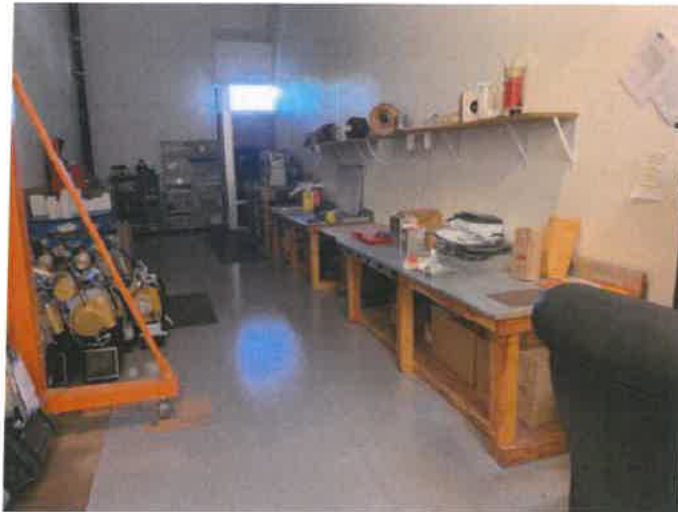
Photo 19: Subject Site (Facing Northeast)
First Floor
Warehouse Area

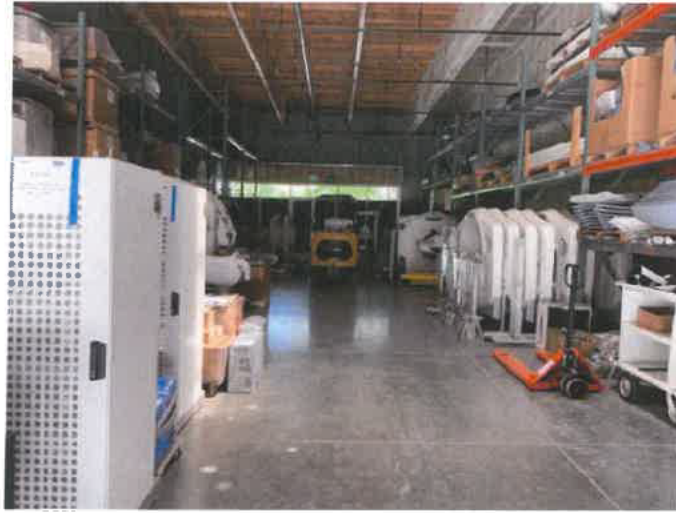
Two Storage Areas – The two storage areas occupy the northwest and southeast ends of the subject site building. Located within the northwest storage area are various shelving units of CT parts and tools (See Photo 21). A propane powered forklift is located in the area. A second approximately 35-gallon propane tank is stored in the area. Discussions with Mr. Neufeld indicated that the second propane tank is typically used on the second forklift (stored in the other storage area), but it is currently stored here since the second forklift is not currently being used. What appears to be a sewer cleanout is located in the south corner. Visual observations of the northwest storage area did not reveal appreciable amounts of hazardous materials, stains or spills. Visual observations of the concrete floor within the northwest storage area did not reveal any obvious evidence of drains, sumps, cracks or other conduits to the subsurface.

Photo 21: Subject Site (Facing Northeast)
First Floor
Northwest Storage Area
