The Nanni Corporation DBA
National Property Inspections

AMI INC, 6678 River Road, Fuquay Varina, NC, 27526

Wednesday, December 13, 2023

Property Location : **6678 RIVER ROAD
FUQUAY VARINA NC 27526**

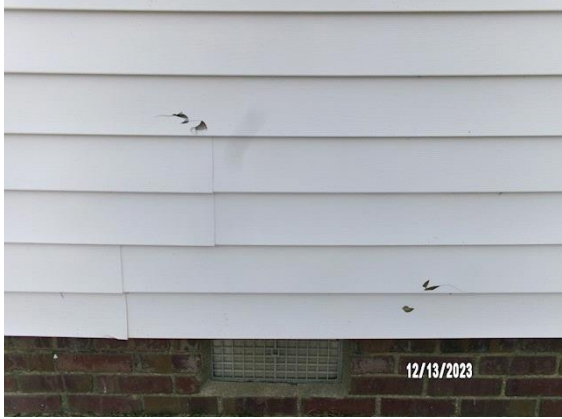
EXTERIOR SURFACE: holes in siding

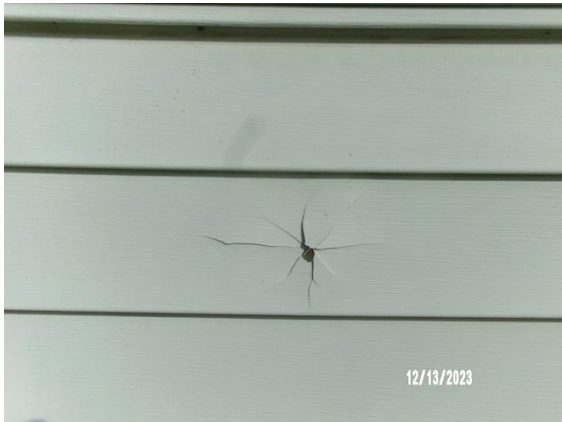
EXTERIOR SURFACE: hole in siding

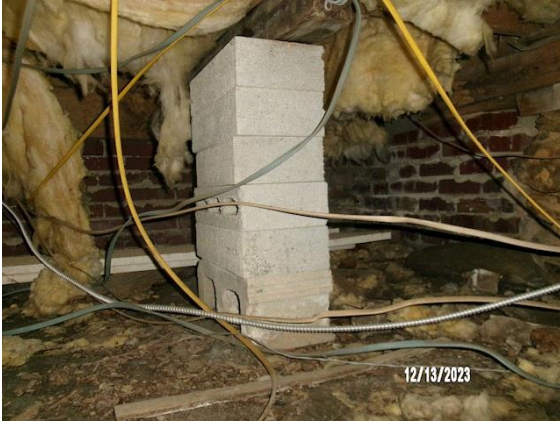
STRUCTURAL FRAME AND BUILDING ENVELOPE:
typical dry-stacked block pier

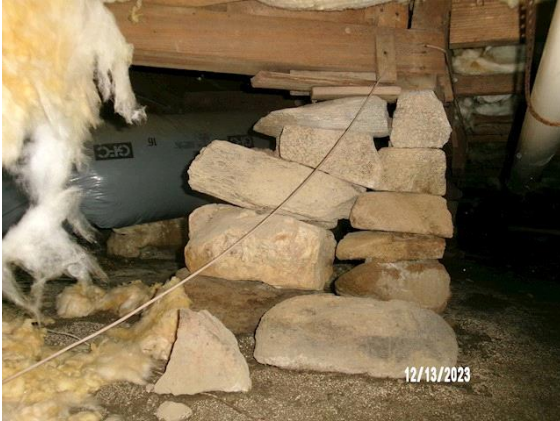
STRUCTURAL FRAME AND BUILDING ENVELOPE:
typical stacked stone pier

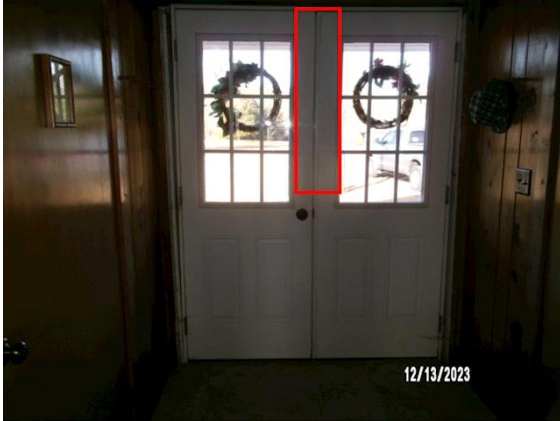
1. The French doors do not make a complete seal along the weather stripping / door stop of the astragal or along the bottom of the door at the threshold. Door separates conditioned and unconditioned air spaces and should make a complete and tight seal to prevent the transfer of air between the exterior and interior of the home.

Doors - East Wing: doors do not seal along astragal

Repair by a qualified contractor is needed.

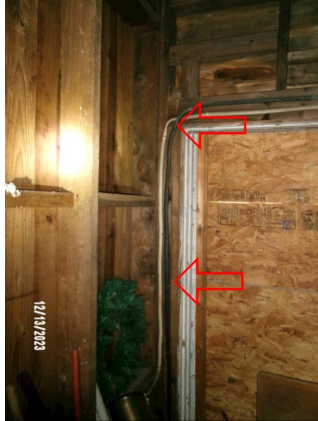
WDI activity in furnace closet
