#4 (RIGHT BUILDING)

835 Minnie St
Jacksonville, FL 32204

NOVEMBER 7, 2024

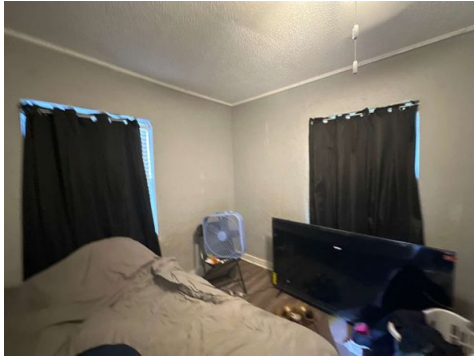
823

5.5.1 Windows

Contact a qualified window repair/installation contractor.

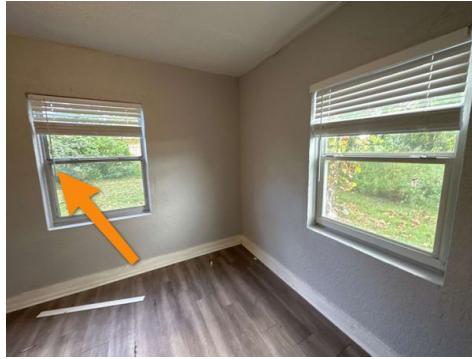
821

5.5.2 Windows

Moderate

Contact a qualified professional.

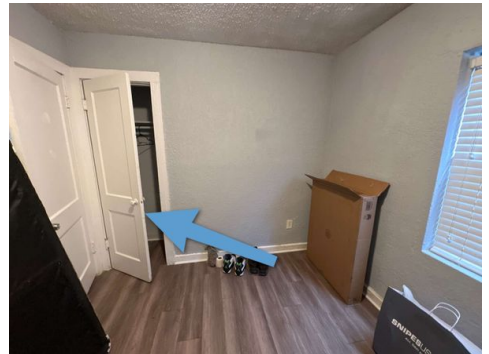
823

5.6.1 Interior Doors

Contact a qualified handyman.

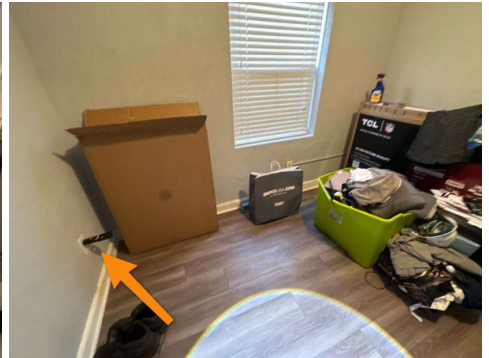
823

6.11.2 Electrical Outlets

The electrical outlets shows reverse polarity in unit 823s bedroom (pictured below). The hot and neutral appeared reversed according to the receptacle tester. Improper wiring can cause a potential electrical shock hazard in rare occurrences, but is typically a easy repair. Recommend further evaluation and repair by a qualified electrical contractor.

Contact a qualified electrical contractor.

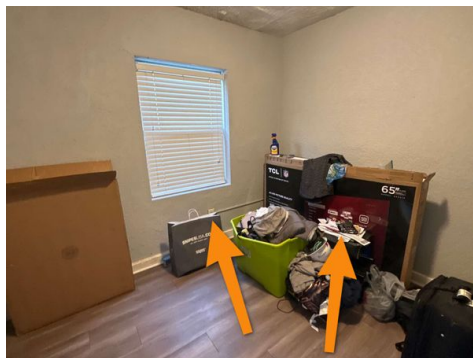
823

6.11.3 Electrical Outlets

Some of the outlets are 2 prong receptacles. This type of outlets do not have a ground, which can be common for older homes (lack of grounds in the wiring). Recommend upgrading for safety.

Contact a qualified electrical contractor.

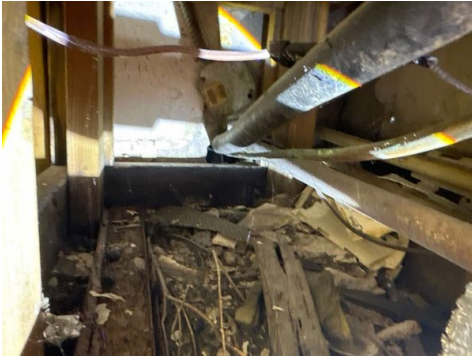
LEAKING AIR AT AIR HANDLER UNIT

The air handler unit is leaking conditioned air at the supply duct connections at unit 823s air handler. The foil tape has failed. Recommend re-sealing the supply ducting to reduce energy loss and potential condensation concerns (a common cause for mold evaluation). There is also no overflow safety switch or drain pan at the air handler and signs of previous leaks. Recommend further evaluation, servicing and repair as needed.

Contact a qualified professional.

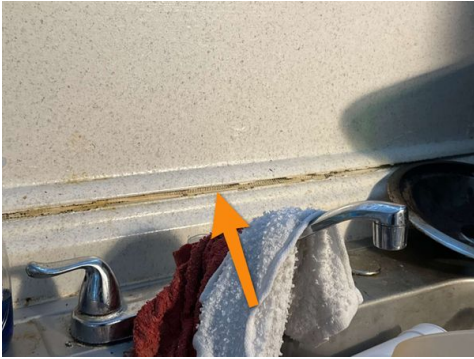
Unit 823s kitchen counter sunk downwards, so needs more support, so the counter is level as intended. There is also fungi growth at the cabinet shelving under the sink due to the leak. Recommend repair as needed and removing or repairing the fungi growth.

Contact a qualified professional.

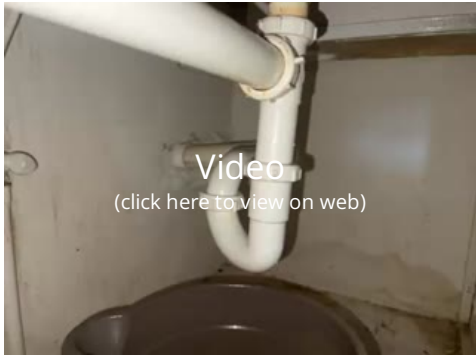
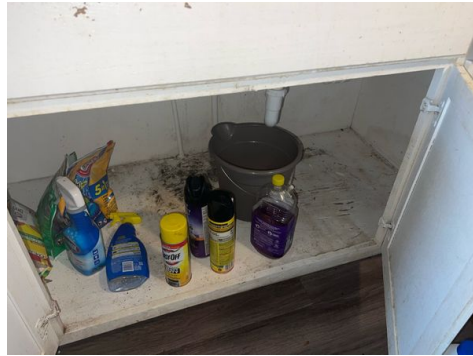
8.4.1 Undersink Plumbing - Kitchen

LEAK PRESENT UNDER KITCHEN SINK

A leak was present under the kitchen sink in unit 823. Repairs are recommended to be conducted as needed by a licensed plumber to rectify the leak.

Contact a qualified plumbing contractor.

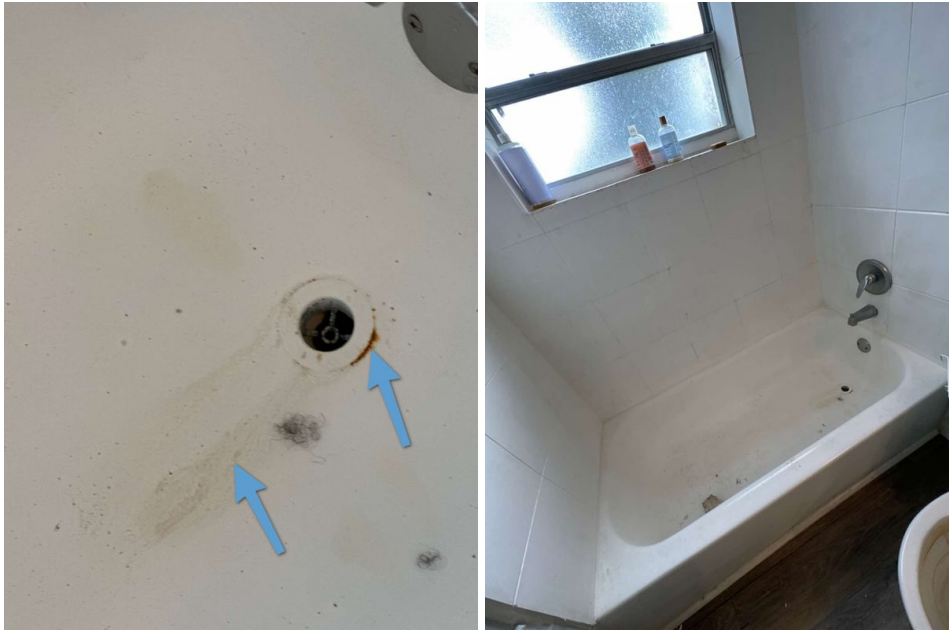
821

WEAR AT BATHTUB SURFACING

Corrosion and wear noted in unit 821s bathtub. Recommend repair to reduce worsening condition overtime or just monitoring (minor, typical wear).

Contact a qualified professional.

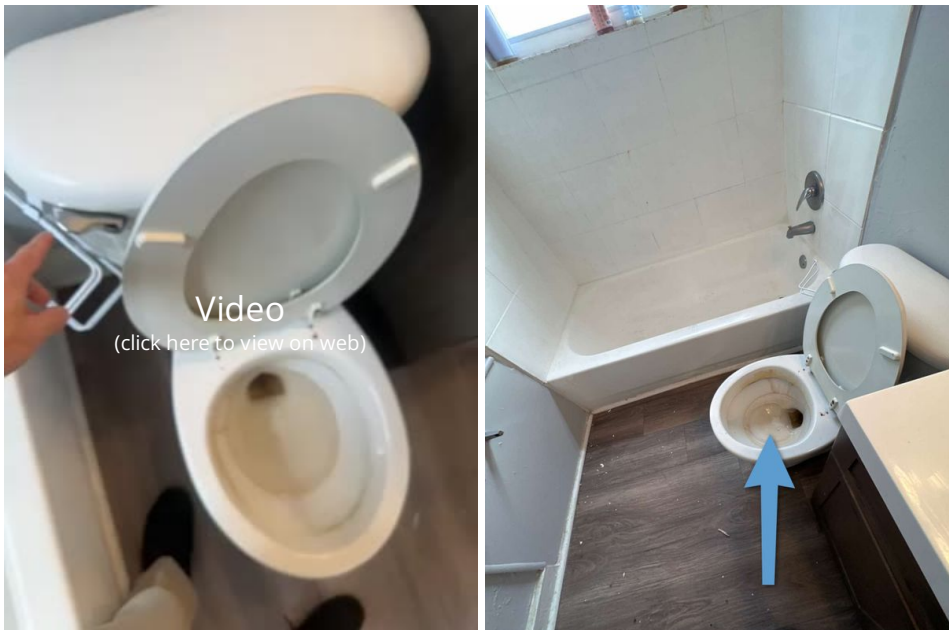
821

Unit 821s bathroom toilet was slow to drain. I had to hold the lever down for a second or two for the toilet to drain (still drained, just not as intended). Needs adjustment or repair in the tank, if desired.

Contact a qualified handyman.

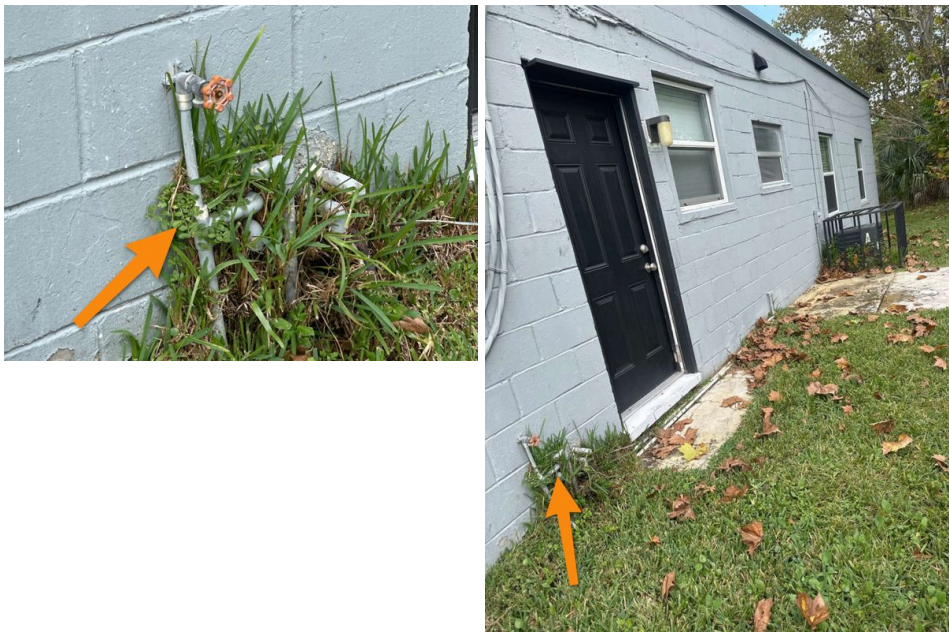
Recommend insulating the exterior supply pipes to help protect the piping from the elements.

Contact a handyman or DIY project

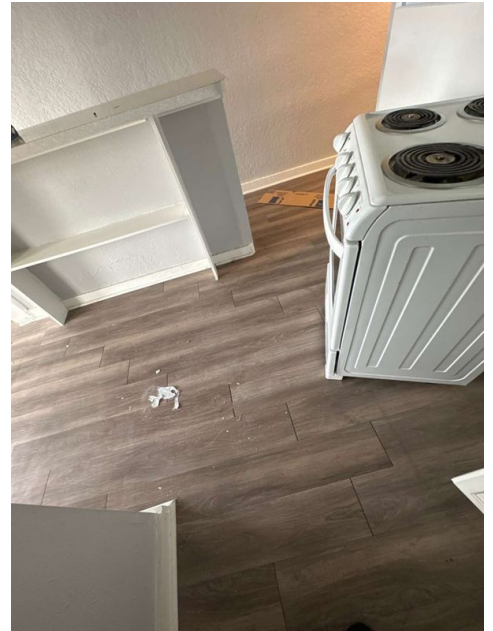
12.2.1 Foundation

There are moderate settlements noted. The structure did not show enough signs for me to label this a significant structural concern (in the inspectors opinion only, a second opinion by a structural engineer is always recommended), but there clearly is settlement. There is settlement though and its simply unclear if the settlement will continue or if it will stay stagnant. Recommend monitoring periodically and being cautious of this.

Recommend monitoring.

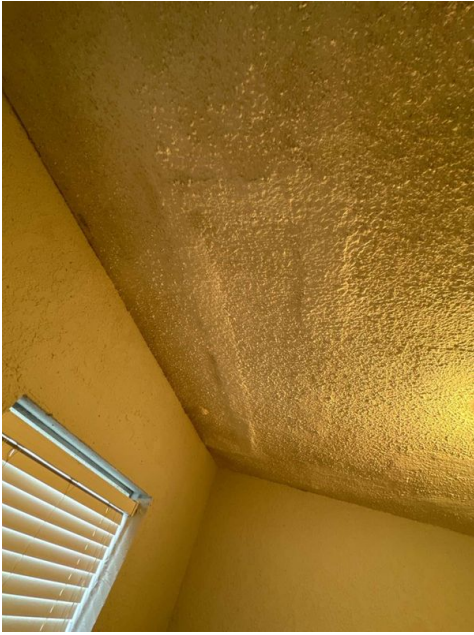
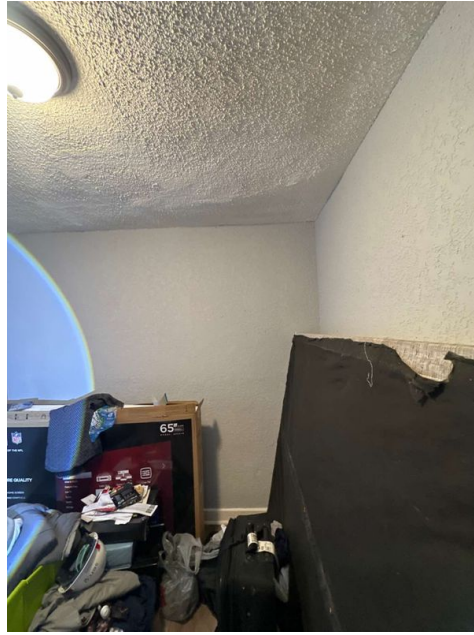
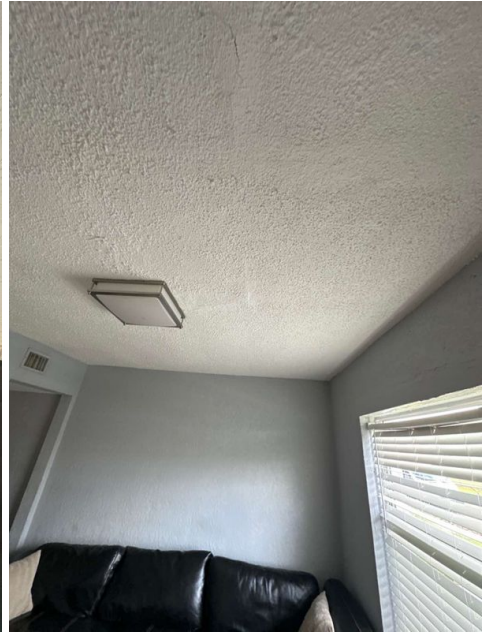
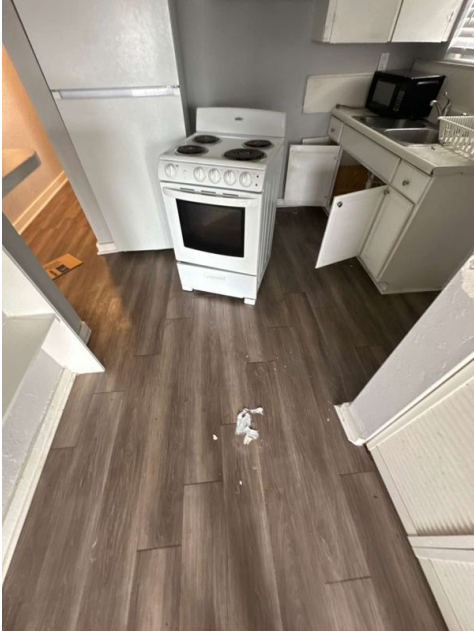
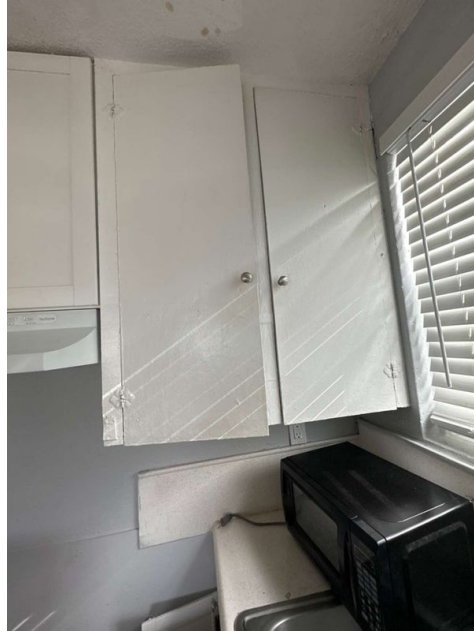
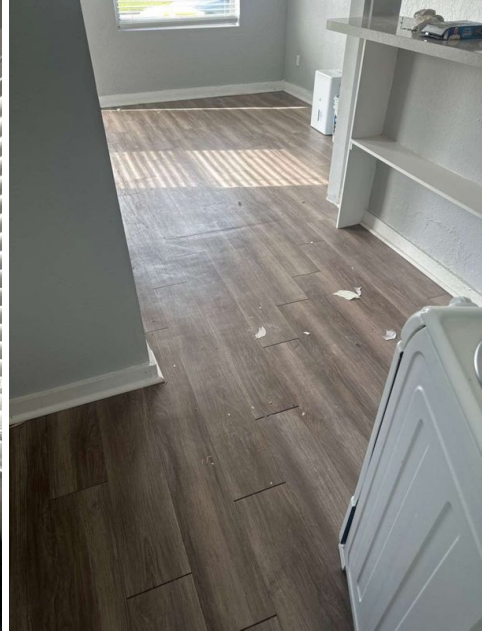
13.3.1 General Wear and Tear

GENERAL WEAR AND TEAR

This is not a new home, so the home has general wear and tear that can be common for its age. You should be aware of the general condition. We inspect with realistic expectations for the age of the home, but here are some photos of some of the more noticeable wear and tear items that were noted.

Contact a qualified professional.

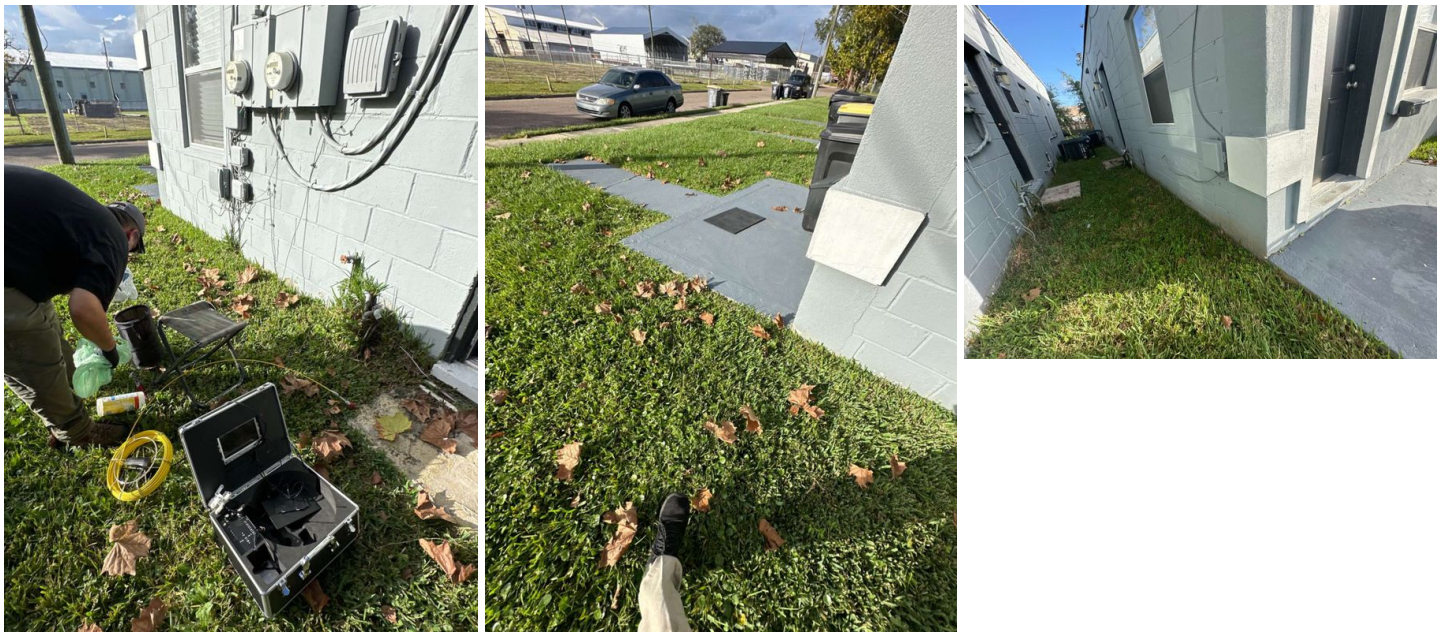
There was no cleanout for this home. There was cast iron drain pipes on the roof, but unclear what goes down underground and to the sewer. Recommend having a plumber further evaluate and install and cleanout and repair as needed.

Contact a qualified plumbing contractor.
